**Revised Draft Remedial Action Plan  
and Site Design for Stabilization of  
Moab Title I Uranium Mill Tailings  
at the Crescent Junction, Utah,  
Disposal Site**

**Remedial Action Selection Report**

**June 2007**

**Moab UMTRA Project**

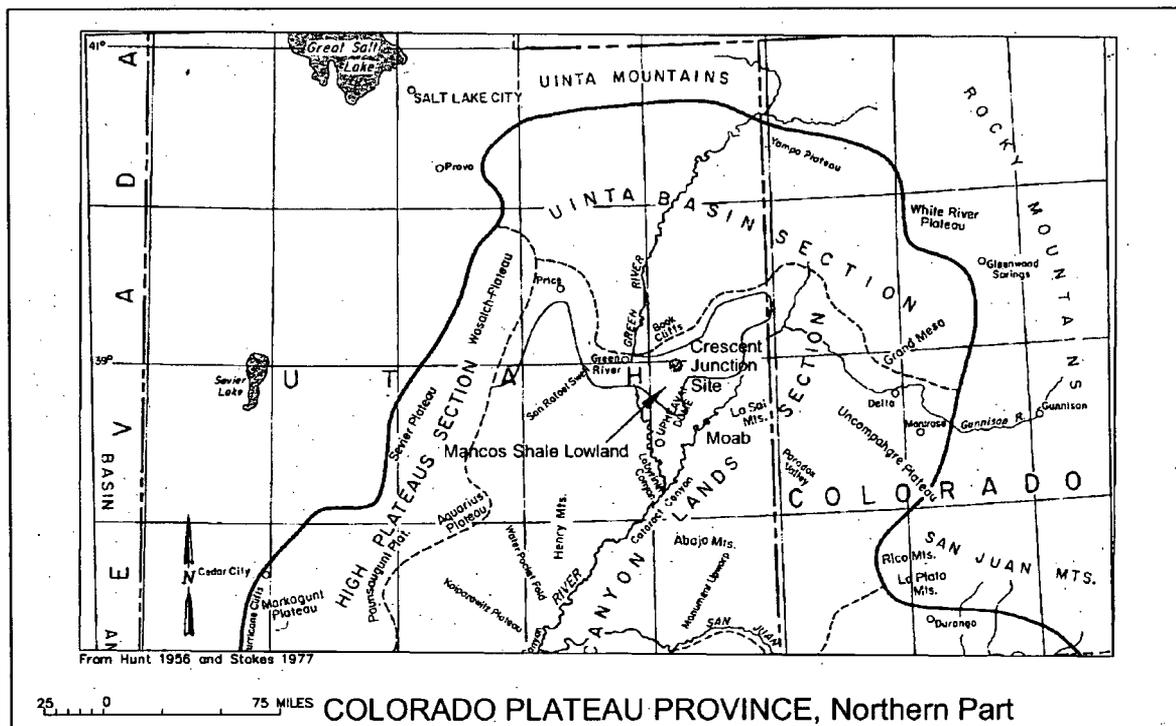
The Crescent Junction Site is in the north end of the Canyon Lands section of the Colorado Plateau physiographic province (Figure 2-1). The Canyon Lands section is characterized by

Figure 2-1. Physiographic Setting of the Crescent Junction Site

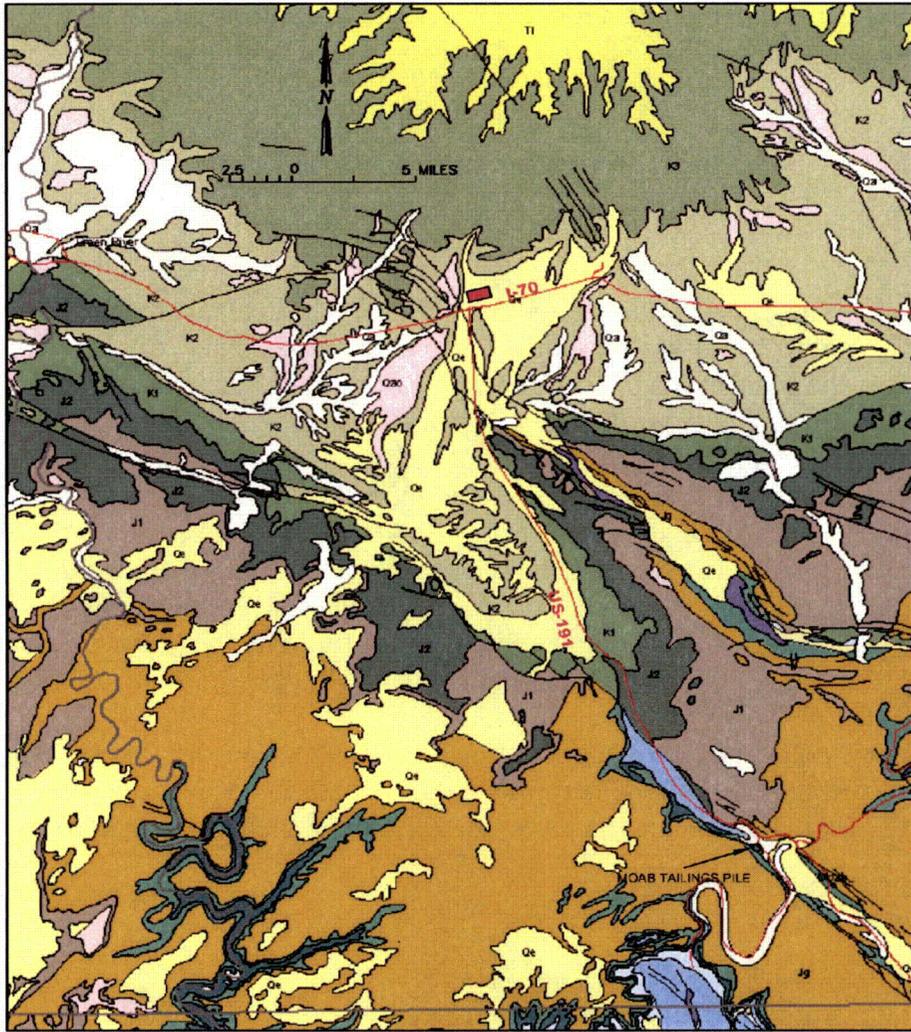
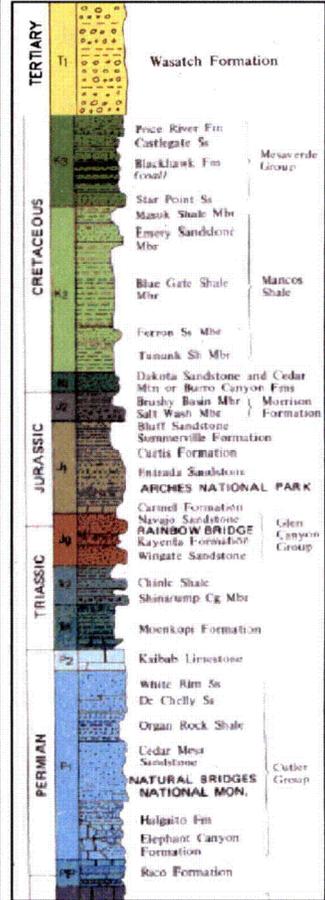
SOUTHEASTERN UTAH  
(FOR SURFICIAL DEPOSITS, SEE EXPLANATION BELOW)

- CRESCENT JUNCTION SITE
- FAULT
- HIGHWAY AND NUMBER
- I-70
- QUATERNARY SURFICIAL DEPOSITS
  - Qa ALLUVIUM AND COLLUVIUM
  - Qe EOLIAN AND ALLUVIAL DEPOSITS
  - Qap OLDER ALLUVIAL DEPOSITS

No evidence of faulting in the Crescent Junction area was observed during the photogeologic evaluation and follow-up field investigations. The only faults noted were outside the withdrawal area, which encompasses the Crescent Junction Disposal Site.

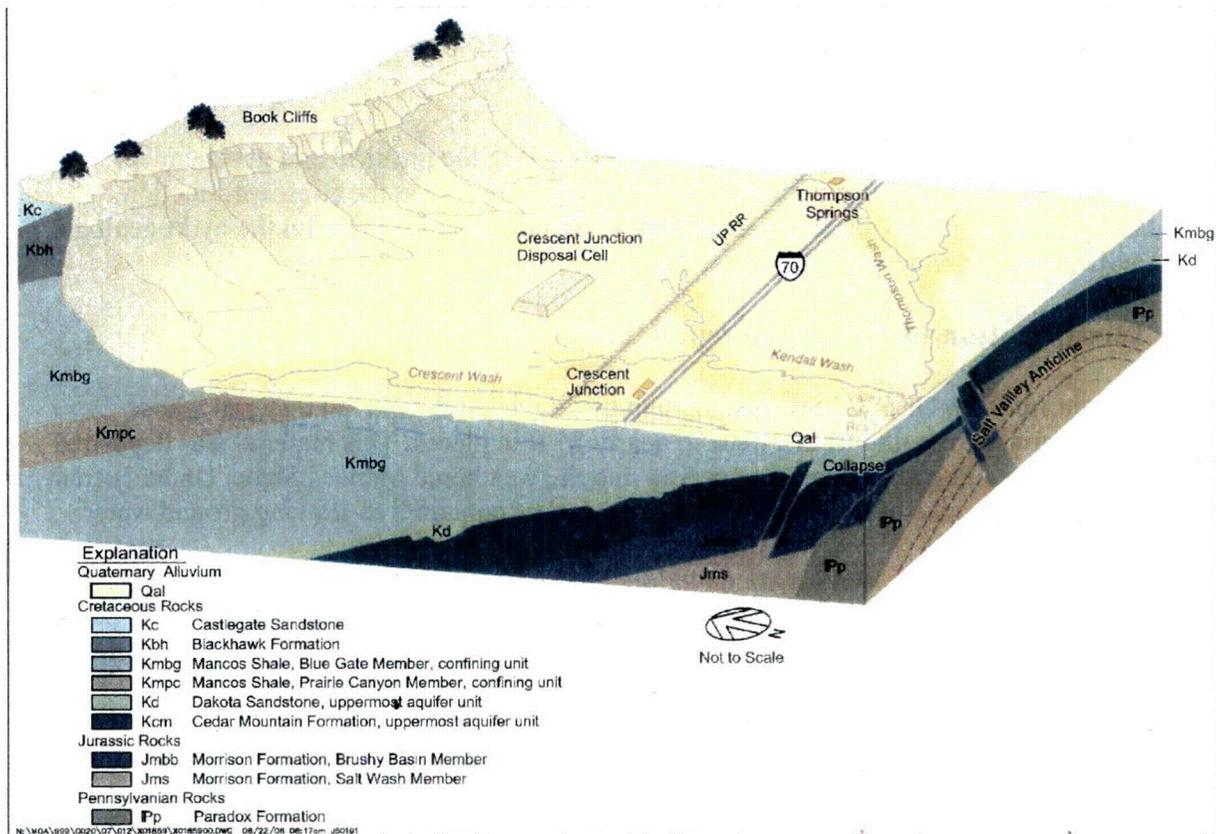
Figure 3–1. Schematic Block Diagram Depicting the Major Hydrogeologic and Topographic Features at the Crescent Junction, Utah, Disposal Site

The alluvial and colluvial materials are underlain by the Mancos Shale, which is approximately 2,400 ft thick below the site and forms an important regional confining unit. The Mancos Shale is composed of calcareous shale, mudstone, and claystone that contains thin sandstone lenses, interbedded siltstone, and zones of limestone concretions and dolomite or limestone beds. These fine-grained rocks have very low permeabilities and inhibit infiltration of precipitation (Hood 1976). The Mancos Shale forms a massive barrier to horizontal and vertical ground water movement (Freethy and Cordy 1991).

Minor quantities of ground water are present in the Mancos Shale at depths that exceed 100 ft. The ground water is very saline to briny with total dissolved solids (TDS) concentrations ranging from 23,000 milligrams per liter (mg/L) at well 0208 to 42,000 mg/L at wells 0201 and 0204. At these TDS concentrations, the State of Utah designates the ground water in the Mancos Shale to be *Class IV-Saline Ground Water* (Utah State Code, R317-6-4, Ground Water Class Protection Levels). Primarily on the basis of its salinity, this ground water is believed to be connate (Freethy 2006, personal communication) and therefore, very old and unconnected to deeper, more regional aquifer systems. It also appears to be disconnected from sources of freshwater recharge. The zone of connate water at the Crescent Junction Disposal Site is not considered an aquifer.

The uppermost aquifer beneath the Crescent Junction Site is the Dakota aquifer, which underlies the Mancos Shale confining unit, approximately 2,400 ft below the ground surface. A schematic diagram of the hydrogeologic units that underlie the Crescent Junction Site is presented in Figure 3-1. The Dakota aquifer is composed of the Dakota Sandstone and the Cedar Mountain Formation. Published accounts of drill holes advanced to the Dakota aquifer within a radius of approximately 20 mi of the Crescent Junction Disposal Site indicate that the ground water is mostly salty (Sumsion 1979). Ground water samples from the Dakota aquifer were not obtained as part of this project because of the great depth at which the aquifer occurs.

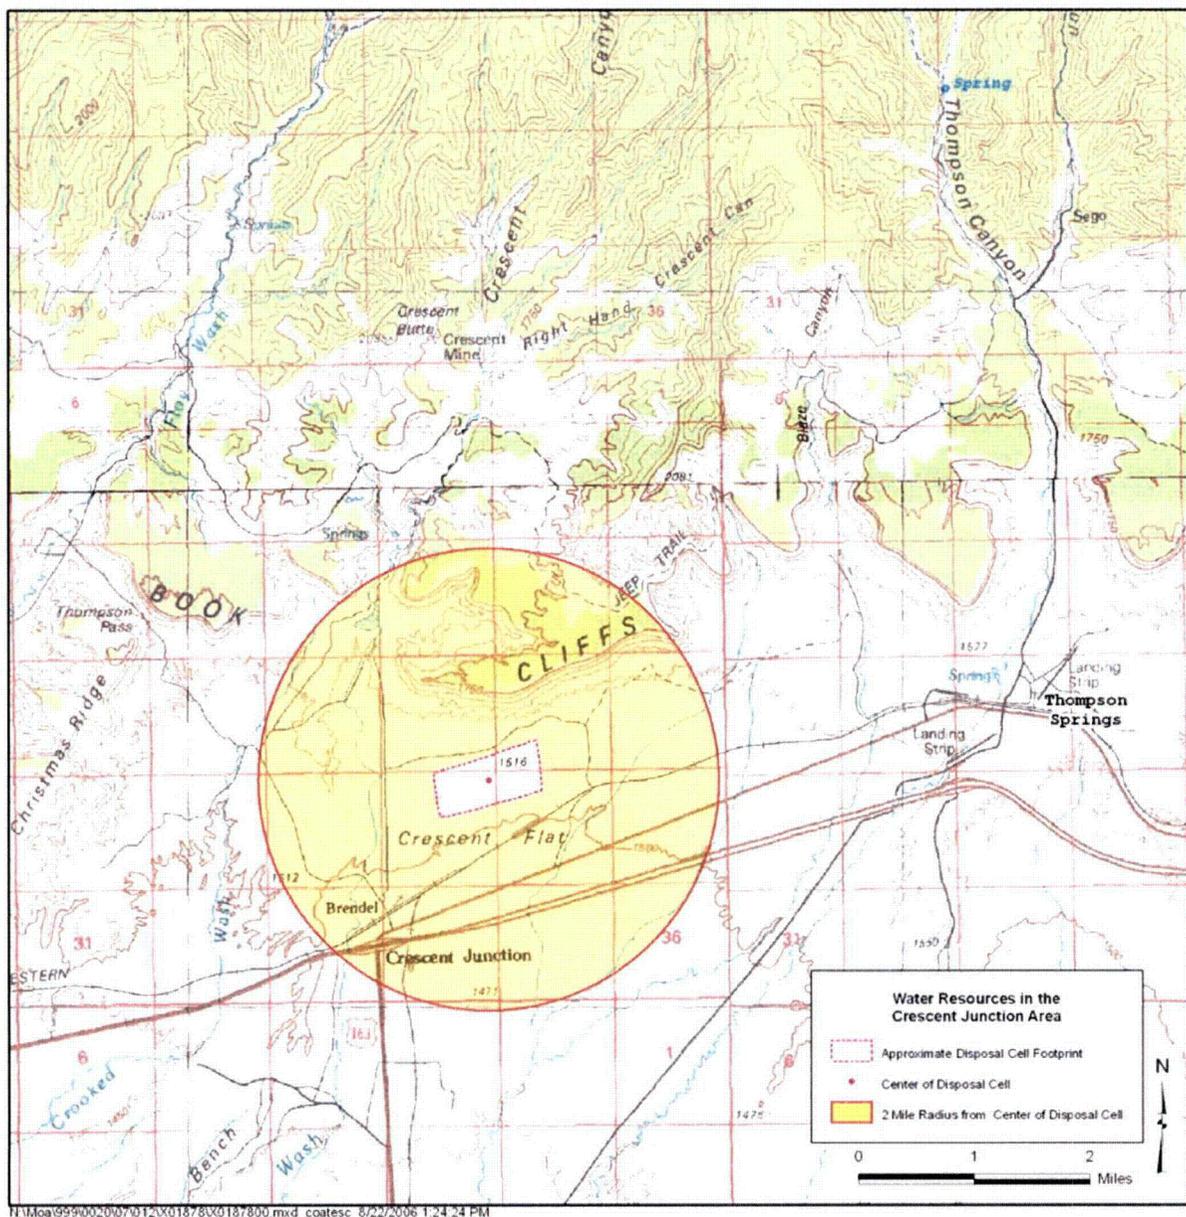
There are no private or municipal wells within 2 mi of the Crescent Junction Disposal Site. Figure 3-3 illustrates the occurrence of water resources in the Crescent Junction area.

Figure 3-3. Water Resources in the Vicinity of Crescent Junction, Utah

The nearest municipal water supply to the Crescent Junction Disposal Site is in Thompson Canyon, located approximately 7 mi north of Thompson Springs, Utah. The springs in this area yield approximately 20 gallons per minute (Sumsion 1979) from a carbonaceous shale layer near the top of the Neslen Formation (Willis 1986), which is a part of the Cretaceous Mesaverde Group. The springs constitute the sole source of potable water in the immediate area. In 2006, DOE installed a new 3-inch water line, which extends from Thompson Springs and serves residential and commercial customers in the vicinity of the Crescent Junction Disposal Site.

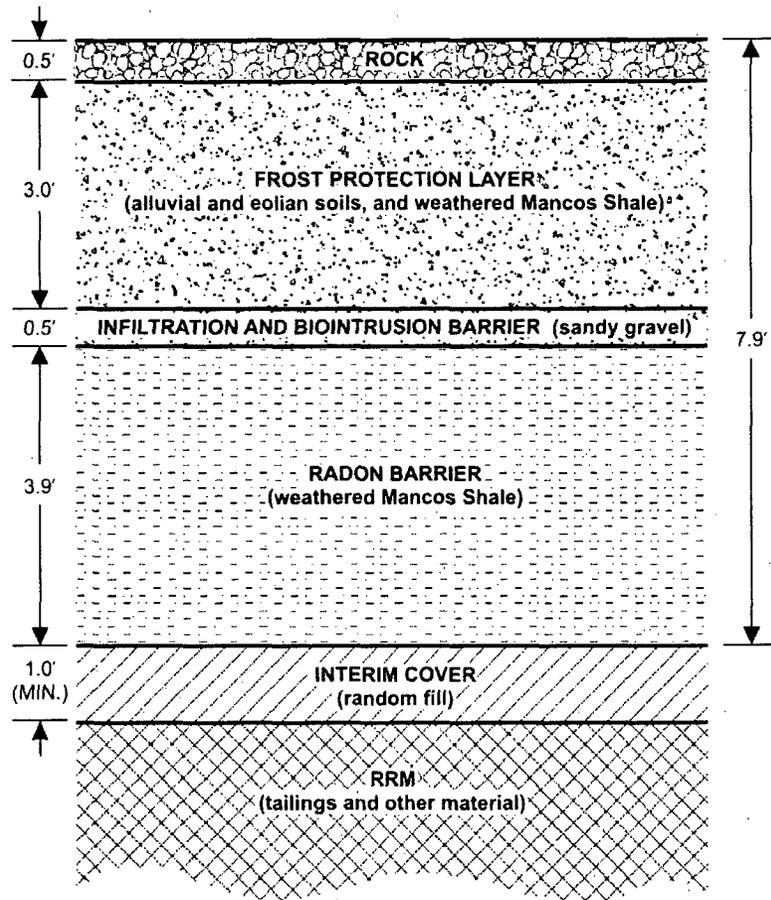
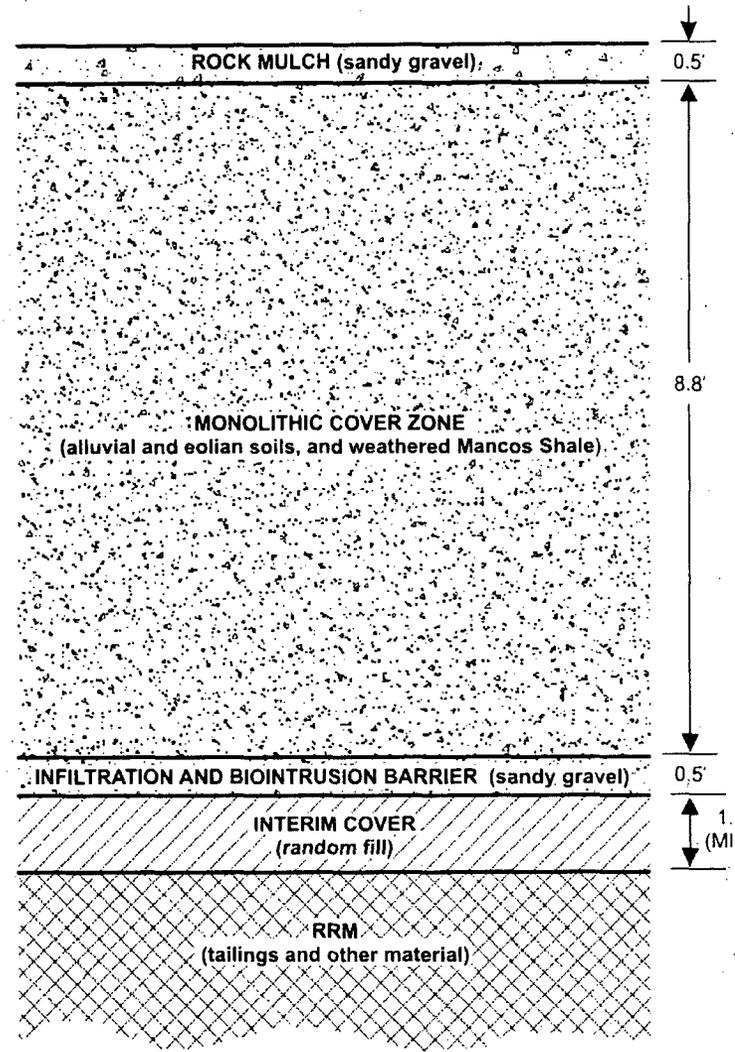
**UMTRA COVER DESIGN**

**ALTERNATIVE COVER DESIGN**

Figure 5-1. UMTRA Project Cover Design and Alternative Cover Design

The radon barrier design parameters and supporting calculations were used in conjunction with the RADON model (NRC 1989a) to determine the cover thickness necessary to meet the EPA radon flux standard of  $20 \text{ pCi}/\text{m}^2/\text{s}$ . Guidance provided in the TAD (DOE 1989) was considered in developing the cover design. The radon barrier layers have been optimized by the RADON model (NRC 1989a) to limit the radon flux to  $20 \text{ pCi}/\text{m}^2/\text{s}$  under long-term physical conditions. As with previous UMTRA Project Title I cover designs, the attenuation of radon by the frost protection, drainage, biointrusion, or erosion protection layers is not considered in the baseline analyses, though these layers will further reduce the radon flux rate at the disposal cell surface. Attachment 1, Appendix B presents the input parameters used for each model run as well as the model run results.

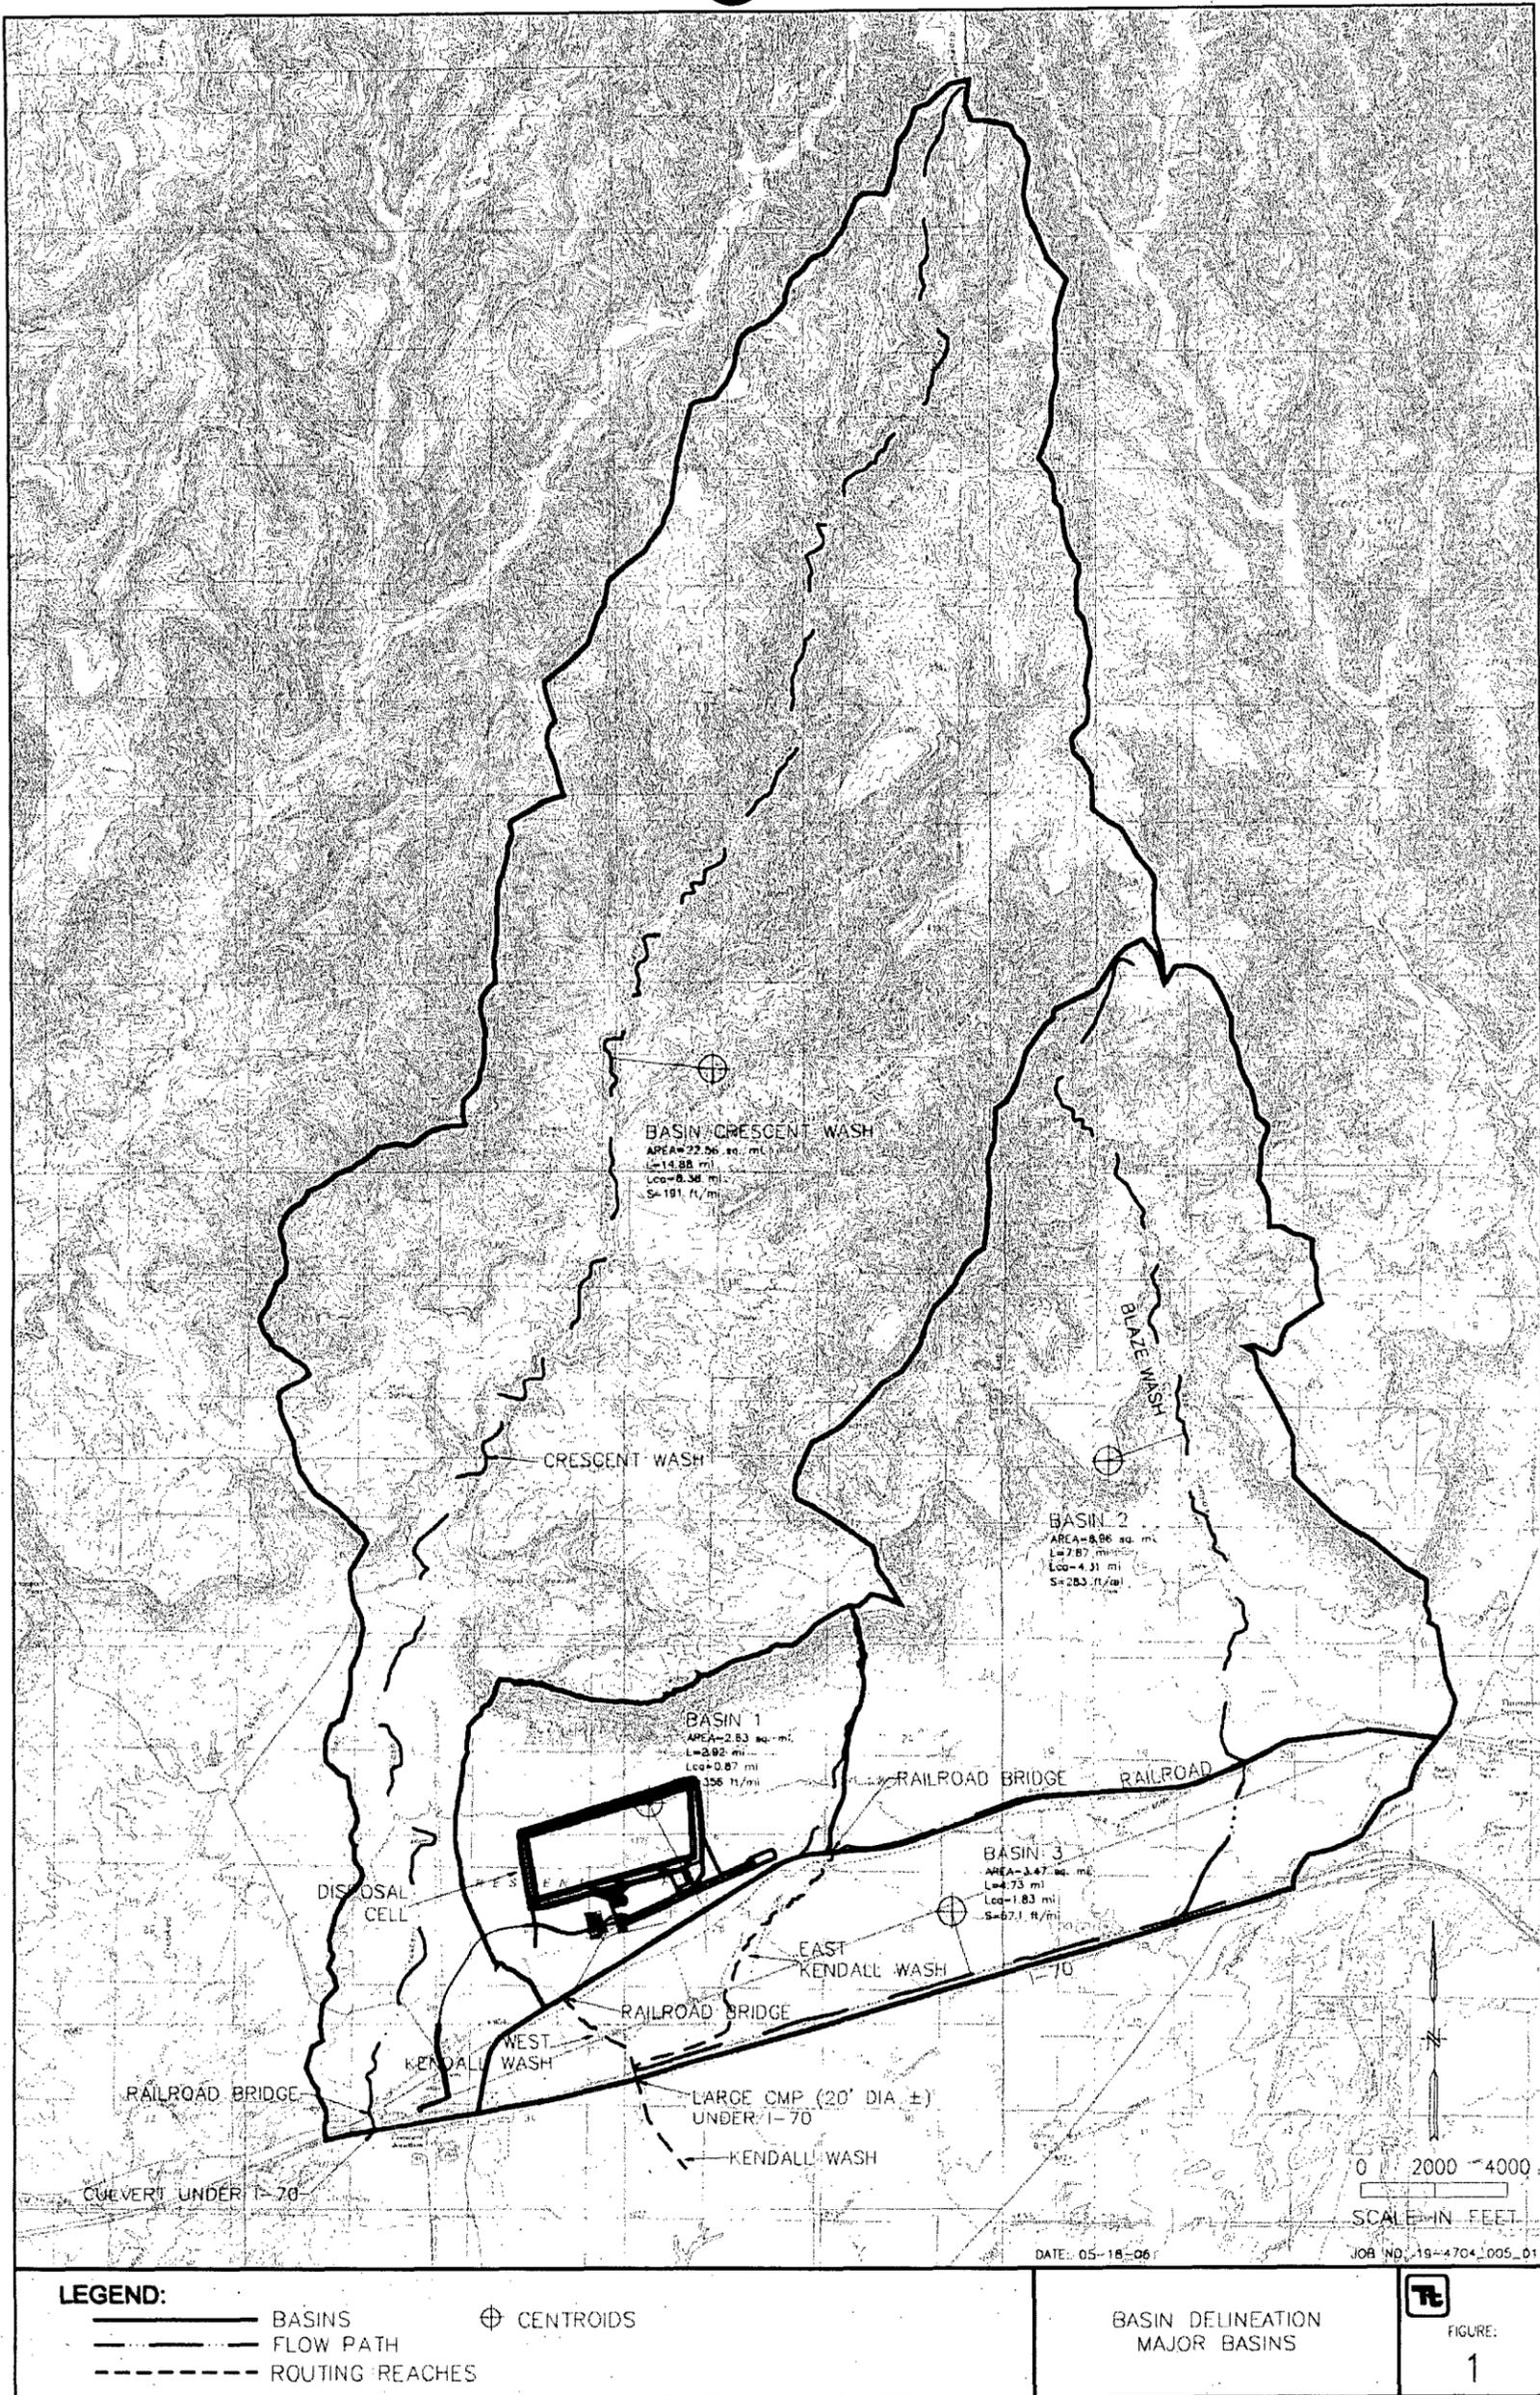
Figure 6-1. Basin Delineations in and Adjacent to the Crescent Junction Disposal Site

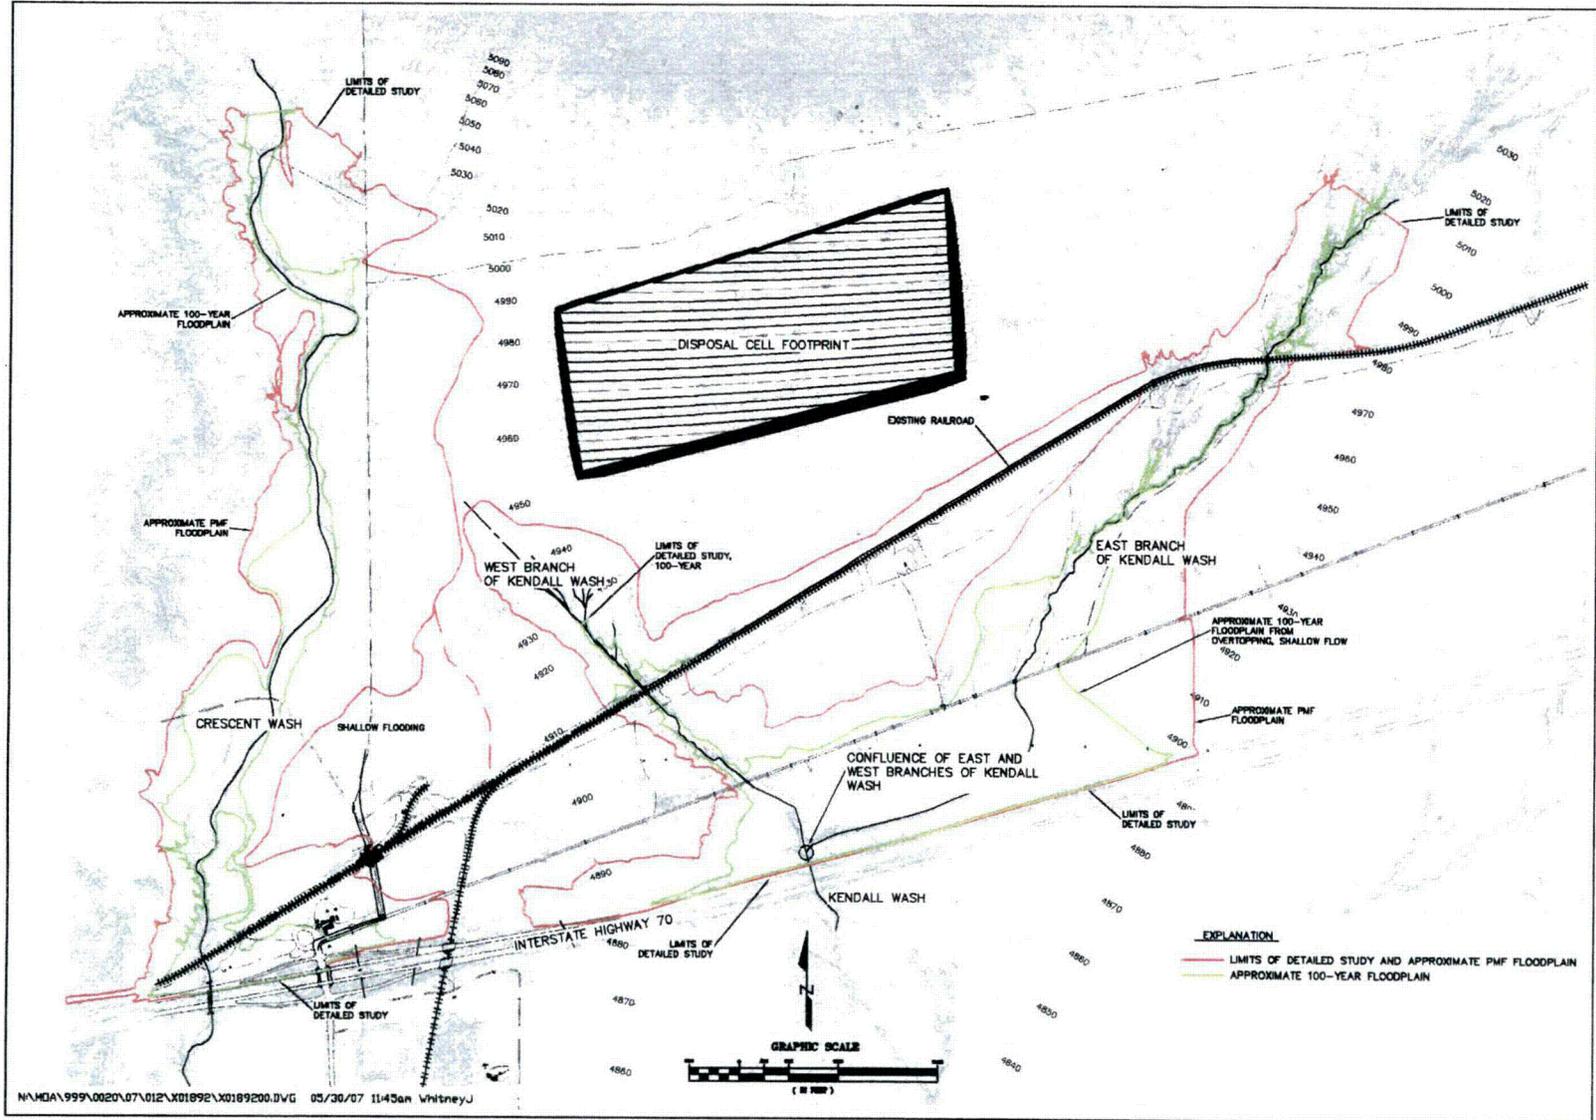
Figure 6-2. PMP and 100-Year Floodplain Delineations for the Crescent Junction Disposal Site

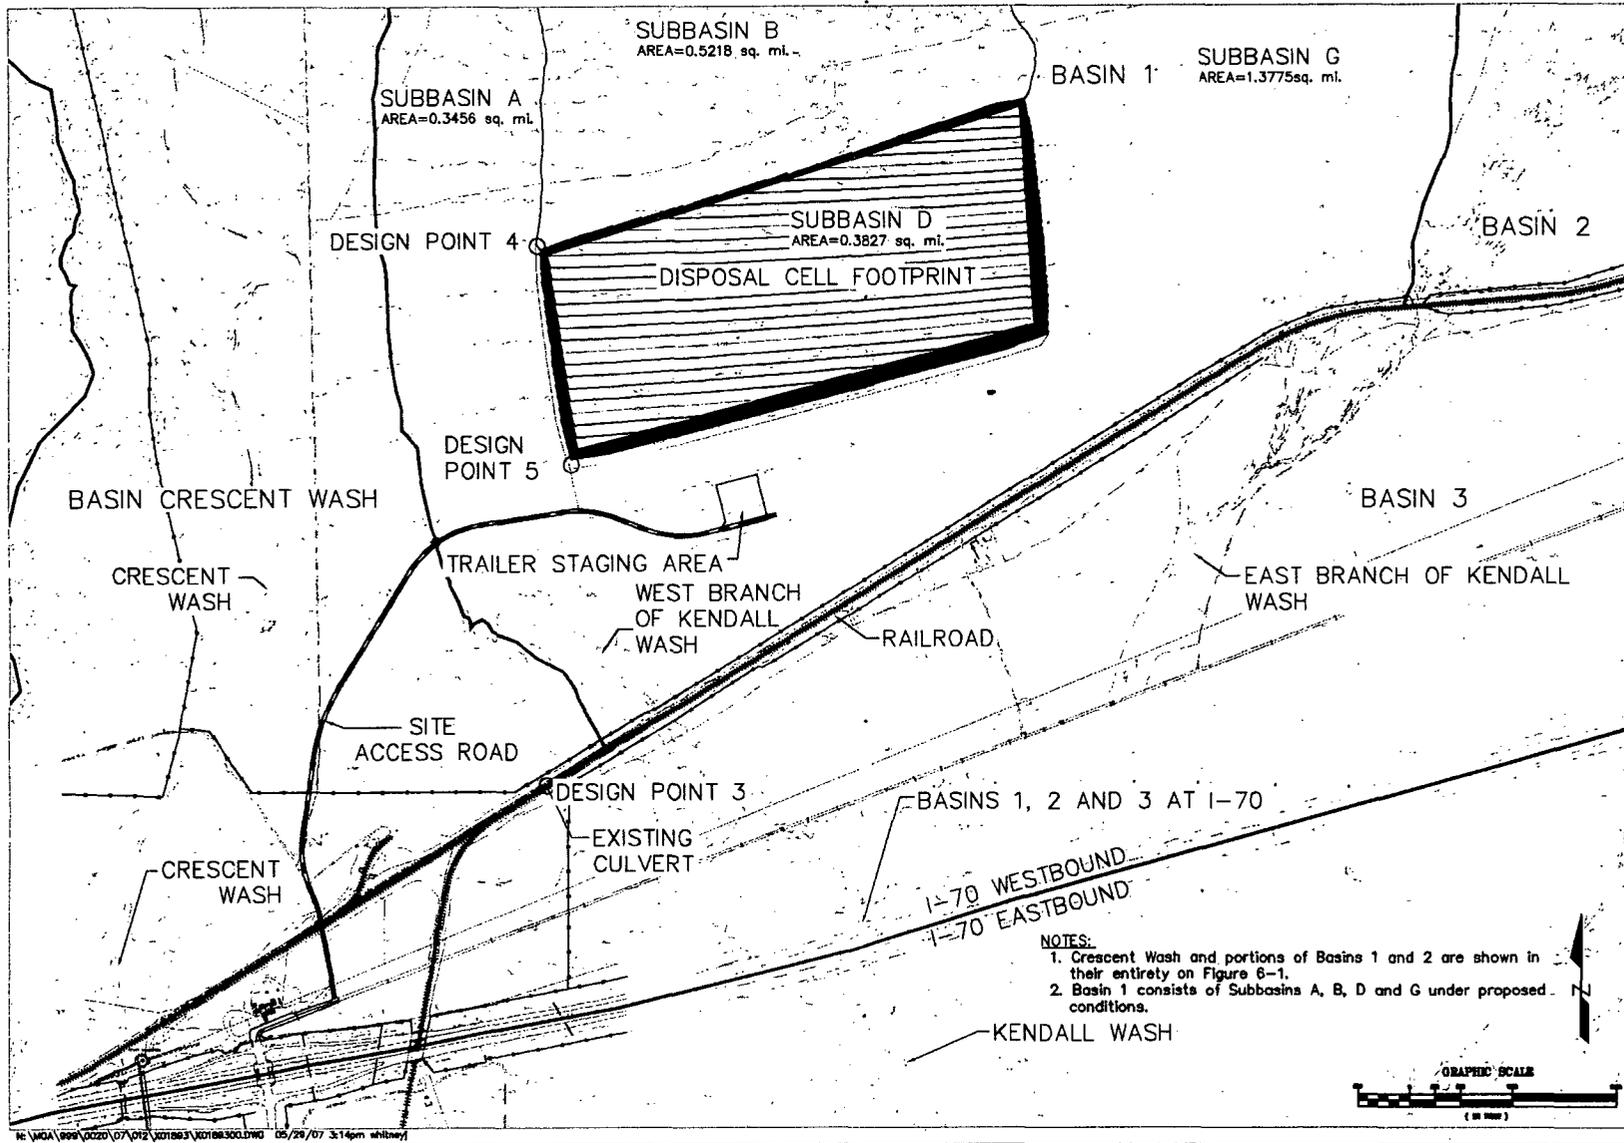
Figure 6-3. Crescent Junction Disposal Cell Site Drainage Plan

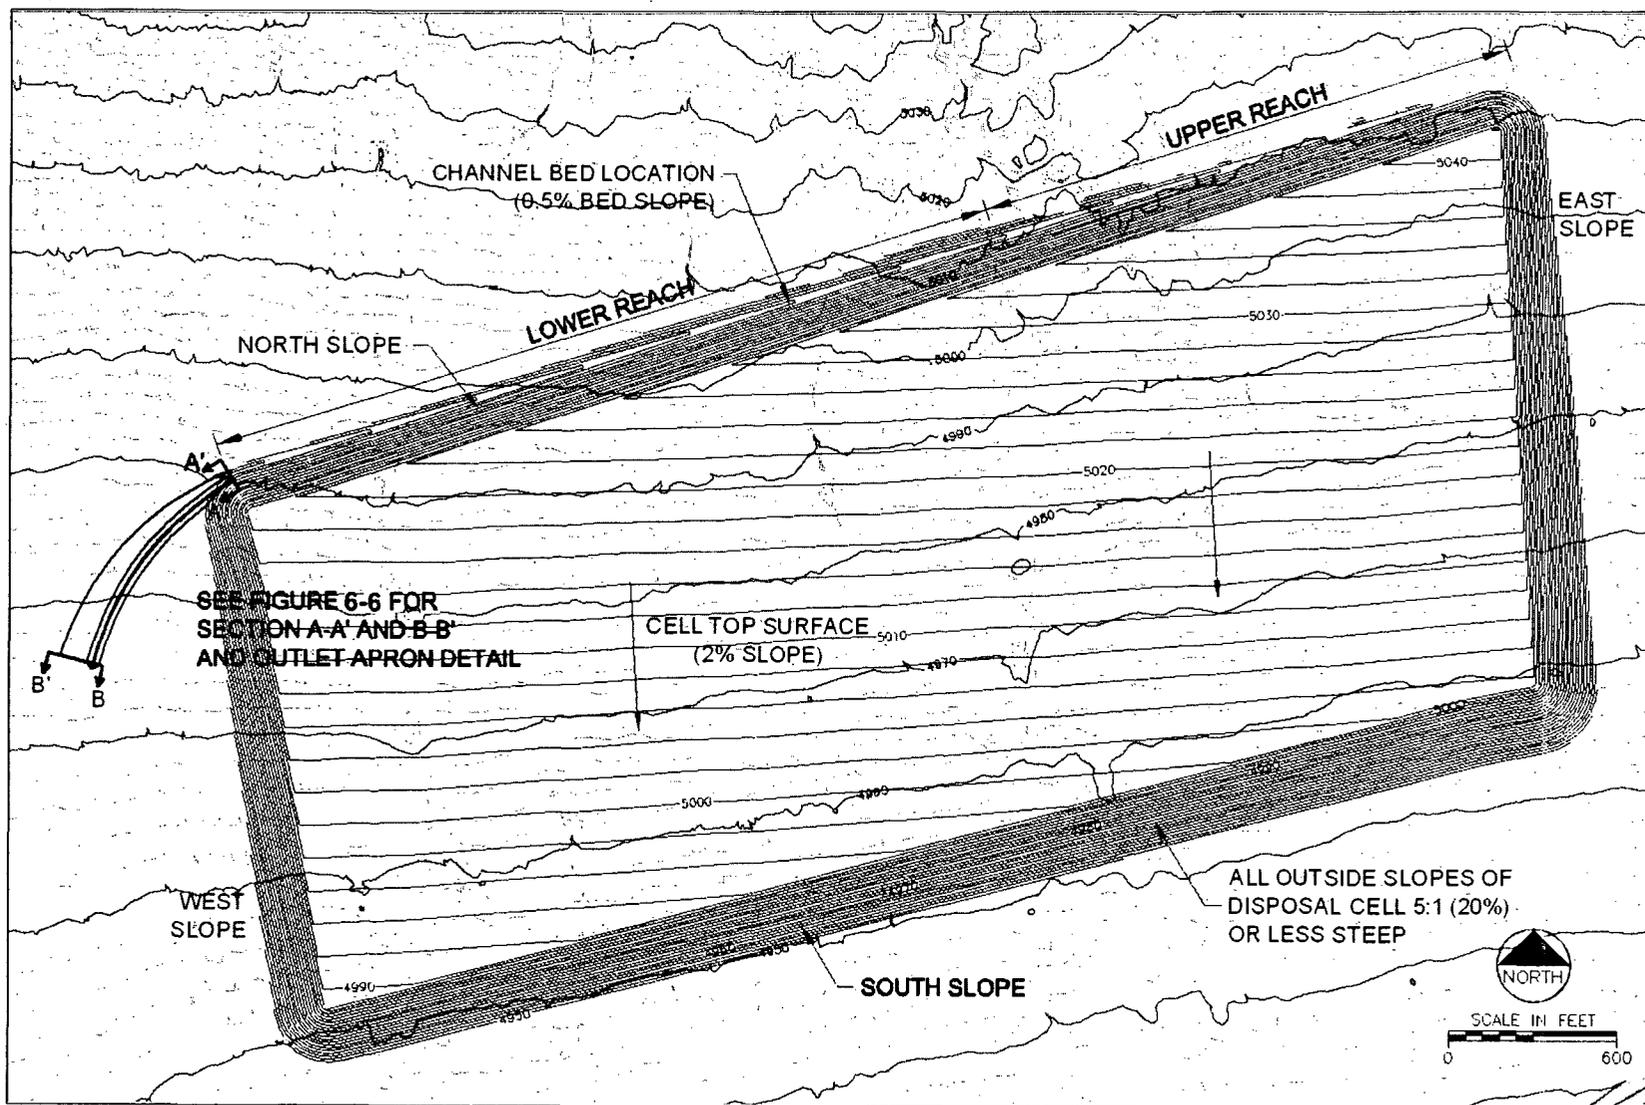
Figure 6-4. Disposal Cell Layout with Erosion Protection Features

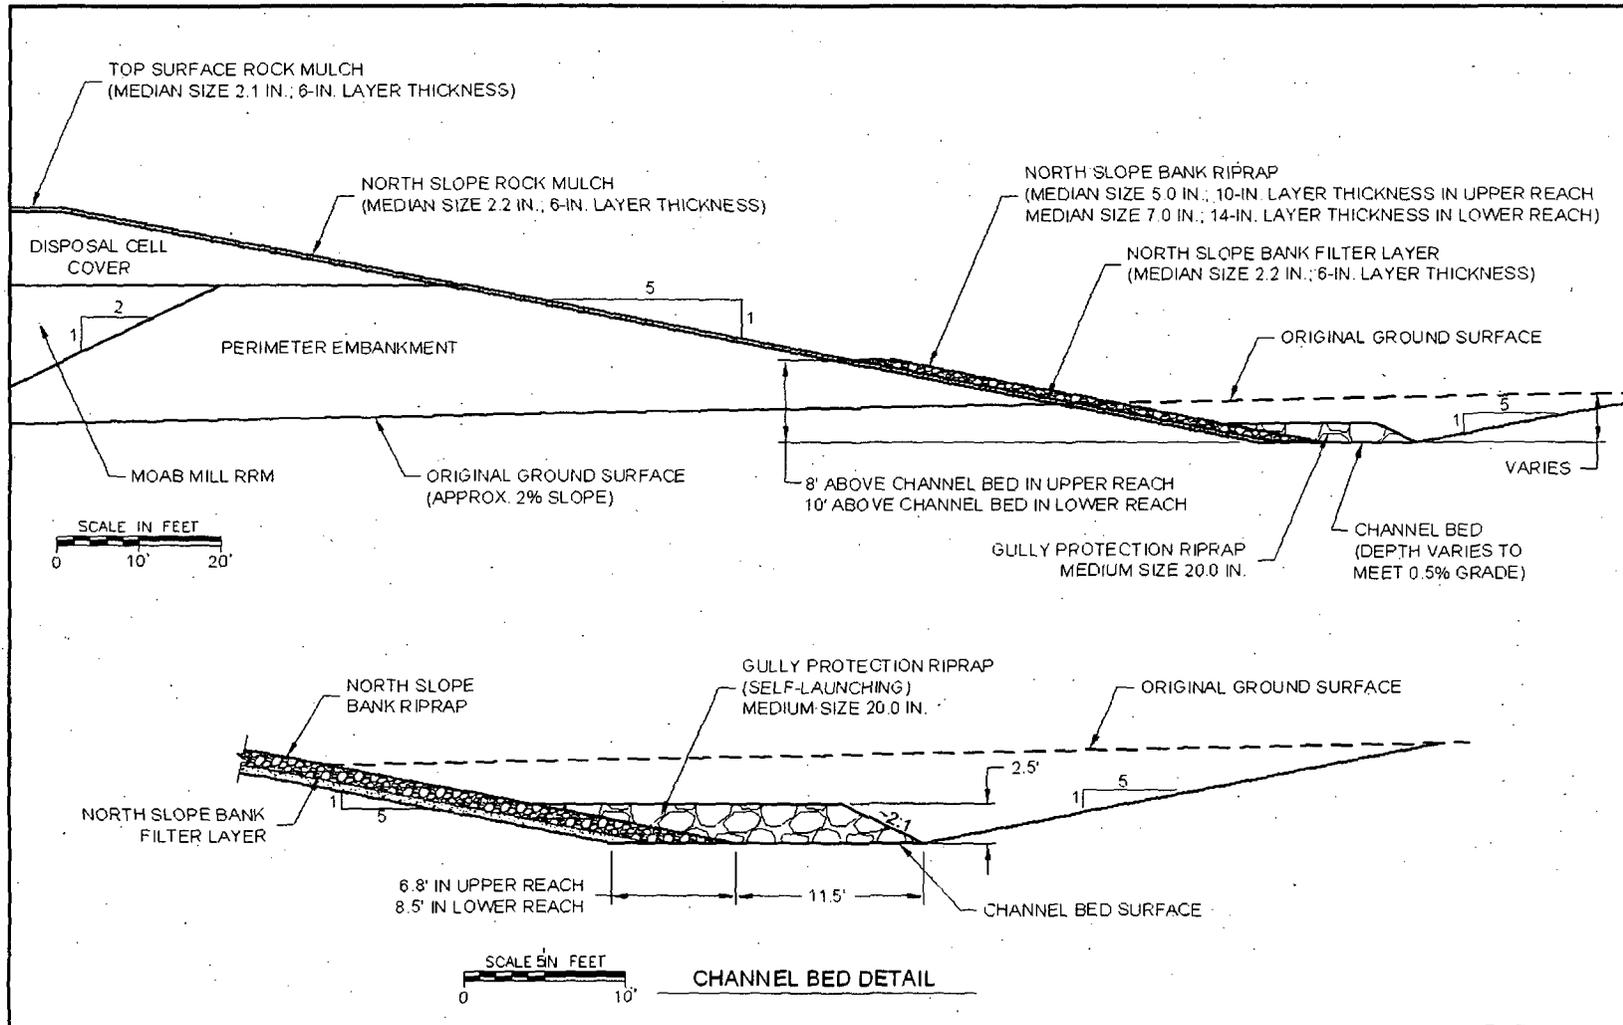
Figure 6-5. Typical Cross Section Through North Slope of Disposal Cell Showing Erosion Protection Material

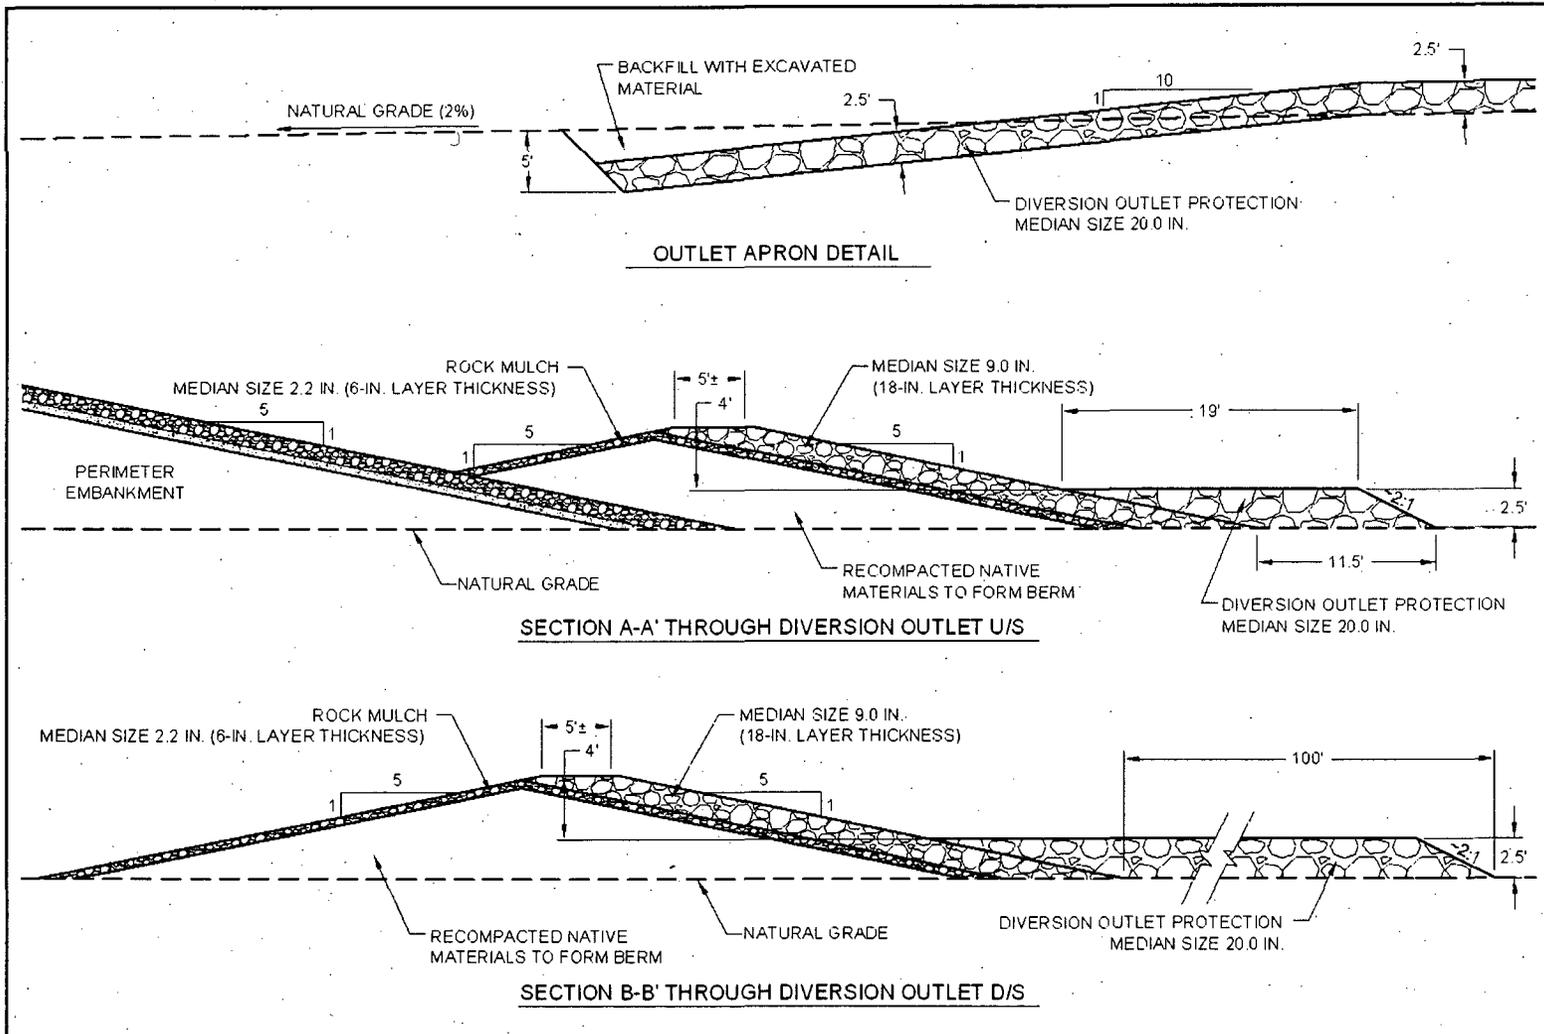
Figure 6-6. Buried Riprap Feature Plan and Cross Section

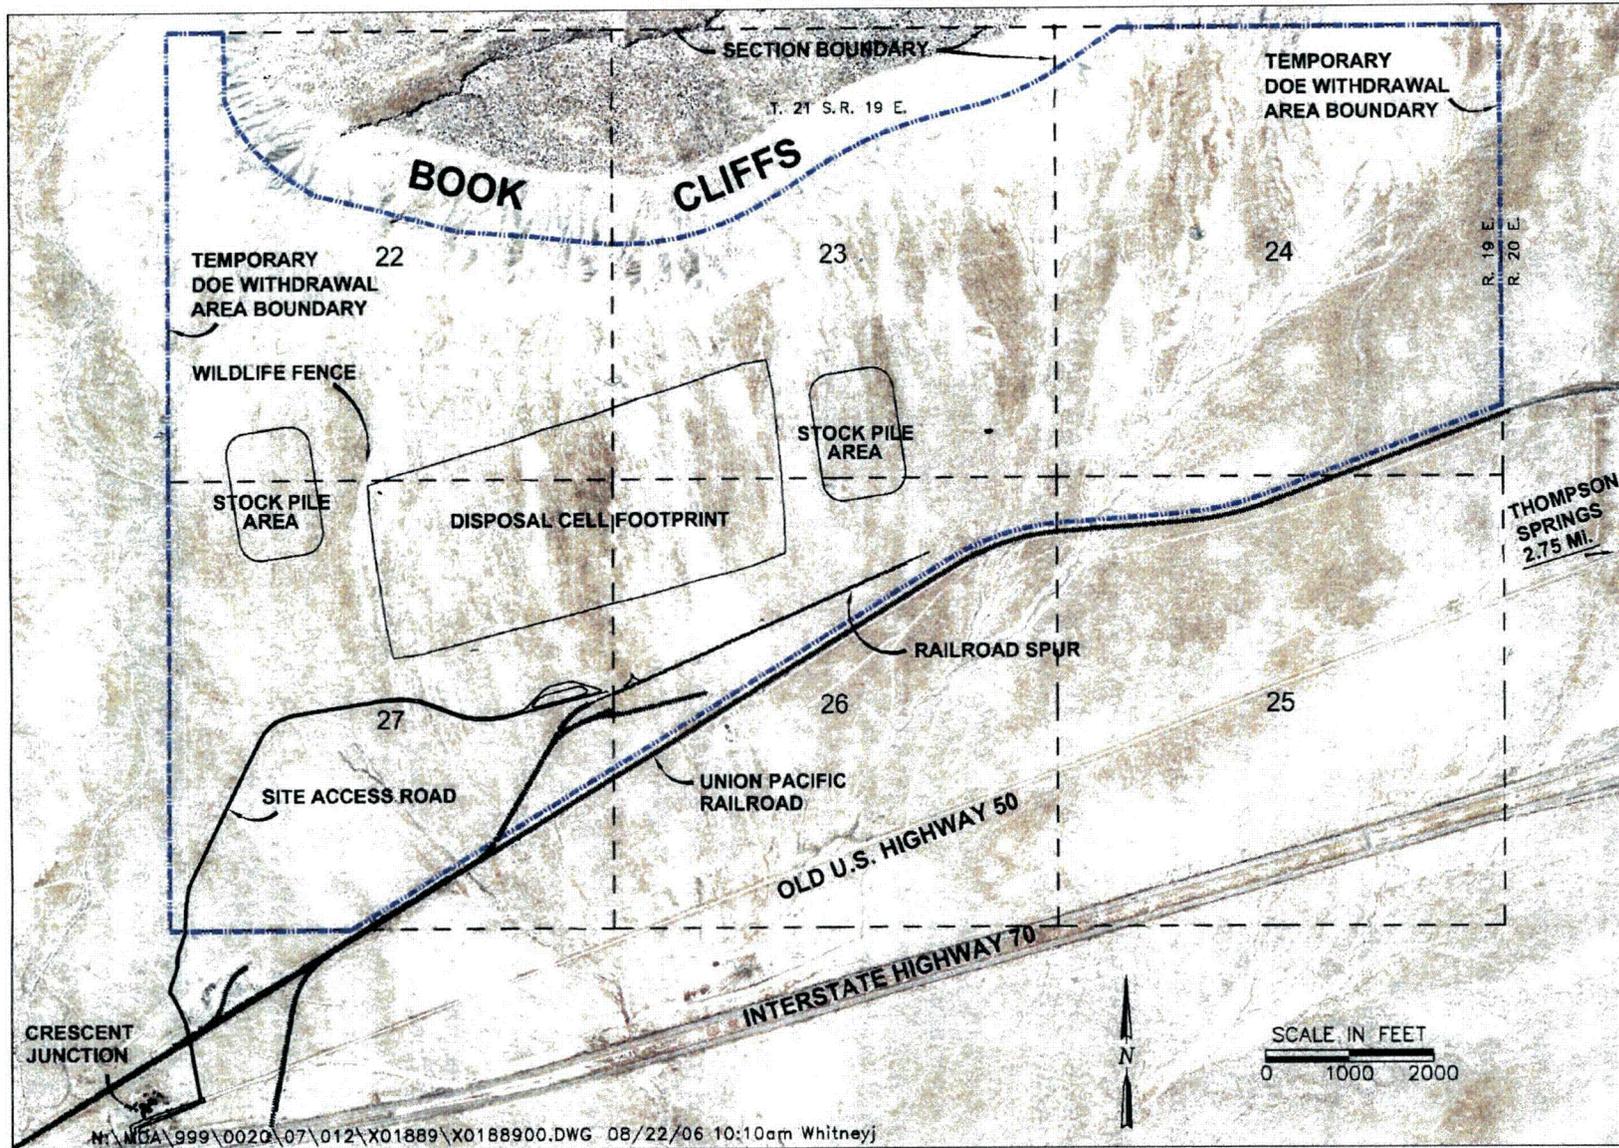
Figure 7-1. Crescent Junction Disposal Cell Footprint and Existing and Proposed Site Features
