**Revised Draft Remedial Action Plan  
and Site Design for Stabilization of  
Moab Title I Uranium Mill Tailings  
at the Crescent Junction, Utah,  
Disposal Site**

**Remedial Action Selection Report**

**June 2007**

**Moab UMTRA Project**

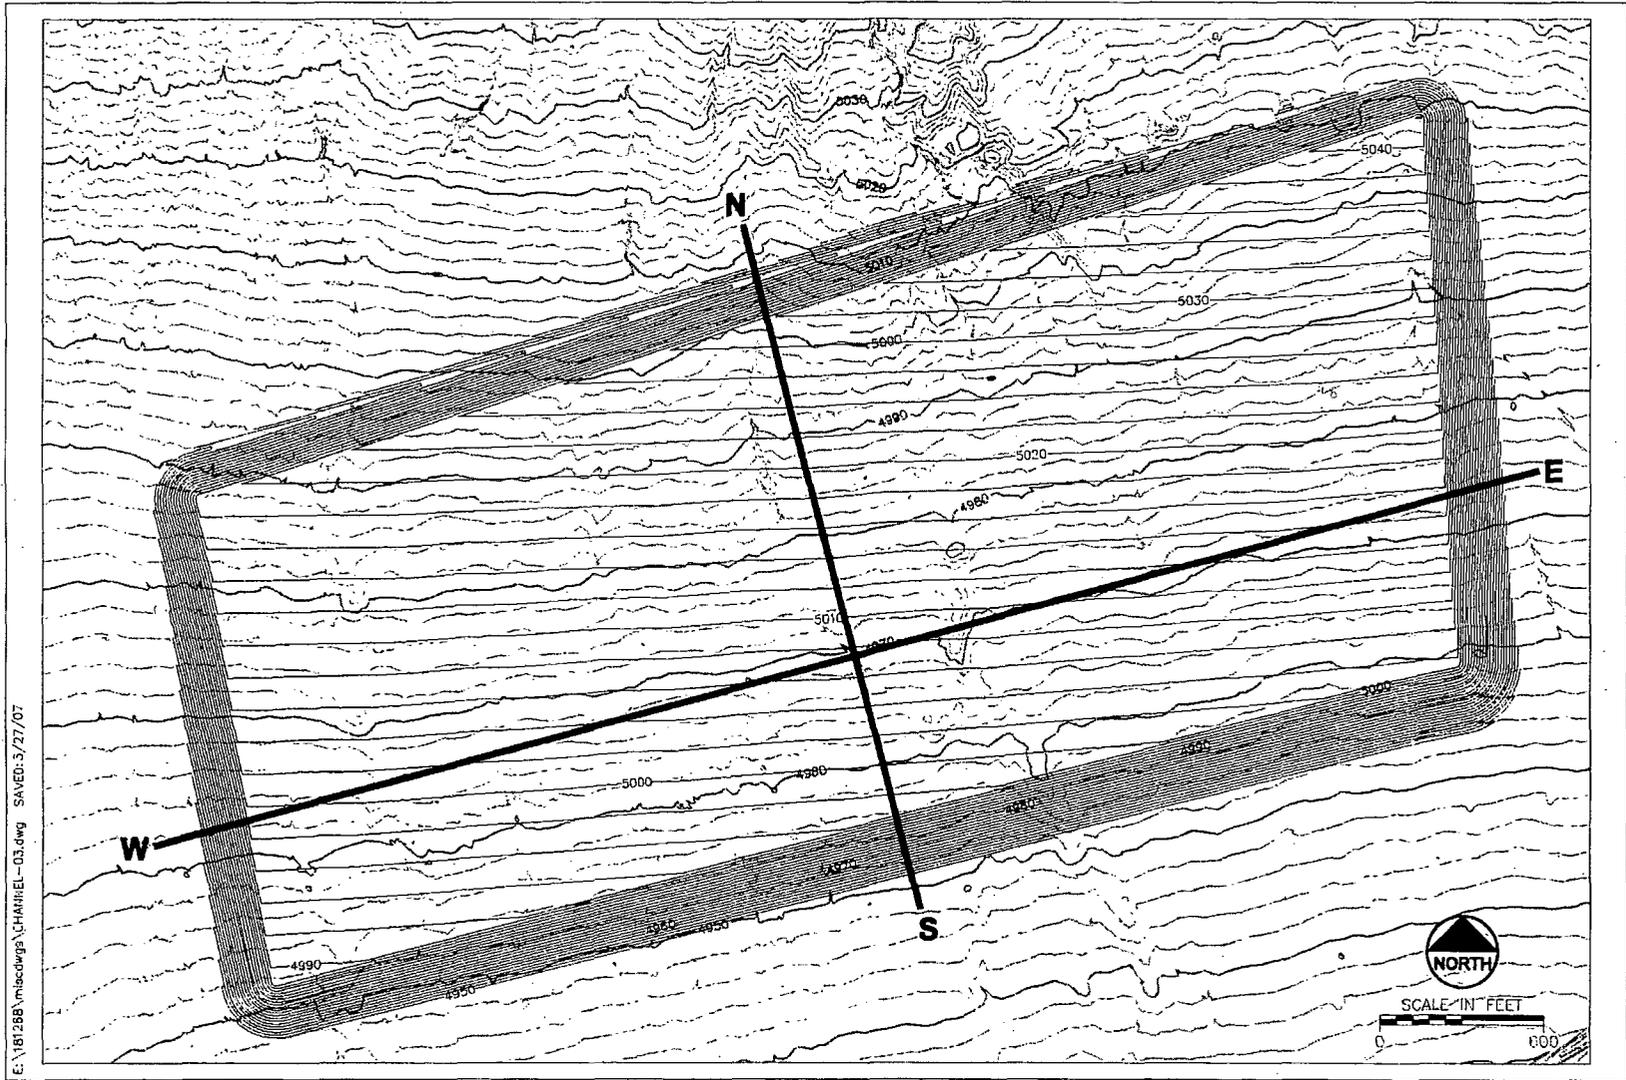
Figure 7-2. Disposal Cell Layout with Typical Cross-Section Locations

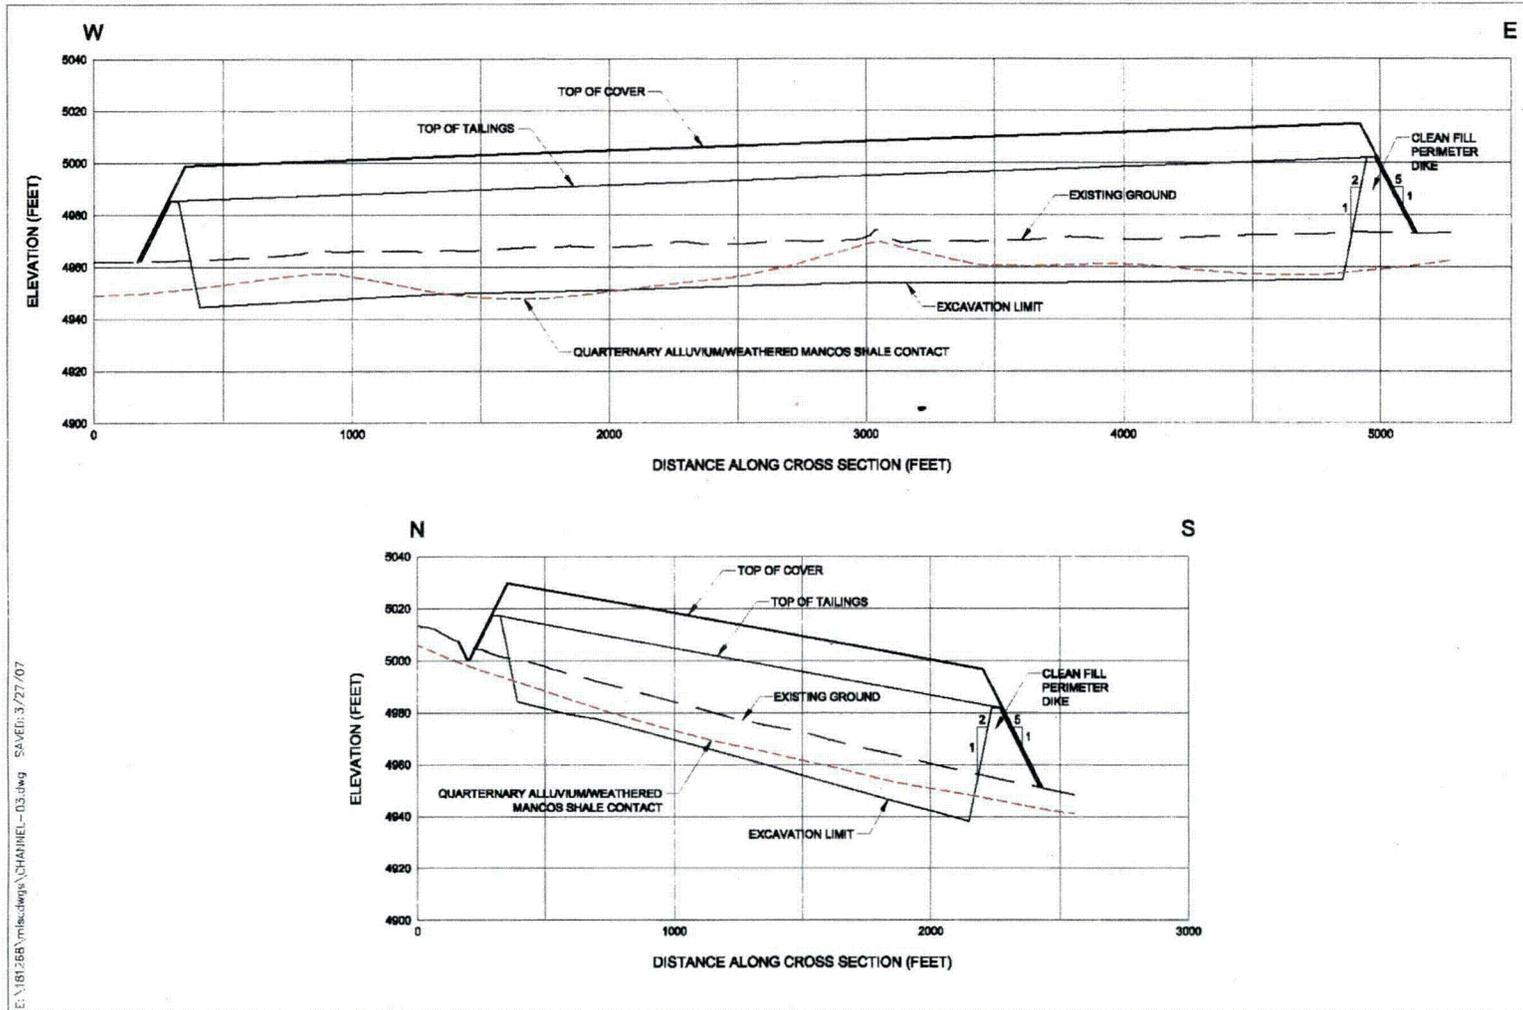
Figure 7-3. Typical Cross Sections for Crescent Junction Disposal Cell

The north side of the disposal cell, nearer to the Book Cliffs, intersects the existing slope at an angle to provide a 0.5 percent grade to the west (Figure 7-3). This reduces the velocity of runoff against the north toe of slope, while maintaining the existing drainage path to the West Branch of Kendall Wash. The west and east sides of the cell are canted inward slightly to provide sheet flow for side slope runoff away from the toe of the side slopes.

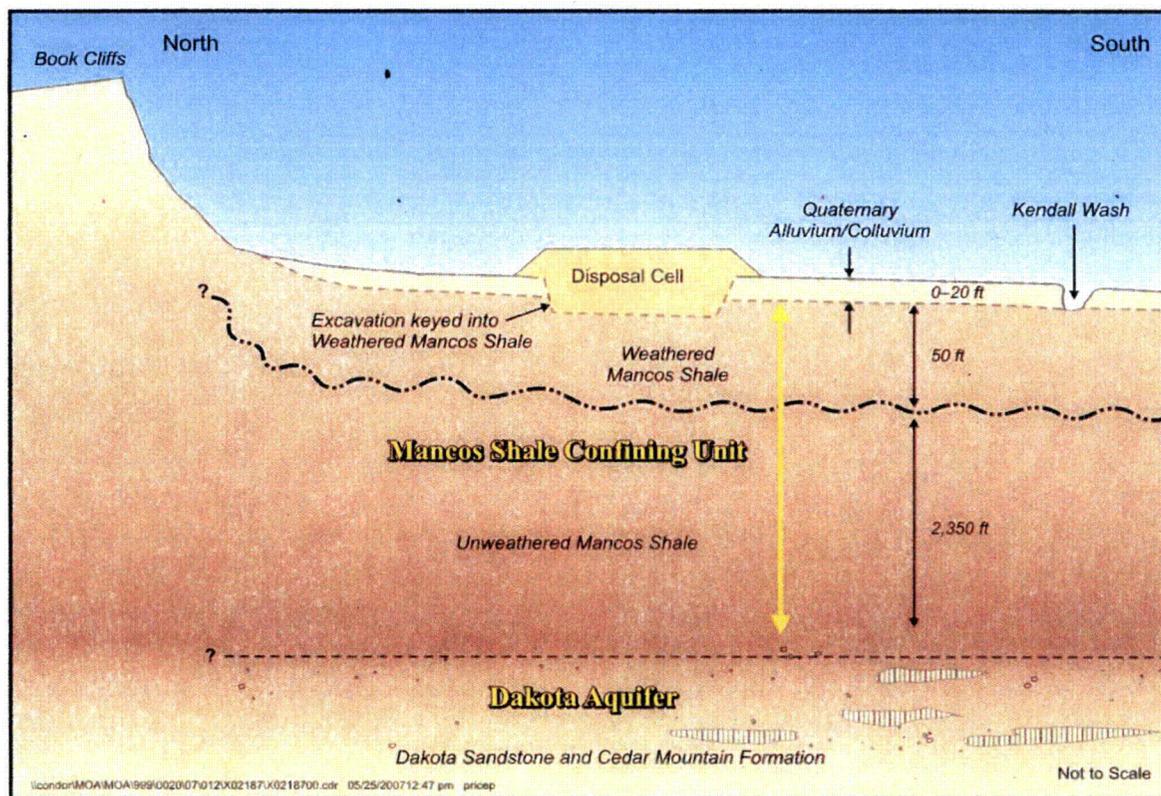
A schematic depiction of the disposal cell in relationship to surrounding geologic and hydrogeologic features is shown on Figure 7-4. As discussed in Section 8.0, the cell construction and site hydrogeology is anticipated to effectively isolate the RRM from the uppermost Dakota aquifer. The stable geologic, seismic, and geomorphic setting of the site will ensure adequate control of the RRM for the design life of the cell.

Figure 7-4. Schematic Diagram of Crescent Junction Disposal Cell and Surrounding Geologic and Hydrogeologic Features
