A Study of Remote Visual Methods to Detect Cracking in Reactor Components

Stephen E. Cumblidge
Michael T. Anderson
Steven R. Doctor

Structural Mechanics in Reactor Technology
(SMiRT 19)

August 12-17, 2007

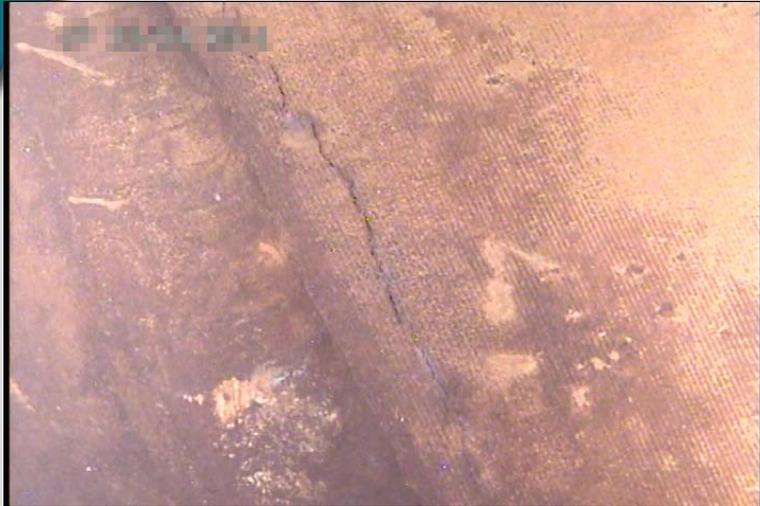
Definite Cracks

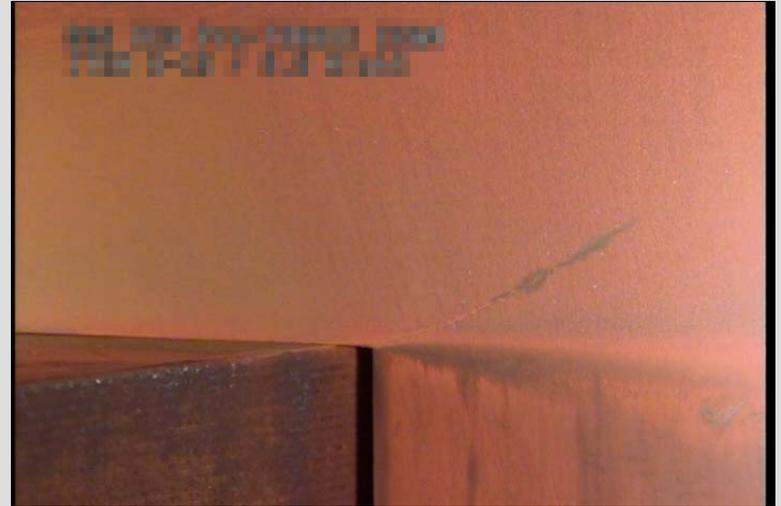
Possible Cracks

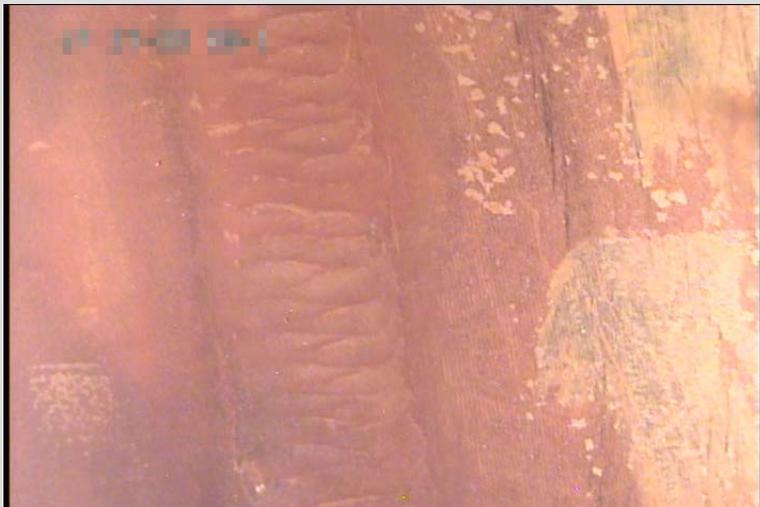
Topography and
Surface Conditions
