A Study of Remote Visual Methods to Detect Cracking in Reactor Components

Stephen E. Cumblidge
Michael T. Anderson
Steven R. Doctor

Structural Mechanics in Reactor Technology
(SMiRT 19)

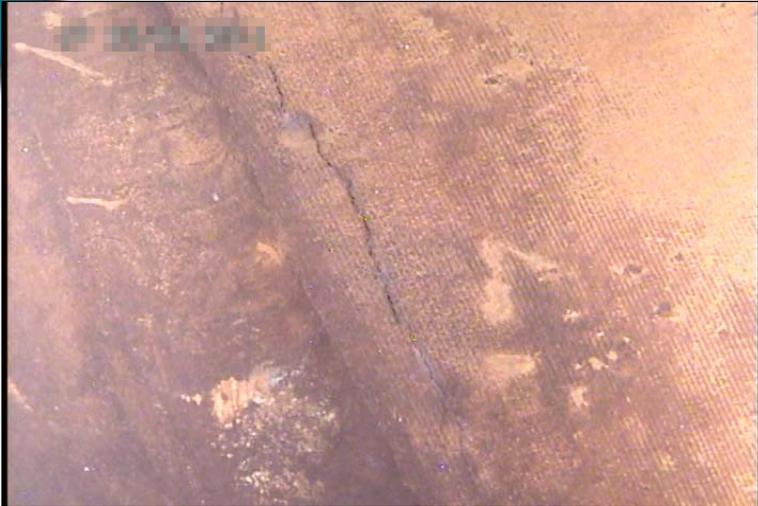
Definite Cracks

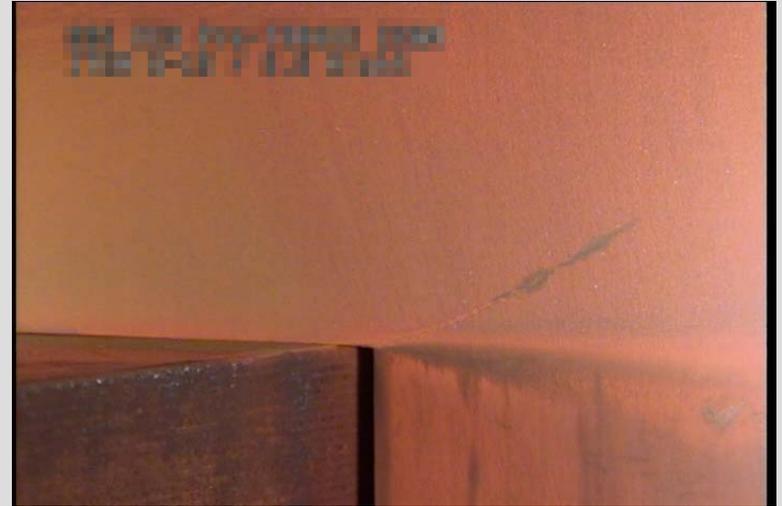
Possible Cracks

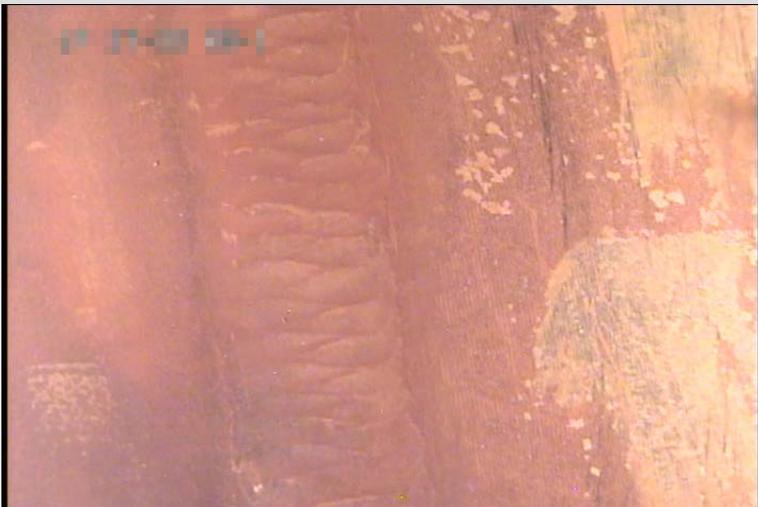
Topography and
Surface Conditions

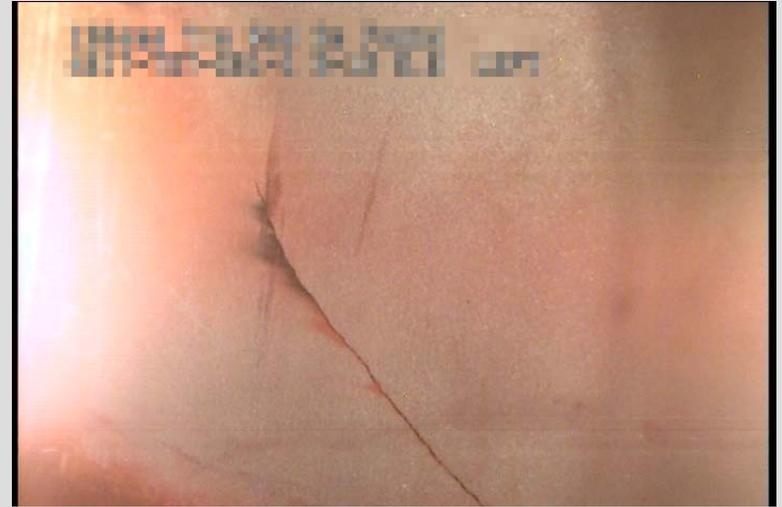
Discolorations at Crack Surface
