Re: St. Lucie Units 1 and 2
Docket Nos. 50-335 and 50-389
Amended 2005 and 2006 Non-Radiological Environmental Reports

ST. LUCIE PLANT

ANNUAL ENVIRONMENTAL

OPERATING REPORT

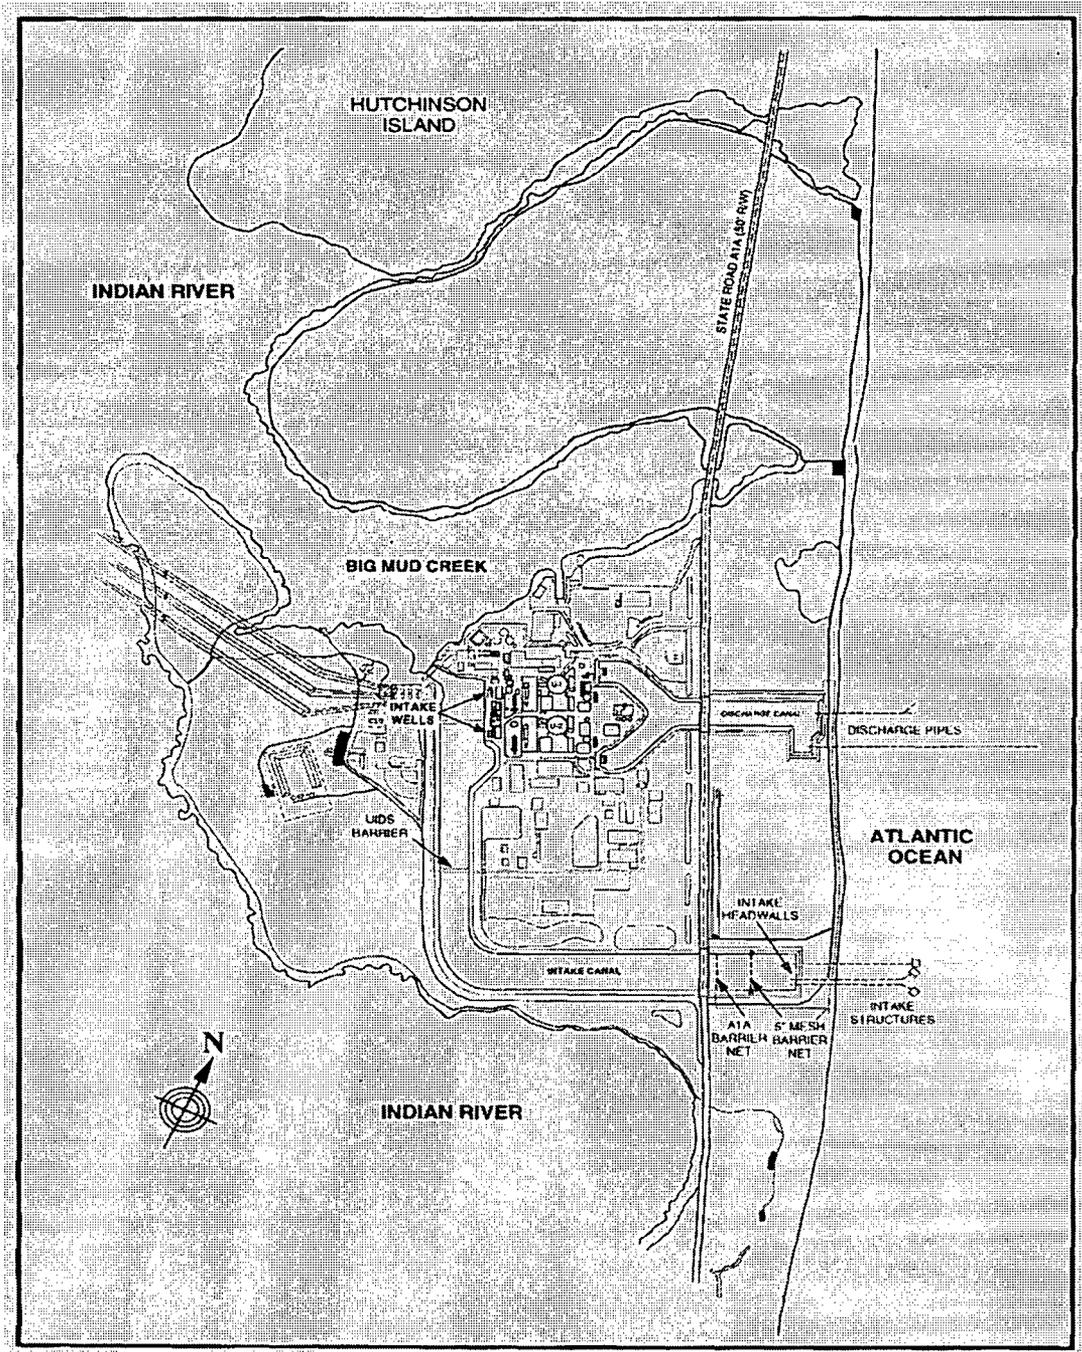
Figure 2. St. Lucie Plant Cooling Water Intake and Discharge System

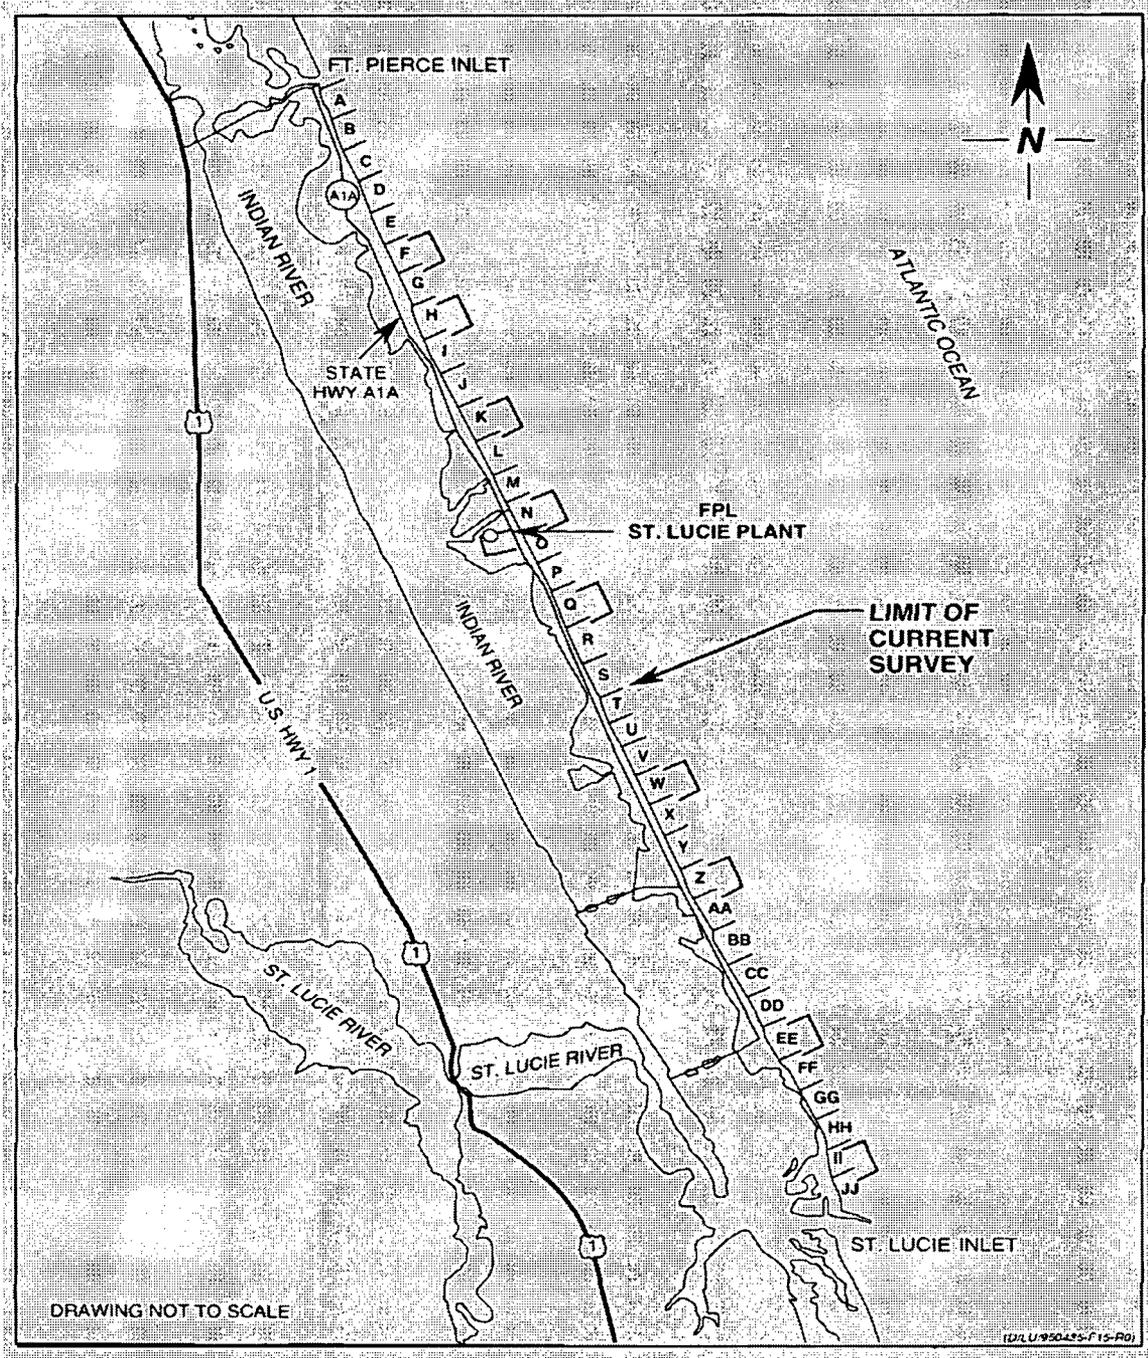
Figure 3. Designation and Location of Nine 1.25-Km Segments and Thirty-Six 1-Km Segments Surveyed for Sea Turtle Nesting, Hutchinson Island, 1971-2005.

From 1981 through 2005, 36 one-km-long segments comprising the island's coastline have been surveyed. The distribution of nests among these 36 survey areas depicts an increase in nesting from north to south along the northern half of the island (ABI, 1987, 1994). Though beach dynamics may sometimes affect the selection of nesting sites by loggerhead turtles, relationships between spatial nesting patterns and specific environmental conditions are often difficult to establish.

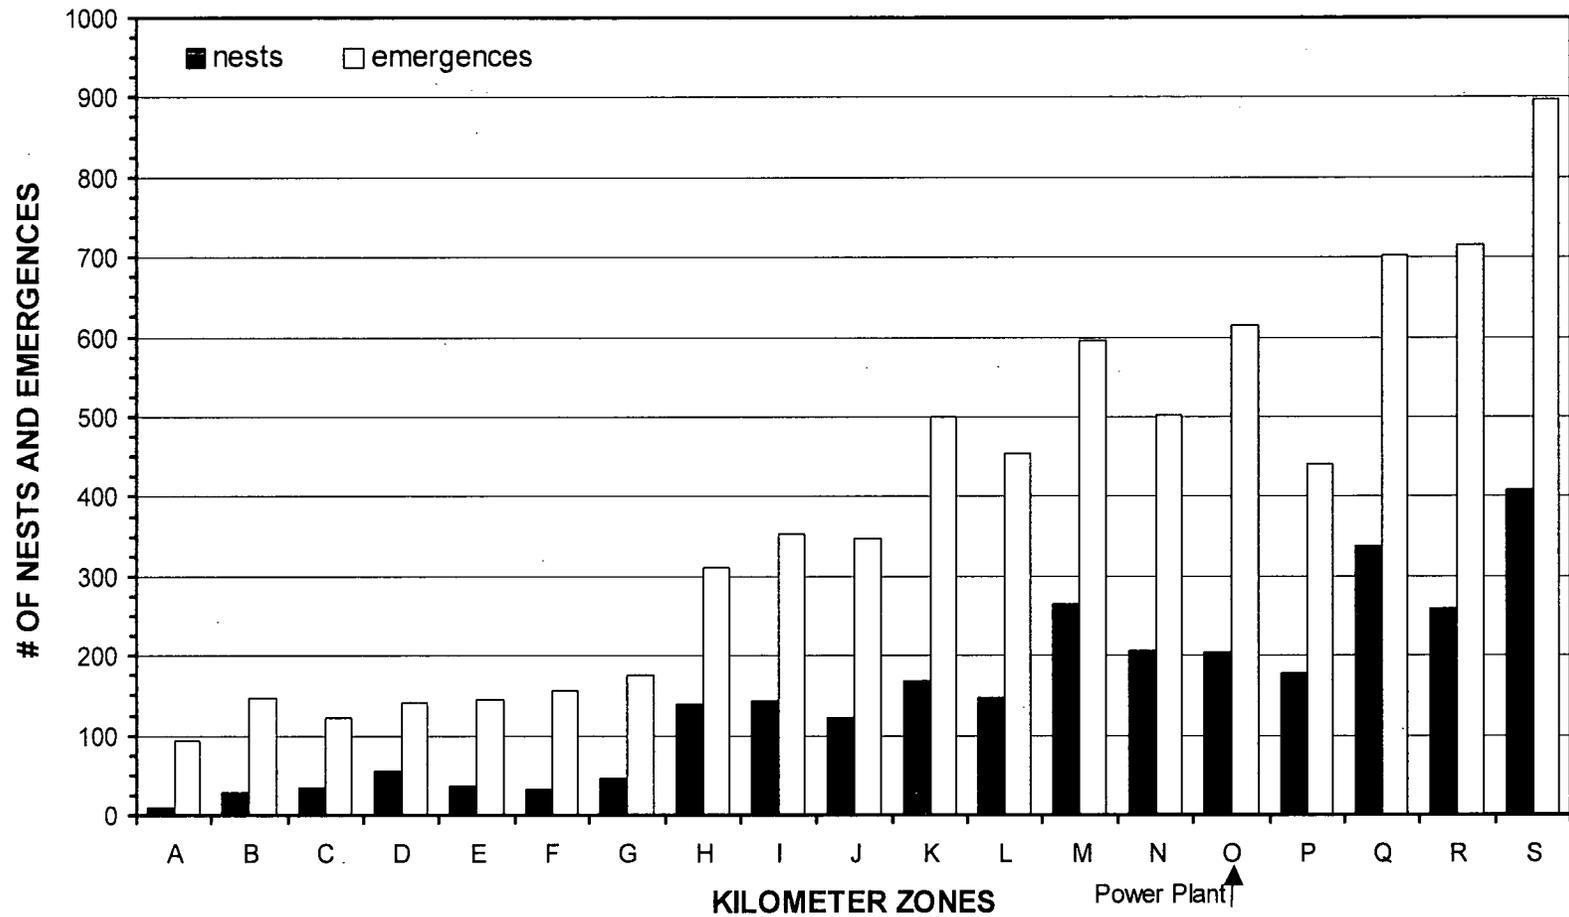
Figure 4. Number of loggerhead turtle nests and emergences for kilometer zones A through S (North to South), Hutchinson Island, April through September 2005.

trend in nest numbers may just be a reflection of the cyclic nature of loggerhead nesting observed over time (Figure 4).

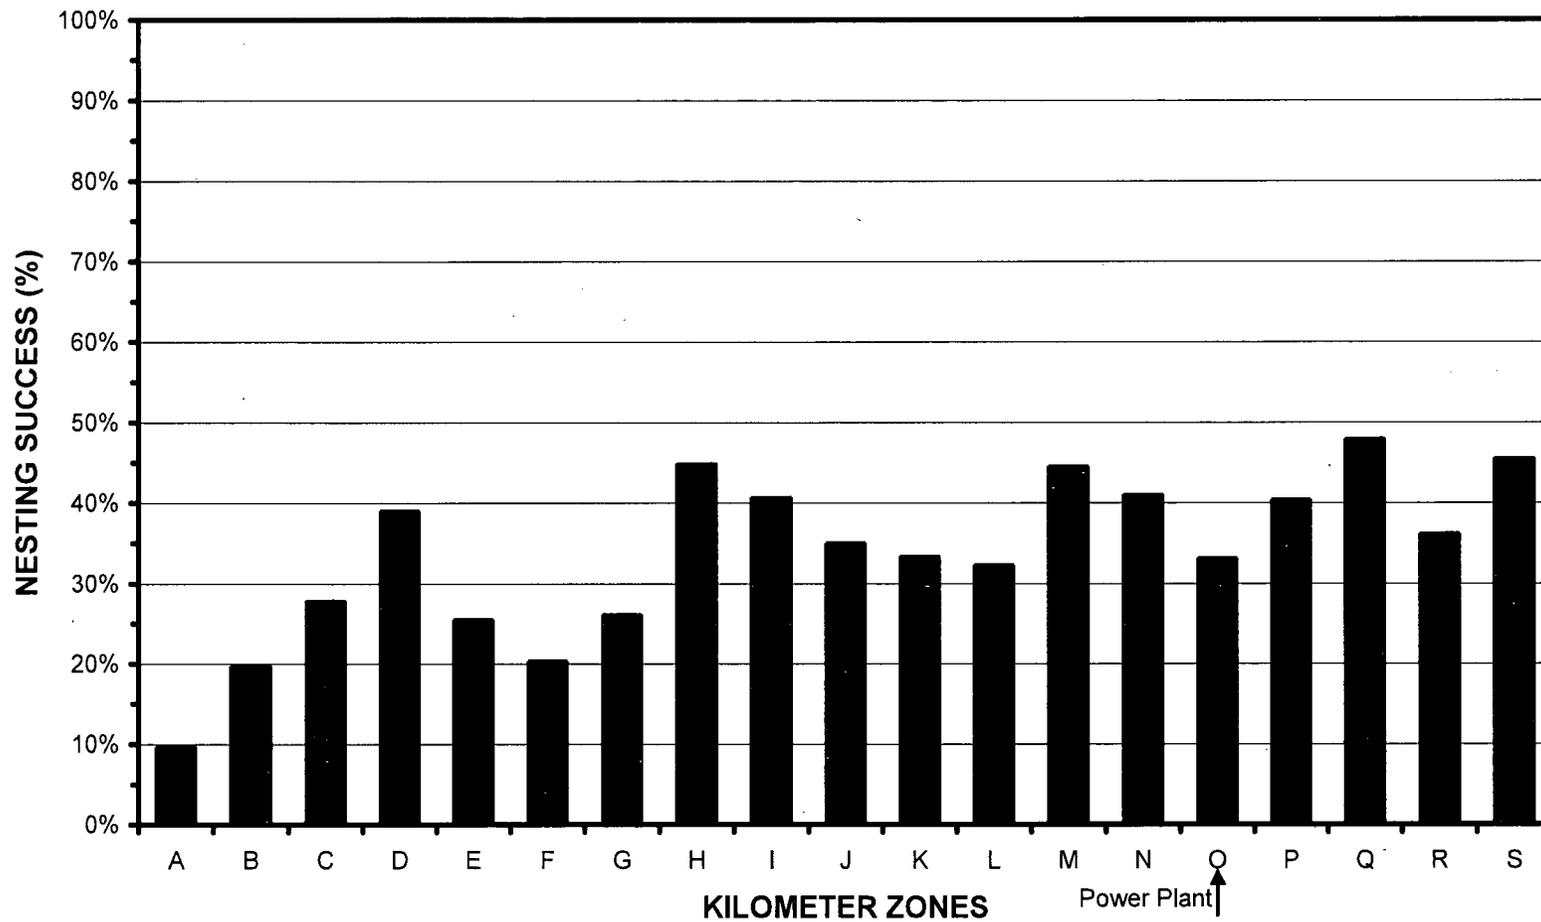
Figure 5. Loggerhead turtle nesting success (percentage of emergences resulting in nests) for kilometer zones A through S (North to South), Hutchinson Island, April through September 2005.

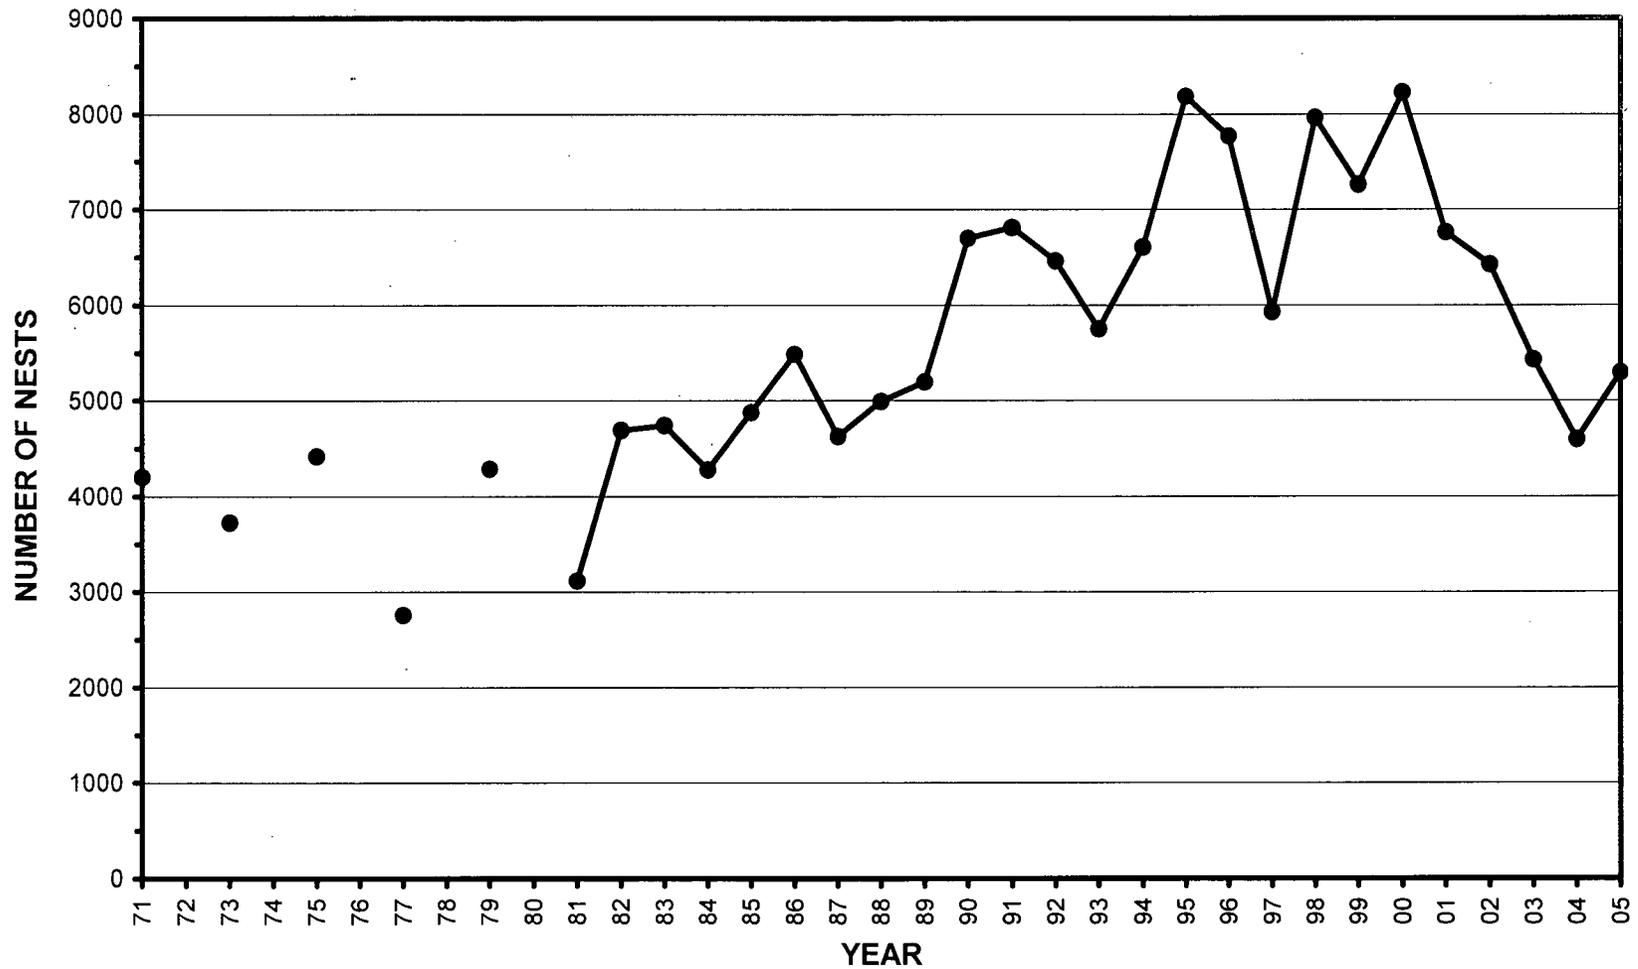
Figure 6. Number of loggerhead turtle nests, Hutchinson Island 1971 through 2005. Values for 1971 through 1979 are estimates (see text), values for 1981 through 2005 are from whole island surveys.

It is clear that loggerhead nesting activity on Hutchinson Island fluctuates considerably from year to year (Figure 6). Annual variations in nest densities are also common at other rookeries, and probably result from non-annual reproductive behavior. No relationships between annual fluctuations in nesting activity and power plant operation or intake/discharge construction were found.

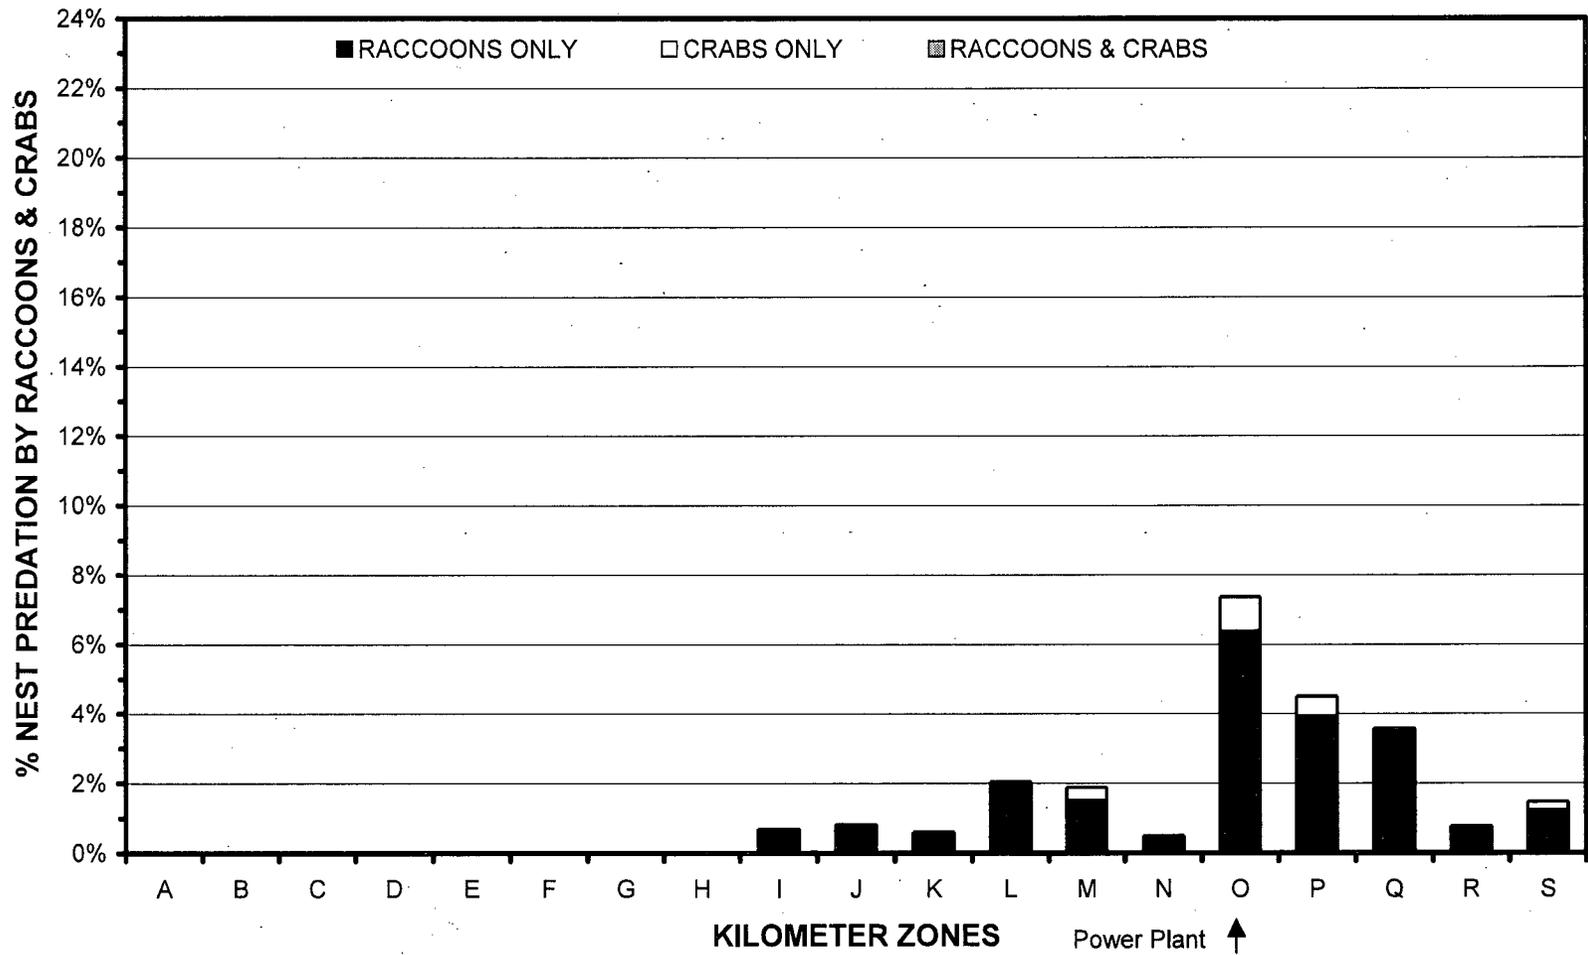
Figure 7. Percentage of loggerhead turtle nests depredated by raccoons and/or ghost crabs in kilometer zones A through S (North to South), Hutchinson Island, April through September 2005.

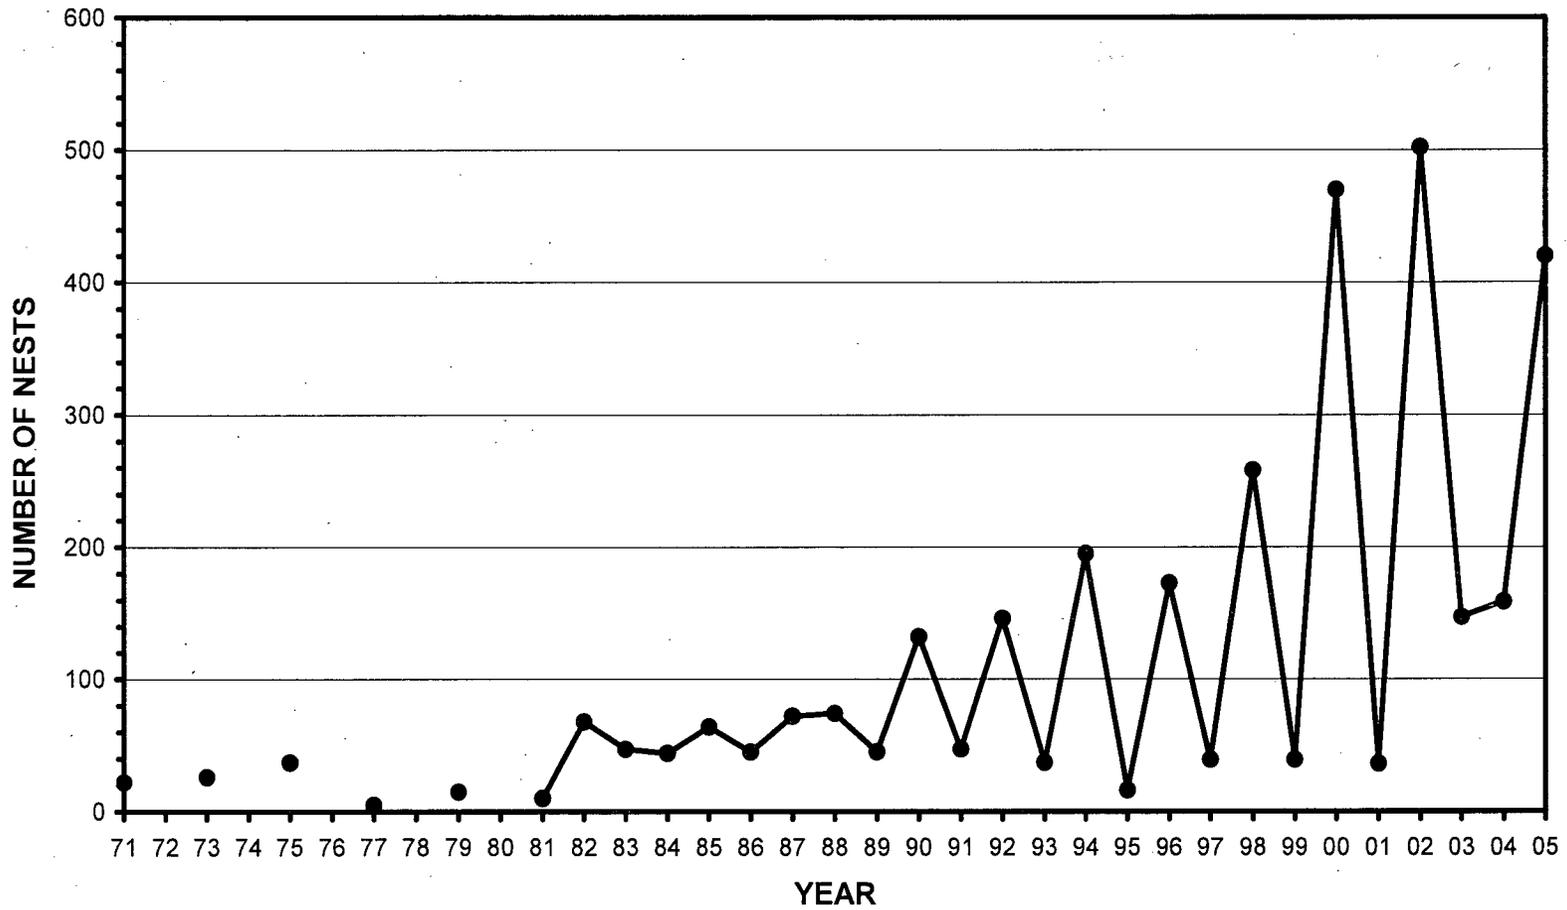
Figure 8. Number of green turtle nests, Hutchinson Island, 1971 through 2005. Values for 1971 through 1979 are estimates (see text). Values for 1981 through 2005 are from whole island surveys.

Since surveys began in 1971, the number of nests observed on the island has ranged from five to 502 for green turtles and from one to 232 for leatherbacks (Figures 8 and 9). Temporal nesting patterns for these species differ from the pattern for loggerhead turtles. Green turtles typically nest on Hutchinson Island from mid-June through the first or second week of September. Leatherback turtles usually begin nesting in March or April and continue to nest through early to mid-July. Considerable fluctuations in green turtle nesting on the island have occurred among survey years (Figure 8). This is not unusual since there are drastic year-to-year fluctuations in the numbers of green turtles nesting at other breeding grounds (Carr et al., 1982). Despite these fluctuations, data collected through 2005 suggest an overall increase in nesting since 1971 and may reflect an increase in the number of nesting females in the Hutchinson Island area. Previous surveys have shown that green turtles nested in greater numbers along the southern half of the island, however this was not the case during the 2005 nesting

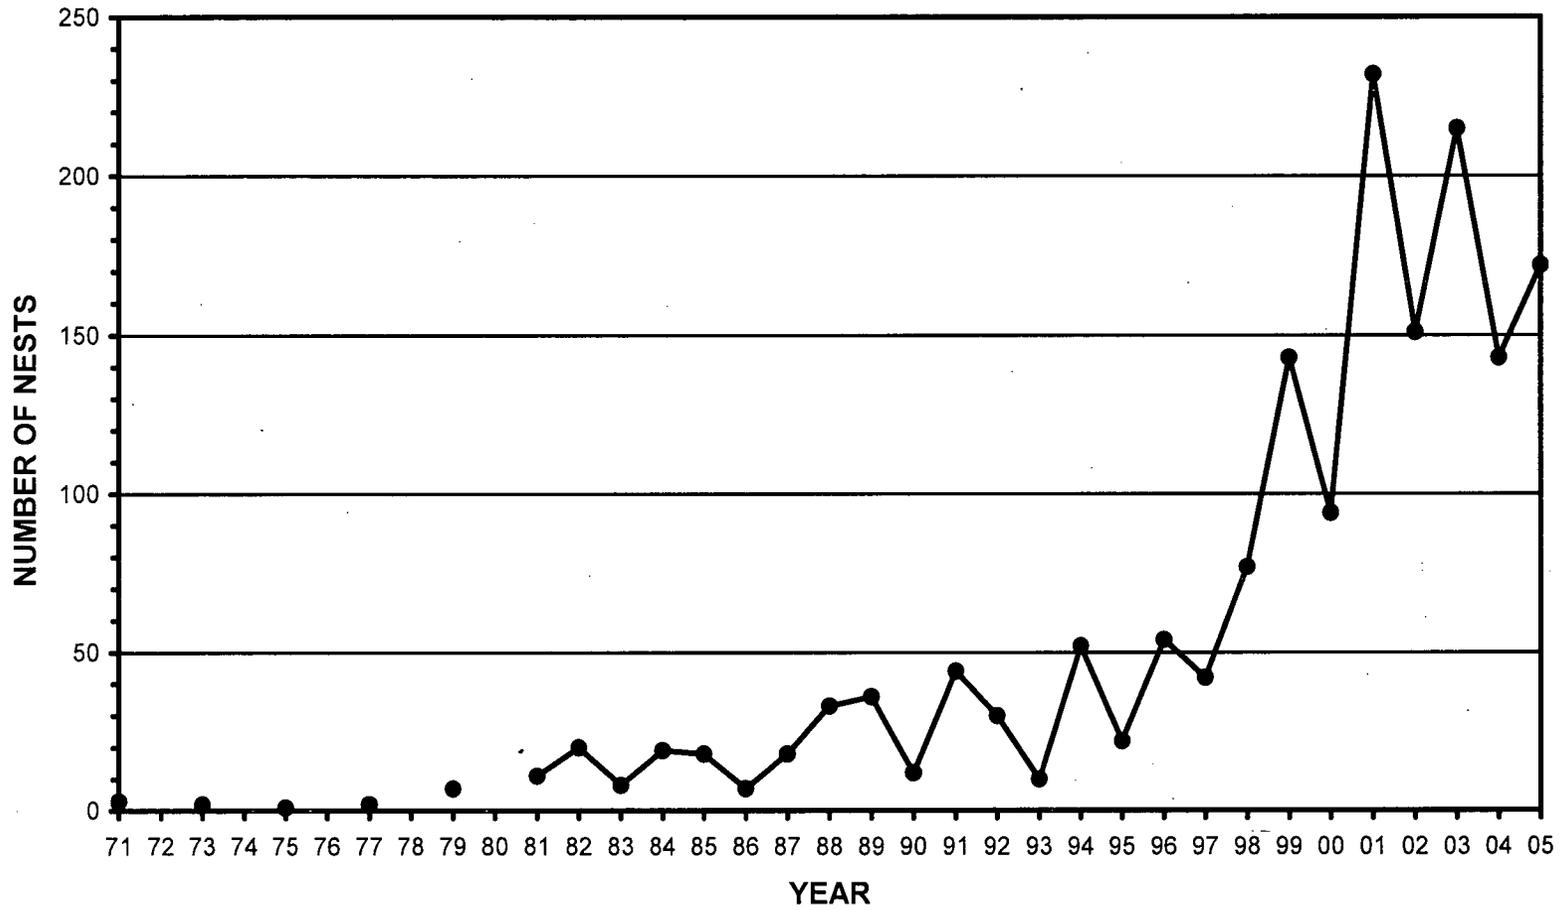
Figure 9. Number of leatherback turtle nests, Hutchinson Island, 1971 through 2005. Values for 1971 through 1979 are estimates (see text). Values for 1981 through 2005 are from whole island surveys.

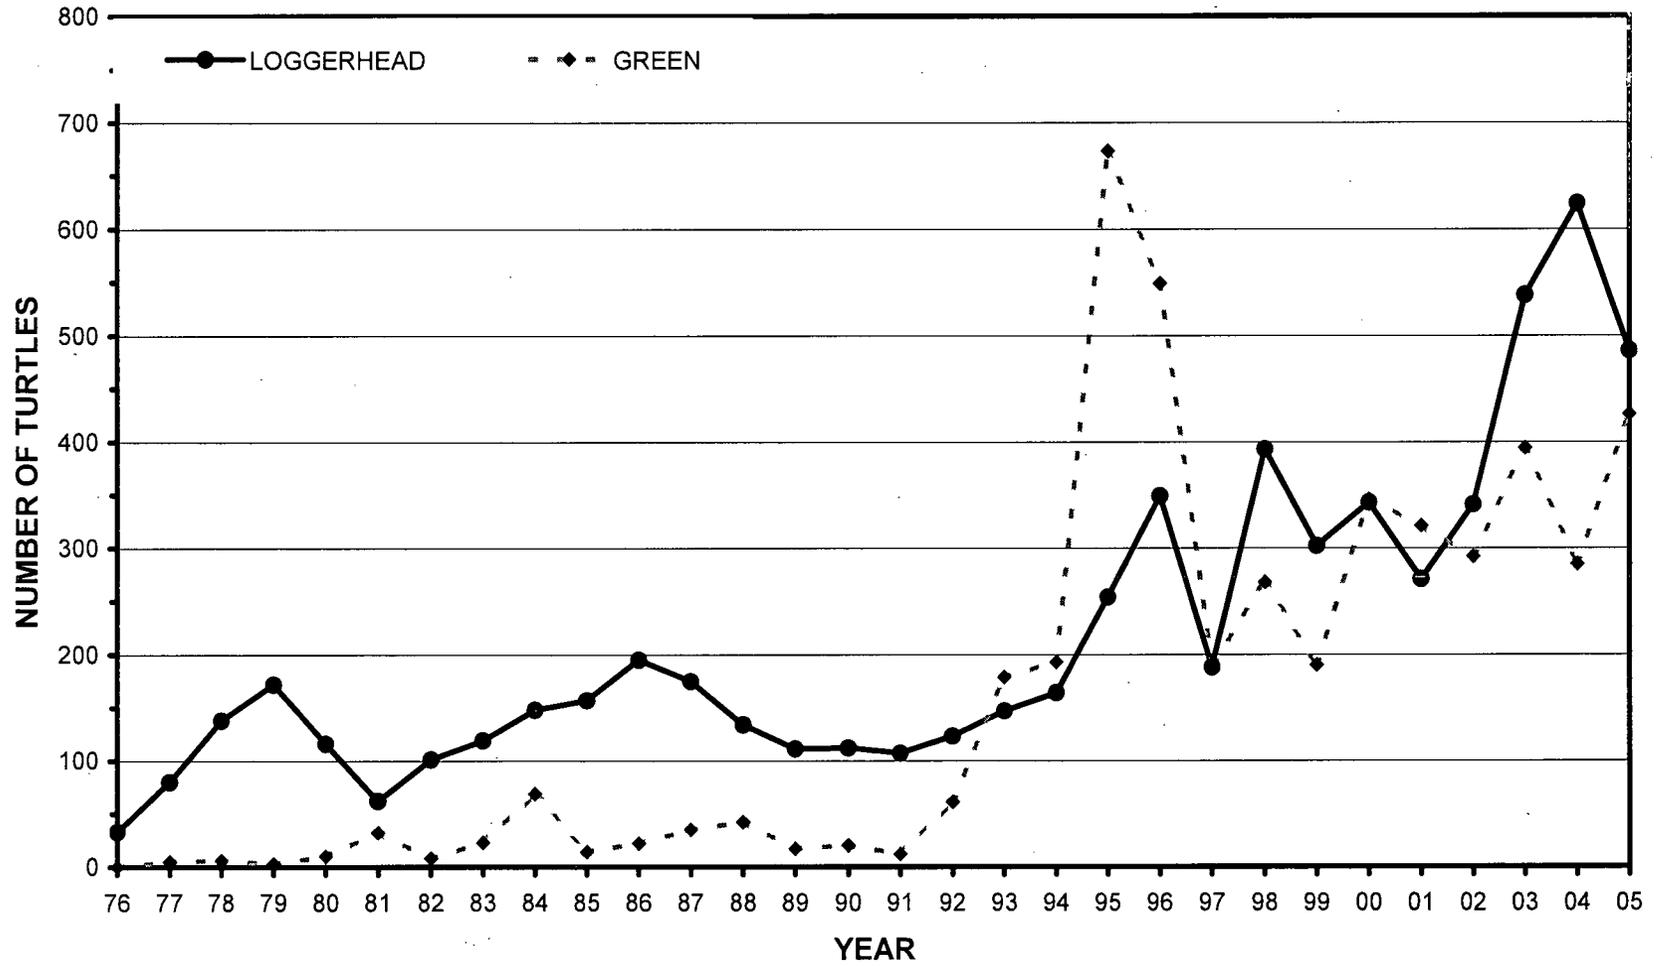
Figure 10. Number of loggerhead and green turtles removed each year from the intake canal at the St. Lucie Power Plant, 1976 through 2005.

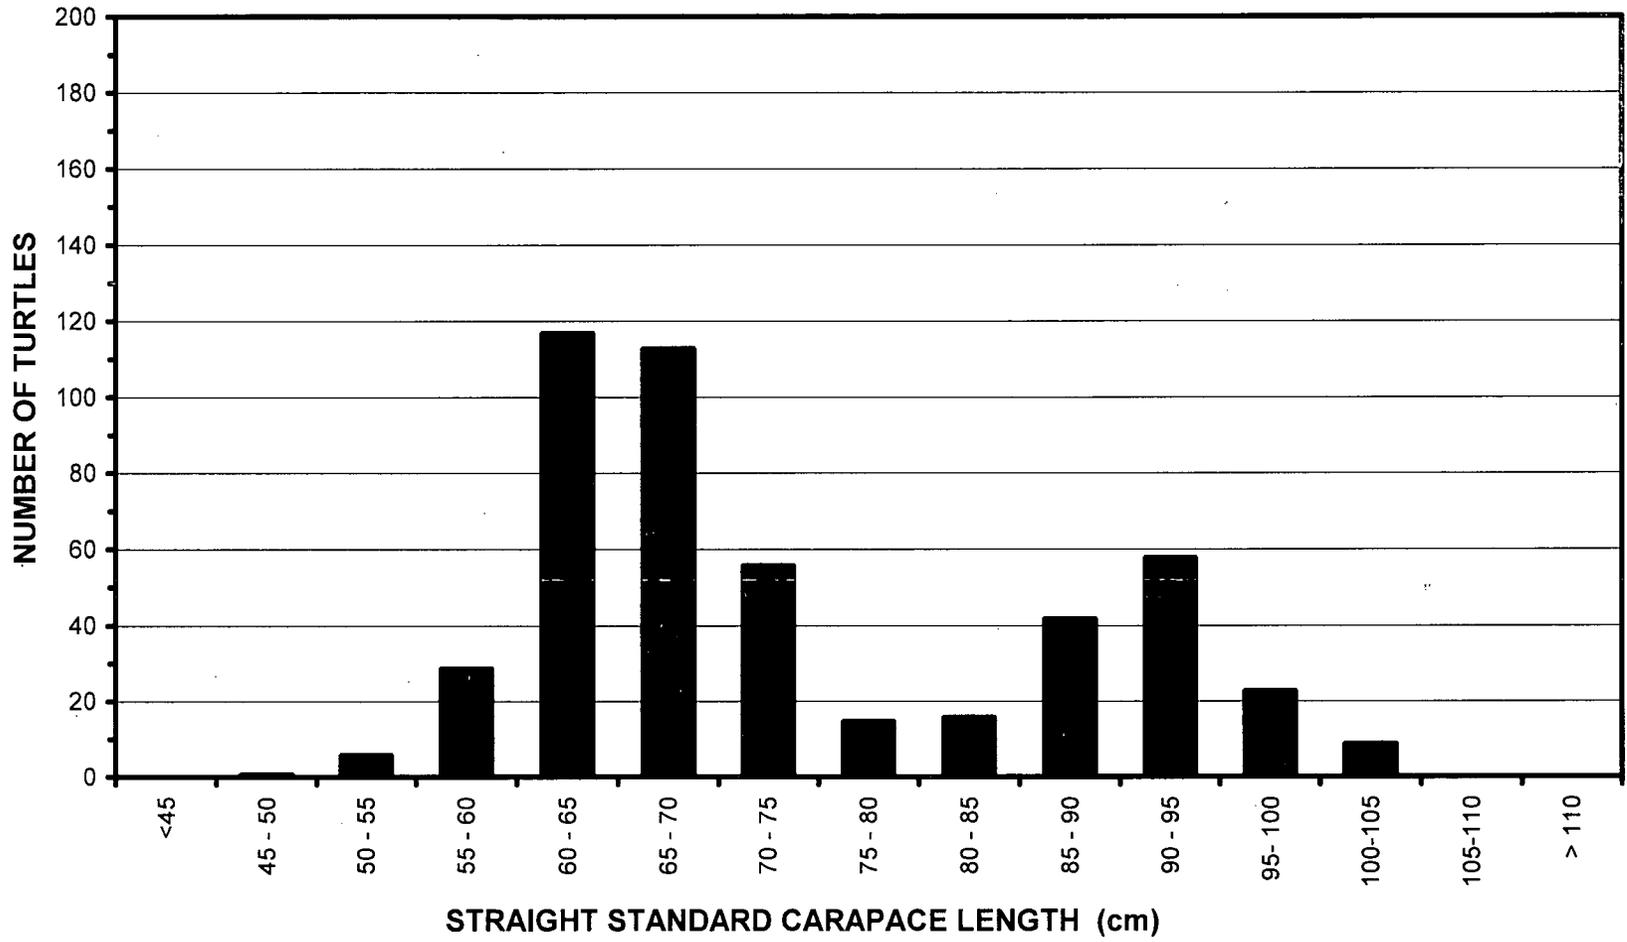
Figure 11. Size distribution (SSCL) of loggerhead turtles (n = 486) removed from the intake canal, St. Lucie Plant, 2005.

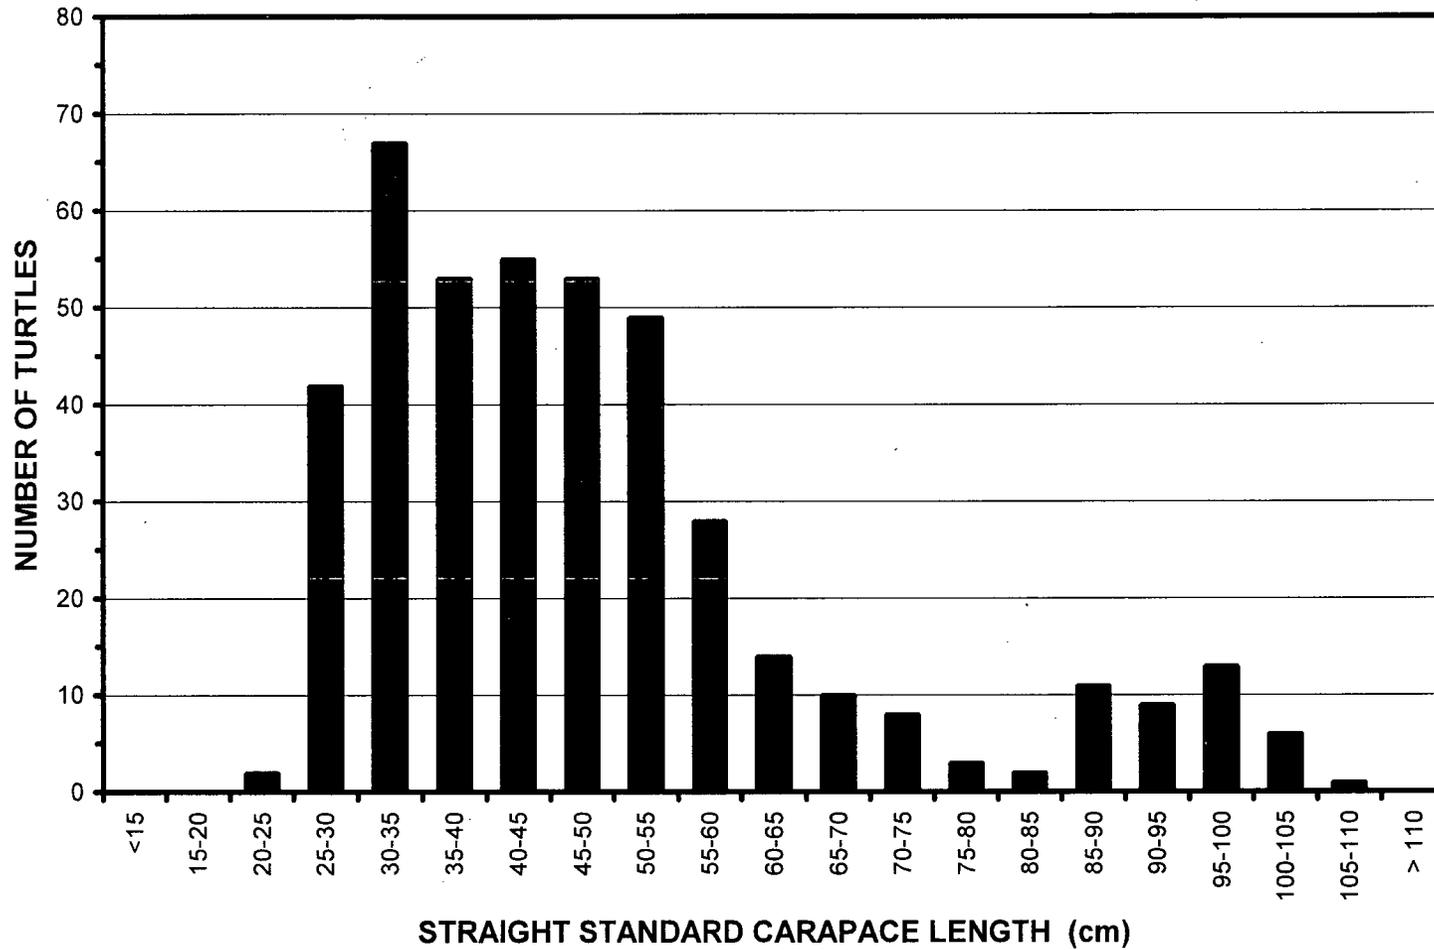
Figure 12. Size distribution (SSCL) of green turtles (n = 426) removed from the intake canal, St. Lucie Plant, 2005.

Of the 426 green turtles captured in 2005 for which straight line carapace lengths are available, 386 were juveniles or sub-adults (SLCL < 83 cm) and 40 were adults (SLCL > 83 cm) (Whitherington and Ehrhart, 1989). Of the 40 individual adult green turtles where sex was noted, 17 were female and 23 were male; a male biased ratio of 1.35:1. The number of adult green turtles captured at the intake canal in 2005 accounts for almost 40% of the total number of adult green turtles captured during the program's history. ABI (1994) discusses sex ratio data for previous years for both species mentioned here.

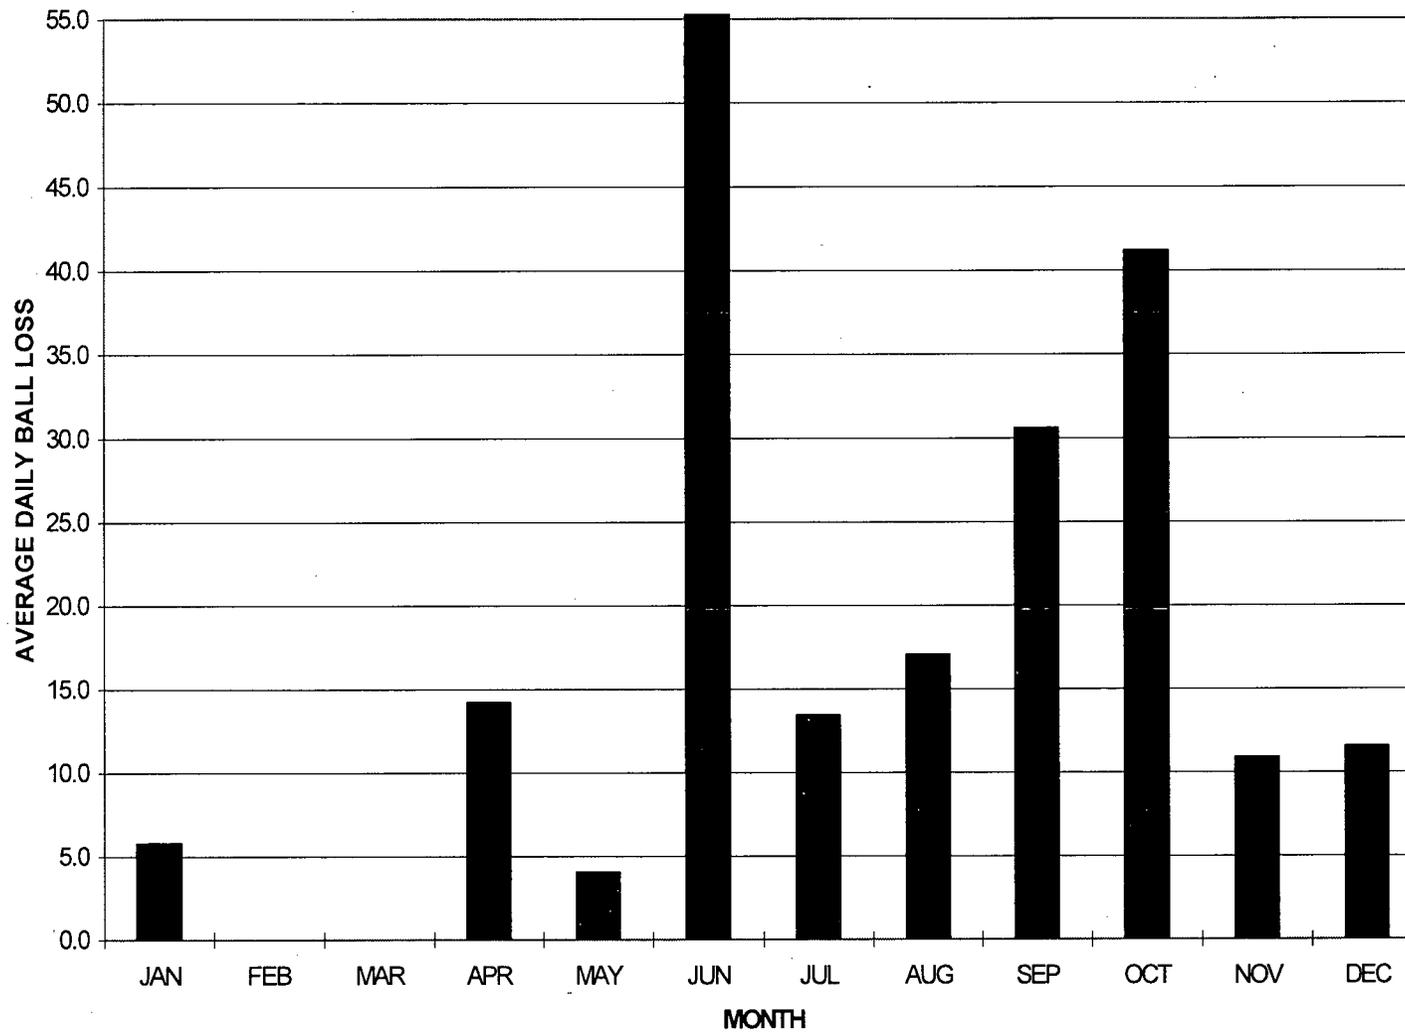
Figure 1. Estimated Average Daily Sponge Ball Loss by Month from St. Lucie Plant (Both Units) for 2003.

The results of the program for 2003 are presented in Table 1. Total sponge ball losses were higher from Unit 1 than Unit 2 in 2003. This was due mostly to two peaks that occurred, one in June and one in October. Only 9 sponge balls were found whole in the environment near the plant in 2003. This number indicates that few balls actually reach the environment whole.

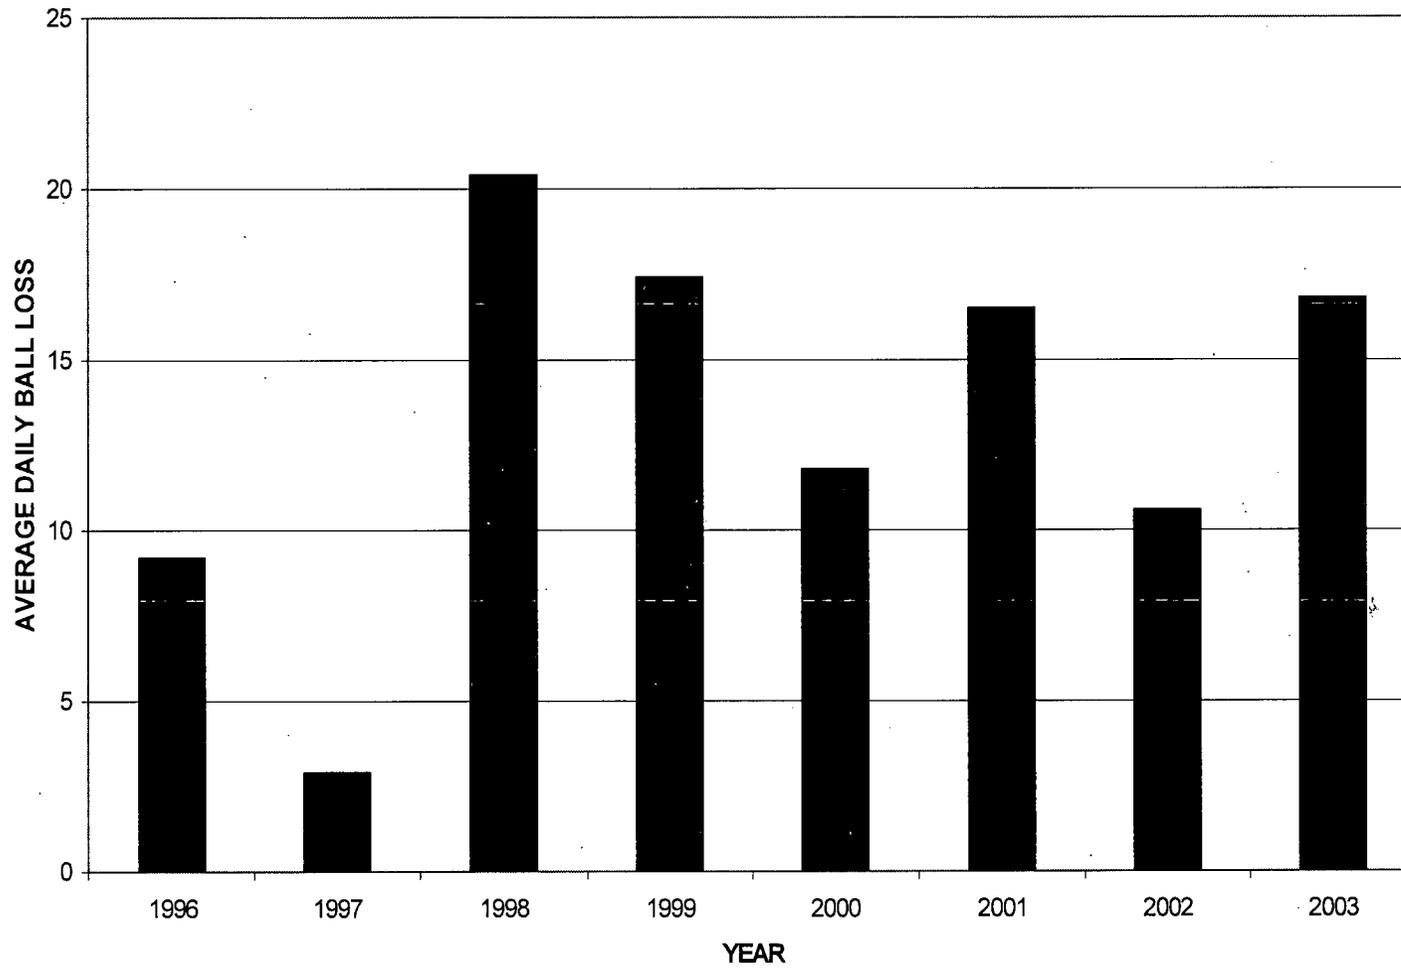
Figure 2. Average Daily Sponge Ball Loss from the St. Lucie Plant (Both Units) Since System Start-Up (January 1996).

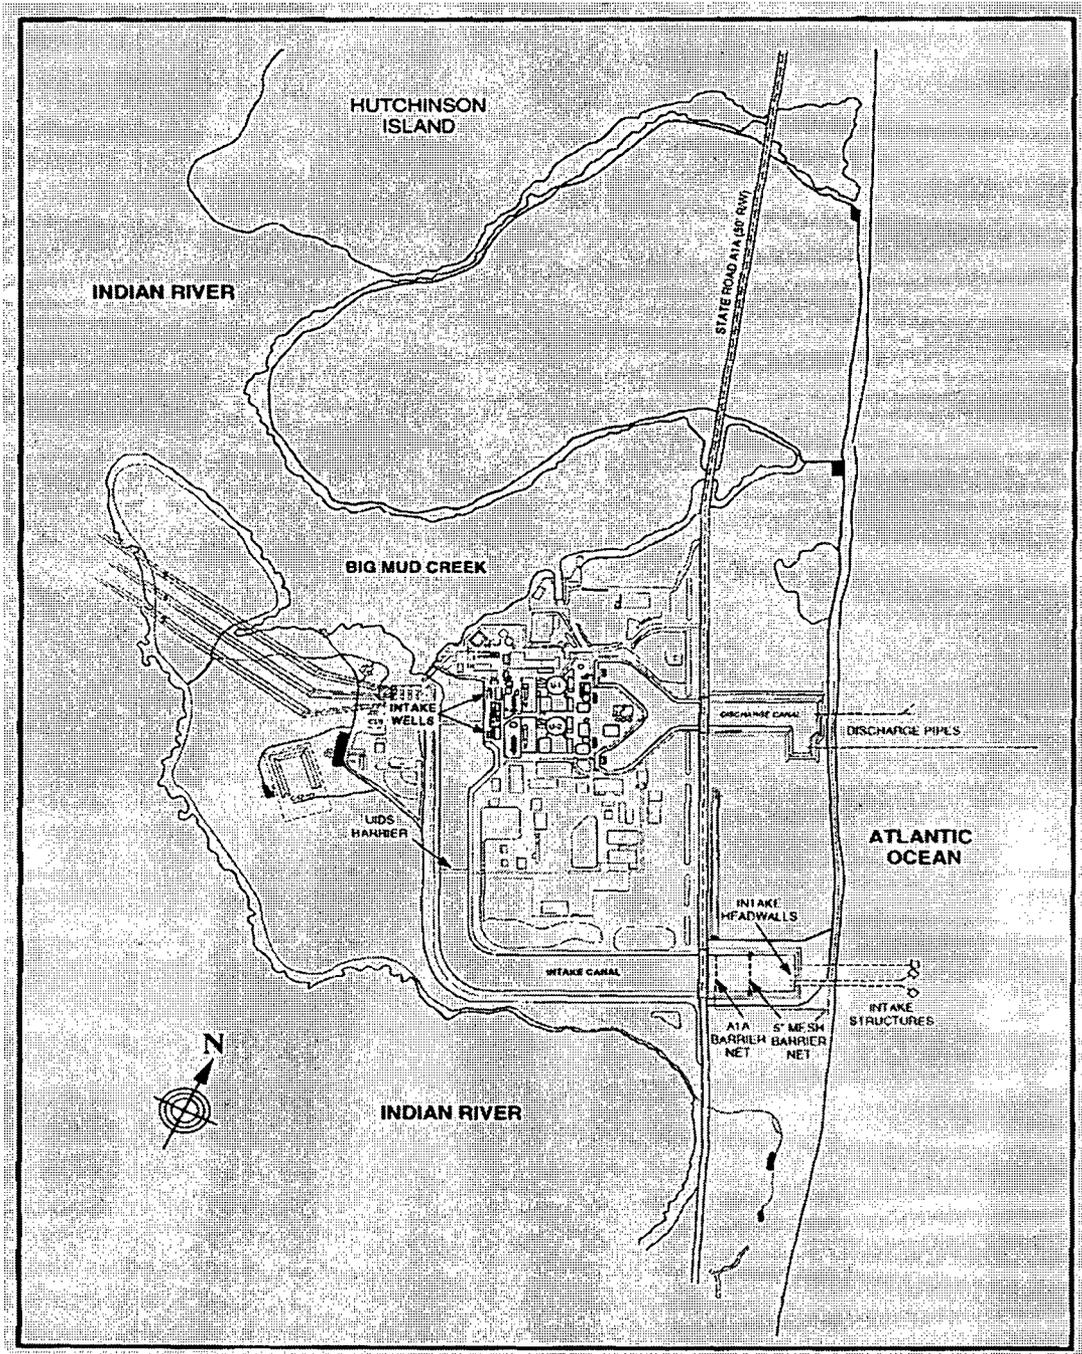
Figure 2. St. Lucie Plant Cooling Water Intake and Discharge System
