Re: St. Lucie Units 1 and 2
Docket Nos. 50-335 and 50-389
Amended 2005 and 2006 Non-Radiological Environmental Reports

ST. LUCIE PLANT

ANNUAL ENVIRONMENTAL

OPERATING REPORT

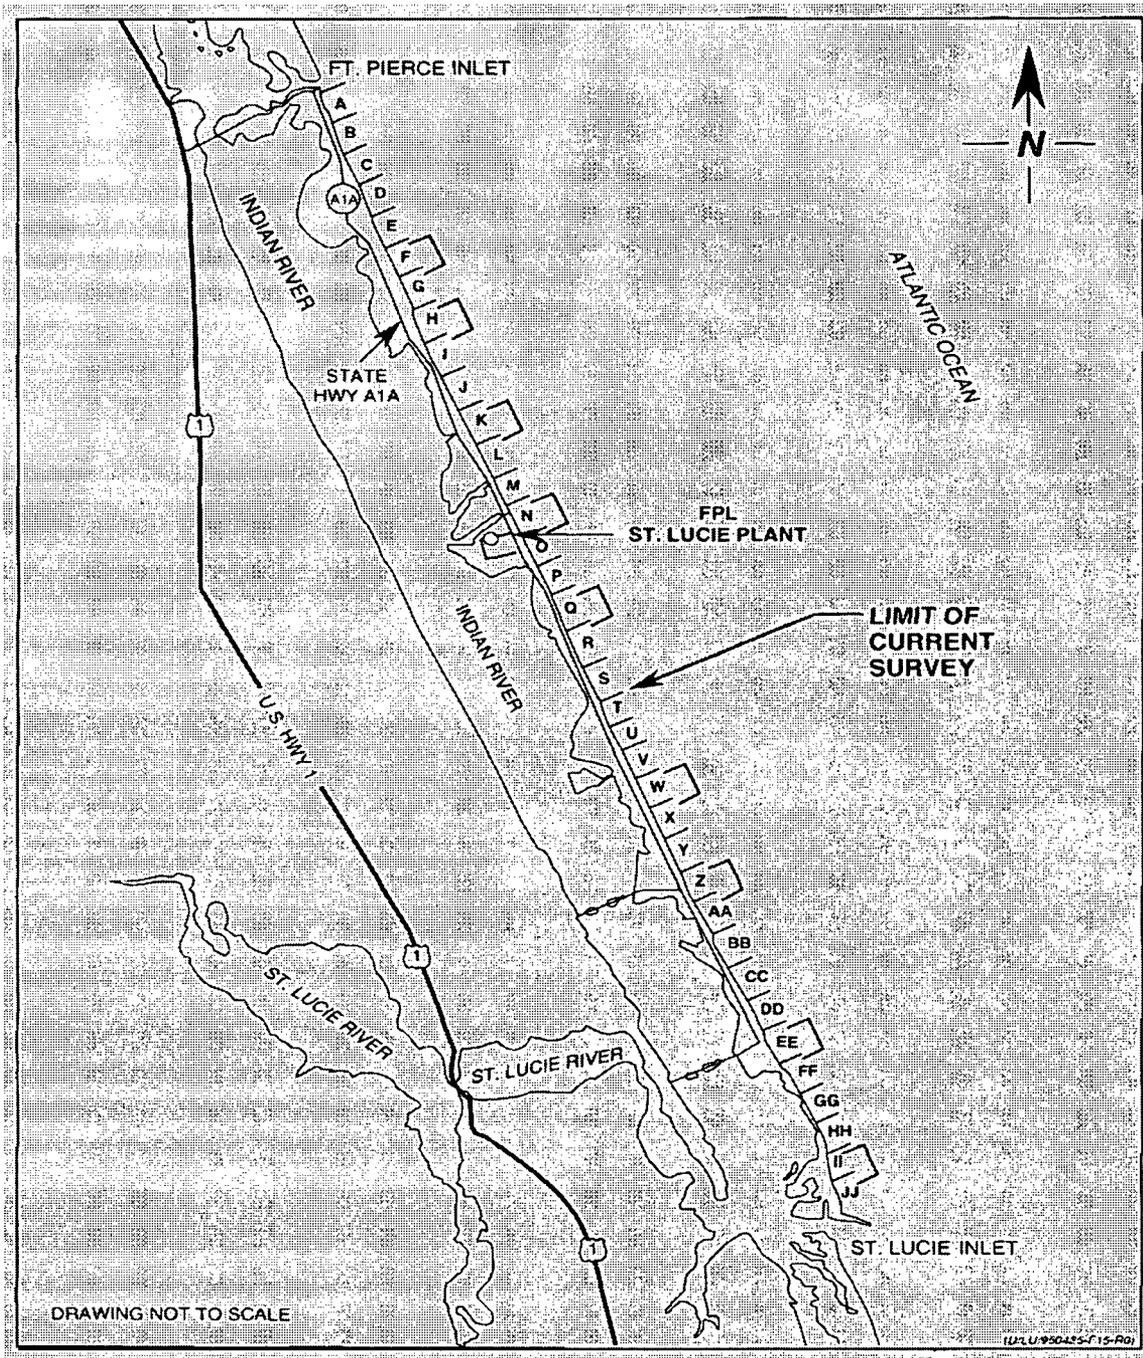
Figure 3. Designation and Location of Nine 1.25-Km Segments and Thirty-Six 1-Km Segments Surveyed for Sea Turtle Nesting, Hutchinson Island. 1971-2006.

From 1981 through 2006, 36 one-km-long segments comprising the island's coastline have been surveyed. The distribution of nests among these 36 survey areas depicts an increase in nesting from north to south along the northern half of the island (ABI, 1987, 1994). Though beach dynamics may sometimes affect the selection of nesting sites by loggerhead turtles, relationships between spatial nesting patterns and specific environmental conditions are often difficult to establish.

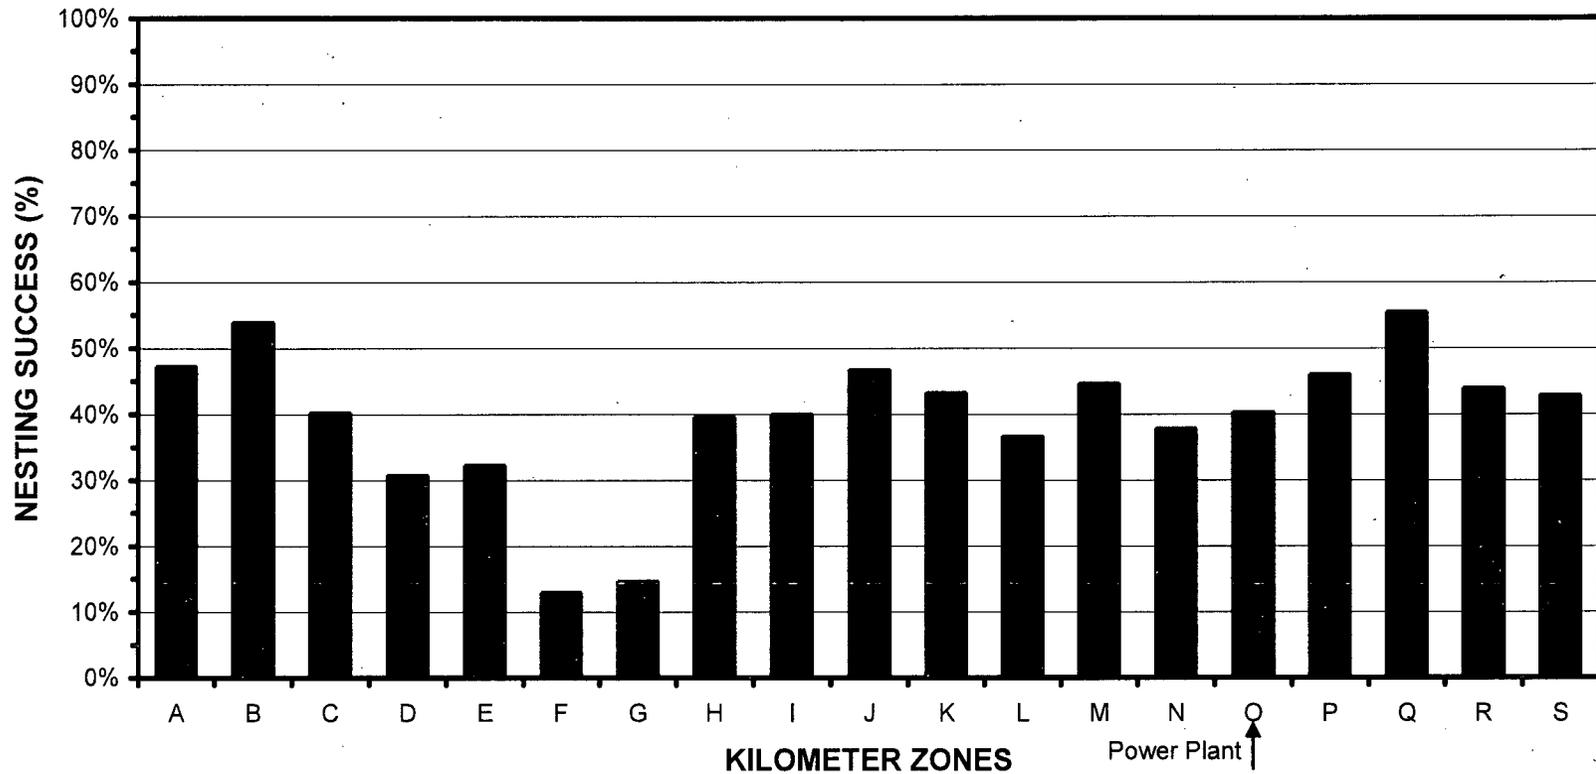
Figure 5. Loggerhead turtle nesting success (percentage of emergences resulting in nests) for kilometer zones A through S (North to South), Hutchinson Island, April through September 2006.

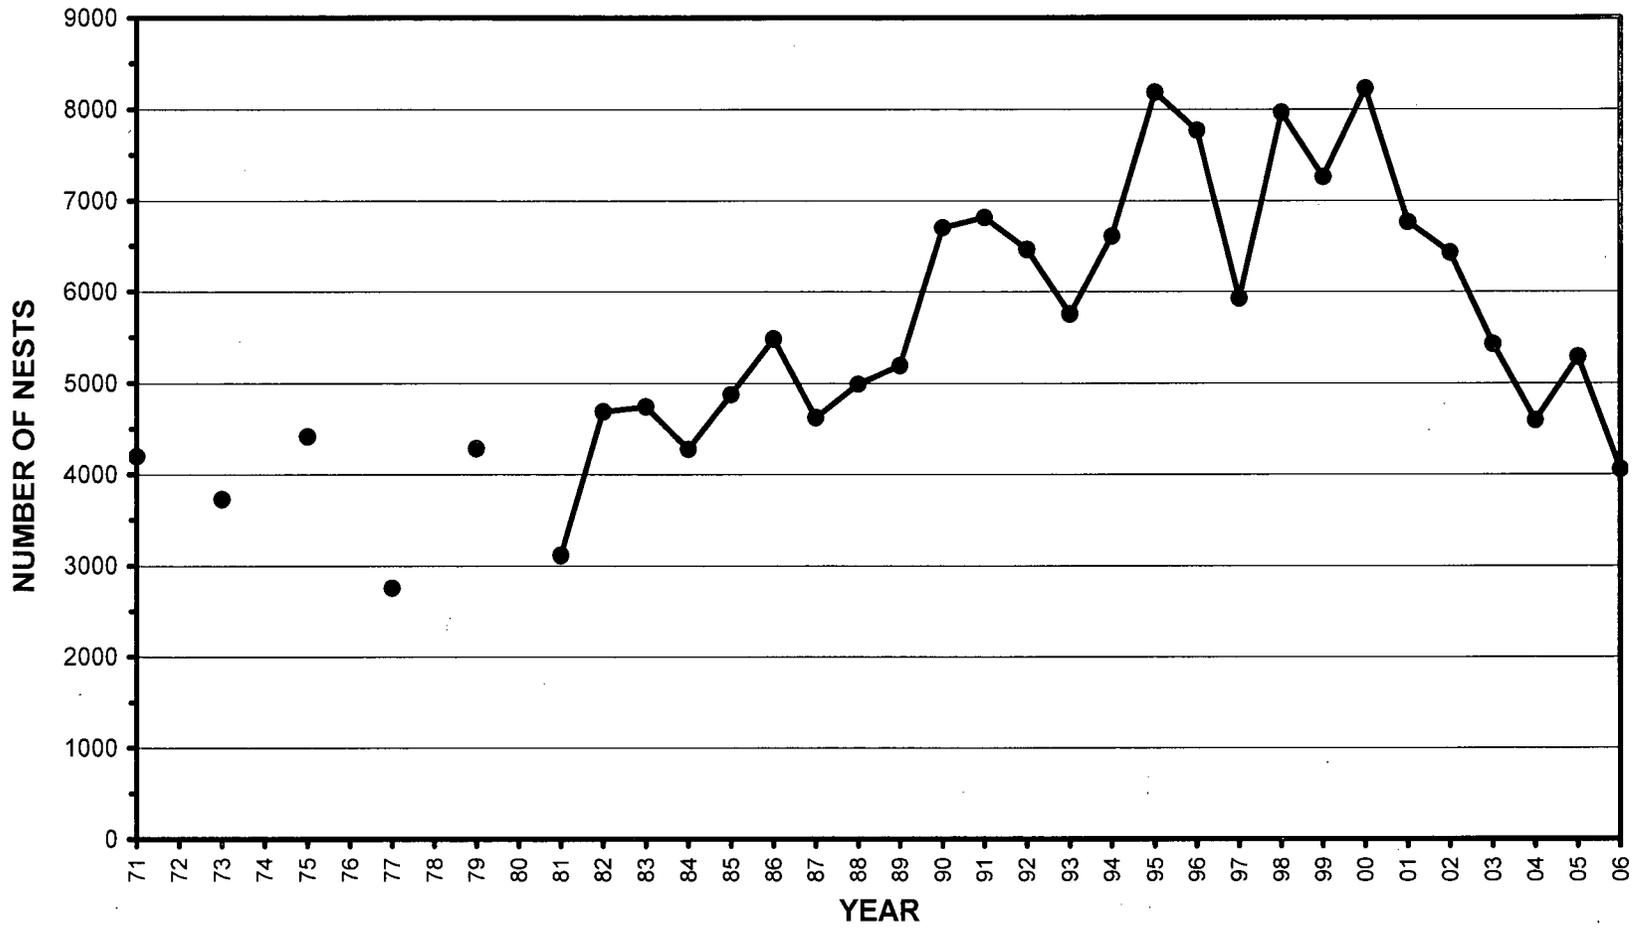
Figure 6. Number of loggerhead turtle nests, Hutchinson Island 1971 through 2006. Values for 1971 through 1979 are estimates (see text), values for 1981 through 2006 are from whole island surveys.

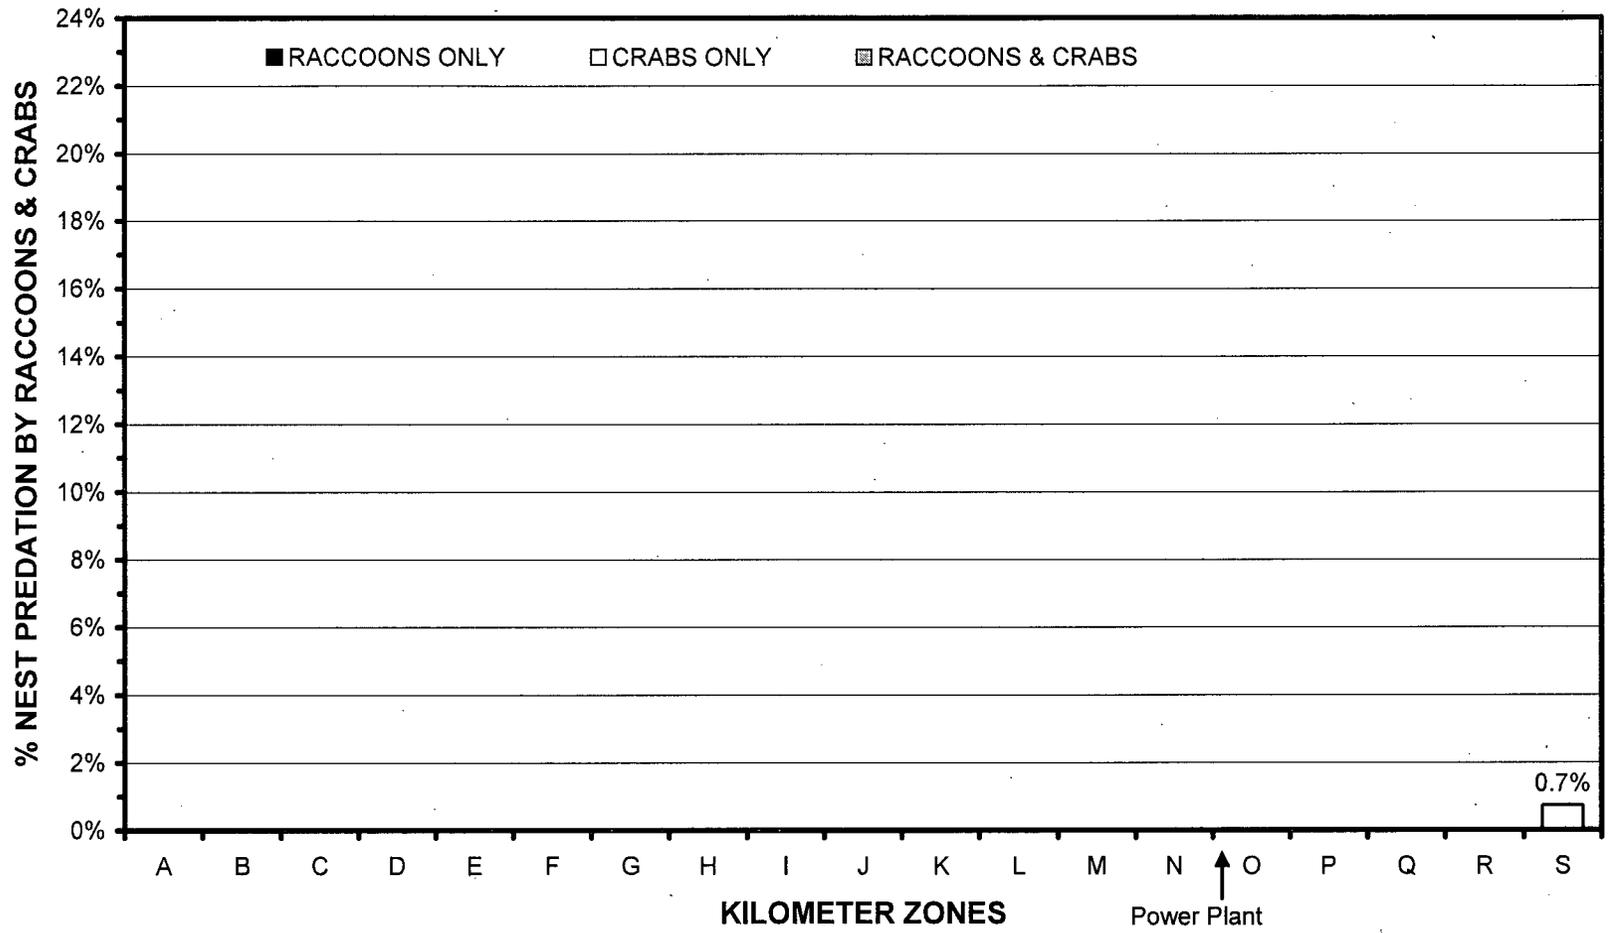
Figure 7. Percentage of loggerhead turtle nests depredated by raccoons and/or ghost crabs in kilometer zones A through S (North to South), Hutchinson Island, April through September 2006.

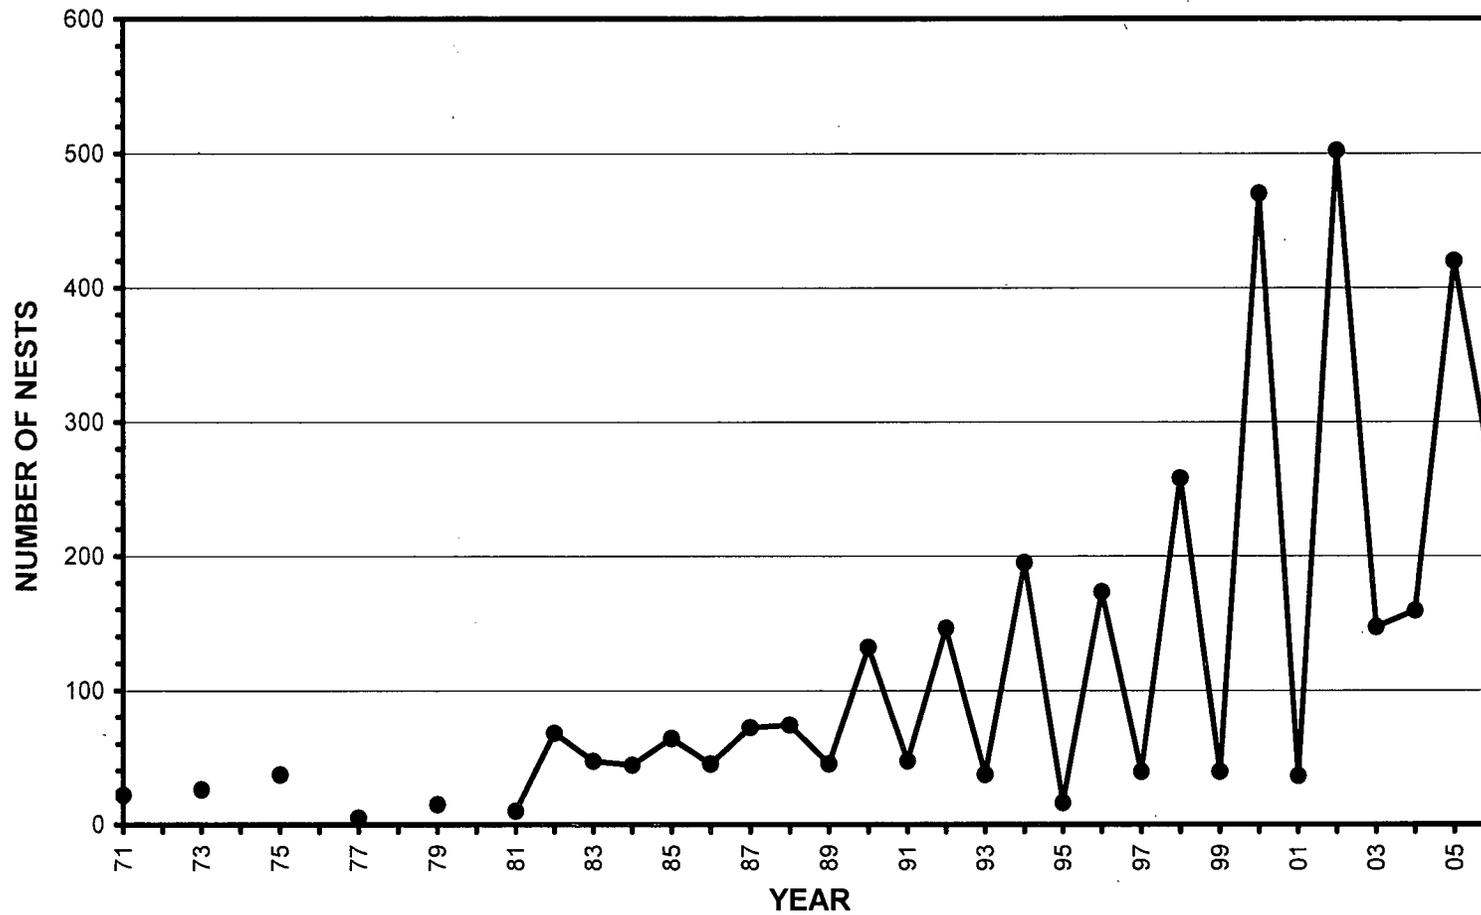
Figure 8. Number of green turtle nests, Hutchinson Island, 1971 through 2006. Values for 1971 through 1979 are estimates (see text). Values for 1981 through 2006 are from whole island surveys.

Since surveys began in 1971, the number of nests observed on the island has ranged from five to 502 for green turtles and from one to 232 for leatherbacks (Figures 8 and 9). Temporal nesting patterns for these species differ from the pattern for loggerhead

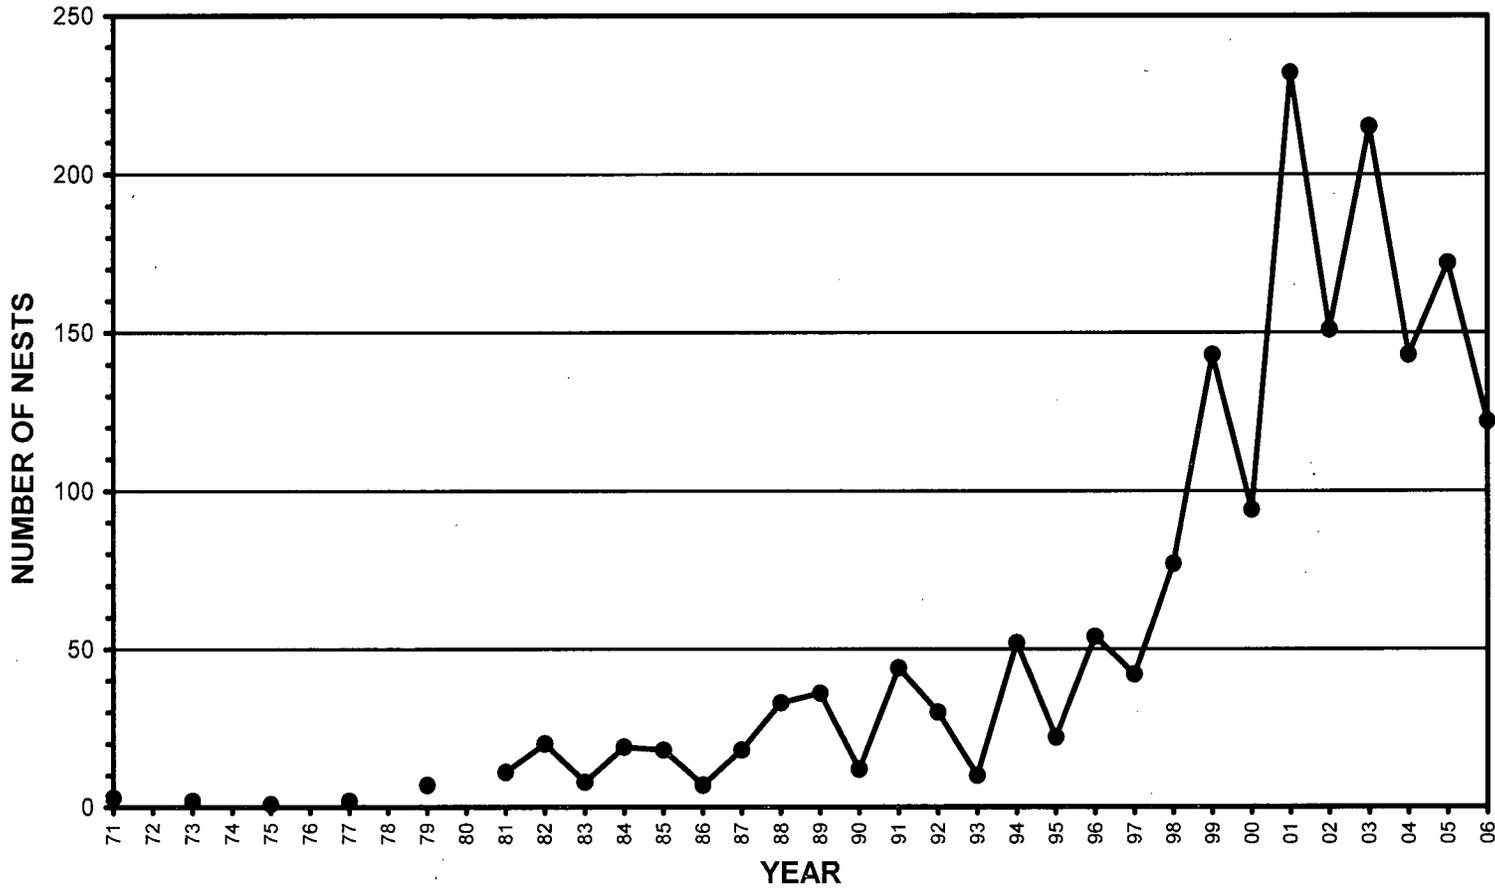
Figure 9. Number of leatherback turtle nests, Hutchinson Island, 1971 through 2006. Values for 1971 through 1979 are estimates (see text). Values for 1981 through 2006 are from whole island surveys.

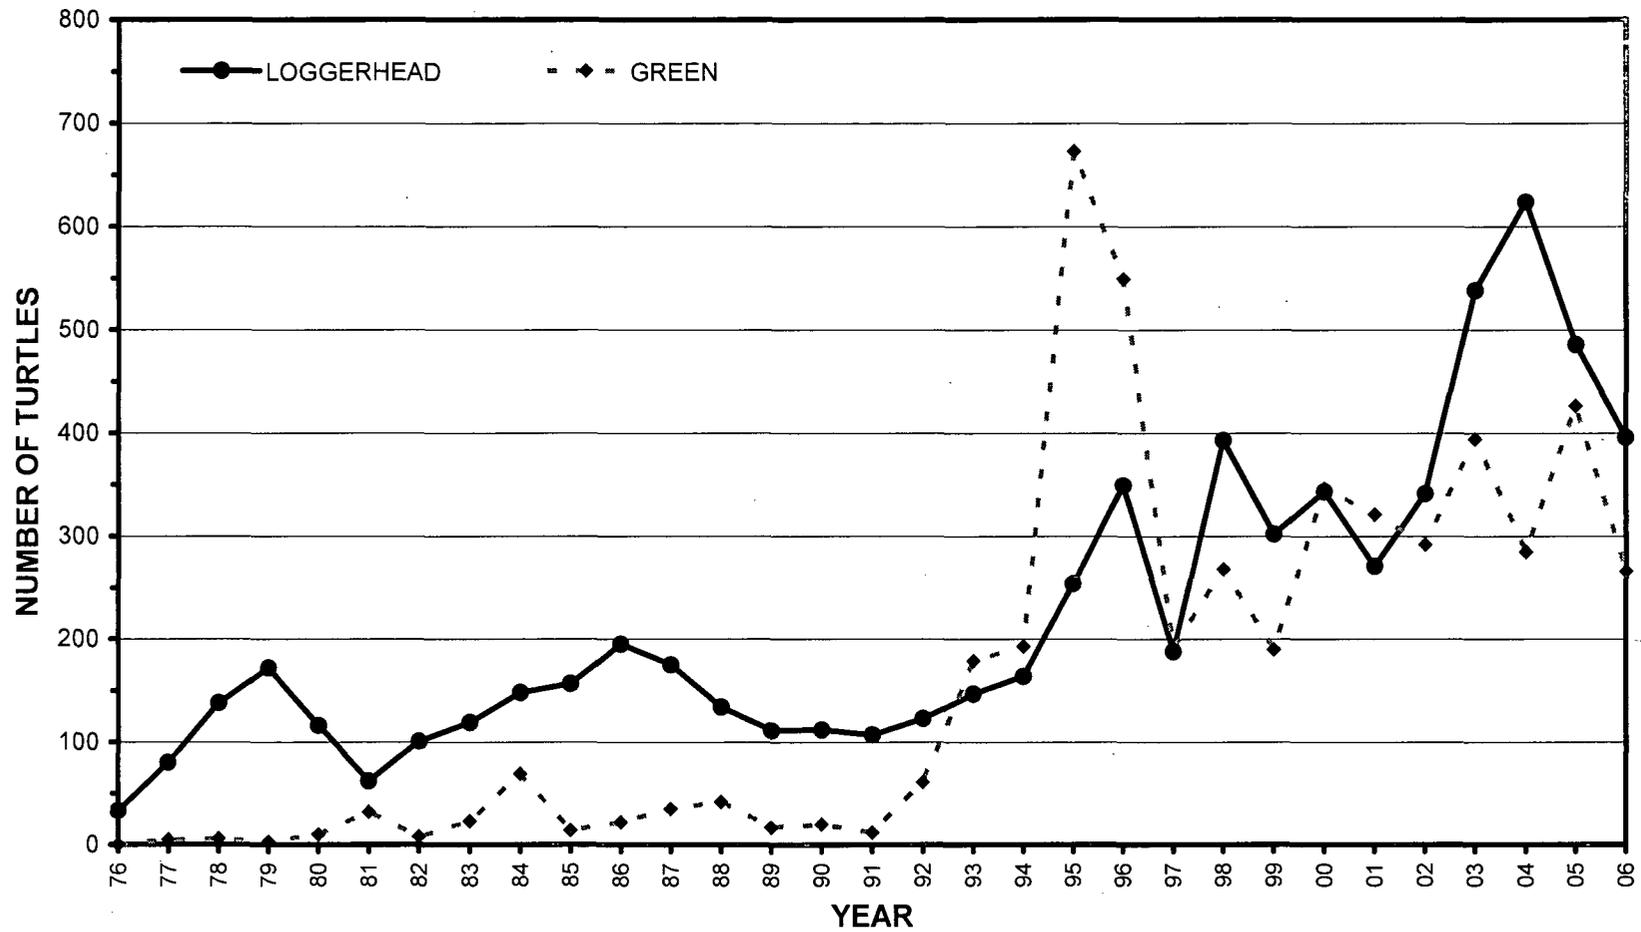
Figure 10. Number of loggerhead and green turtles removed each year from the intake canal at the St. Lucie Power Plant, 1976 through 2006.

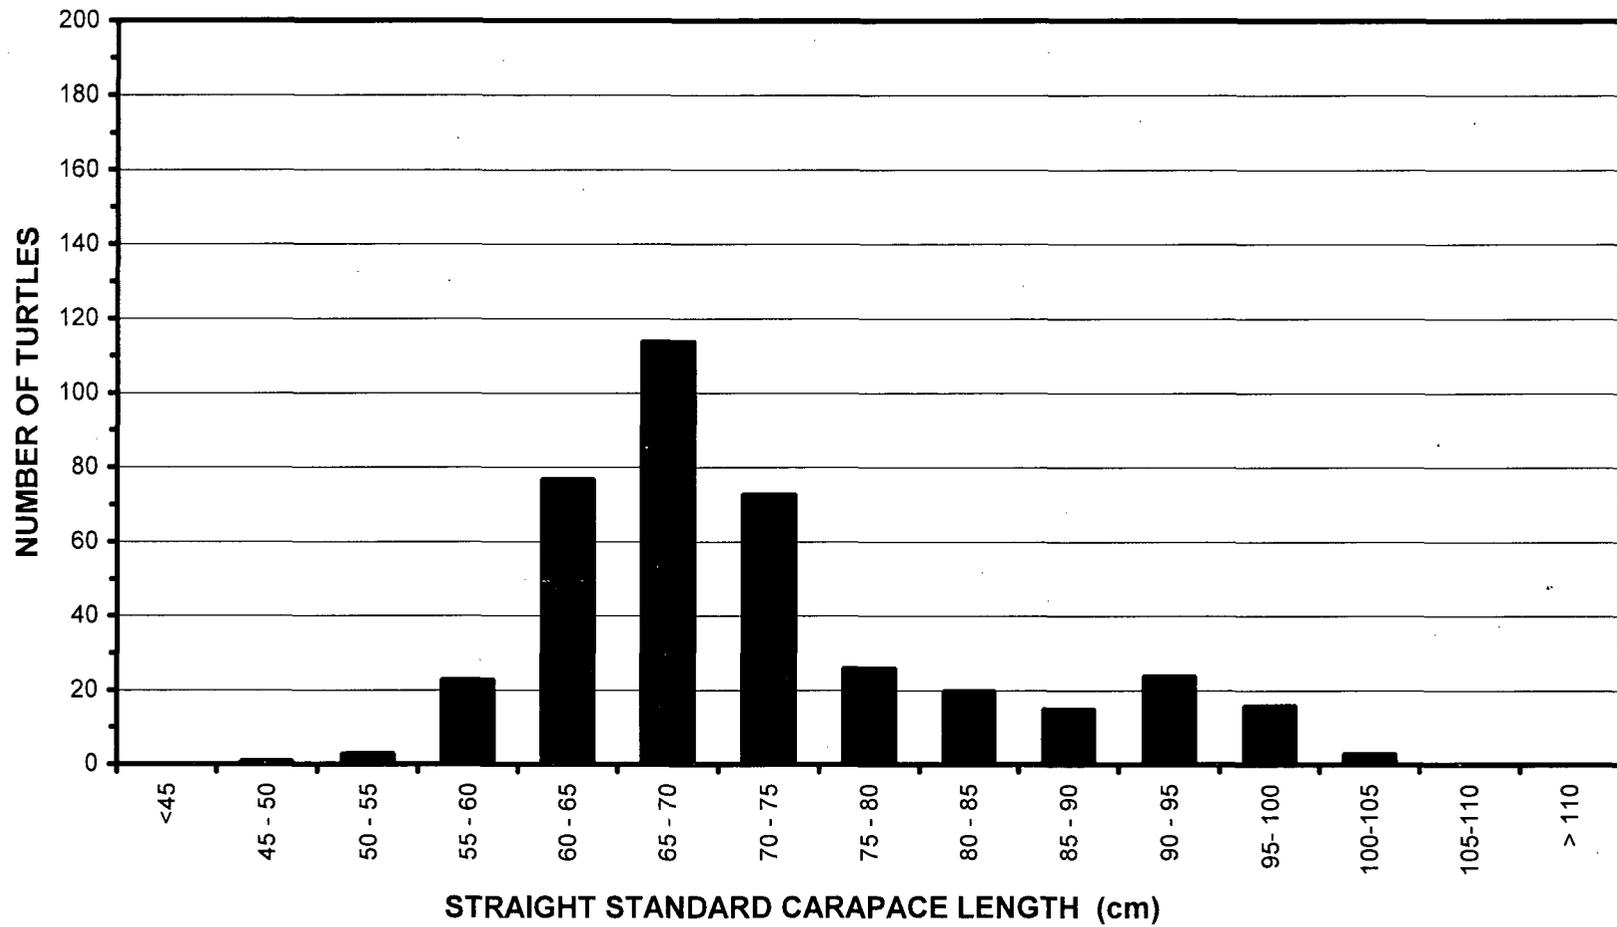
Figure 11. Size distribution (SSCL) of loggerhead turtles (n = 395) removed from the intake canal, St. Lucie Plant, 2006.

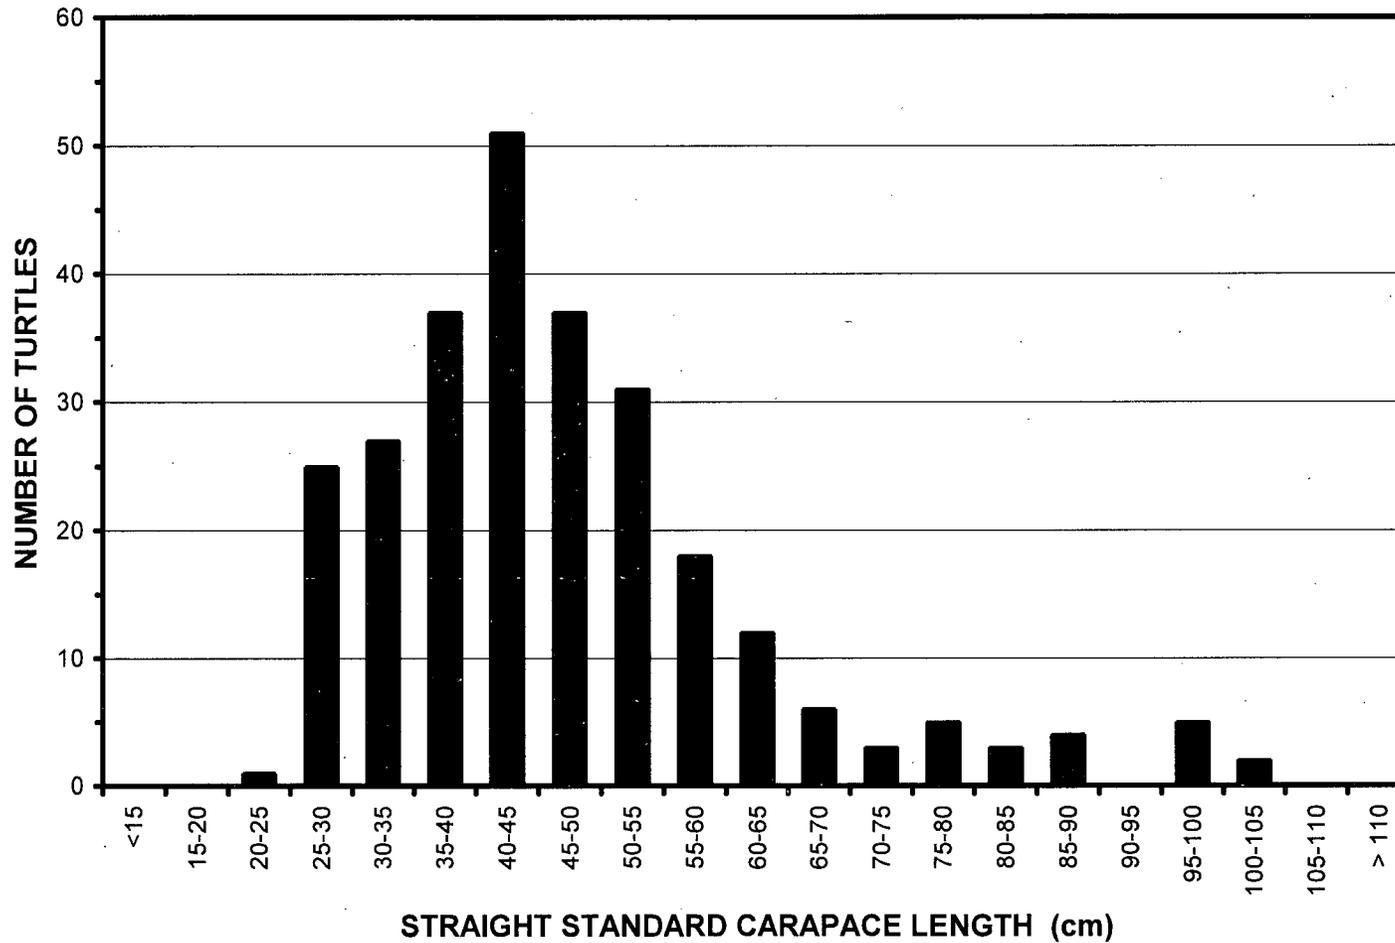
Figure 12. Size distribution (SSCL) of green turtles (n = 267) removed from the intake canal, St. Lucie Plant, 2006.

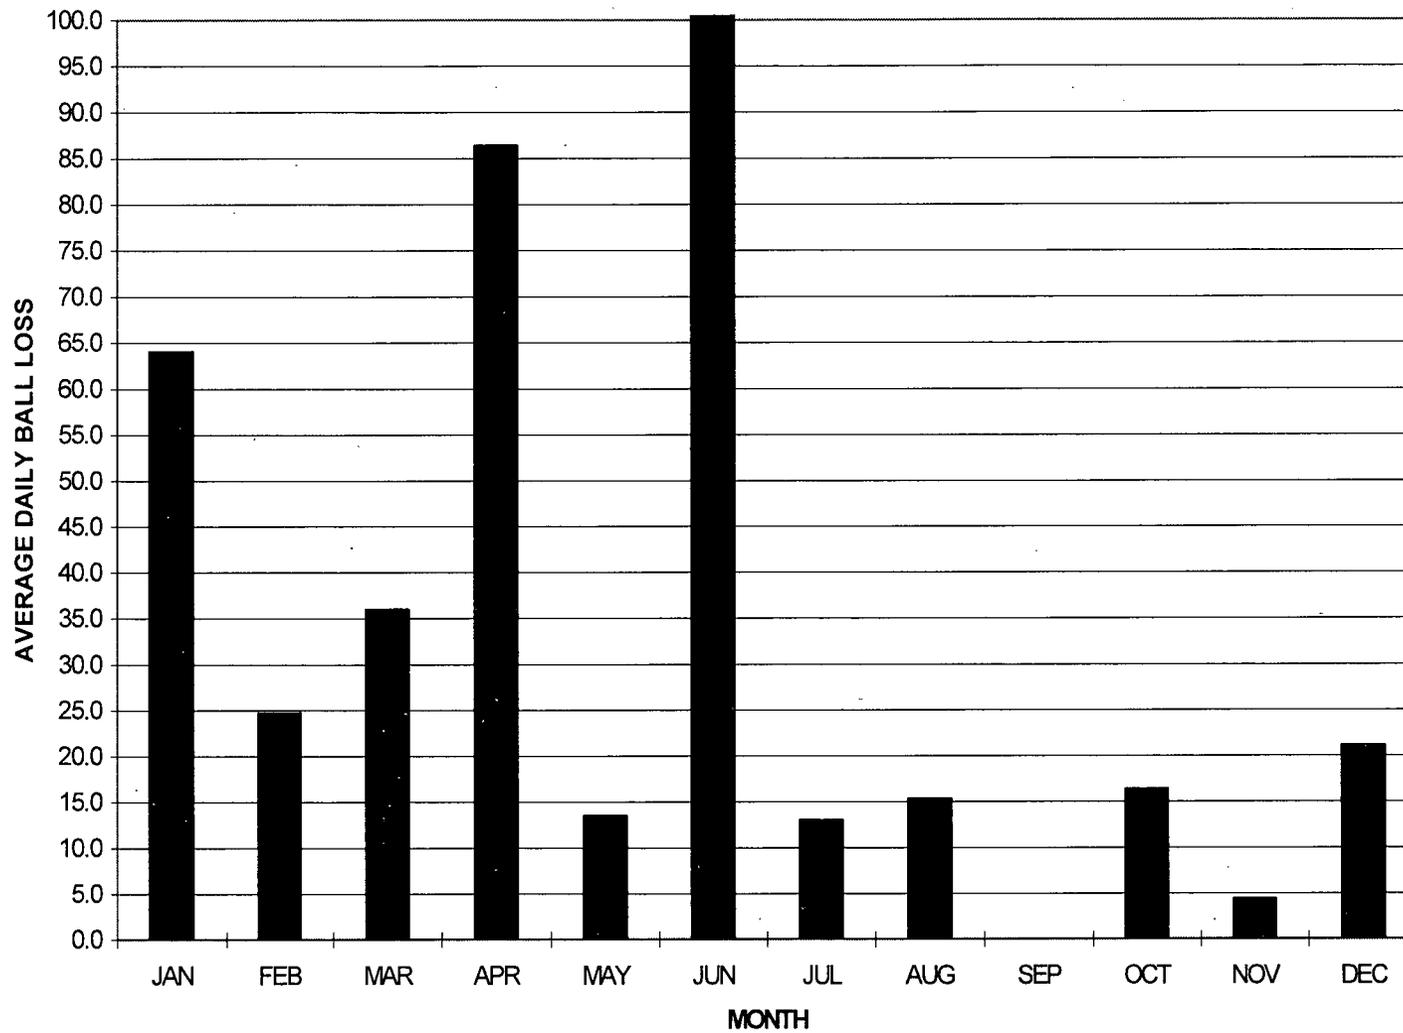
Figure 1. Estimated Average Daily Sponge Ball Loss by Month from St. Lucie Plant (Both Units) for 2006.

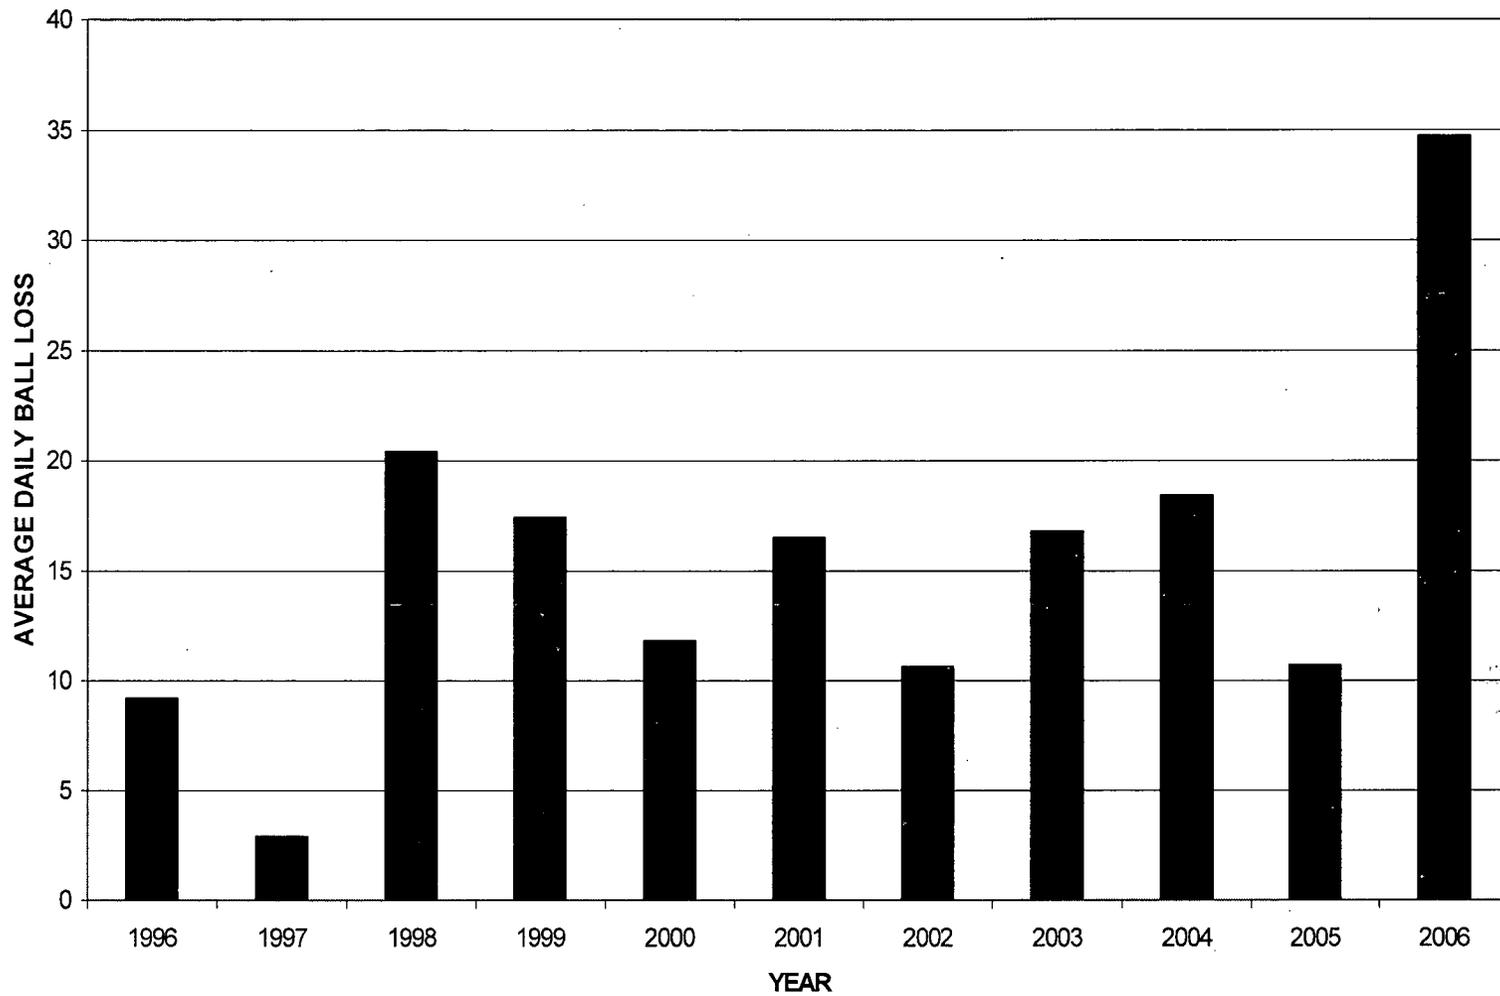
Figure 2. Average Daily Sponge Ball Loss from the St. Lucie Plant (Both Units) Since System Start-Up (January 1996).
