TEST PIT LOGGING RESULTS

The purpose of the excavation and logging of exploratory test pits was to characterize the subsurface conditions of soil and bedrock at designated locations to support the COL for the two new AP1000 units. The use of test pit excavations as an exploratory tool was proposed in the Geotechnical Data Collection Plan, Rev.0. Quality Assurance (QA) aspects of the field work were governed by the MACTEC QAPD, Rev 0, dated April 14, 2006.

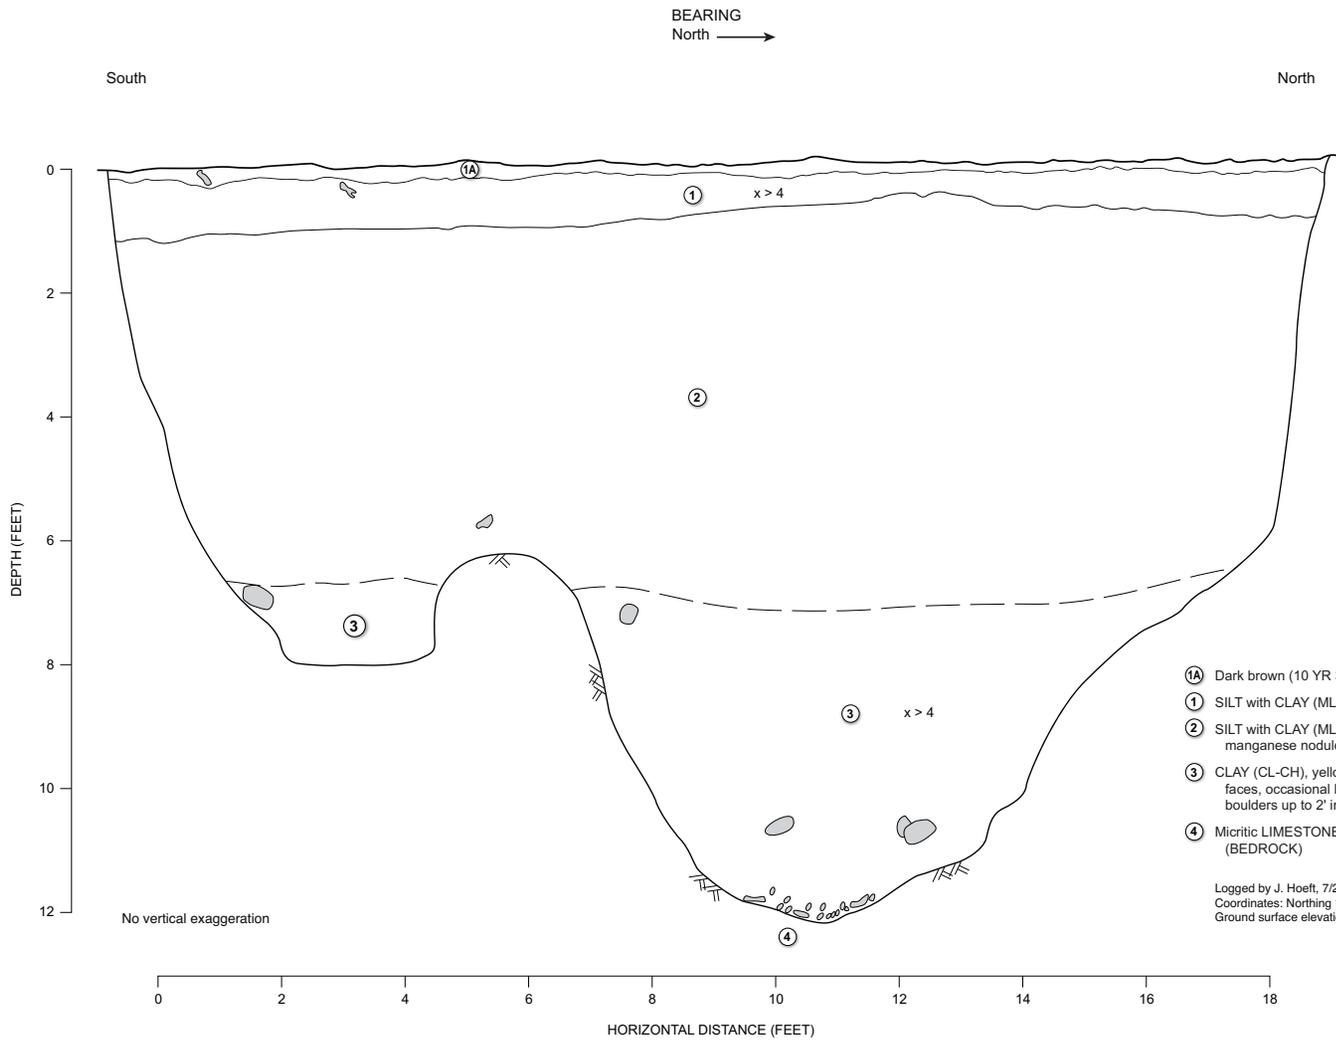
Test Pit T-1403, West Wall

The west wall of the pit was cleaned and logged as shown on Figure 1. The test pit did not expose fill materials. The upper 6.5 ft. exposed silt with clay soils, relatively dry and stiff. A resistant bedrock pinnacle was noted at 6 ft, dropping off quickly to the north and south. Below a horizontal contact at 6.5 ft were clay soils containing limestone boulders and gravels. Bedrock consisting of micritic limestone was observed, it was moderately weathered and medium strong. Free water or seepage was not observed. The test pit was backfilled and site graded flat.

- Geologic Units**
- ①A Dark brown (10 YR 3/3), roots and organic matter (TOPSOIL)
 - ① SILT with CLAY (ML-MH), yellowish brown (10 YR 5/6), dry, very stiff (friable)
 - ② SILT with CLAY (ML-MH), yellowish brown (10 YR 5/6), dry to moist at bottom, has prevalent manganese nodules, near base becoming mottled with yellowish red (5 YR 4/6), occasional roots
 - ③ CLAY (CL-CH), yellowish brown (10 YR 5/6), moist, hard, occasional manganese nodules, pressure faces, occasional limestone boulders and large gravel, limestone clasts have white weathered rind, boulders up to 2' in diameter
 - ④ Micritic LIMESTONE, medium grey (N5), slightly weathered, medium strong, strong HCl reaction (BEDROCK)

T-1403 was excavated on the western edge of the Annex Building of Unit 3 for the purpose of characterizing top of bedrock conditions (Figure 1). Nearby boring B-1014 had encountered bedrock at a depth of 6 feet, therefore provided a relatively shallow depth for test pit logging. The location was in the woods, so the likelihood of fill being encountered was small. The test pit was excavated to a maximum depth of 12 feet, the practical refusal of the backhoe reach and the top of bedrock.

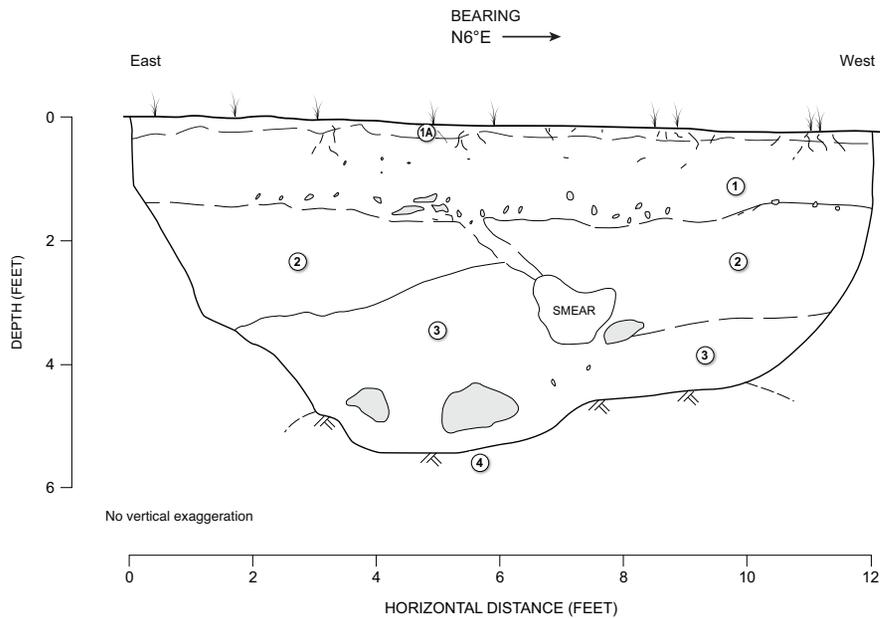
The west wall of the pit was cleaned and logged as shown on Figure 2. The test pit exposed approximately 1.5 feet of fill material consisting of relatively dry and stiff silt with clay and variable amounts of angular gravel. Below a horizontal contact at 1.5 ft were stiff, dry clayey soils with increasing limestone boulders and gravels with depth. Bedrock consisting of micritic limestone was observed; it was slightly weathered and medium strong. Free water or seepage was not observed. The test pit was backfilled and site graded flat.

- ①A Upper zone
- ① SILT with CLAY (ML-MH), brownish yellow (10YR 6/6 dry), dry, hard, angular gravel and organics, gravel is 0.02-0.2' in diameter; also areas of CLAY (CL-CH), reddish brown (2.5YR 4/4), dry, hard, gravel is limestone (FILL/TOPSOIL)
- ② CLAY with SILT (CL-CH), light olive brown (2.5 YR 5/6), dry, hard, contains manganese modules (0.01-0.03')
- ③ CLAY (CL-CH), yellowish brown (10YR 5/6), moist, very stiff, gravel and cobble sized limestone (mostly along the contact of ④), angular white weathering rind
- ④ Micritic LIMESTONE, medium gray (N5), micrite, slightly weathered, medium strong

T-1404 was excavated on the eastern edge of the proposed Nuclear Island of Unit 4 for the purpose of characterizing top of bedrock conditions and conditions of fill (Figure 2). Nearby CPT-1306 was pushed to refusal at a depth of 6.4 feet, therefore allowing a relatively shallow depth for test pit logging. The location was sloping, so the likelihood of fill being encountered was moderate. The test pit was excavated to a maximum depth of 5.5 feet, which was practical refusal on the top of bedrock.

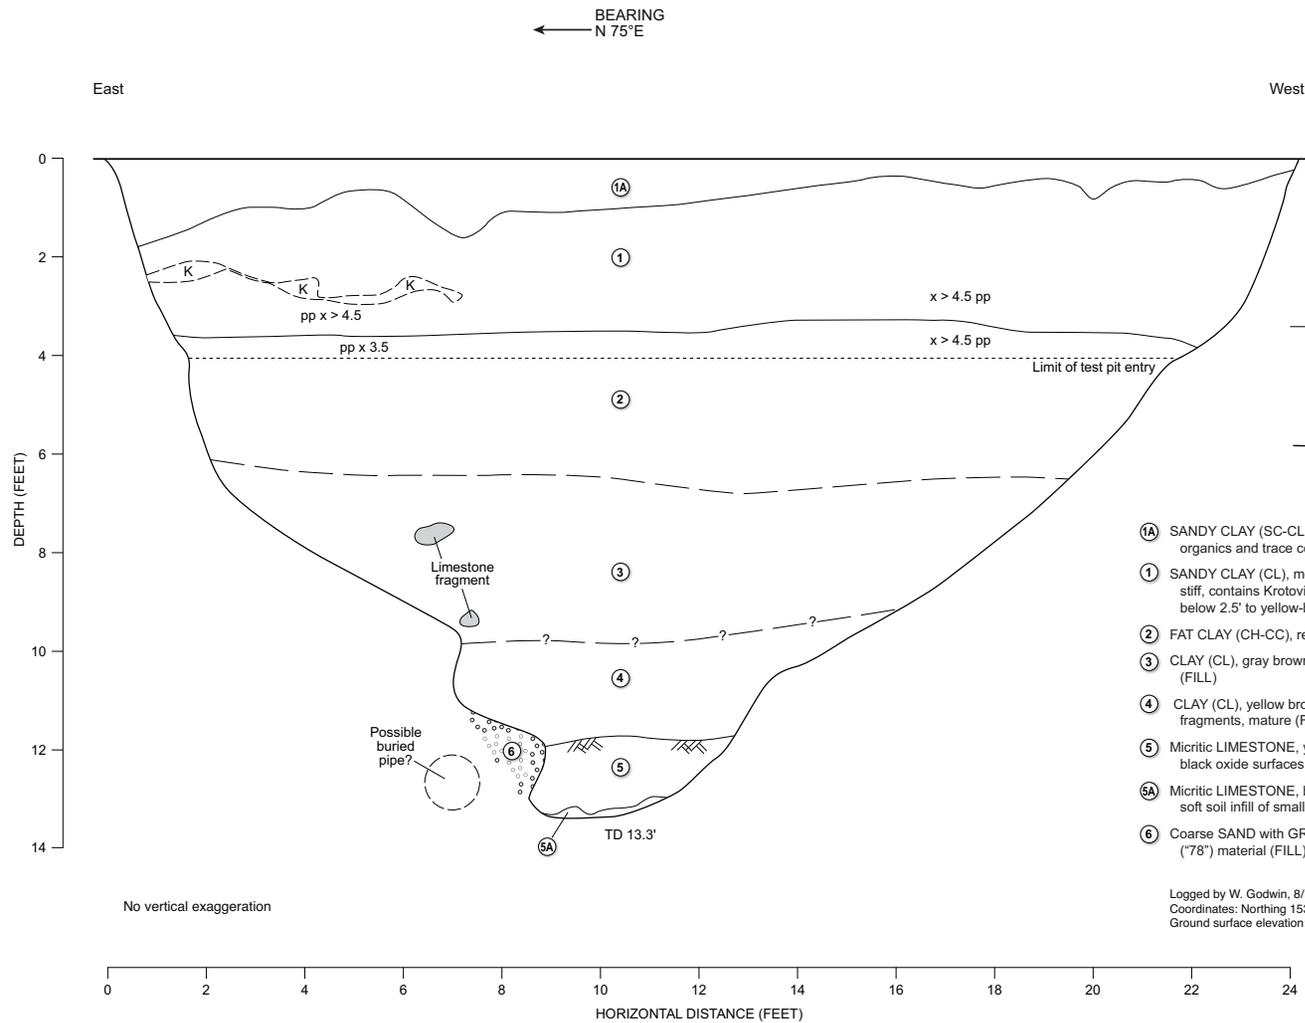
The south wall of the pit was cleaned and logged as shown on Figure 3. The test pit exposed approximately 12 feet of fill soils. To a depth of 4 feet the fill was sandy clay of high plasticity with some burrow disturbance. Between 4 and 6 feet was a grey brown and blue fat clay fill of

medium stiffness. Below 6 ft the clay was less plastic, moist to wet and stiff, representing a different type of fill than above. There were no observed subvertical shears, or offset soils indicative of faulting. Bedrock consisting of deeply weathered, friable micritic limestone was observed below 12 feet, becoming less weathered and hard at a refusal depth of 13.3 feet. From 12 to 13 feet the eastern end of the pit exposed clean gravel (identified by long-time TVA personnel as "78" type bedding material). It was loose and had a tendency to fall into the unsupported excavation. The presence of this material at such a great depth and adjacent to intact limestone bedrock suggests that there is a subdrain or other utility pipe nearby. Although TVA personnel do not have drawings that support the presences of an active utility, historic photos show a preexisting swale in this area that may have had a subdrain placed in a V-slot, covered with gravel and backfilled just to the east. Minor seepage was observed. The test pit was backfilled and site graded flat.

- ①A SANDY CLAY (SC-CL), medium brown to white, dry, loose, contains abundant rootlets, organics and trace concrete fragments (FILL)
- ① SANDY CLAY (CL), medium to mottled red-brown and yellow (10 YR 4/6), moist, medium stiff, contains Krotovina bores (K), coarse sand to gravel, clasts of limestone gradual below 2.5' to yellow-brown with black SAND

- ② FAT CLAY (CH-CC), reddish brown (2.5 YR 4/4), moist, medium stiff (FILL)
- ③ CLAY (CL), gray brown and blue (Gley 2 5/1), moist, medium stiff organic-rich, odoriferous (FILL)

- ④ CLAY (CL), yellow brown (10 YR 5/1) moist to wet, stiff, includes medium sand, chert fragments, mature (FILL)
- ⑤ Micritic LIMESTONE, yellowish red brown with black (5 Y 7/6), deeply weathered, friable, black oxide surfaces, wet (BEDROCK)

- ⑤A Micritic LIMESTONE, buff white to light gray (6 N 6), hard, shiny, closely fractured, contains soft soil infill of small 3-6" vugs (test pit refusal)

- ⑥ Coarse SAND with GRAVEL (SP), gray (10 YR 5/1), loose, wet, possible pipe bedding ("78") material (FILL)

T-1406 was excavated in the central portion of the proposed Turbine Building of Unit 4 for the purpose of investigating the nature of lineament no. 4 and conditions of potential fill (Figure 3). The test pit location was chosen to be near the intersecting seismic lines S-1532 and S-1528 and the mapped lineament as well as nearby boring B-1054. B-1054 had encountered rock at a depth of 17.2 feet; therefore a larger excavator was used. The location was gently sloping, so the likelihood of fill being encountered was moderate. The test pit was excavated to a maximum depth of 13.3 feet, which was practical refusal on the top of bedrock.

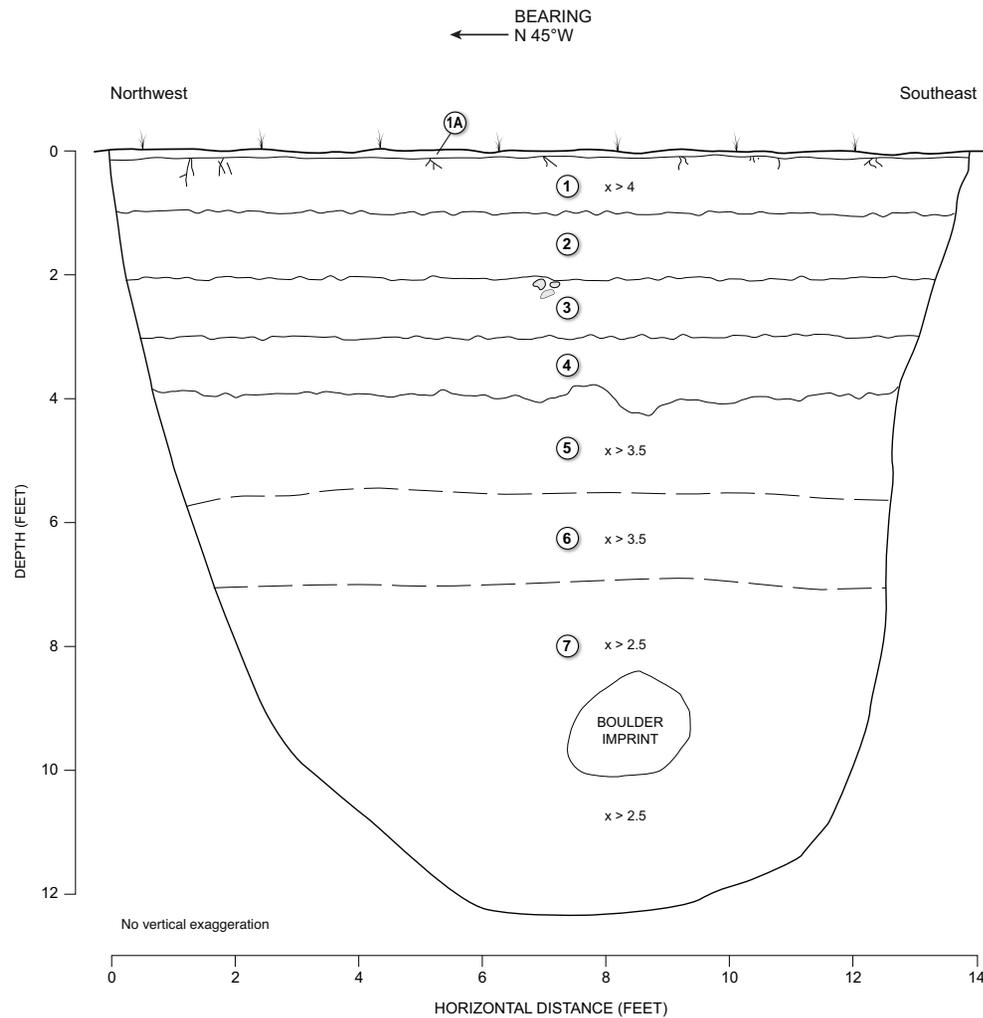
The northeast wall of the pit was cleaned and logged as shown on Figure 4. The test pit exposed approximately 4 feet of fill material consisting of thin lifts of alternating clay and gravel that were dry to moist and stiff silt with dense. Below 4 ft. were thick, near horizontal soil layers of mottled, very stiff clay. Numerous pressure faces were observed with increasing boulder and gravel contents with depth. Below a horizontal contact at 6.5 ft were stiff, dry clayey soils with increasing limestone boulders and gravels with depth. Free water or seepage was not observed. The test pit was backfilled and site graded flat.

- ①A Upper 0.3' are dark brown (10 YR 3/3)
- ① SILT with CLAY (ML-MH) yellowish brown (10 YR 5/4 dry), dry, hard, organics throughout
- ② (Several lifts) GRAVEL with CLAY and SILT, light yellowish brown (10 YR 6/4), dry, hard/very dense, limestone angular gravel (<0.1' diameter) ~ 95% gravel (FILL)

- ③ CLAY with GRAVEL, red (2.5 YR 4/6), damp, hard, gravel is 0.02' diameter to fist sized, ~15% gravel (FILL)
- ④ GRAVEL with CLAY and SILT, pale yellow (2.5 Y 7/4), dry, hard/dense, ~95% gravel, gravel is angular limestone (<0.15' diameter) (FILL)

- ⑤ CLAY (CL-CH), dark yellowish brown (10 YR 4/4), moist, very stiff, medium plastic, pressure faces
- ⑥ CLAY with SILT (CL-CH), yellowish brown (10 YR 5/6), mottled with yellowish red (5 YR 4/6), moist, very stiff, occasional gravel-size limestone clasts, angular

- ⑦ CLAY (CL-CH), yellowish brown (10 YR 5/6), moist, very stiff, medium plastic pressure faces, some pressure faces are light gray (2.5 Y 7/1); below 9' change to CLAY with GRAVEL and BOULDERS (CL-CH), yellowish brown (10 YR 5/6), moist, very stiff, gravel and boulders are micritic limestone, medium gray (N5), with weathering rind of a white color, boulders are 1-2.5' in diameter

T-1409 was excavated opposite the proposed Administration building south of Unit 4 for the purpose of characterizing top of bedrock conditions and conditions of fill (Figure 4). A boring (H-46) reported in the FSAR (1986) had encountered solution features at an elevation of 614 to 616 feet. It was hoped that these features could be observed in the test pit excavation. The test pit was excavated to a maximum depth of 12 feet, or elevation 615 feet) and did not encounter bedrock at all.

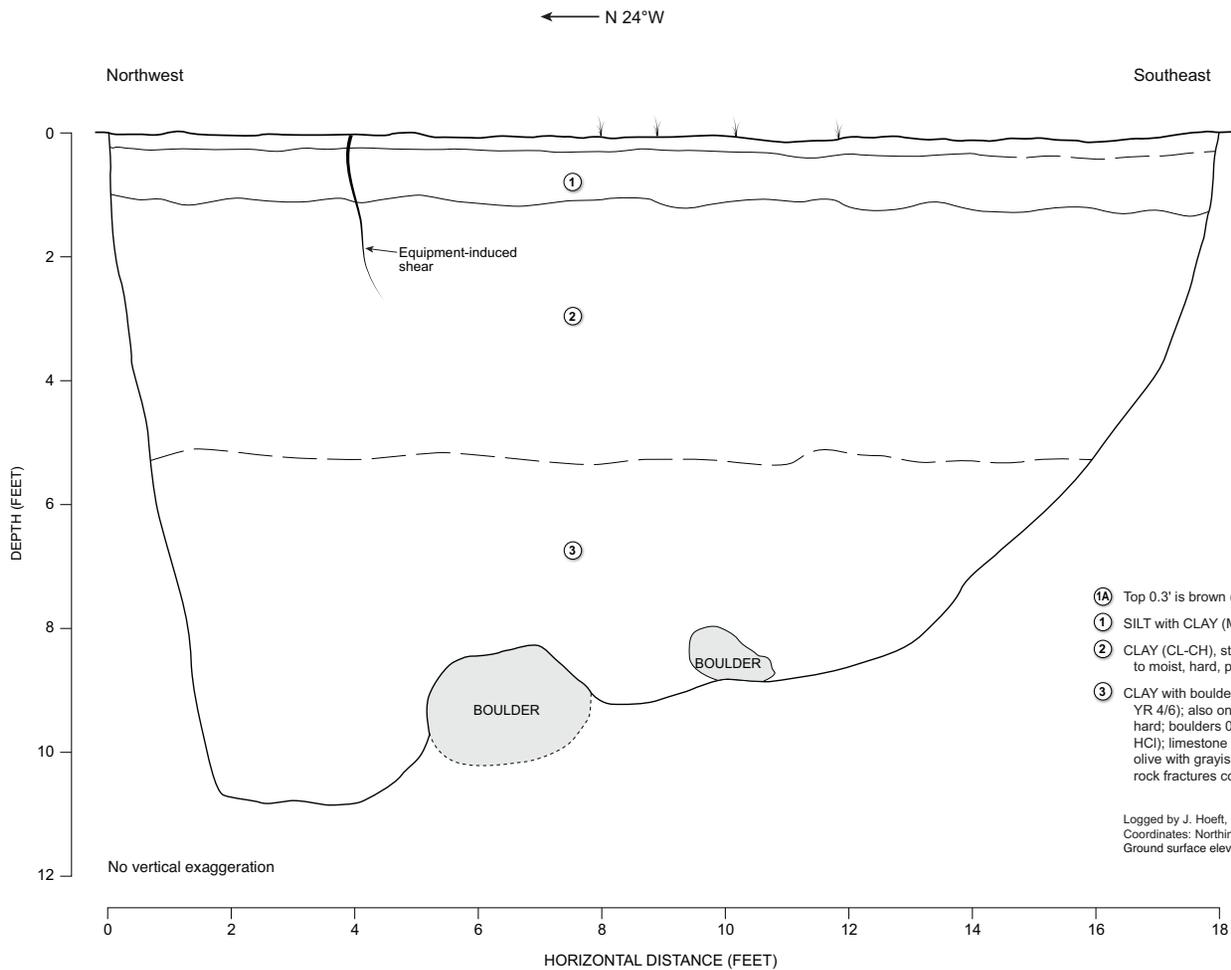
The west wall of the pit was cleaned and logged as shown on Figure 7. The test pit exposed a 1-foot-thick horizontal fill layer of dry and loose silt, overlying a thick fill interval of silty clay to clayey gravel. The gravelly wedge of fill was exposed at the northern end of the test pit, and transitioned into the clayey gravel subunit to the south. Beneath the fill layer at a depth approximately 4.5 feet was a massive, residual soil. The flat lying nature of this unit and the fact that the test pit extended to near the center of the surface feature, precluded the presence of subsurface collapse. Bedrock was not encountered. Free water or seepage was not observed. The test pit was backfilled and site graded flat.

- ①A Top 0.3' is brown (7.5 YR 4/4) (TOPSOIL)
- ① SILT with CLAY (ML-MH), strong brown (7.5 YR 4/6), dry, hard, friable, roots and organics
- ② CLAY (CL-CH), strong brown (7.5 YR 5/8), mottled with brownish yellow (10 YR 4/6), damp to moist, hard, pressure faces, occasional manganese nodules
- ③ CLAY with boulders (CL-CH), yellowish brown (10 YR 5/6), mottled with yellowish red (5 YR 4/6); also on some pressure faces— color light greenish gray (GLEYS 1 7/5), moist, hard; boulders 0.7-2.0' in diameter, contain white powdery weathered rind (reaction to HCl); limestone to calcareous siltstone boulders are moderate yellow (5 Y 7/6) to pale olive with grayish yellow (5 Y 8/4), weathering profile— top is more weathered than bottom, rock fractures conchoidally

T-1414 was excavated opposite the Power Stores building south of proposed Unit 4 for the purpose of characterizing fill and top of bedrock conditions, and to investigate a surface feature seen in historic photos (Figure 7). A 1980 site topographic map and an aerial photo dated 1979 depicted a pit or excavation in this area during construction. It was unclear whether this feature was artificial (i.e. drainage sump) or a result of collapse. Test pit T-1414 was positioned to extend from just outside the boundary of the feature to the middle or deepest portion. It also was near boring B-1081 and seismic line S-1525. Boring B-1081, to the northwest had encountered bedrock at a depth of 11.5 feet. The test pit was excavated to a maximum depth of 6 feet.

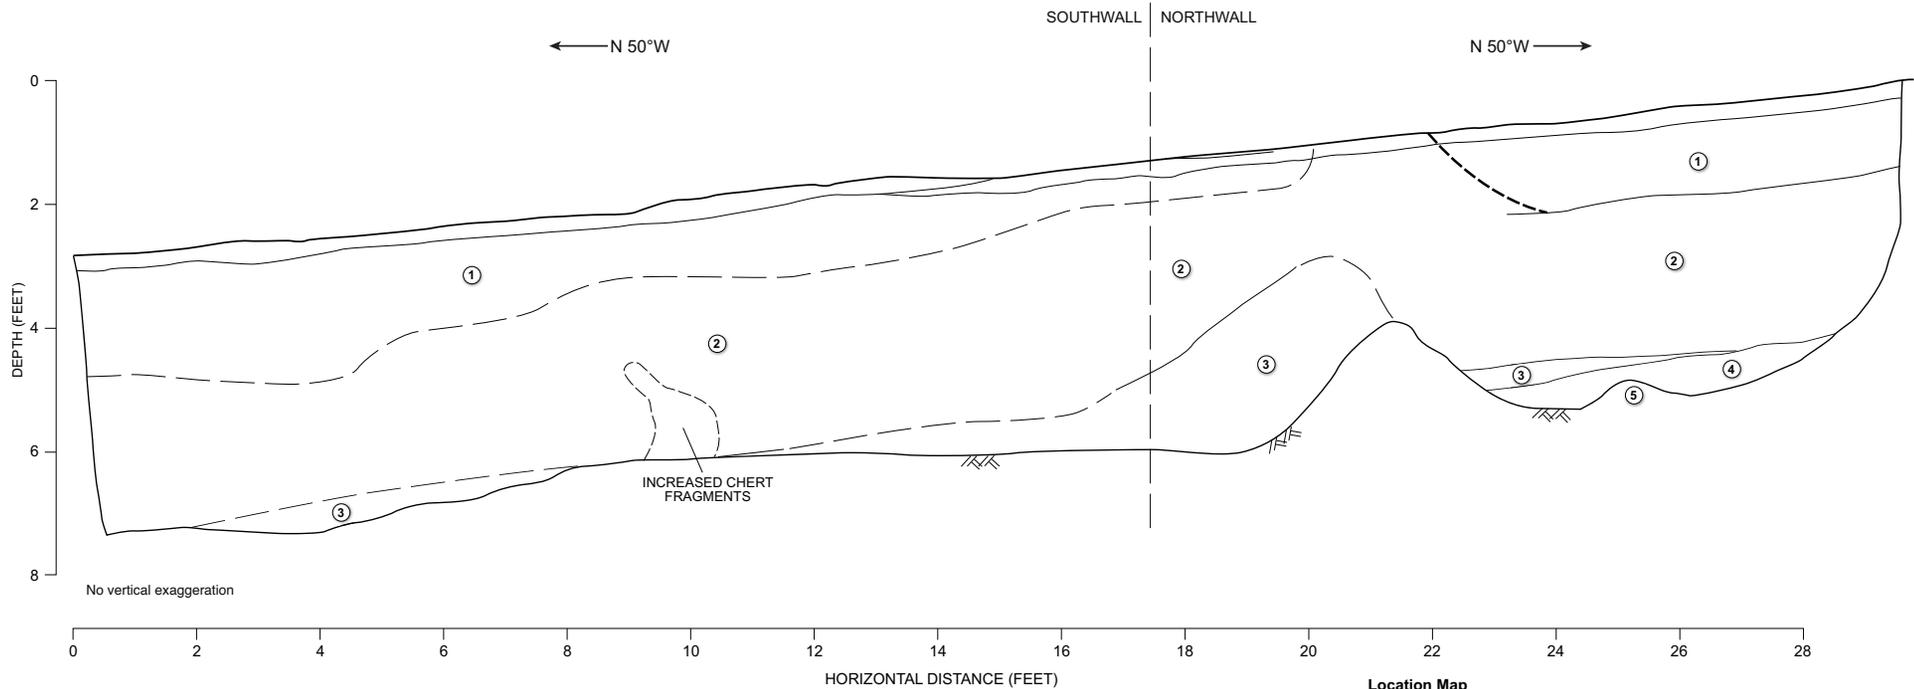
The west wall of the pit was cleaned and logged as shown on Figure 8. The test pit exposed a thin surface soil layer of dry and loose silt, overlying a very thick fill interval of silt with clay to gravel. A pinnacle of bedrock was exposed at the base of this unit at a depth of 6 ft. It consisted of micritic limestone. Below 6 feet was a hard, moist clay soil horizon that contained increasing amounts of small boulders and gravel with depth. Small fragments of bedrock were obtained from the deepest part of the test pit and these along with the pinnacle, reacted strongly with dilute hydrochloric acid. This suggests that the bedrock is not dolomitic. Free water or seepage was not observed. The test pit was backfilled and site graded flat.

- ① SILT with CLAY (ML-MH), yellowish red (5 YR 4/6), damp, very stiff, friable, top 0.3' is SILT with CLAY (ML-MH), dark brown (7.5 YR 3/4), damp to moist, medium stiff to stiff, (TOPSOIL, LEAF LITTER, HUMUS)
- ② CLAY with SILT (CL-CH) strong brown (7.5 YR 5/8), mottled with yellowish red (5 YR 4/6), damp to moist, very stiff to hard, occasional chert fragments, black with weathering rind 0.05-0.2', ~10% chert
- ③ SILT with CLAY (ML-MH), brownish yellow (10 YR 6/6), dry, hard, occasional manganese nodules and chert fragments, ~25-30% chert.
- ④ CLAY (CL-CH), yellowish brown (10 YR 5/6), moist, stiff, hard, occasional chert fragments, black in color with weathering rind, angular edges, high plasticity
- ⑤ Micritic LIMESTONE, locally weathered as surficial sand, predominantly weak to moderately strong, slightly weathered

T-1415 was excavated on a wooded parcel of land 1300 feet west of proposed Unit 4 on a small peninsula beside the Town Creek Embayment (Figure 8). Its purpose was to determine the

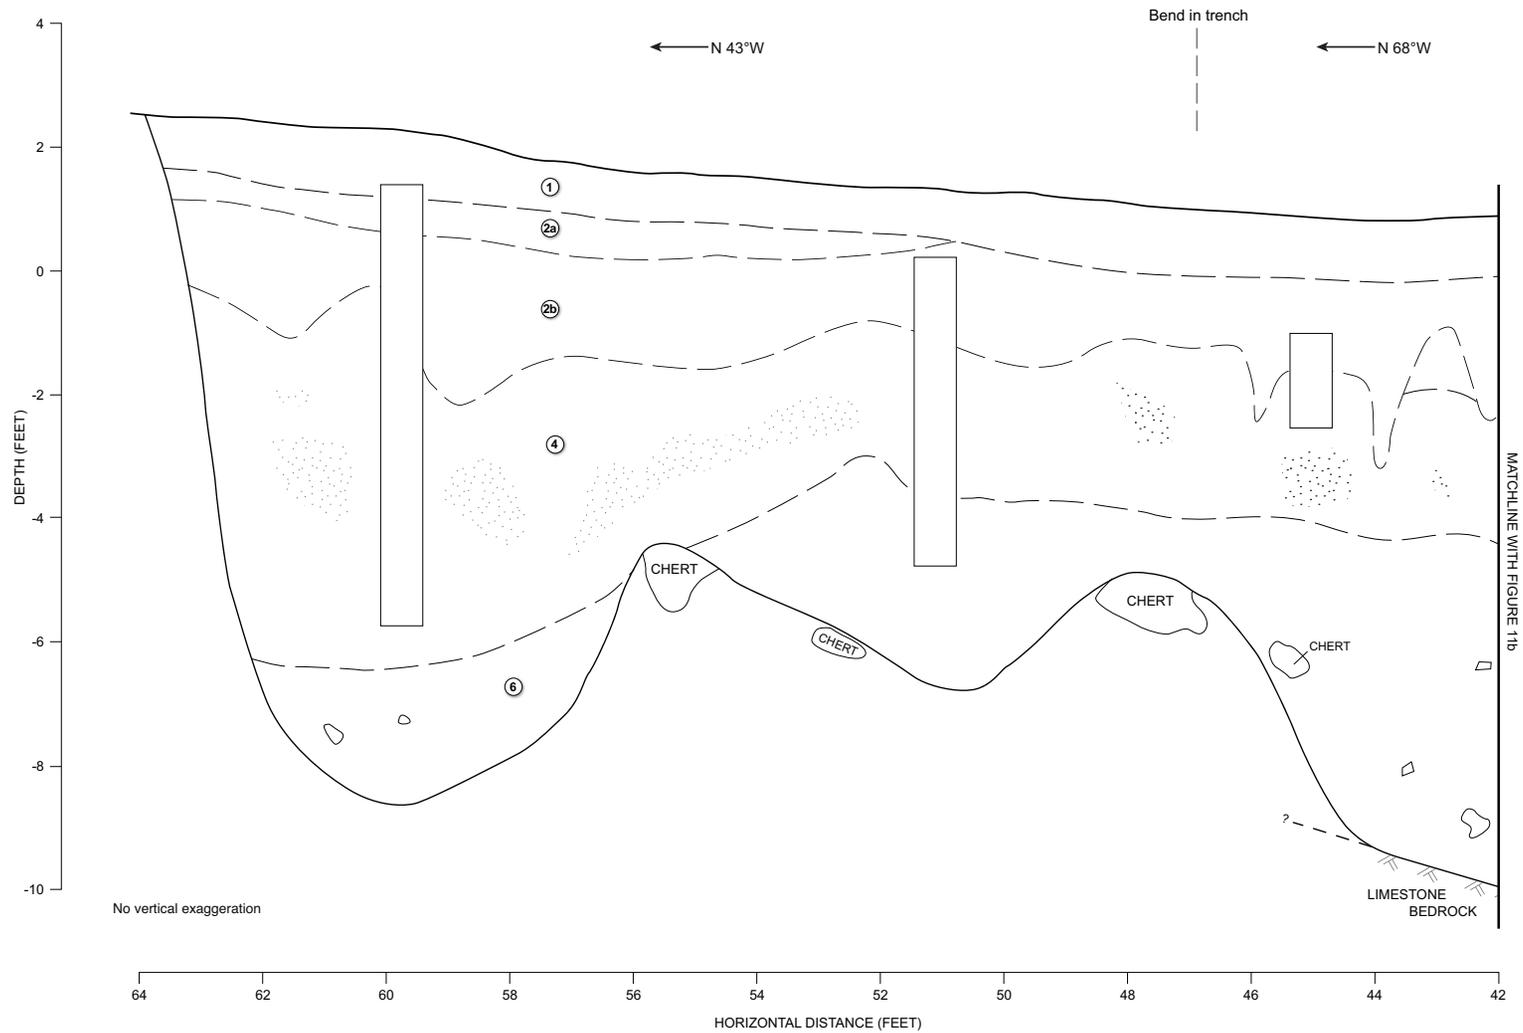
Test Pit T-1417 East

The test pit exposed 7 to 12 feet of residual soil over an irregular bedrock surface. A mature soil profile is developed within the residuum. The upper 2 to 4 feet of the profile is a firm, clayey silt with an organic-rich topsoil. In places this horizon forms "tongues" penetrating down into the more clay-rich subsoil. These are interpreted to form from the vertical penetration of perched water into the subsoil; the tongues represent areas where clays and iron oxides have been removed by leaching.

The subsoil is moist silty clay with mottling and concretions of iron and manganese, features indicative of mature weathering in a environment of fluctuating groundwater conditions. Beginning several feet above the bedrock surface, angular chert fragments and large irregular chert nodules float within the clay matrix. The bedrock surface is irregular, with portions that are somewhat planar and oriented parallel with bedding strike and dip. Very large chert nodules in places prevented excavation to the top of rock. The contact between the soil and the bedrock is clear, occurring over a few inches. The top of the bedrock is moderately weathered and resistant to scraping of the bucket.

No evidence of shearing was observed within the residual soil. No displacements were noted in the soil horizon boundaries. The bedrock surface is at its deepest over the projection of the lineament, as would be expected in the axis of a topographic swale where water is concentrated and weathering rates are thus higher. However, no shearing or offset in the bedrock was observed.

- ① CLAYEY SILT, partially buried by fill, brown to pale brown (10 YR 5/3-6/3), many roots (A HORIZON)
- ② CLAYEY SILT, light yellowish brown (10 YR 6/4), common (E HORIZON)

- ③ SILTY CLAY, mottled reddish yellow (7.5 YR 6/6) to strong brown (7.5 YR 5/6) and light brownish gray (10 YR 6/2), silty clay, sticky, plastic, 5% fine angular chert fragments, trace of Fe concretions, moist (BT1 HORIZON)

- ④ SILTY CLAY, mottled reddish yellow (2.5 YR 6/6) and brown (7.5 YR 5/4) with light brownish gray (2.5 Y 6/2), sticky, plastic, 10% fine to medium angular chert clasts and 5% black Fe concretions, Fe/Mn black coatings on some chert clasts, moist (BT2 HORIZON)

- ⑤ SILTY CLAY, yellowish brown (10 YR 4/5, 5/6), sticky, plastic, with about 30% Fe concretions, concretions are 0.3-0.6 cm in diameter, roughly spiral, black, %5 angular chert fragments, moist (BT3 HORIZON)

- ⑥ Slightly SILTY and SANDY CLAY, mottled yellowish brown (10 YR 5/6), black (10 YR 2/1) and gray (10 YR 6/1), angular fragments of chert comprising 10-50% of the horizon, chert fragments are sand to gravel sized black, gray and pink, moist (BT4 HORIZON)

Base of horizon 6 abruptly contacts the surface of the limestone bedrock. Bag samples were collected from horizons 1 through 6.

T-1417 was excavated on the north side of the proposed RadWaste Building of Unit 3 for the purpose of continuing the investigation of lineament no. 12 and inspecting bedrock conditions across the associated swale (Figures 10, 11a, 11b). The test pit extended from the south end of T-1416 and continued approximately normal to the projection of the mapped lineament and crossed the swale. The location was a wooded area, gently sloping to the southeast, then almost level across the swale. In order to ensure that the lineament was crossed and the entire width of the swale inspected, test pit T-1417 was extended a total of 62 feet southeast (azimuth of 120 degrees) from the southeast end of T-1416. The test pit was completed in two sections, T-1417E and T-1417W, each excavated, logged and backfilled on separate consecutive days.

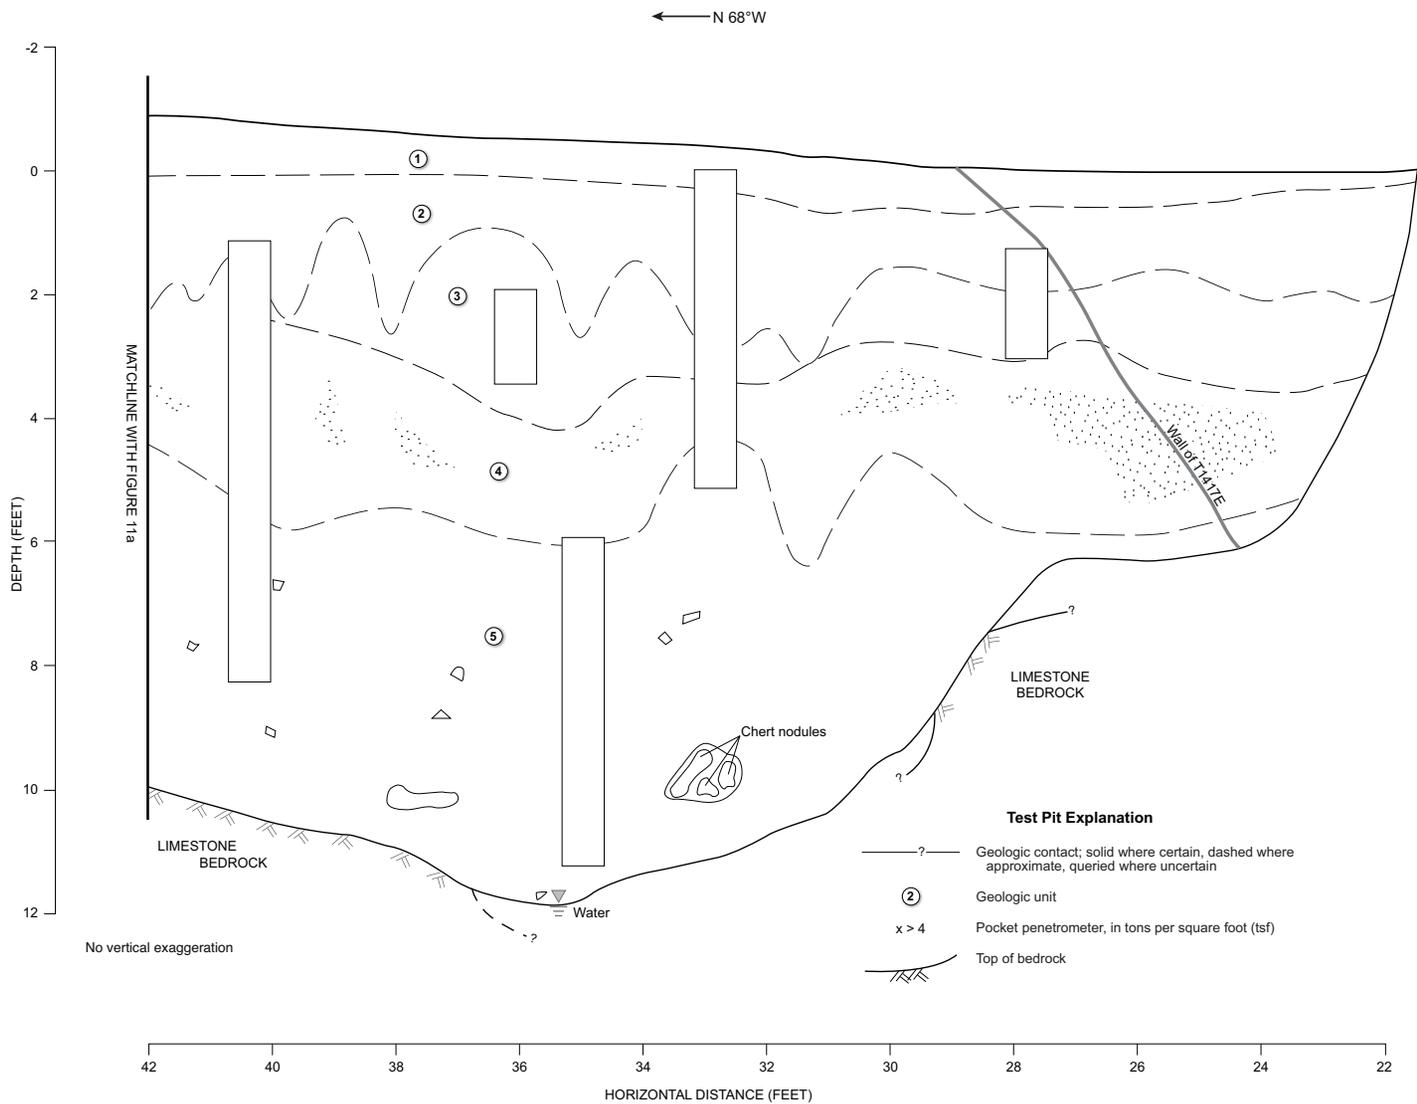
Test Pit T-1417 West

- ① CLAYEY SILT, brown to pale brown (10 YR 5/3-6/3), leaves and humus at surface (TOPSOIL)
- ② CLAYEY SILT, light yellowish brown (10 YR 6/4), toward west color gradually changes to yellowish brown (10 YR 5/6), and an upper reddish brown horizon (5 YR to 7.5 YR 4/4) is present (2a), moist

- ③ SILTY CLAY, mottled reddish yellow (7.5 YR 6/6) and brown (7.5 YR 5/4) with light brownish gray (2.5 YR 6/2), sticky, plastic, 5% fine angular chert fragments, trace of Fe concretions, moist

- ④ SILTY CLAY, mottled reddish brown (7.5 YR 6/6) and brown (7.5 YR 5/4) with slight brownish gray (2.5 Y 6/2), sticky, plastic, 10% angular chert fragments, 5-10% black Fe-Mn concretions, moist

- ⑥ CLAY with SAND and SILT, mottled yellowish brown (10 YR 5/6), black (10 YR 2/1), and gray (10 YR 6/1), with angular fragments and irregular nodules of black, dark gray, and pinkish chert, nodules are 0.2-1.5 ft. in diameter and float in clay matrix; nodules are surrounded by a black halo of Fe-Mn stained clay 0.02-0.05 ft. thick

Groundwater was generally absent in T-1417, but small amounts were observed in two areas. The first was encountered along two vertical partings or cracks within the upper clayey silt near the axis of the swale. This appears to be perched surface water percolating laterally. The second occurrence of groundwater was in the lowest point of the test pit. A puddle of groundwater less than 0.1 foot deep accumulated here after excavation.
