Rancho Seco

Final Status Survey Summary Report

Waste Gas Valve Gallery Floor and Lower Walls (Room 059)

Survey Unit F8130231

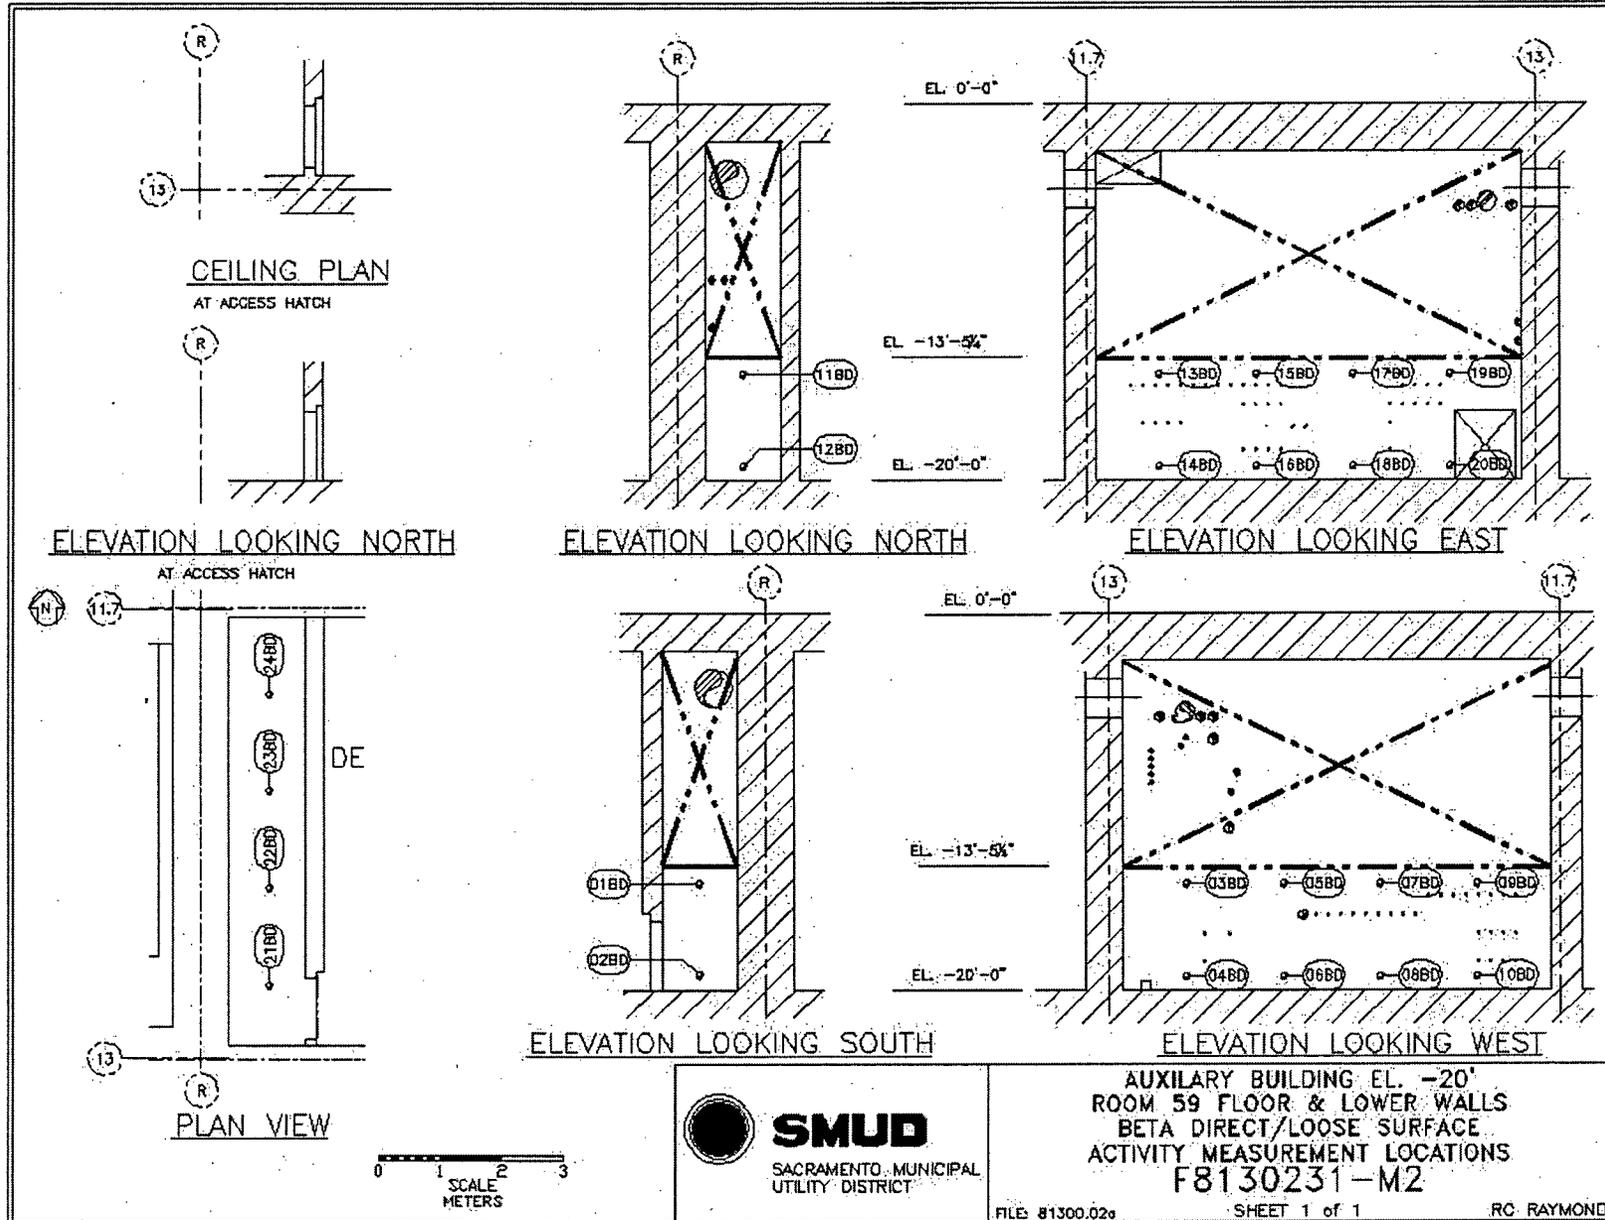
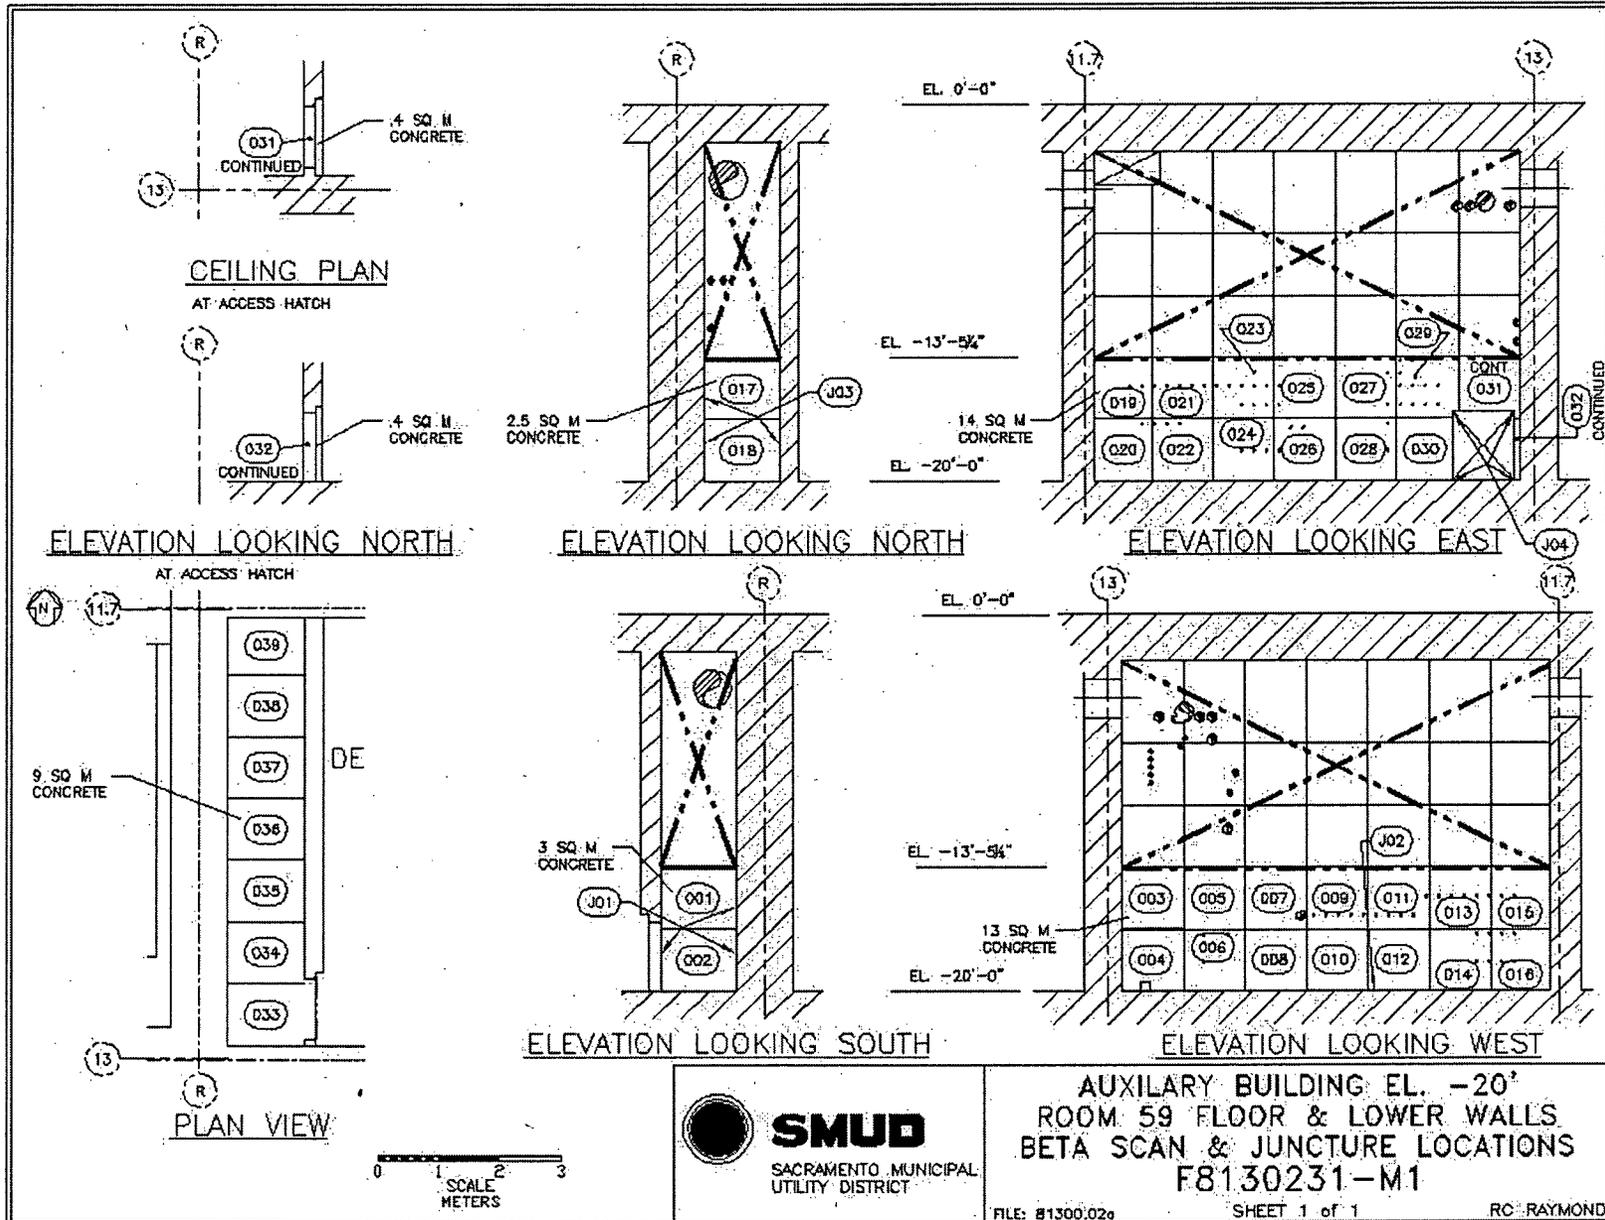
Maps

The Survey Unit Design Parameters are presented in Table 1 below. The survey unit and measurement locations are depicted on the maps in Attachment 1. Direct measurement locations were determined using a random-start, fixed grid pattern and 43 m² were scanned for approximately 100% coverage. Samples of removable contamination were collected at each direct measurement location. The instrumentation used for the survey along with the MDC values are listed in Tables 2-1 and 2-2 in Attachment 2.
