Rancho Seco

Final Status Survey Summary Report

Waste Gas Compressor Room Upper Walls and Ceiling (Room 022)

Survey Unit F8130291

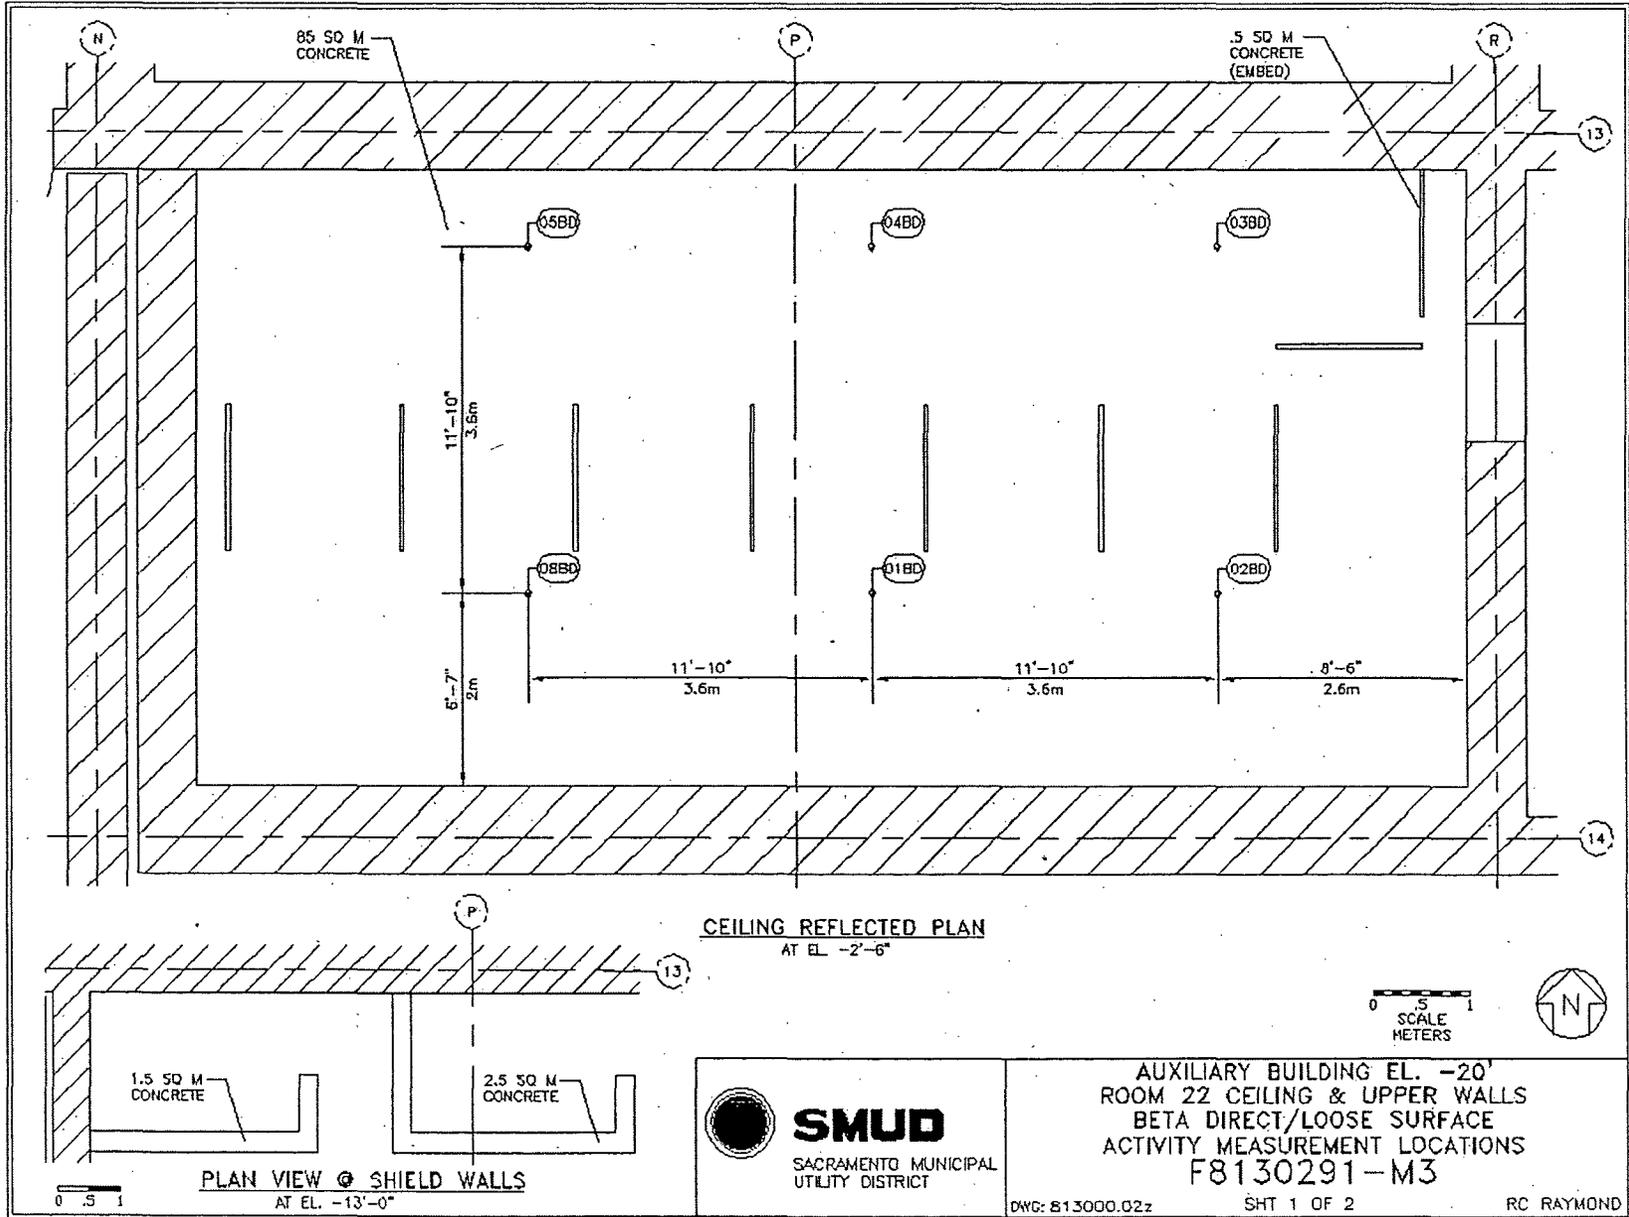
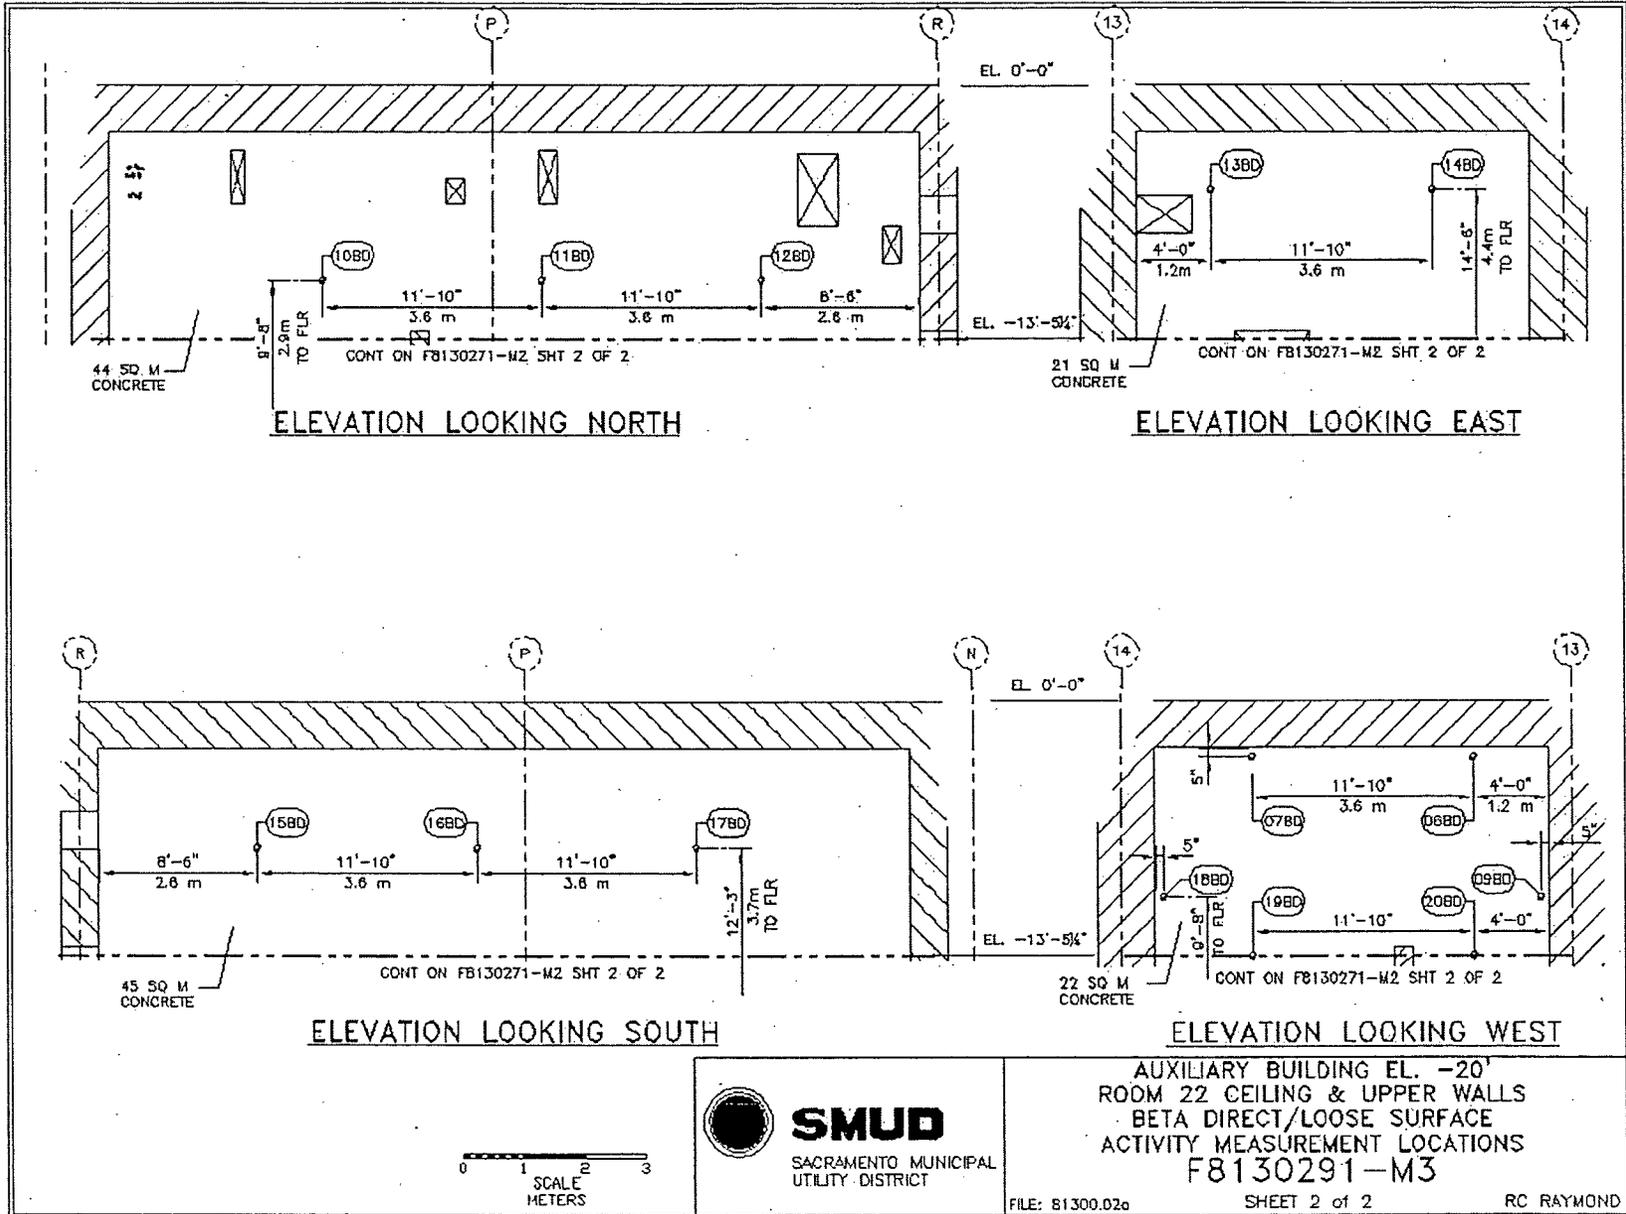
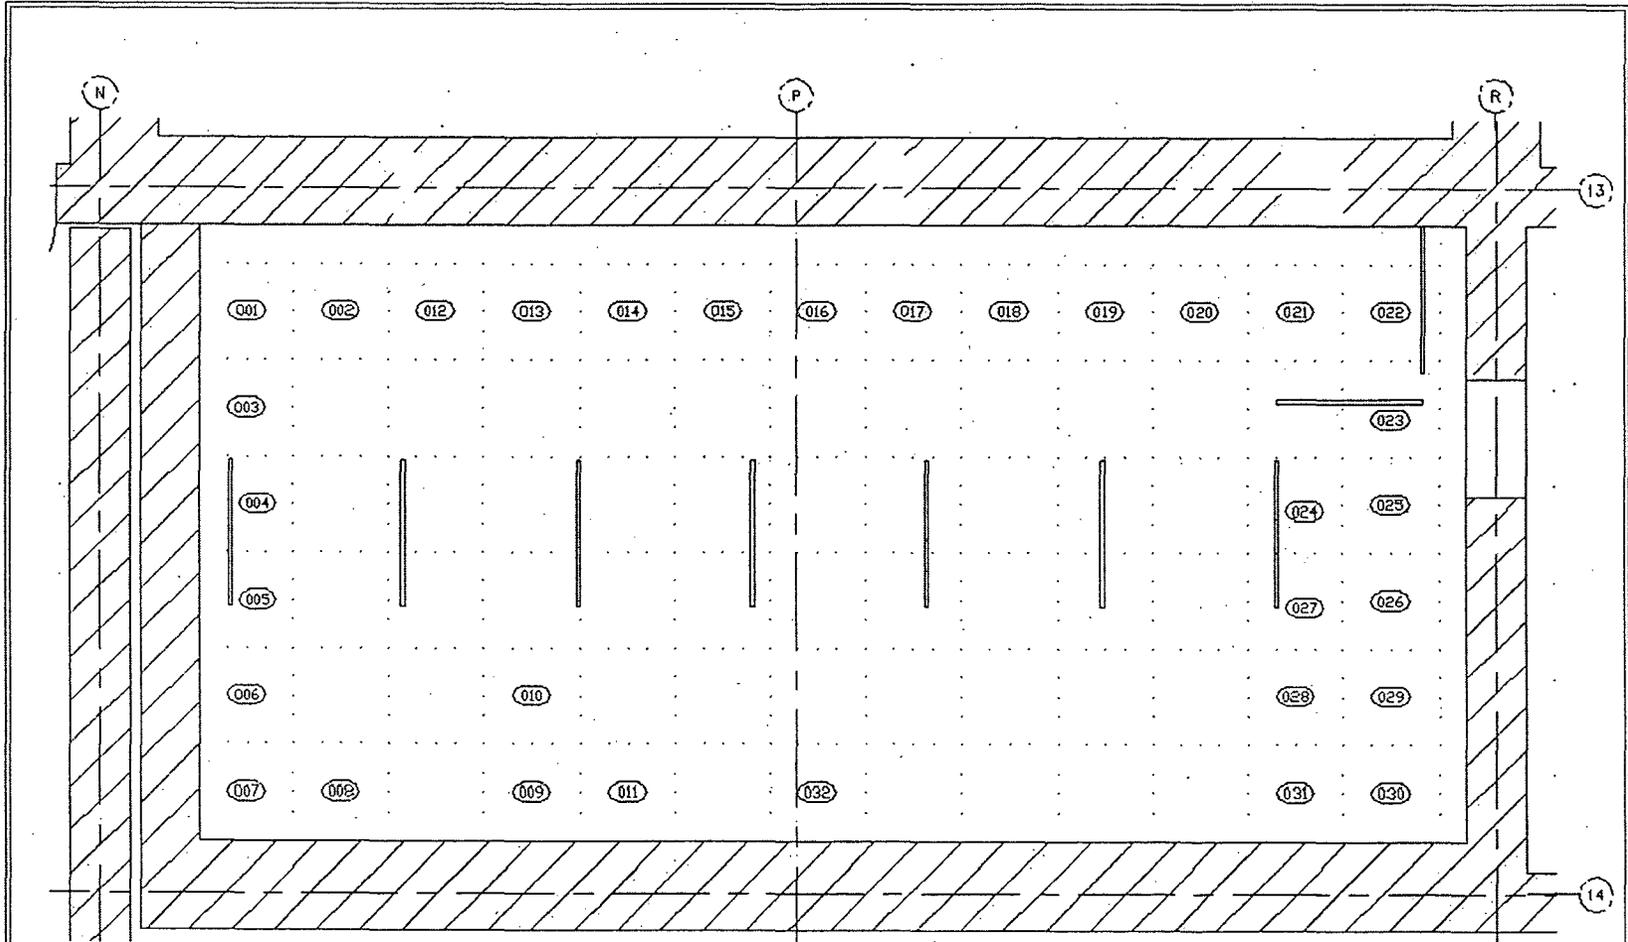
AUXILIARY BUILDING EL. -20'
ROOM 22 CEILING & UPPER WALLS
BETA SCAN MEASUREMENT LOCATIONS
F8130291-M2

The Survey Unit Design Parameters are presented in Table 1 below. The survey unit and measurement locations are depicted on the maps in Attachment 1. Direct measurement locations were determined using a random-start, fixed grid pattern and 80 m² were scanned for approximately 36% coverage. Samples of removable contamination were collected at each direct measurement location. The instrumentation used for the survey along with the MDC values are listed in Tables 2-1 and 2-2 in Attachment 2.

CEILING REFLECTED PLAN
AT EL. -2'-6"
