Shearon Harris Nuclear Power Plant

Units 2 and 3

Part 2, Final Safety Analysis Report

Soil Map of Site Location

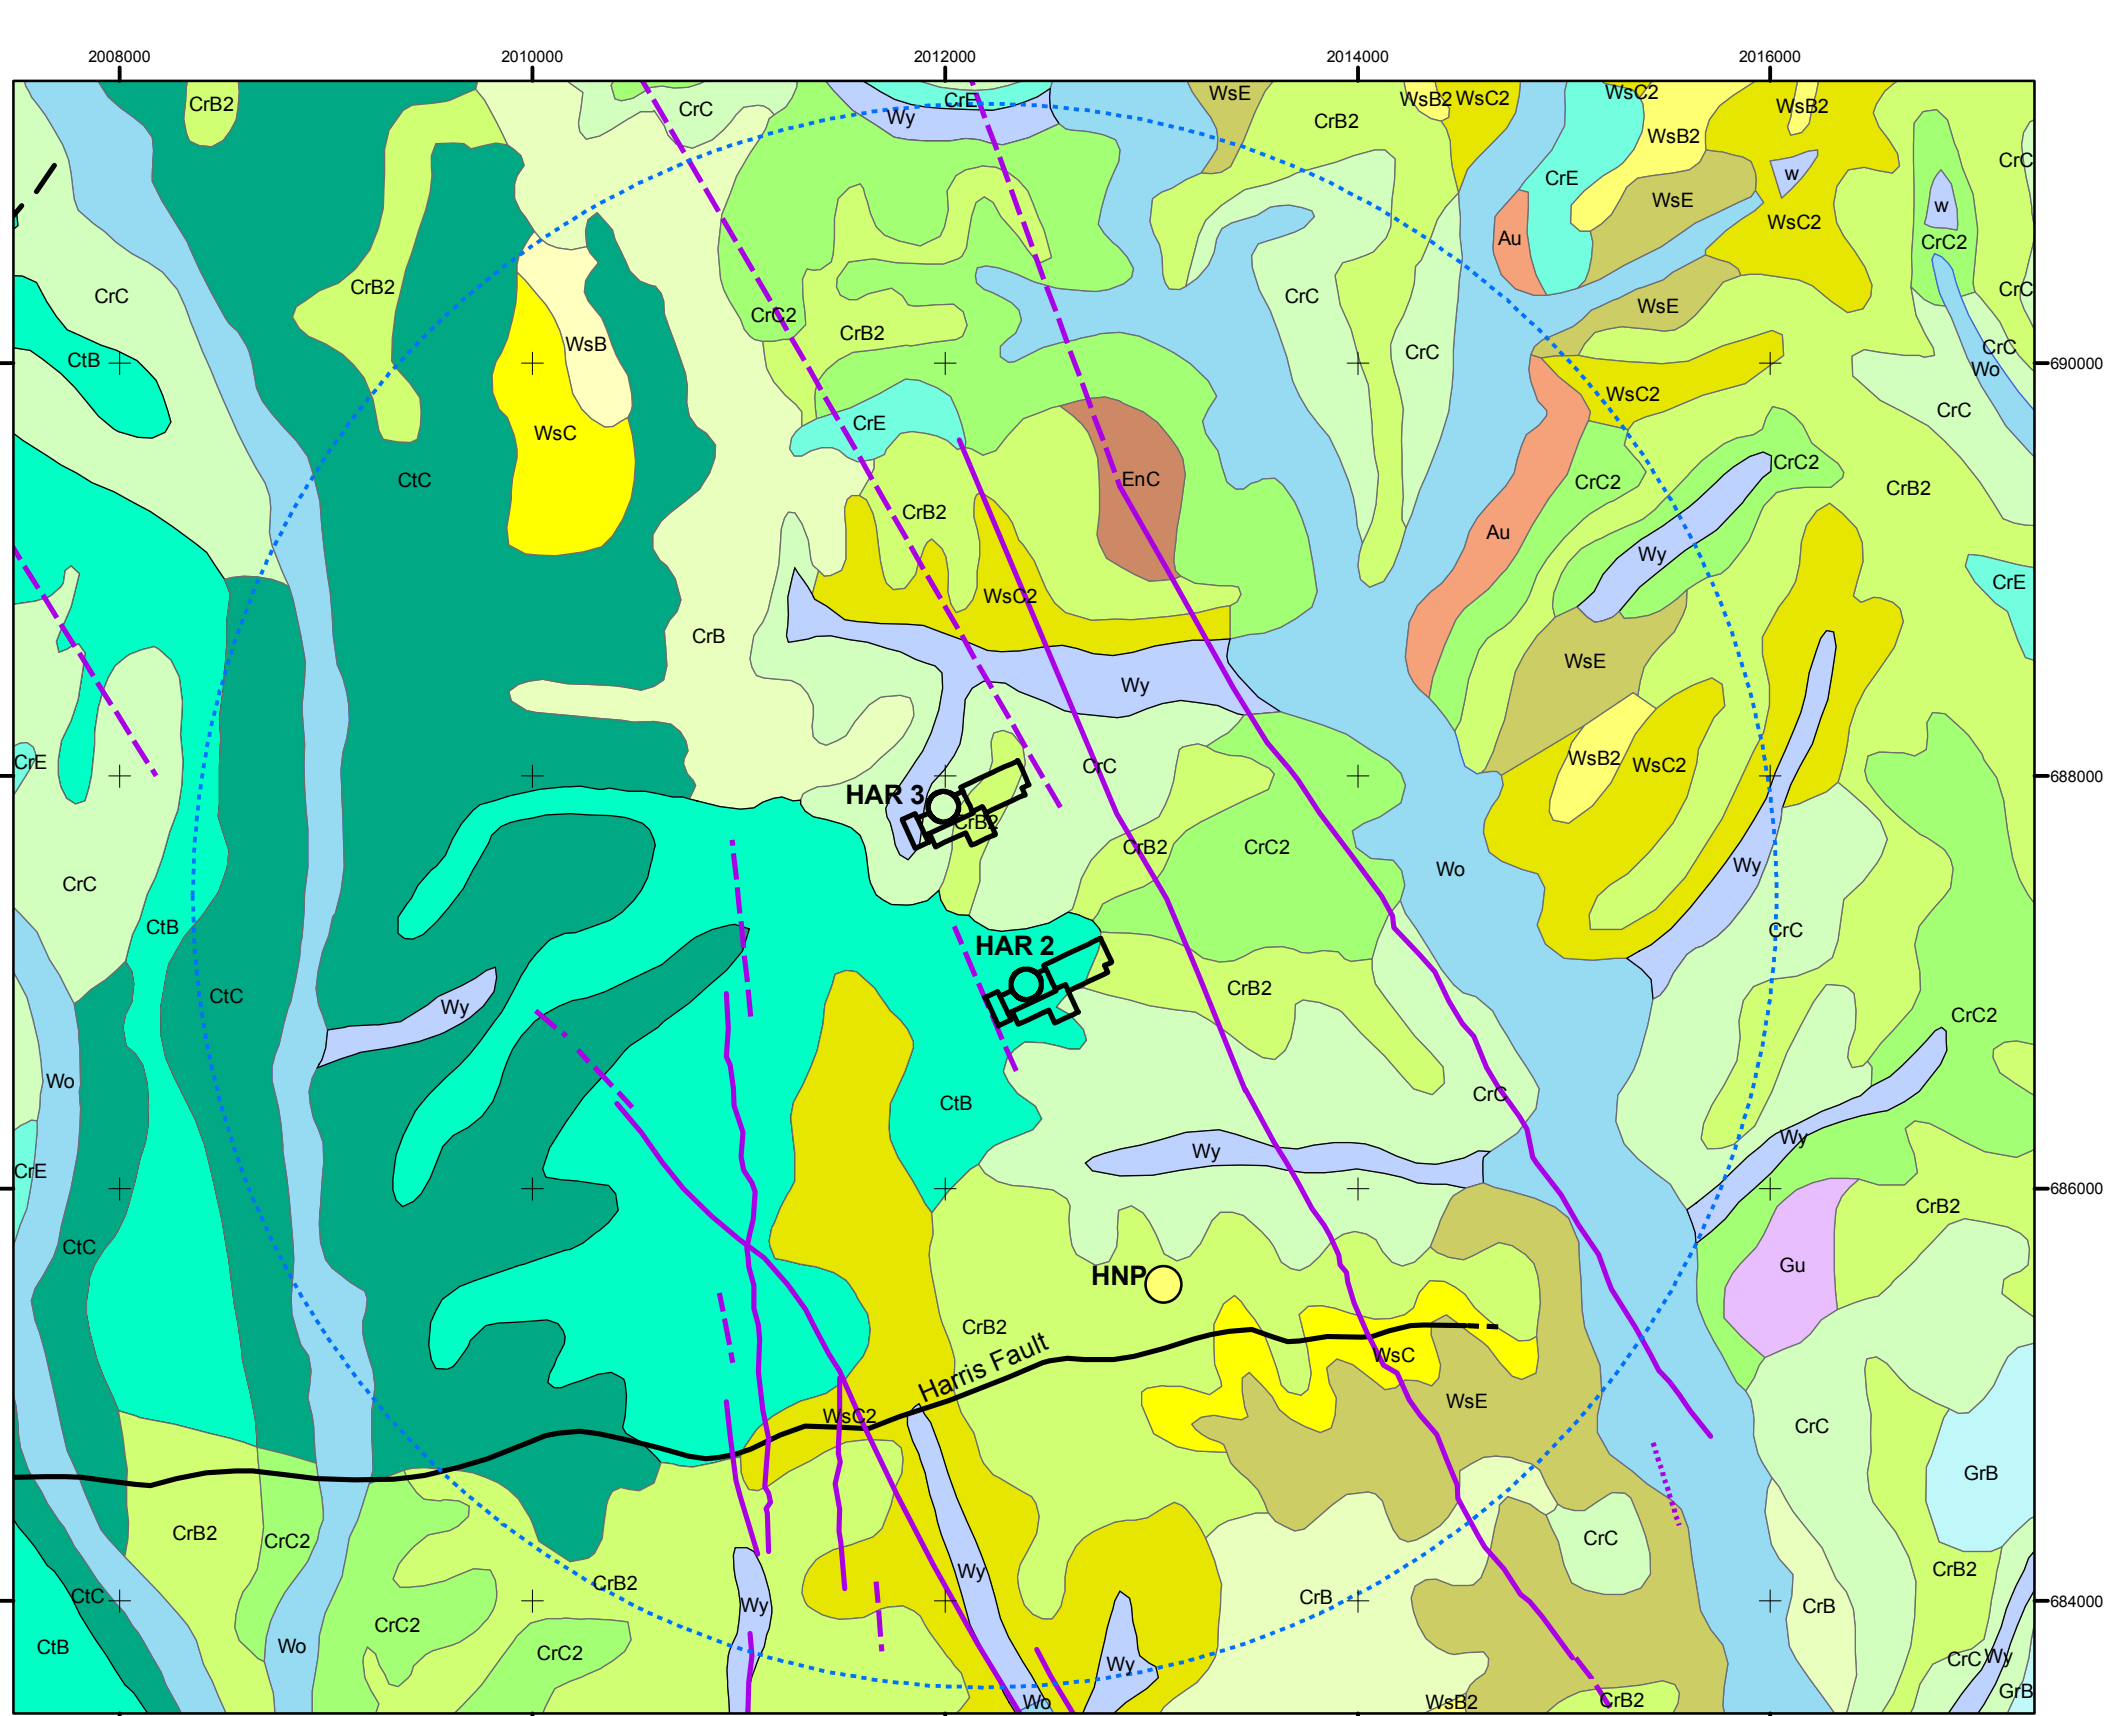
FIGURE 2.5.1-235

(1-km [0.6-mi.] Radius)
