March 10, 2008
261-4779-LTR-04

Subject: Resolution of NRC Questions Regarding ALION VUEZ 30 Day Testing Program
Status of Responses

Alion Problem Statement No. 1

Alion Problem Statement No. 4

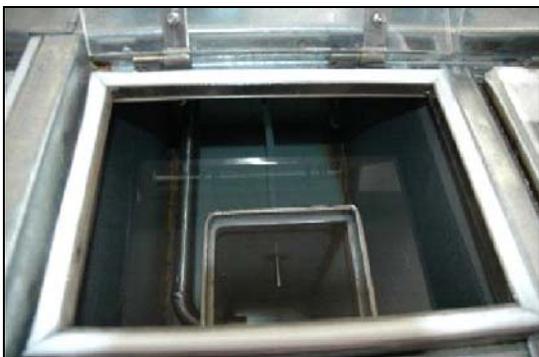
Figure 1a – Inside view of tank

The VUEZ 30 day debris head loss testing represents a combination of ICET and vertical loop debris head loss testing. The screen installed in the experiment is a horizontally oriented flat plate on which the plant specific debris bed was developed and head loss measured (see Figures 1a through d). The screen is slightly spherical on the bottom to inhibit the formation of voids that may build up underneath the debris bed. The sump solution is circulated in the areas outside the suction plenum and drawn down through the debris bed and recirculated.

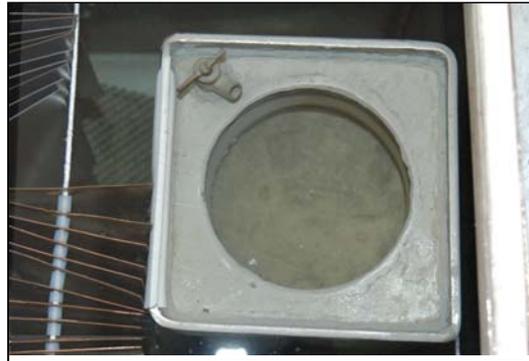
Figure 1d – Formed Debris Bed

The debris beds developed in the VUEZ test loop provide a representative, average debris bed (bed thickness and composition) on which the impact of chemical effects was measured over the 30 day mission time.

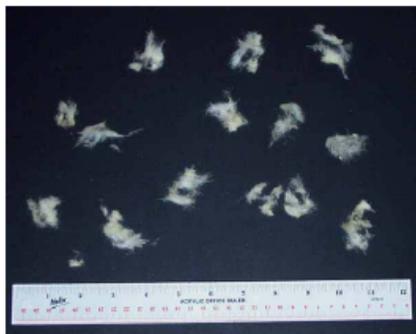
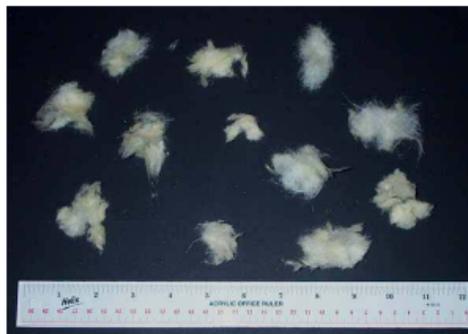
Figure 3-3. Fiberglass Insulation Debris of Two Example Size Classes

Multiple attached or interwoven strands that exhibit considerable flexibility and that, because of random orientations induced by turbulent drag, can exhibit low settling velocities.
4

Clumps of fibrous debris that have been noted to sink when saturated with water. Generated by different methods by various researchers but easily created by manual shredding of fiber matting.
6

Fiberglass shreds in size Class 3

Fiberglass shreds in size Class 5

The fibrous materials are either dried in an oven or boiled to remove the oils or gasses trapped within the fibers. This process helps to ensure that the materials do not agglomerate, float and simulate aging (lose resiliency). The material is then shredded (Figure 2) consistent with standard head loss testing practices (leaf shredder, cuisenart, etc.) to resemble the size distribution presented in Table 3-2 and Figure 3-3. The particulate surrogates are procured with an average size distribution near 10 micron.

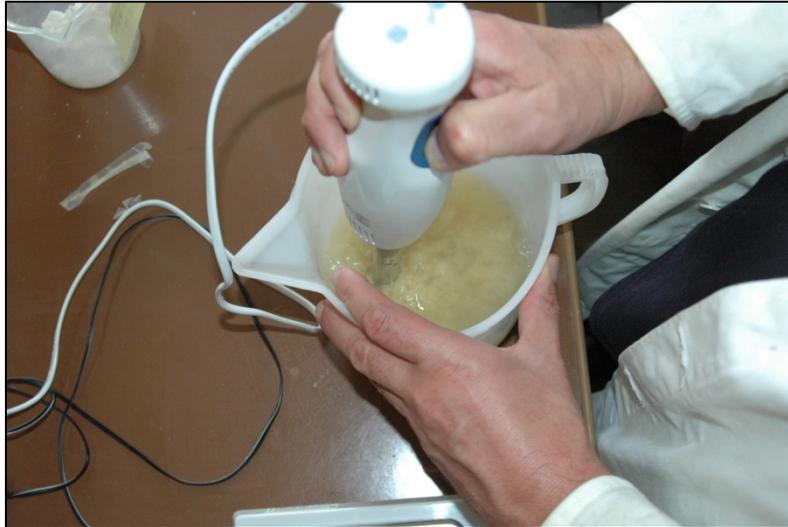
Figure 4a – Debris Blending

The fiber and particulate mixture is thoroughly mixed in a beaker containing the test solution (Figure 4 a & 4b). The mixture is slowly added through a funnel to ensure an even distribution across the test screen area while the pump is circulating (Figure 5). The bed is constructed to be uniform (minimal clumps, unevenness, etc.) to the extent possible by the technicians. A close up of actual completed bed (witnessed during the NRC visit) is provided in Figure 6.

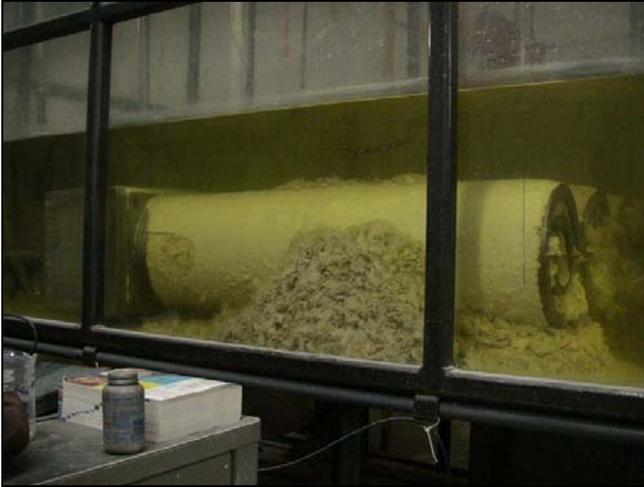
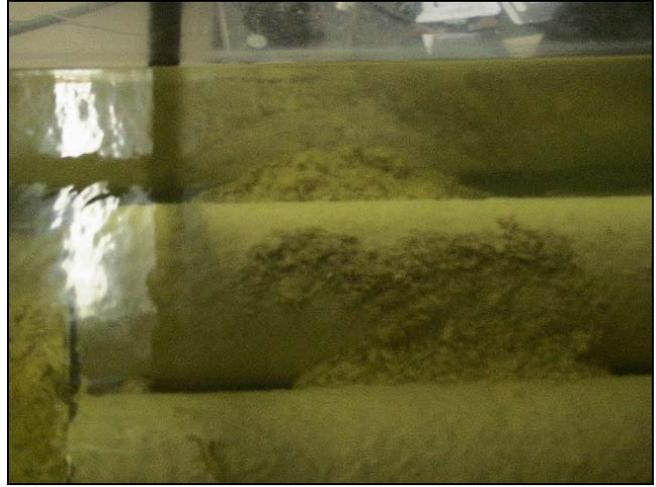
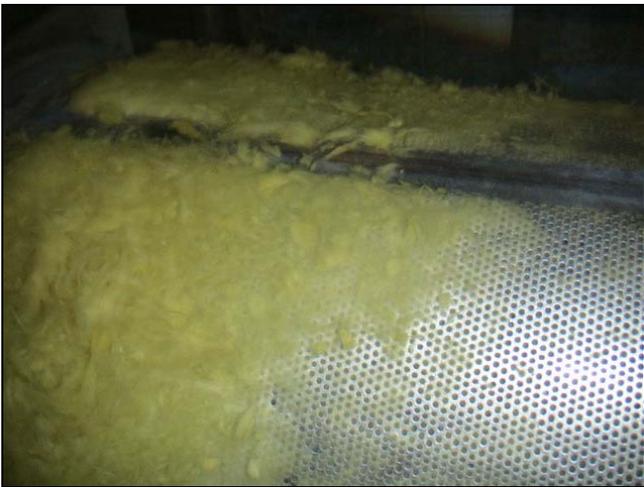
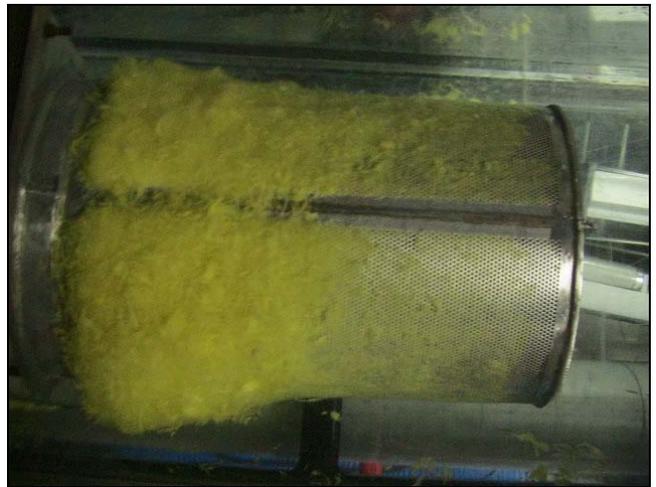
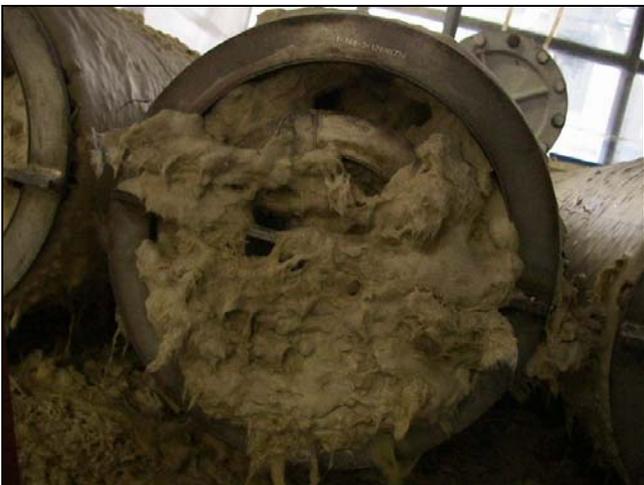
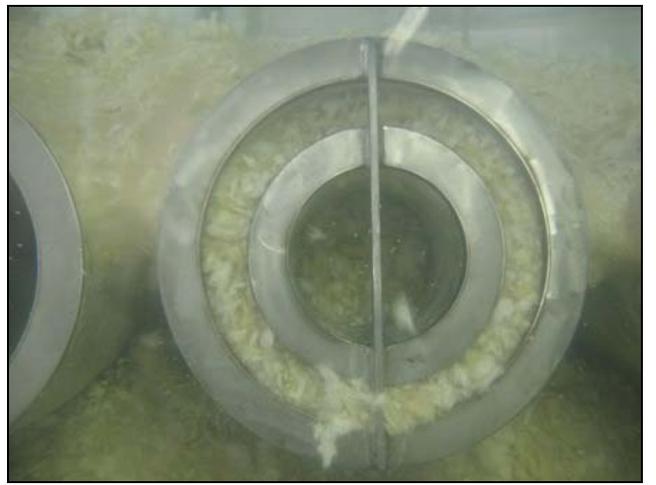
Figure 7: Sample Non-Chemical Tank Testing Debris Beds

First, the materials are procured by Alion and received at the Warrenville Laboratory; they are subsequently packaged and sent over to VUEZ. The materials (fiber, particulate, Cal-Sil, etc.) therefore are identical between the two facilities and experiments. Alion's process for "destroying" bulk fibrous insulation is to run the fiber blanket through a leaf shredder, which is common industry practice. The fiber is then weighed and boiled to remove oils and trapped gases that may cause the fibers to float when introduced into the tank. The soaked fiber is then poured into a larger mixing container (5 gallon bucket) with more water and particulate. The particulate and fiber slurry is then "mixed" or "beat" using a motorized paint mixer (attached to a drill). The non-chemical test consists of a full tank of water circulating through the prototype screen at the prescribed flow rate and temperature. The 5 gallon bucket(s) are then dumped into the large tank with the prototype screen in the discharge (return) flow to minimize settling. Most of the material accumulates on the sump screen. Some of the material tends to sink and collect in corners of the tank. This material is "agitated" by trolling motor, paddles, stirs, etc., to coax it onto the screen. This process is designed to ensure that the debris accumulates on all surfaces of the screen with minimal gravitational settling. As the debris collects on the screen and develops head loss, additional debris is attracted to those clean screen areas based on velocity. The debris loads or distributes in such a manner as to maintain the lowest possible head loss through the entire surface area. The resulting debris beds are shown in Figure 7.

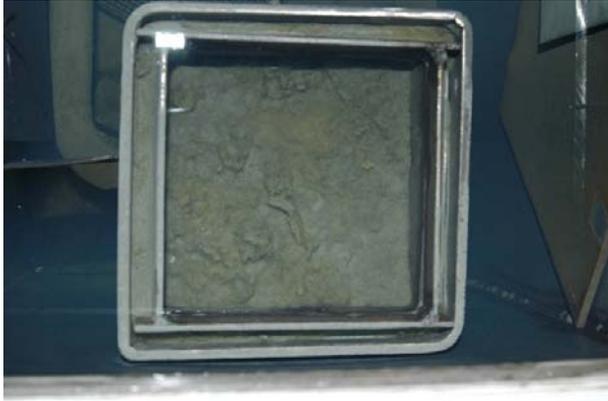
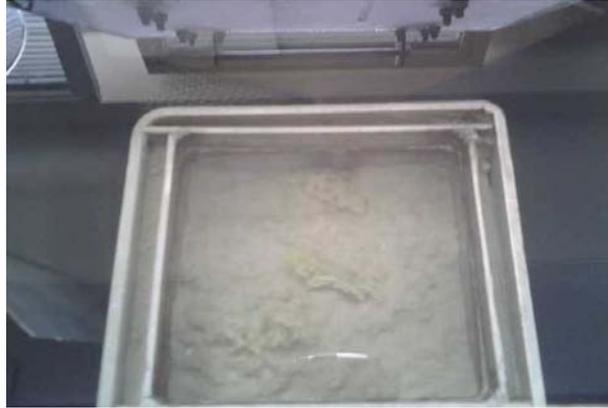
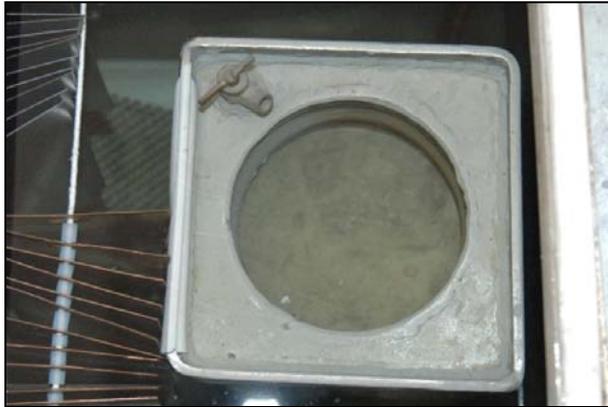
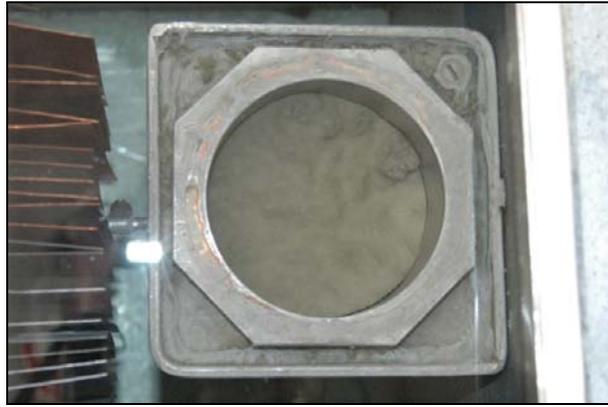
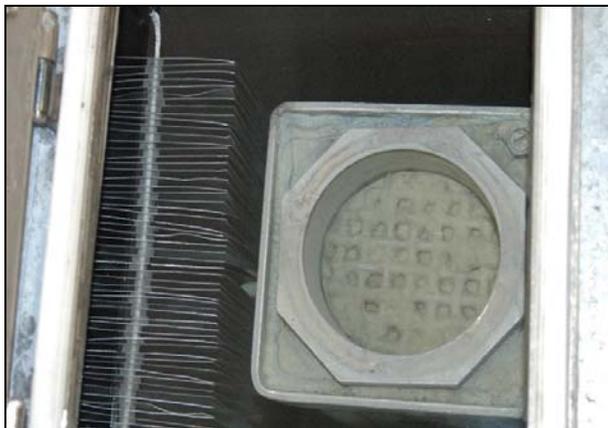
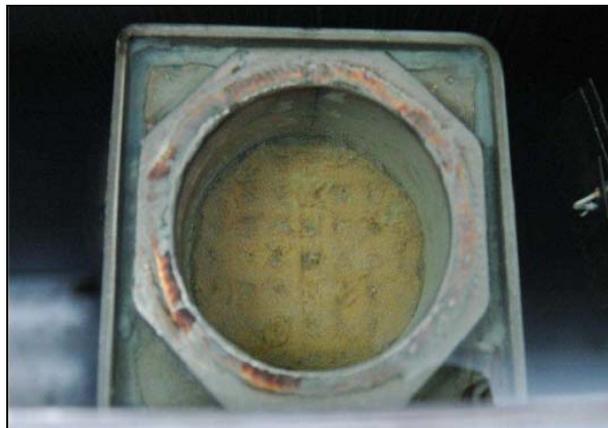
Figure 8: Sample VUEZ Vertical Screen Debris Beds

The debris materials for VUEZ are bulk processed the same way in that they are shredded, boiled and then baked as shipped materials need to be dry. VUEZ processes the debris materials further and finer as described earlier in this letter. A sampling of 6 different debris beds is provided in Figure 8. As evident from the two (2) sets of pictures, the VUEZ beds are reasonably representative, and "finer" than those used in the non-chemical tank testing.

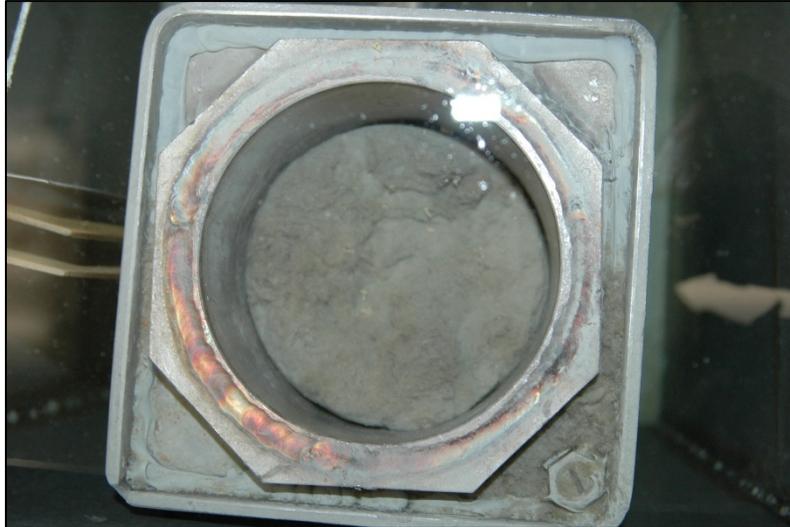
Figure 7 – Example of Bed Shrinkage

Alion has seen a few debris beds that may shrink under the high temperature and environmental aging associated with the chemistry and pull away from the sides of the debris cup (Figure 7). Although the debris beds still exhibit appreciable head loss, there is a concern regarding by-pass flow around the edges of the debris bed. This condition was identified by Alion and the NRC during their visit. To preclude any apparent issues associated with by-pass flow due to environmental effects (shrinkage), ALION/VUEZ modified the test screen by welding a seal ring in near the bottom. This essentially creates an o-ring to prevent by-pass flow. The bed is compressed down onto and under the seal ring to provide a more effective seal in the event of bed shrinkage at the perimeter.

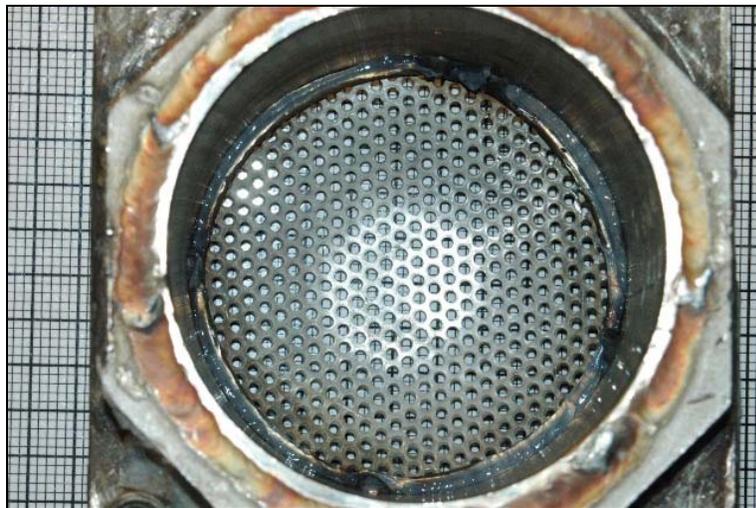
Figure 8 – Modified Screen with Seal Ring

The results to date have not changed appreciably with and without the metal o-ring. Alion has not identified any bypass flow in the earlier testing. The change to install the o-ring was an improvement to remove any concern that might arise. The installation of this o-ring does not in any way imply that by-pass flow was observed in the past or question the results of the earlier work.
