Fuel Performance Meeting

April 8-9, 2008
Lynchburg, VA

AREVA NP Inc.

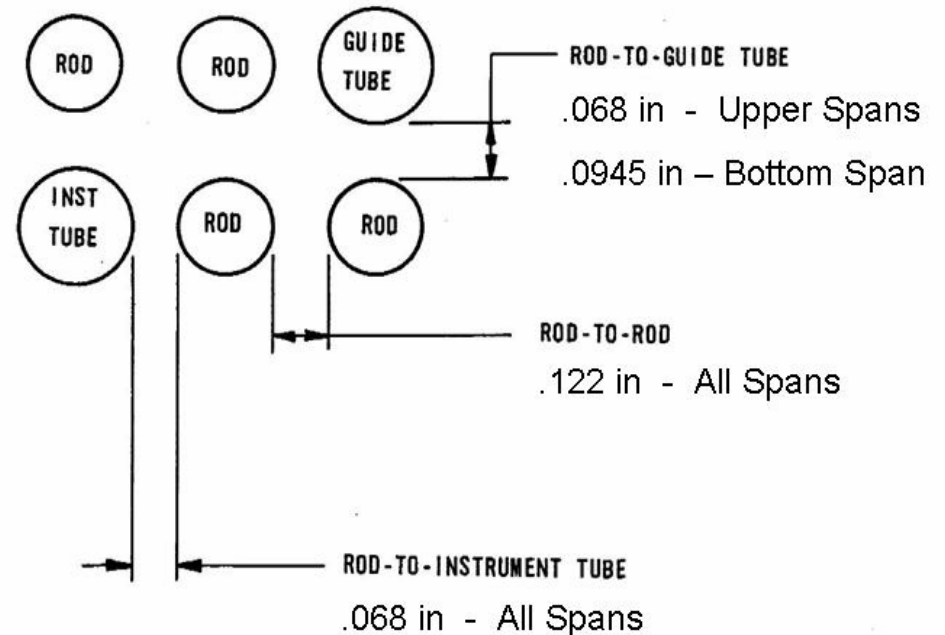
Rod Bow

- > ***Alters design pitch dimensions, or water channel gap, between adjacent rods within a Advanced Mark-BW fuel assembly array which affects:***
 - > ***Local nuclear power peaking***
 - > ***Local heat transfer to coolant***
- > ***Consequence → local excessive over-heating of fuel rod cladding which may lead to failure***

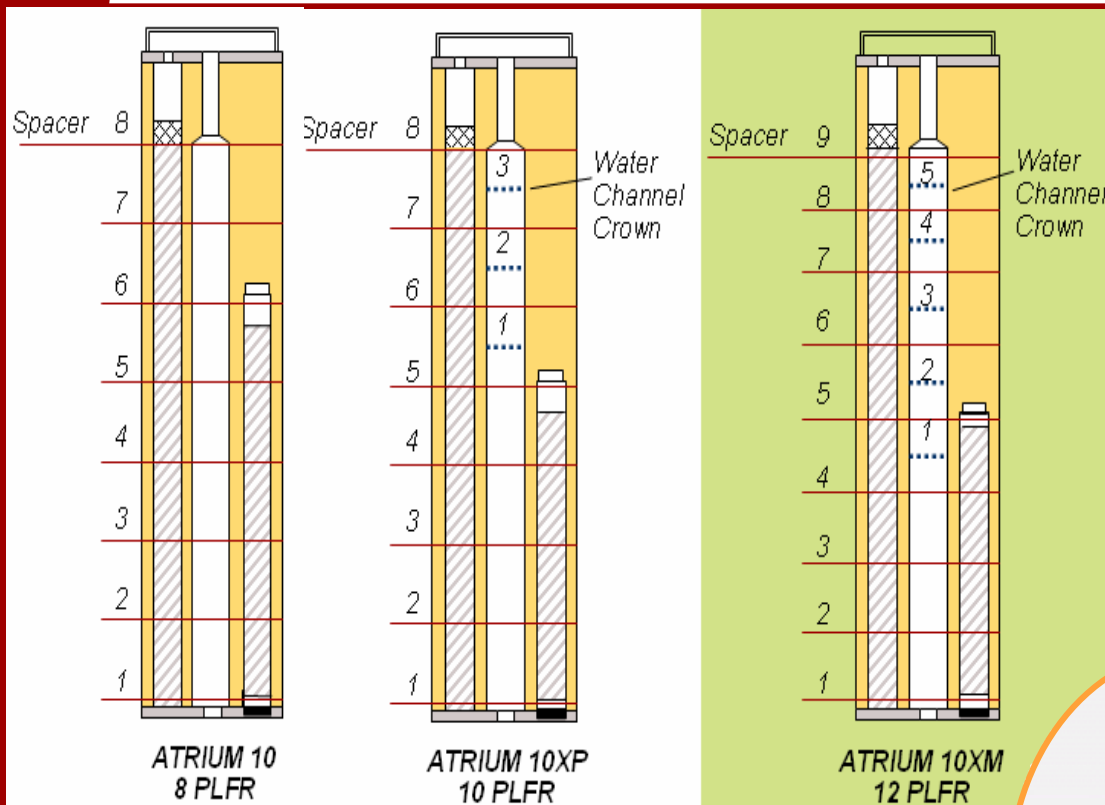
ATRIUM™ 10x10 Fuel Designs **Increasing Critical Power Capability**

- > **Additional spacer grid**
 - ◆ **Extends critical power capability for ATRIUM™ 10x10 configuration**

- > **Progressively smaller spacer spans**
 - ◆ **Optimizes critical power capability in high void elevations**

- > **Water channel crown**

- ◆ **Strips liquid film from water channel for use in fuel rod cooling**

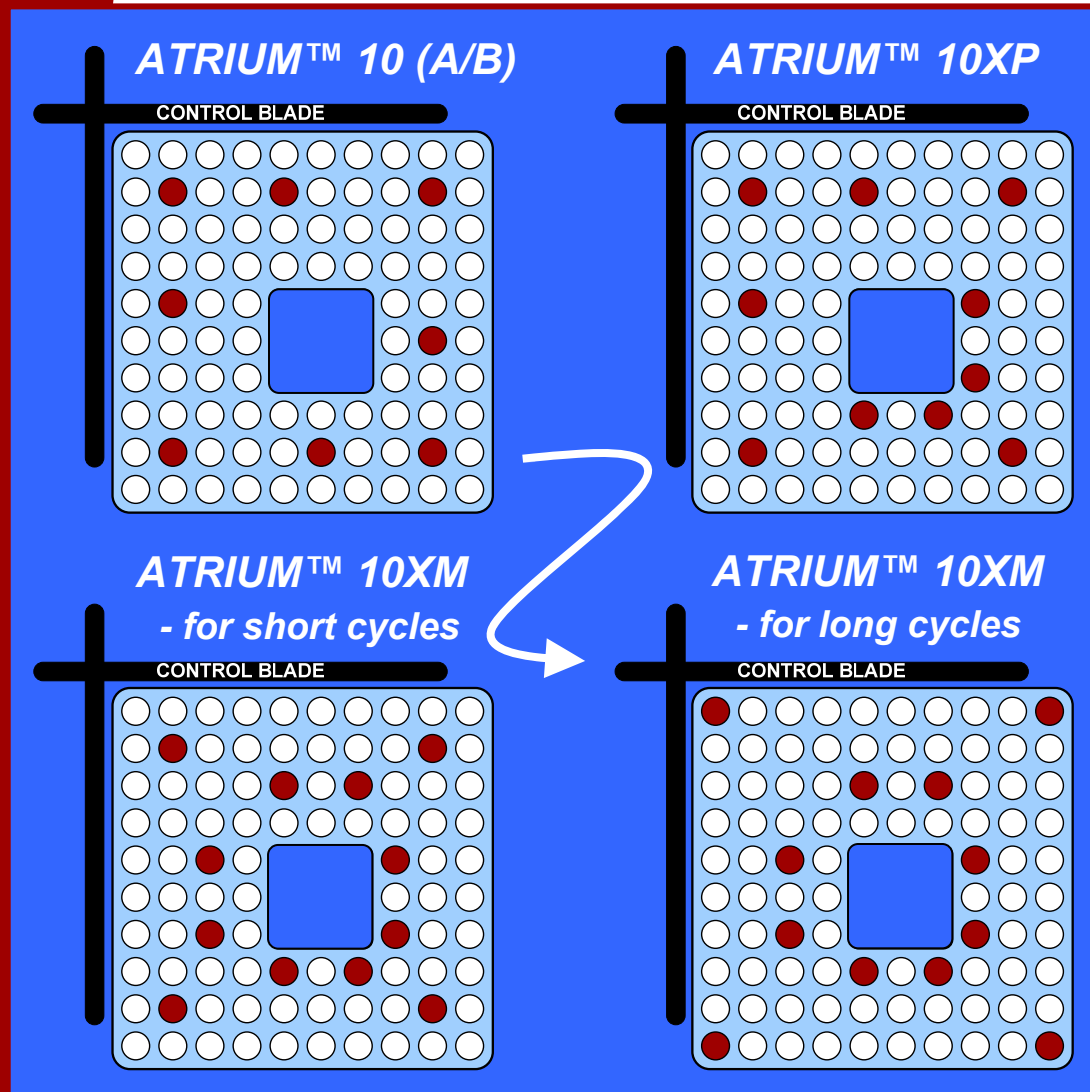
ATRIUM™ 10x10 Fuel Designs

Increasing Stability, Mass, and Critical Power Capability

- > **Larger fuel rod diameter for ATRIUM™ 10XP & 10XM**
 - ◆ **More efficient fuel-to-moderator distribution**
 - ◆ **Proportional increase in cladding wall thickness for reliability**
- > **Part-length fuel rod (PLFR) number and length selected to meet pressure drop and stability requirements**
- > **PLFR placement selected to provide critical power and shutdown margin benefits**

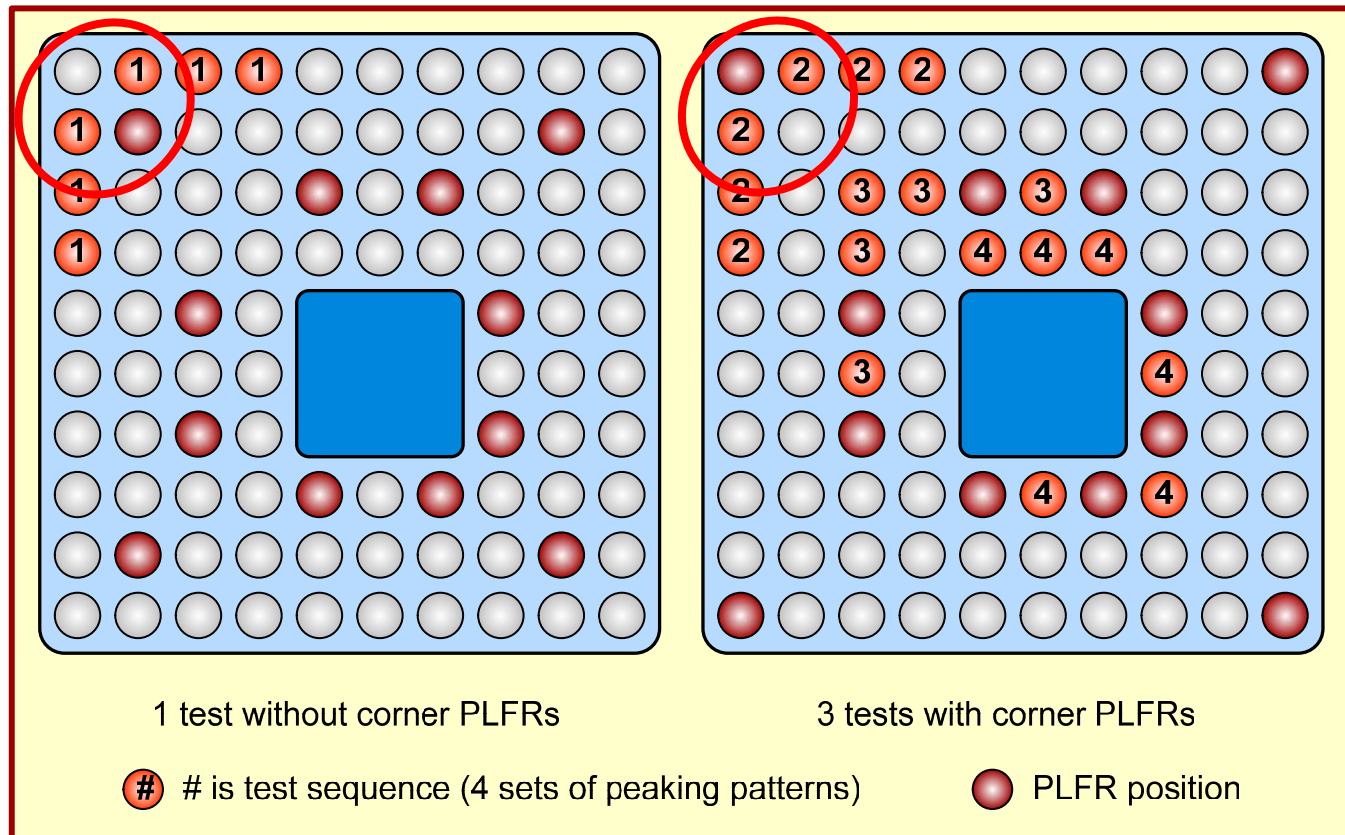
ATRIUM™ 10XM Critical Power Capability - Demonstrated by Rigorous Testing

- > ***PLFR placement for neutronic benefits must be carefully evaluated with respect to impact on local thermal performance***
- > ***Relocation of corner PLFRs for long-cycle ATRIUM™ 10XM has been explicitly tested with limiting upskew power profile***

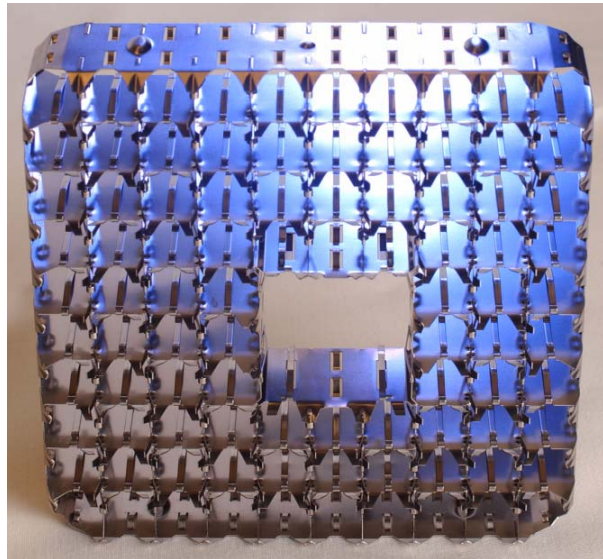
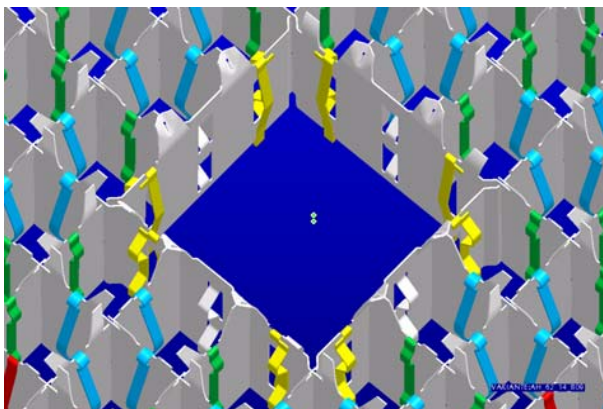
ATRIUM 10XM Spacer Grid ULTRAFLOW Type 62

- > ***Structure and fuel rod support features continue proven reliability of the ATRIUM 10 ULTRAFLOW grid***
- > ***Extensive operational experience in both ATRIUM 10XP and ATRIUM 10XM fuel designs***
 - ◆ ***>3800 in use, burnup to 52 GWd/MTU***
 - ◆ ***LFAs since 2002***
 - ◆ ***Reloads since 2005***
- > ***Vaned egg-crate style grid with limited flow path obstruction***
 - ◆ ***Solid strips reduce pressure drop and potential for debris capture***
- > ***Structure is fabricated from Alloy 718 sheet for low pressure drop and dimensional stability throughout life***

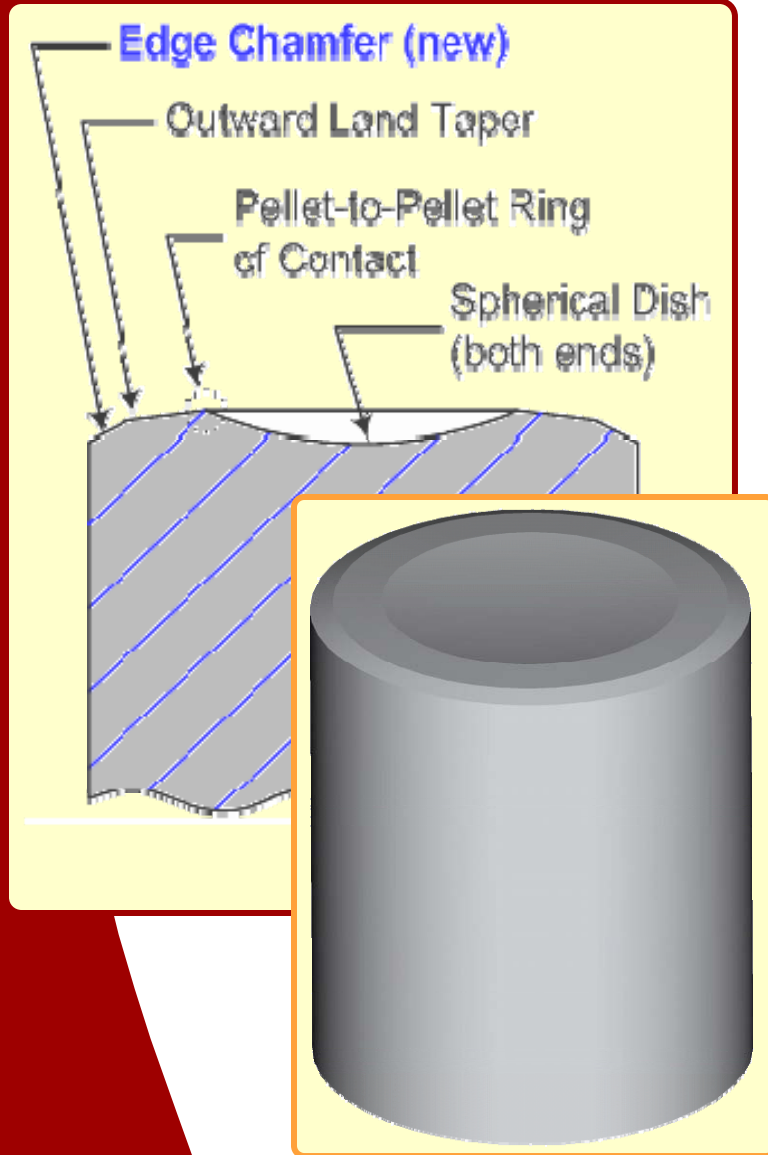
Improved Fuel Pellet Geometry - Chamfered Design for BWR 10x10 Fuel

- > ***AREVA ceramic experts have established a preferred global standard geometry for fuel pellets***
 - ◆ ***Retains favorable outward land taper, dished end, and ~1.2 length-to-diameter ratio of current pellet***
 - ◆ ***Adds small edge chamfer at both ends***
- > ***Edge chamfer reduces pellet susceptibility to chipping***
 - ◆ ***Supplements tightened MPS specifications and pending automated pellet inspections***

***Effective design response to
reducing Missing Pellet
Surface conditions***

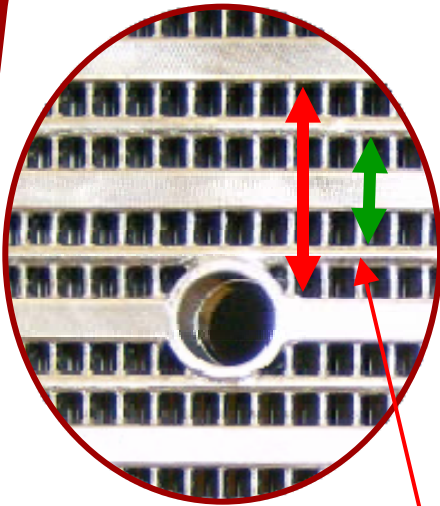
AREVA FUELGUARD™ Lower Tie Plate

- > **Step 1: Interim enhancement to limit wire length capable of passing through grid**
- ◆ **Reload delivery to Brunswick 1Q08**
 - ◆ **Wire length limited by length that can pivot around bars on exit side of grid**
 - ◆ **Extra bars will reduce passable wire length**

**Extra bars between standard
FUELGUARD™ bars**

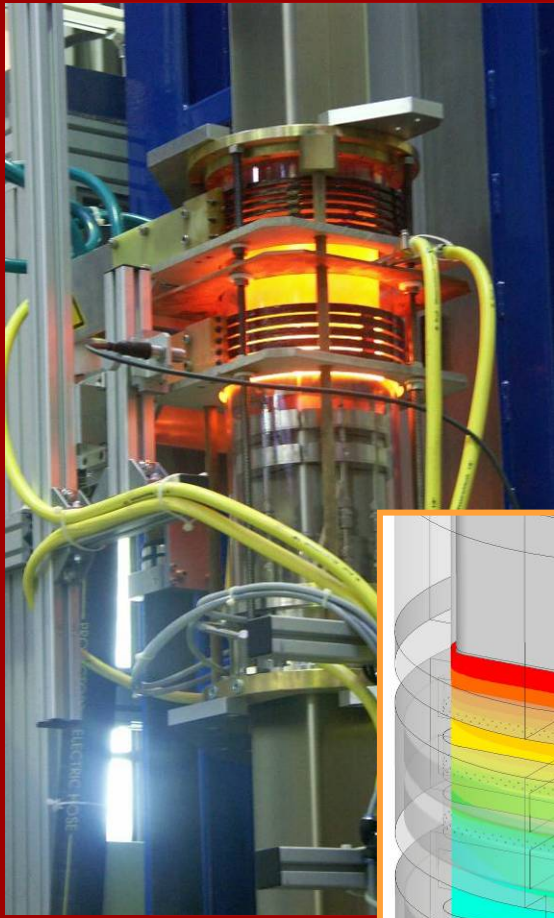
Fuel Channel Enhancements β -quench at Near-Final Geometry

- > AREVA has developed a proprietary process to β -quench fuel channels**
 - ◆ Eliminates sheet rolling texture and randomizes crystal alignment → leading to near-zero fluence-induced growth**

- 1. Channel is locally heated into β -phase region and held a short time - inert cover gas (argon) precludes oxidation and scaling**
- 2. Channel is rapidly quenched to yield random crystallographic orientation**
- 3. Final sizing and heat treatment for corrosion resistance (SPP size and distribution) is then completed**

Lead β -quench treated fuel channels are showing near-zero growth after three annual cycles

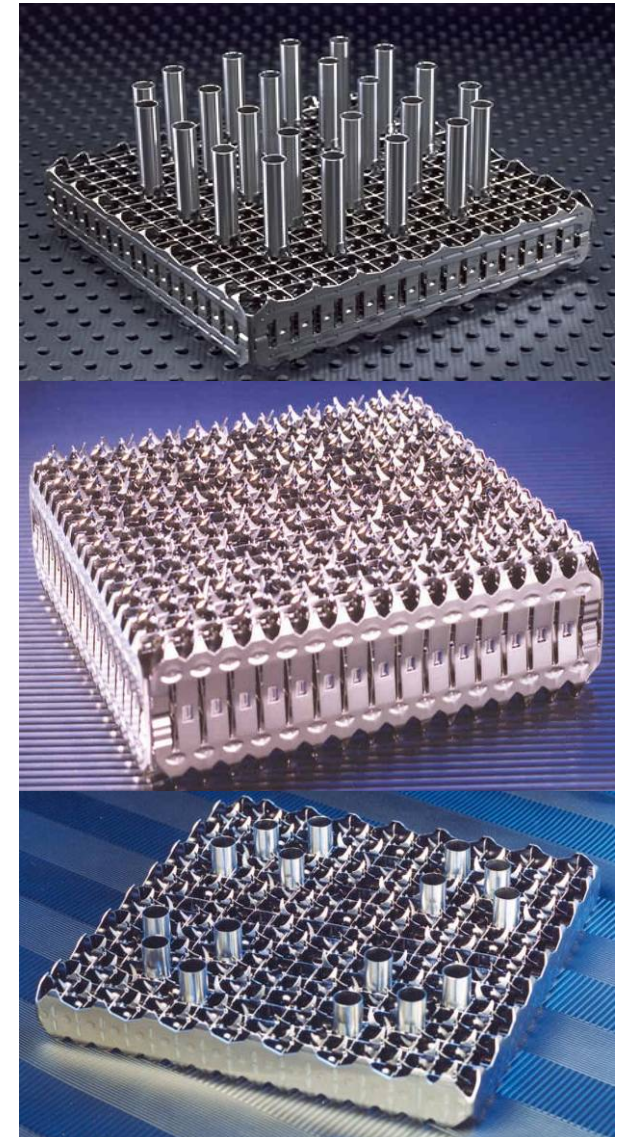
Design Features – Spacer Grids

- > ***End Grids – Alloy 718 (Low Cobalt)***
 - ◆ *Utilized at bottom and top positions*
 - ◆ *Non-vaned*
- > ***Intermediate Grids – M5***
 - ◆ *Optimized mixing vanes*
 - ◆ *Non-vaned version available for lower region*
 - ◆ *Wide support – fretting resistance*
 - ◆ *Handling robustness*
- > ***Mid-Span Mixing Grid – M5***
 - ◆ *Added thermal performance*

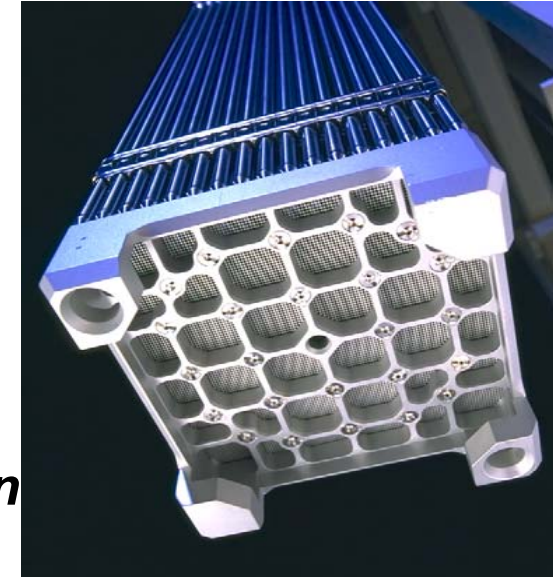
> TRAPPER Plate

- ◆ ***Cast Frame and Web***
 - ***Provides structural support***
 - ***Accommodates attachment of guide tubes with secured cap screws***
- ◆ ***No debris passing through TRAPPER has caused failures since introduction (over 2,500)***
- ◆ ***Two Mesh sizes offered***

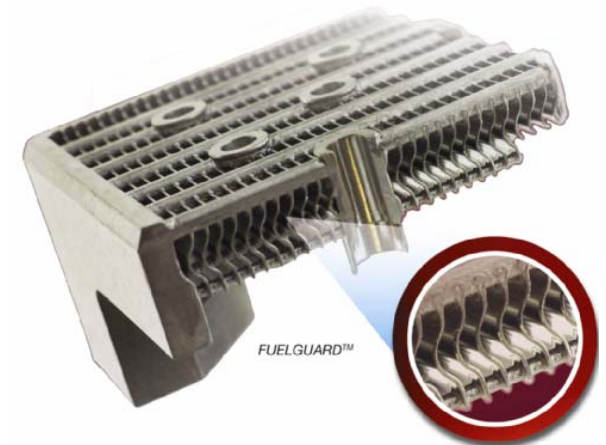
> FUELGUARD™ Offered with Advanced Mark-BW(A)

- ◆ ***No debris passing through FUELGUARD has caused failures since introduction (over 6,300)***

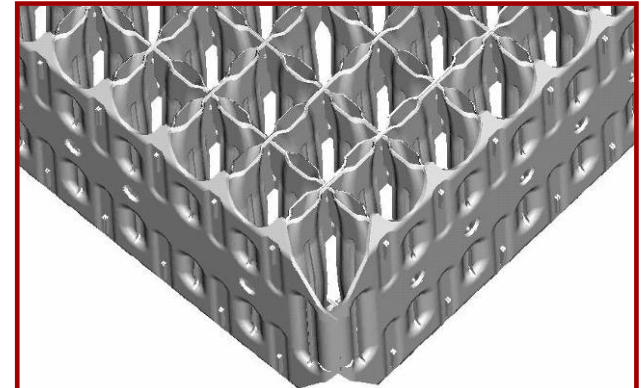
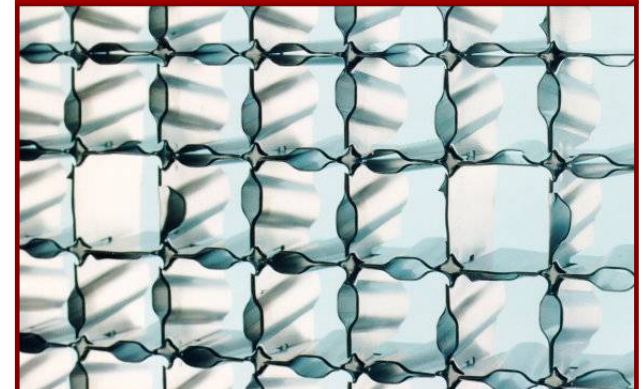
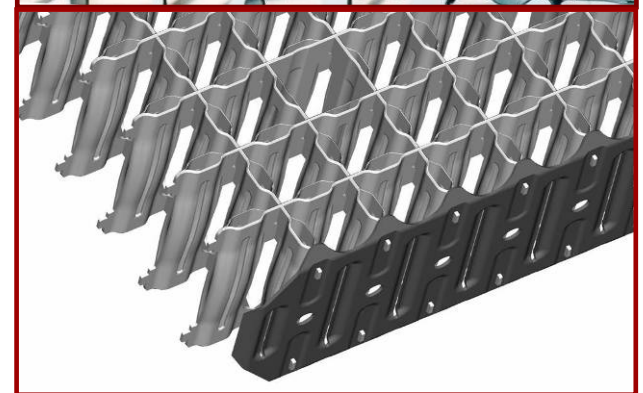
> **HMP End Grid**

- ◆ **Lower Grid Location**
- ◆ **Alloy 718 Material**
- ◆ **Straight Flow Channels**
- ◆ **Capture Rings**

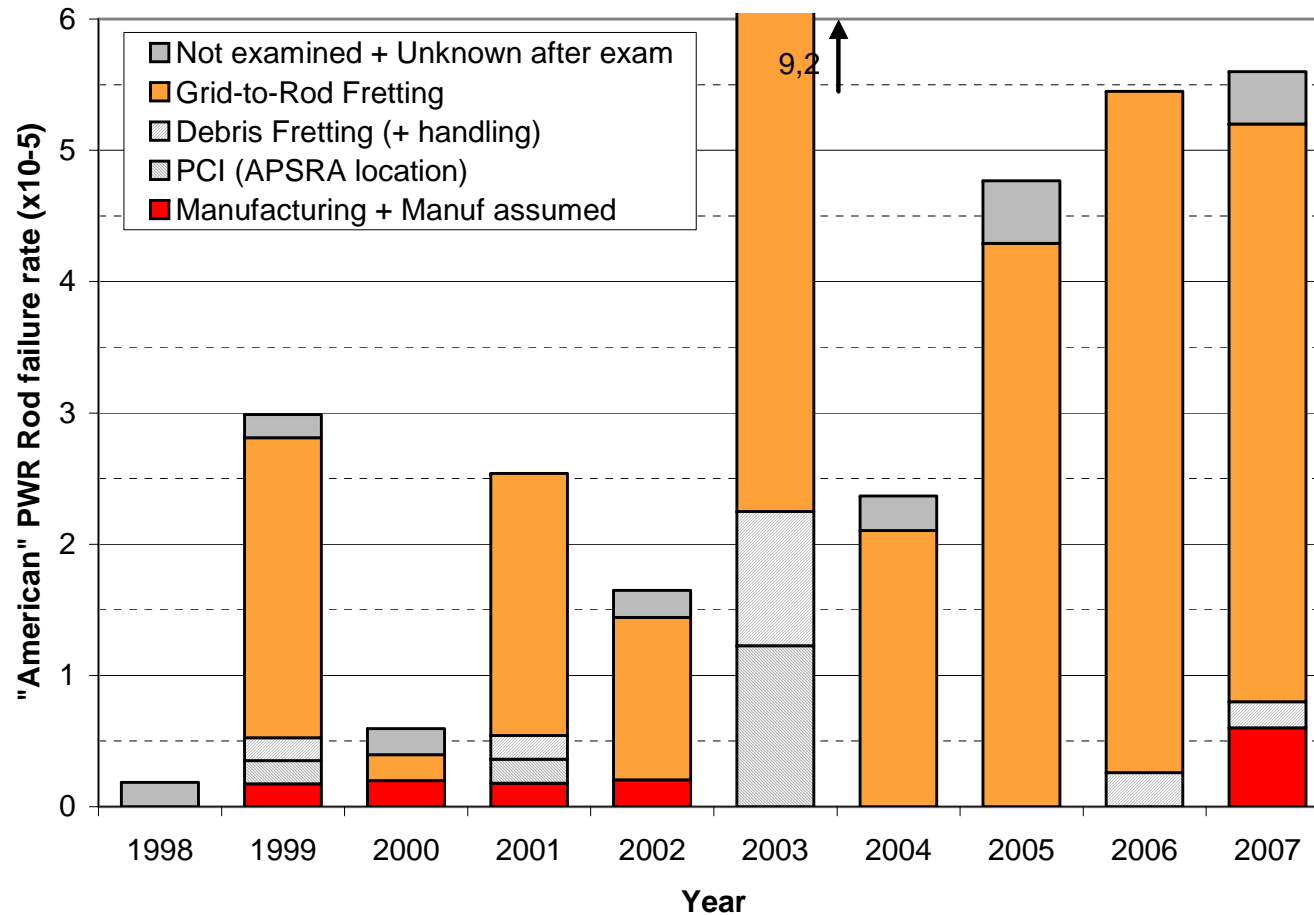
PWR Ten Year Failure Rate

Predominant Failure Mechanism Is Spacer Grid Fretting Wear

- > Failure should be eliminated by completion of the transition to HTP fuel assembly design***
 - ◆ ANO – Completed next cycle***
 - ◆ Davis-Besse - Completed next cycle***
 - ◆ Millstone 2 – 2 more cycles***
 - ◆ Oconee 1 – 3 more cycles***
 - ◆ Oconee 2, & 3 – 2 more cycles each***
 - ◆ TMI – 1 more cycles***
- > Failures currently under irradiation at Davis-Besse, Oconee 3, and Robinson still need to be investigated***

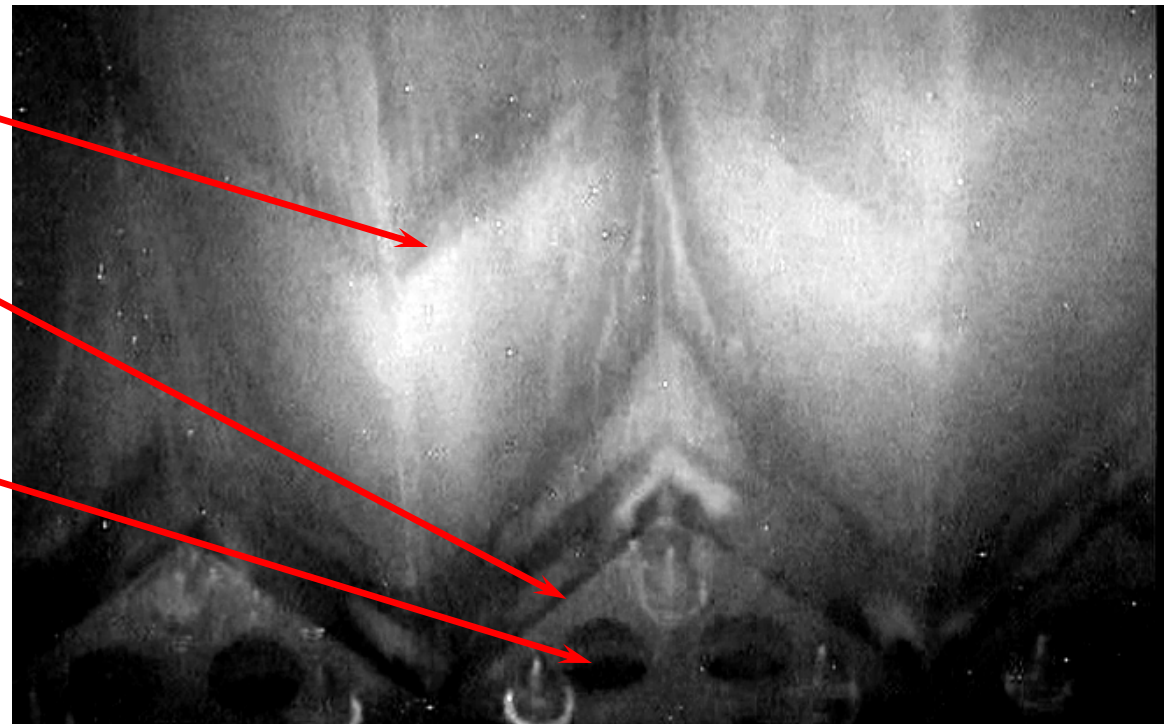
***Larger gap between
assembly and baffle***

***Inlet & outlet core plate
holes interior to the
assemblies***

- > Former non-HTP™ assemblies have experience random fretting failures on core periphery***
- > CE14x14 reactors exhibit high cross-flow behavior in lower and upper core regions***

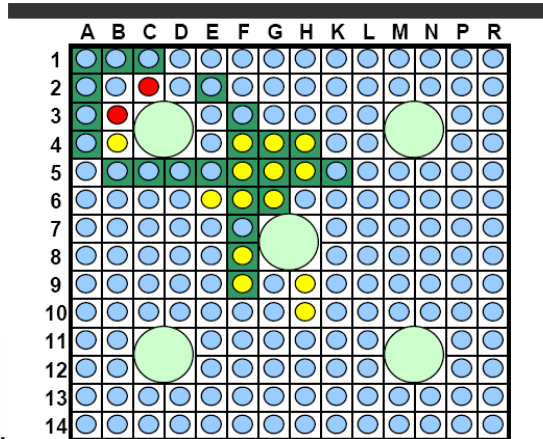
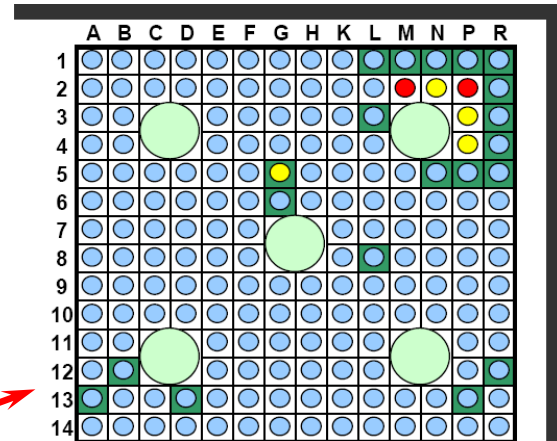
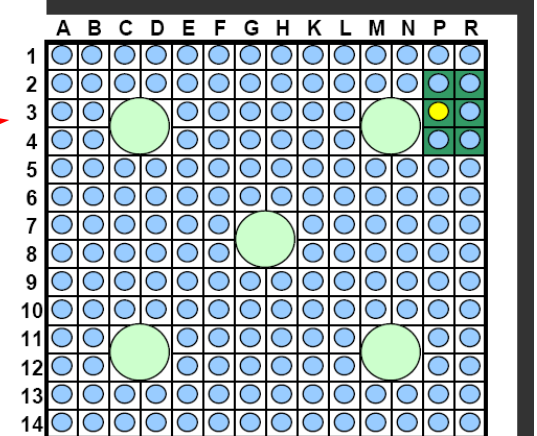
History: Millstone-2 Cycle 17 Failures

- ◆ Total 68 "T" assemblies inspected
- ◆ 2 failed "T" assemblies (2 rods each)
- ◆ Loose rods – precursor (1 additional assembly)

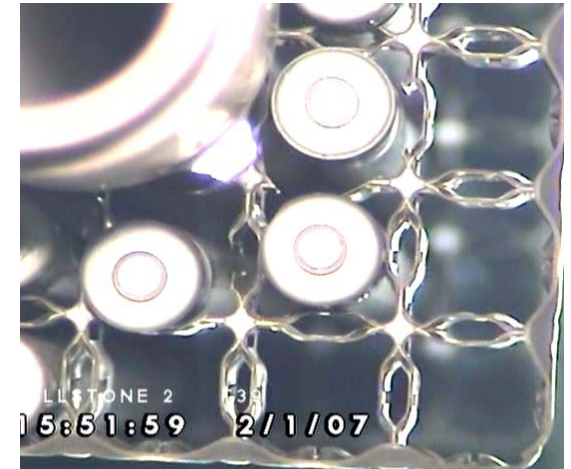
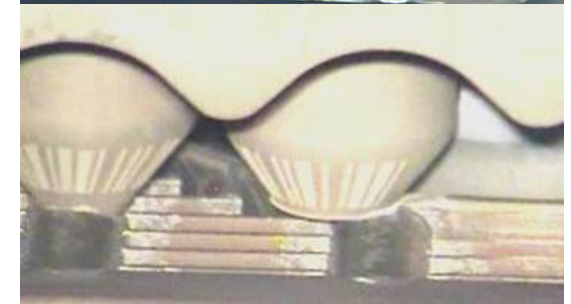
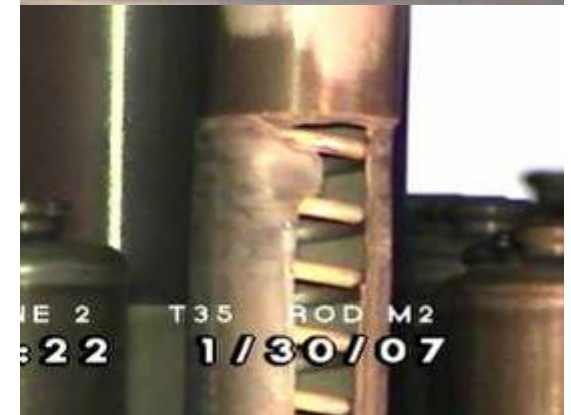
History: Progression to Failure

- > ***During 1st and 2nd cycles, Zircaloy grid springs relax***
- > ***In low power 3rd cycle, gap forms in the upper grid locations (long lower end cap prevents gap at bottom)***
- > ***Cross-flow causes rod vibration, grid wear, and gap in bottom grid***
- > ***With gaps at all elevations, rod spins due to hydraulic forces and wears grids and rod eventually to failure***
- > ***Spinning necessary to get fretting failure with HTP spacer***

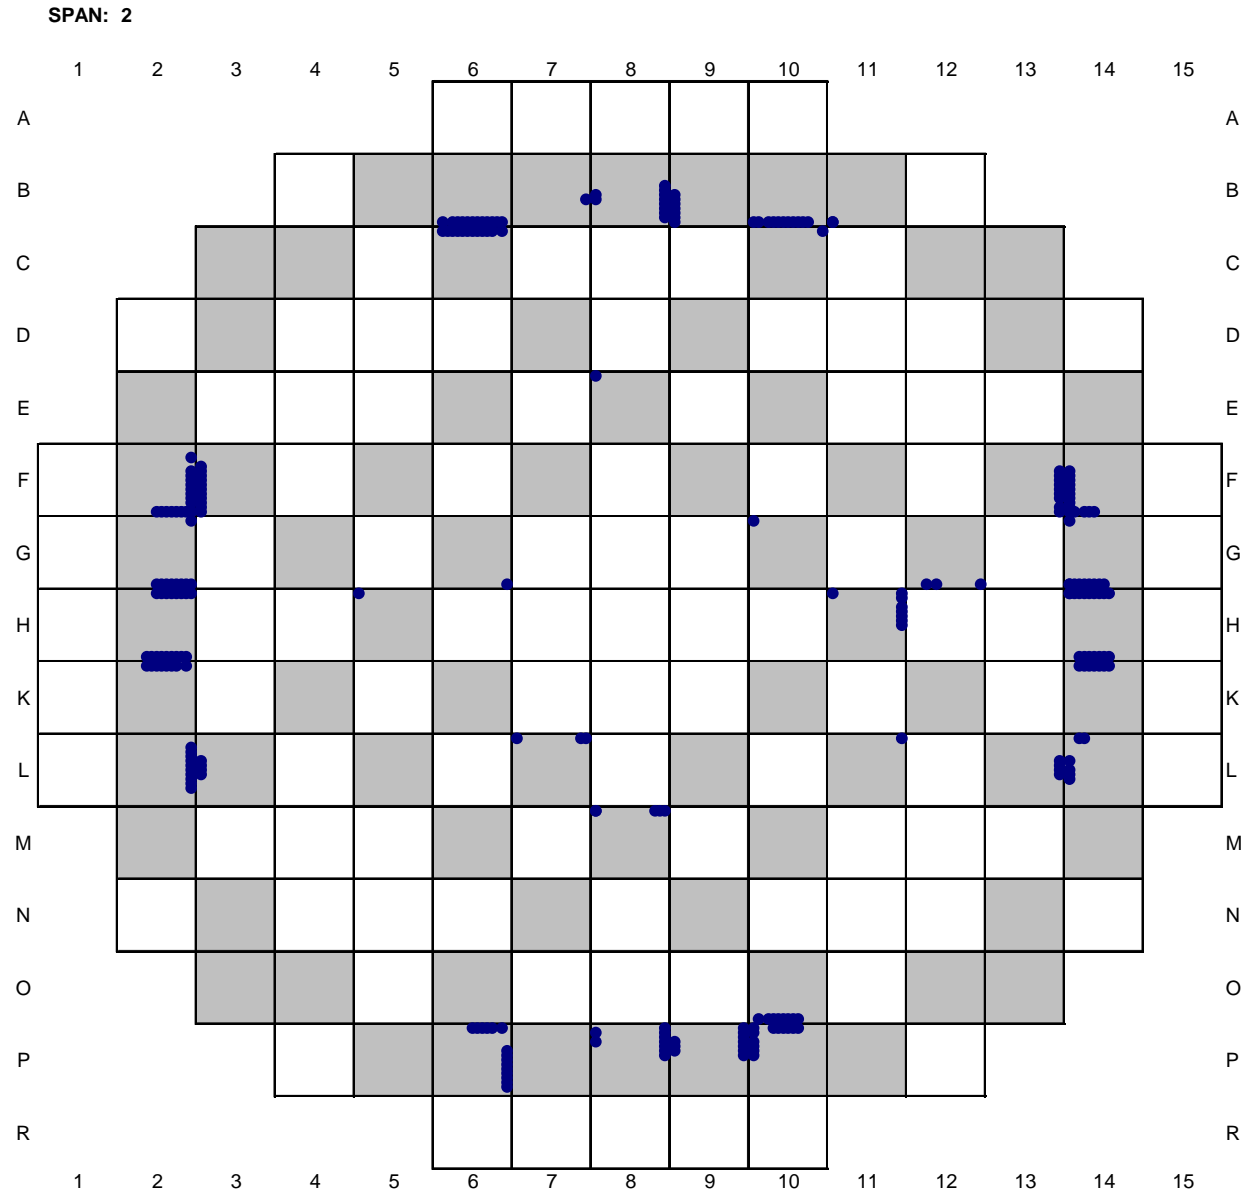
Observations during 15 RFO

- > 37 Mark-B-HTP™ fuel assemblies were observed with crud deposits on the perimeter rods***
- > Most fuel rods observed with elevated levels of crud deposits operated adjacent to other fresh fuel assemblies during Cycle 15***
- > The crud was primarily noted between the 2nd and 3rd spacer grids from the top of the assemblies, with lesser amounts sometimes visible between the 3rd and 4th grids from the top***

- > Actions being taken by AREVA NP***
 - ◆ Reviewing plant RCS chemistry records to determine any potential source for the elevated crud deposits on the fuel cladding***
 - ◆ Performing thermal-hydraulic modeling of the Cycle 15 core to determine any potential causes of the crud condition***

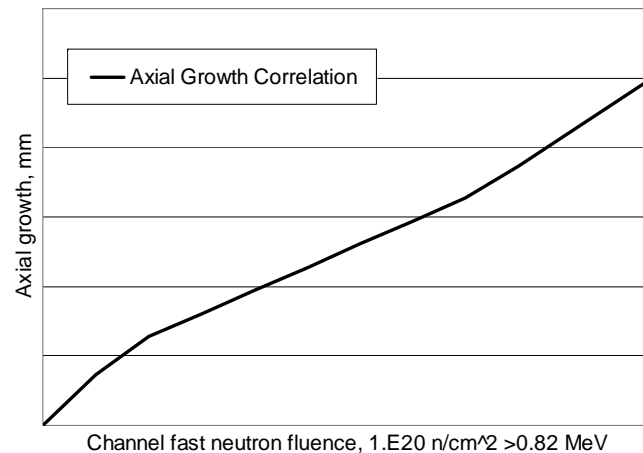
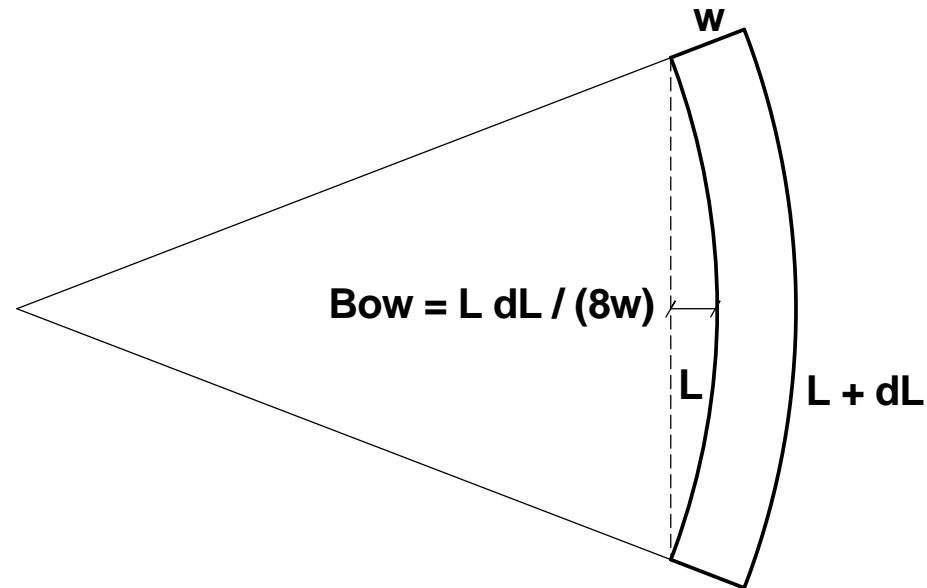
> Fuel channel bow

- ♦ **“Classic” bow is attributed to the differential growth between opposite sides of the fuel channel due to fast neutron fluence.**

- ♦ **Following this approach, bow would be nearly proportional to the fast fluence gradient.**

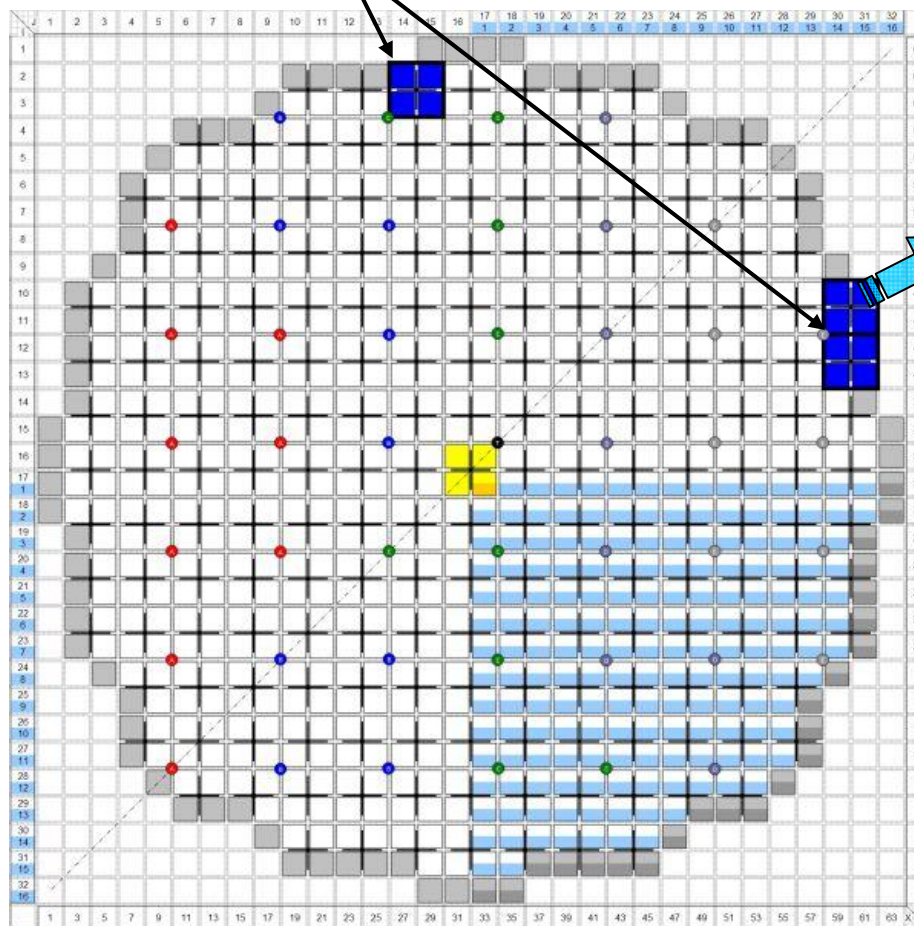
> Case study – Grand Gulf peripheral cell friction

3 no-settle cells

- > Case study – Grand Gulf peripheral cell friction**
 - ◆ Friction cell observations**
 - Contains higher exposure fuel assemblies (4th of 18-month cycles)**
 - Little early-in-life control (low EFID)**
 - Accumulated fluence gradient is not high enough to explain the amount of bow to cause friction**
 - Operation in a positive flux gradient location (core peripheral location with bow towards blade)**
 - Fuel had operating on the core periphery in a prior cycle**
 - Zry-2 fuel channels**
- > Other cells at Grand Gulf and LaSalle Units 1 and 2 share the same common characteristics as above.**

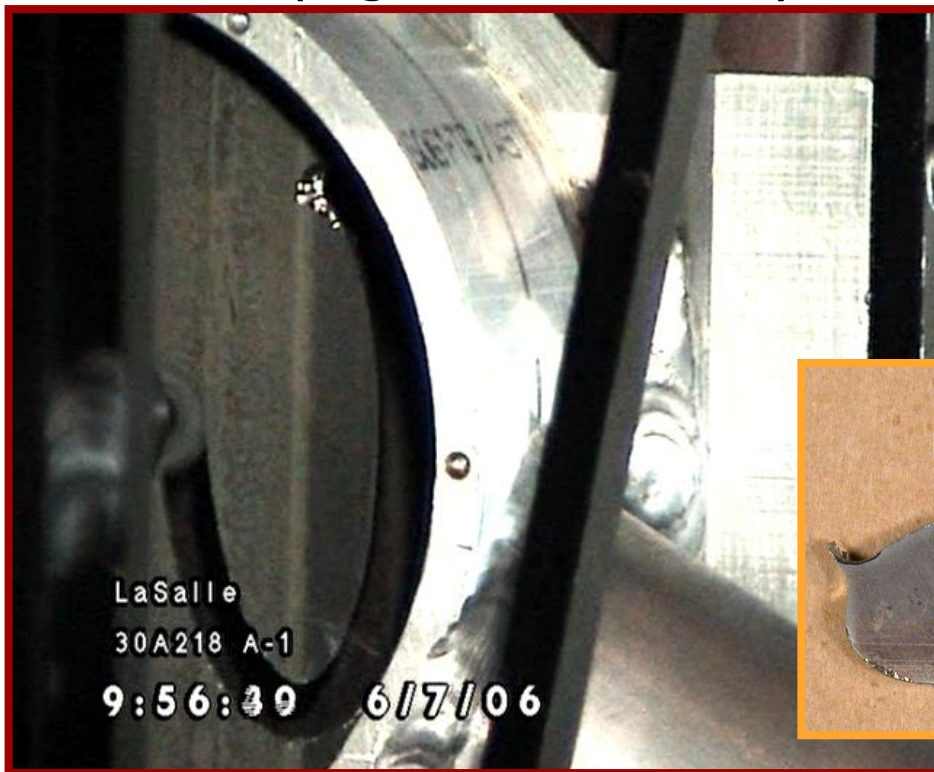
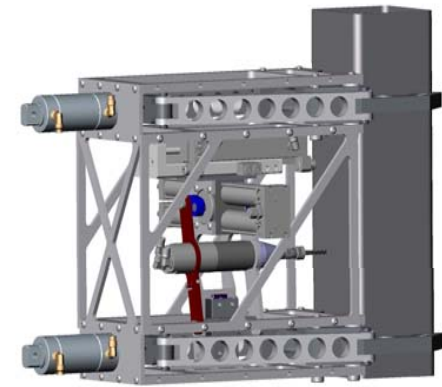
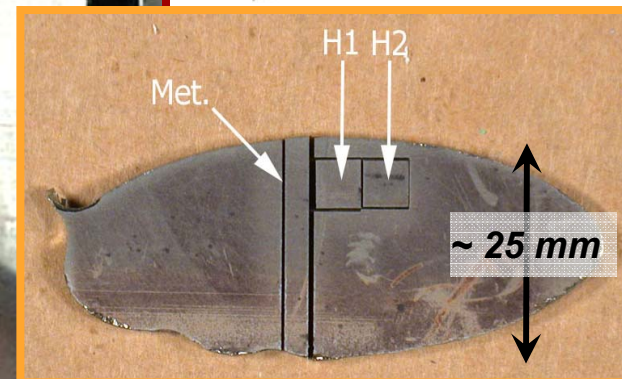
- ♦ ***AREVA NP performed several hot cell examinations of Zircaloy-2 and Zircaloy-4 fuel channel coupons derived from two plants in the U.S. (together with EPRI)***

- > Hot cell examinations have confirmed that Zry-4 does not exhibit the same sensitivity to shadow corrosion as Zry-2***
