Rancho Seco

Final Status Survey Summary Report

Extended Parking/Storage Area

Survey Unit F5010041

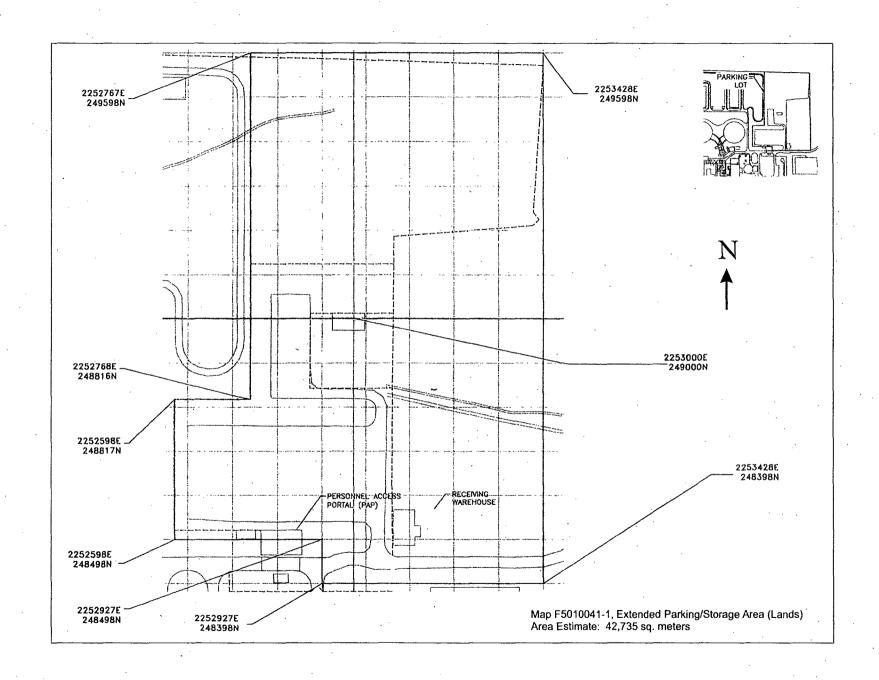
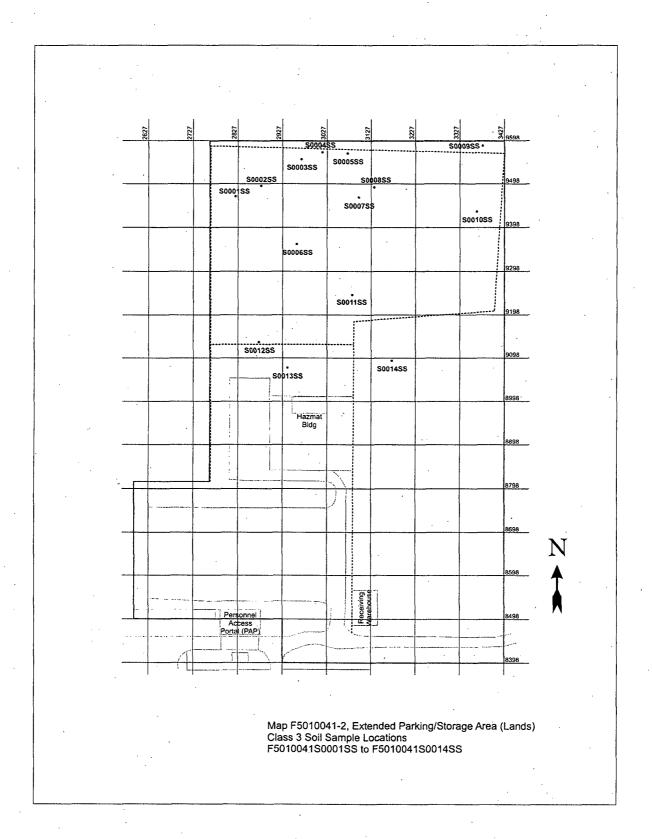
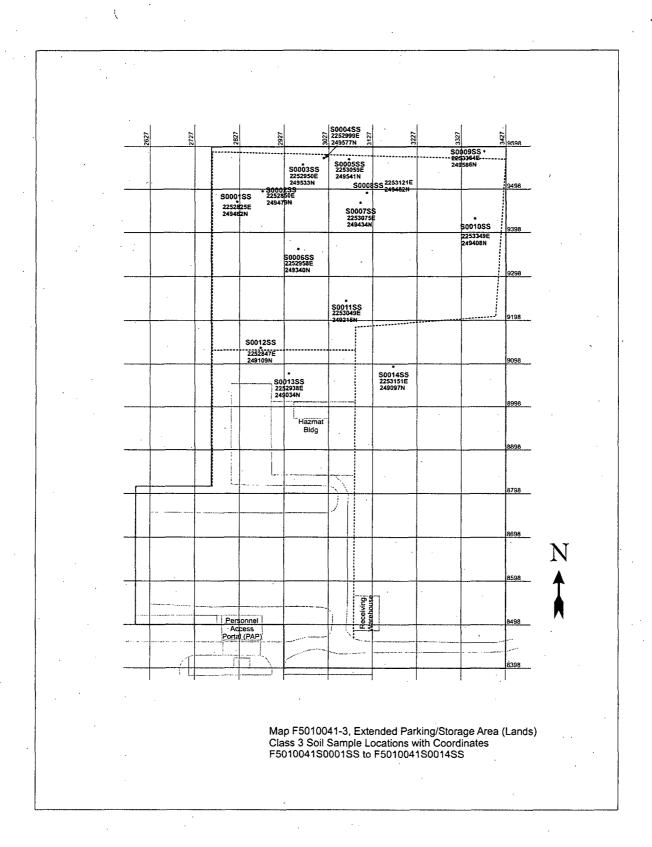
Attachment 1 Maps March 17, 2008 Survey Unit F5010041

The Survey Unit Design Parameters are presented in Table 1 below. The survey unit and measurement locations are depicted on the maps in Attachment 1. Direct measurement locations were randomly determined and 3,080 m² were scanned for approximately 7% coverage. Soil samples were collected at each direct measurement location and analyzed by HPGe detector. The instrumentation used for the survey along with the MDC values are listed in Tables 2-1 and 2-2 in Attachment 2.
