Rancho Seco

Final Status Survey Summary Report

Corridor Auxiliary Building, Elevation 20', (Room 207)

Survey Unit F8131361

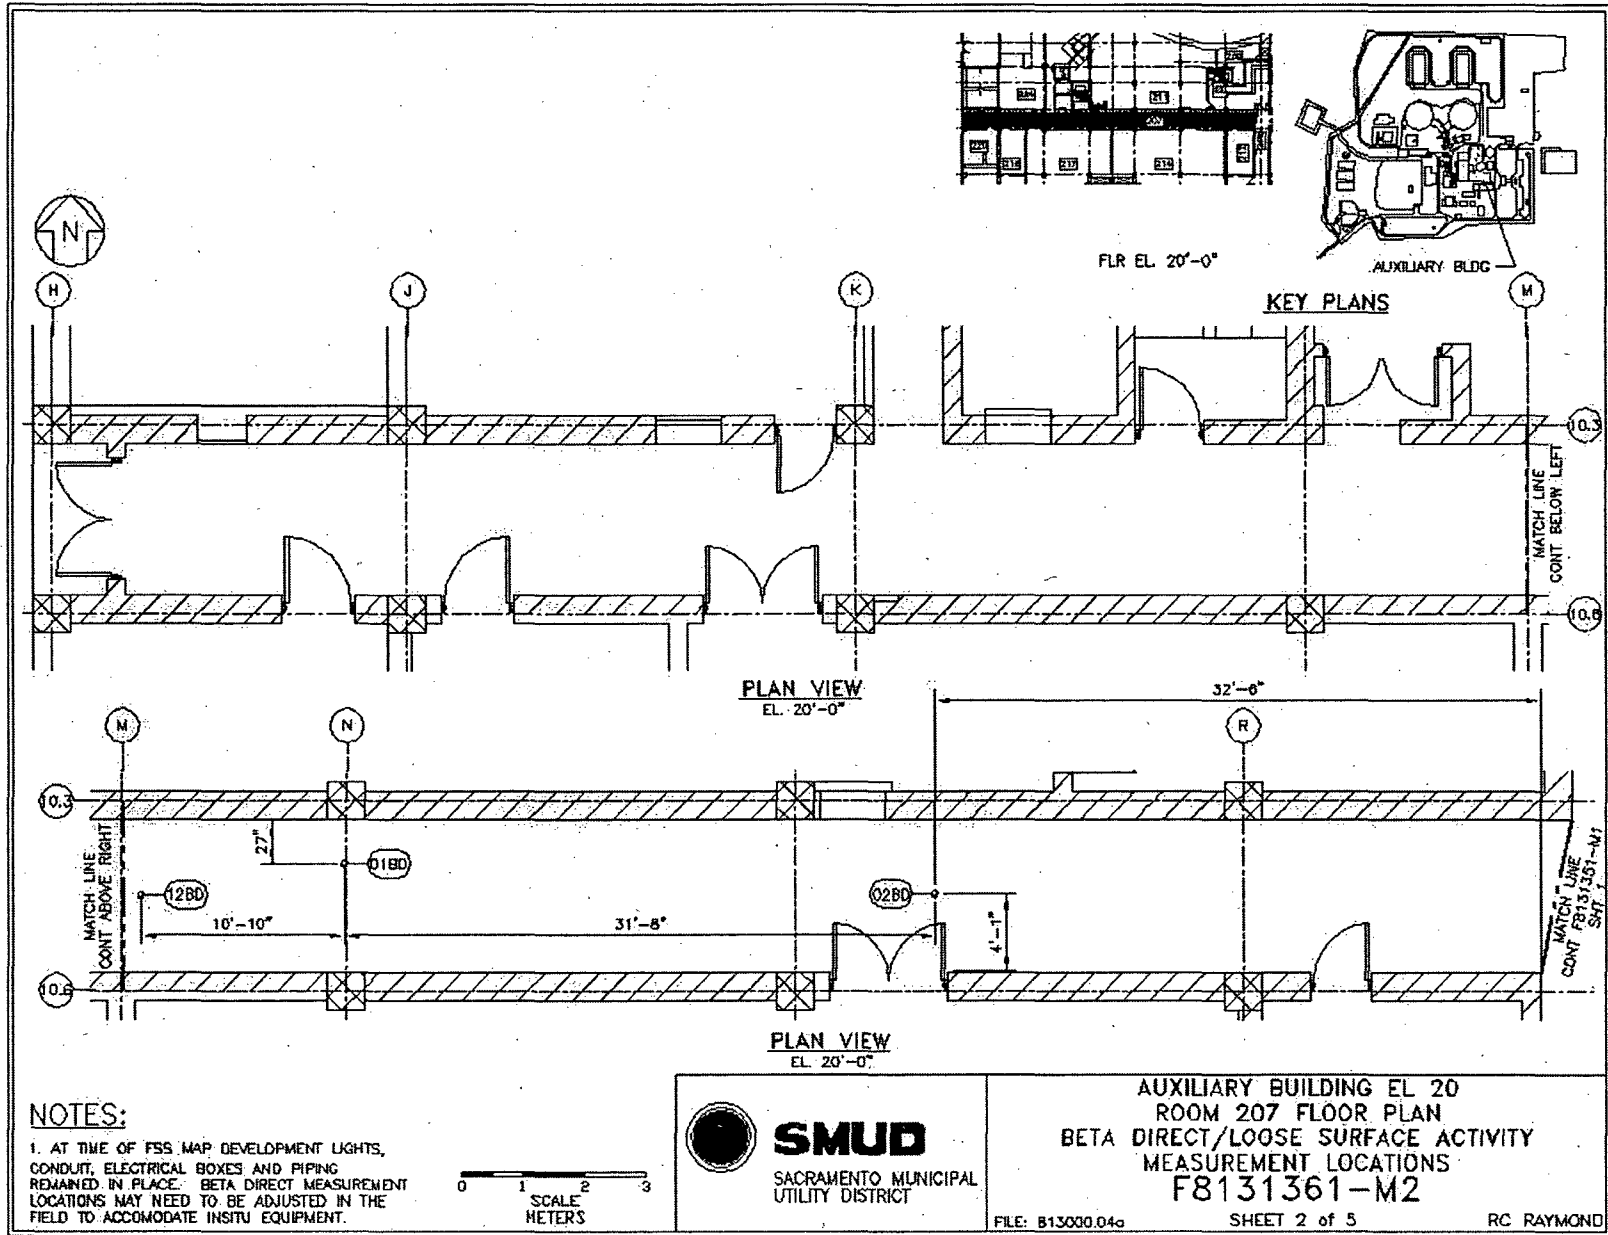
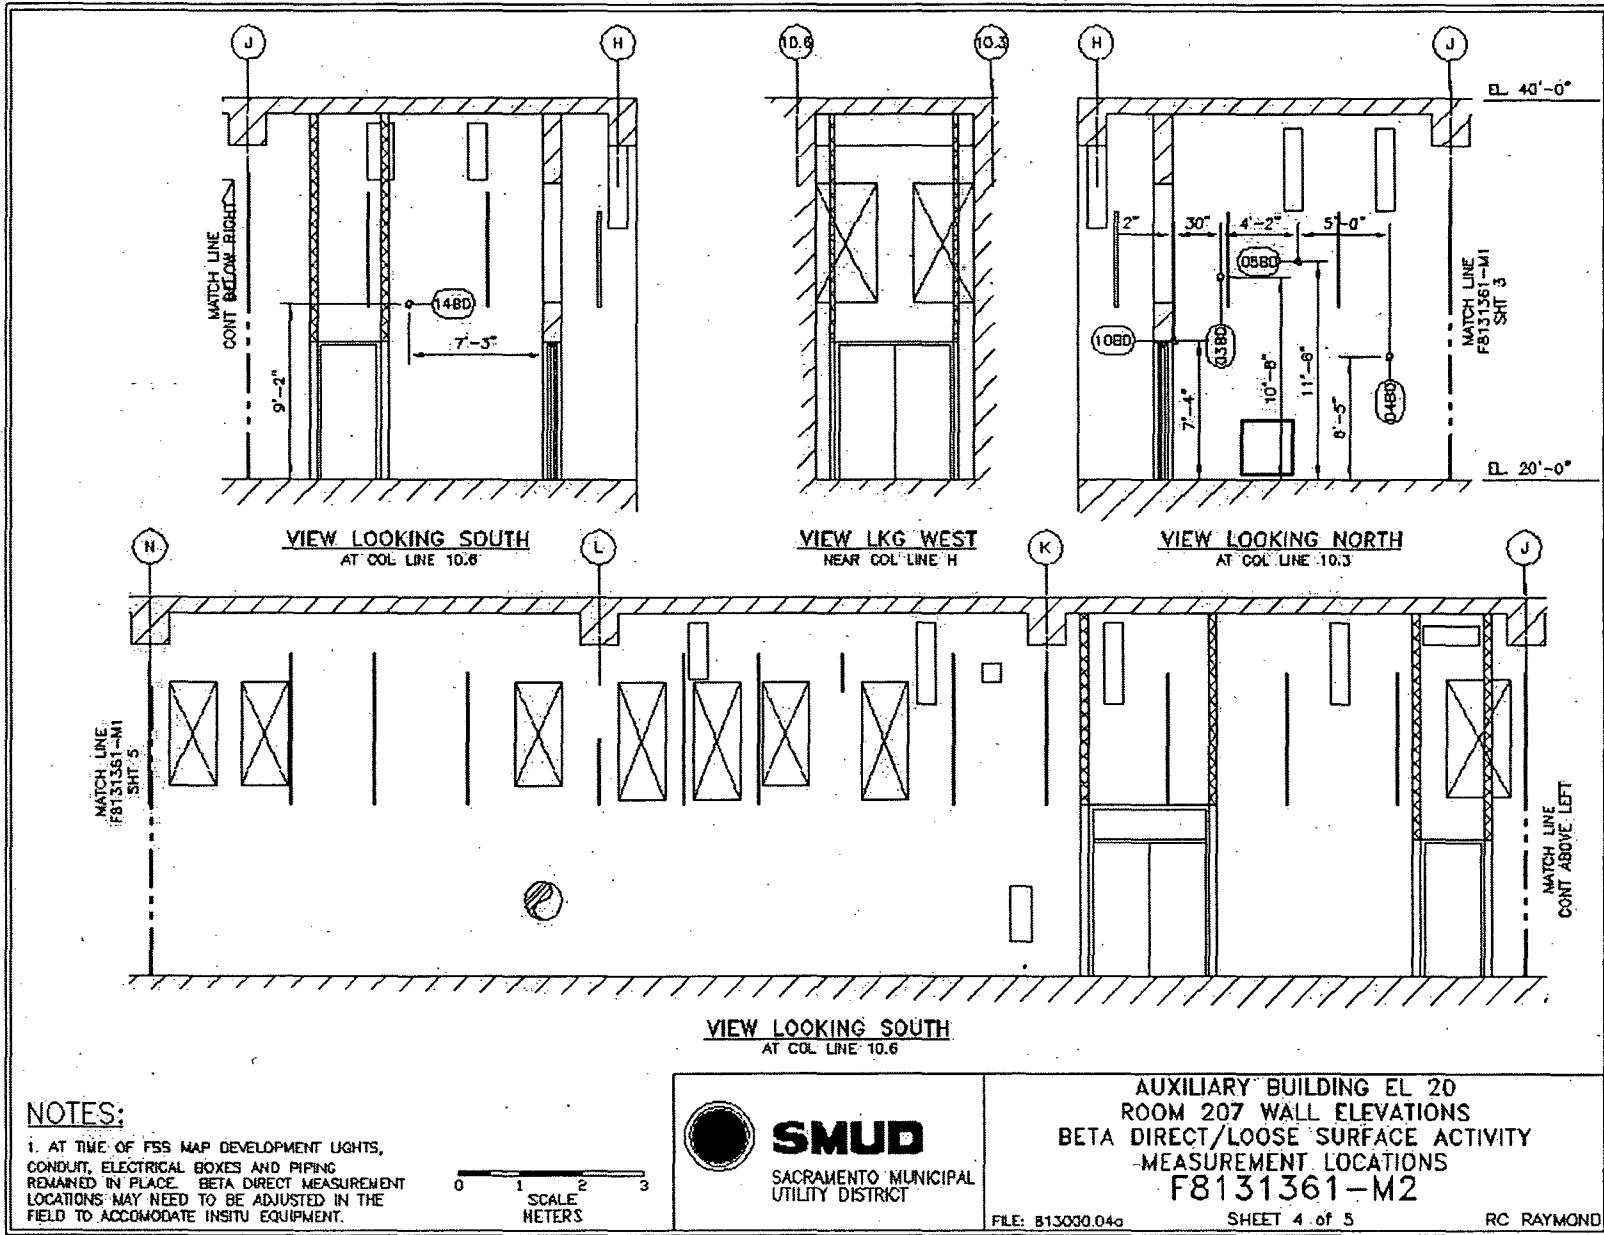
AUXILIARY BUILDING EL 20
 ROOM 207 WALL ELEVATIONS
 BETA DIRECT/LOOSE SURFACE ACTIVITY
 MEASUREMENT LOCATIONS
F8131361-M2
 FILE: 813030.046 SHEET 4 of 5 RC RAYMOND

The Survey Unit Design Parameters are presented in Table 1 below. The survey unit and measurement locations are depicted on the maps in Attachment 1. Direct measurement locations were randomly determined and 85 m² were scanned for approximately 10% coverage. Samples of removable contamination were collected at each direct measurement location. The instrumentation used for the survey along with the MDC values are listed in Tables 2-1 and 2-2 in Attachment 2.

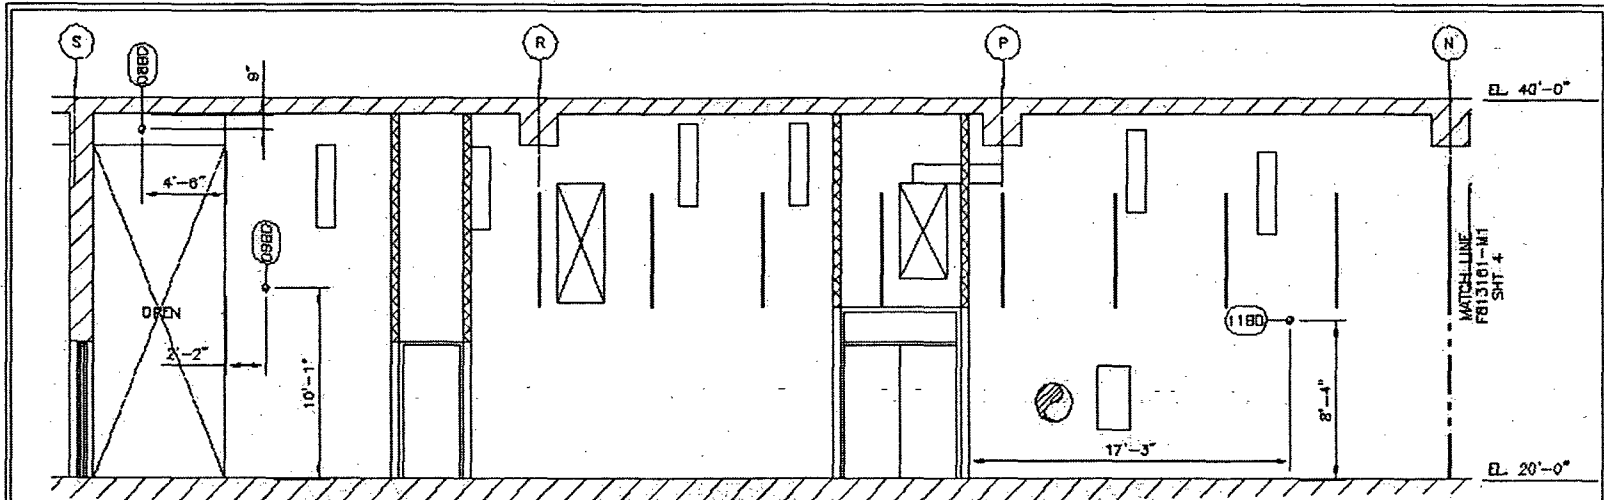
AUXILIARY BUILDING EL 20
ROOM 207 WALL ELEVATIONS
BETA DIRECT/LOOSE SURFACE ACTIVITY
MEASUREMENT LOCATIONS
F8131361-M2

VIEW LOOKING SOUTH
AT COL LINE 10.6
