Progress Energy Florida
Levy Nuclear Plant
Units 1 and 2
Part 3, Environmental Report

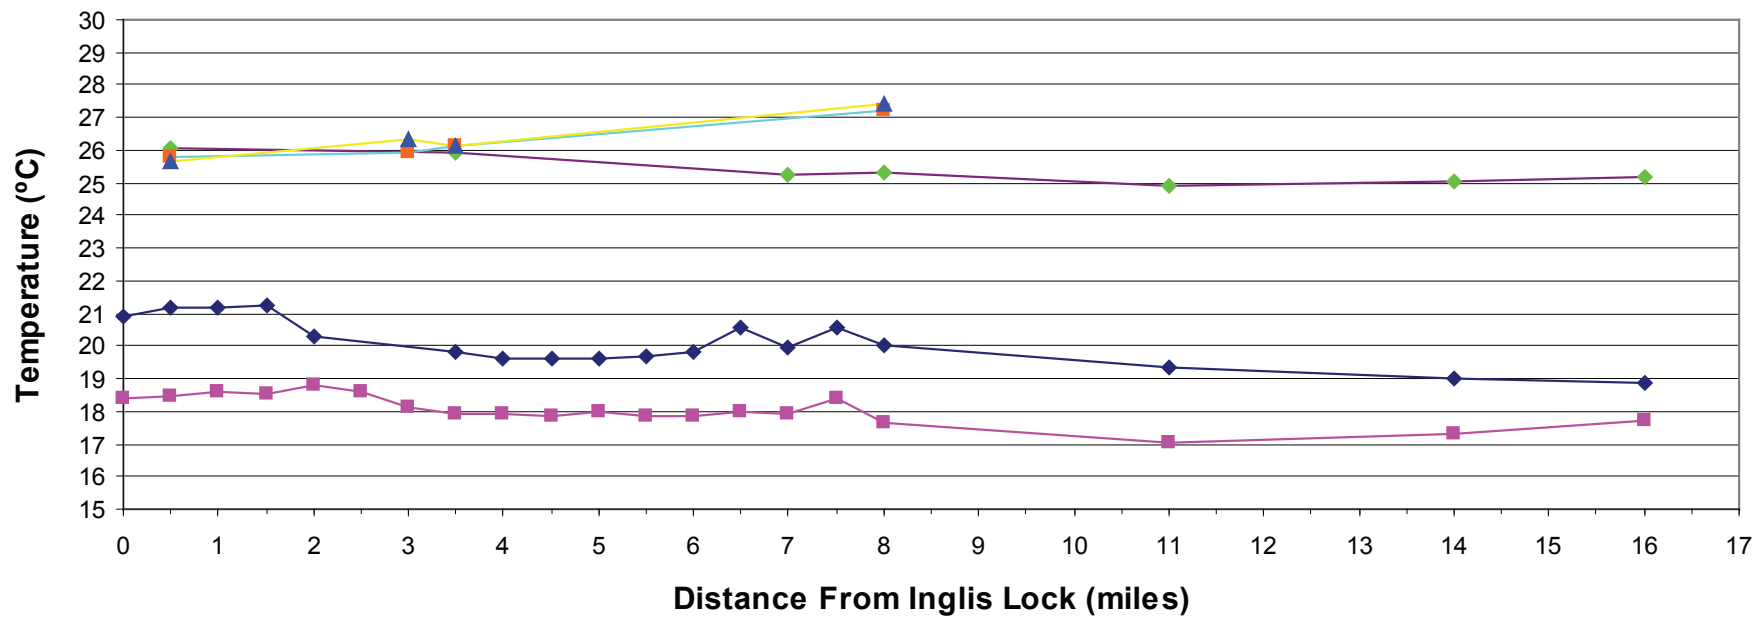
Water Temperature Pattern
 at 2 Meter Depth
 FIGURE 2.4-19
