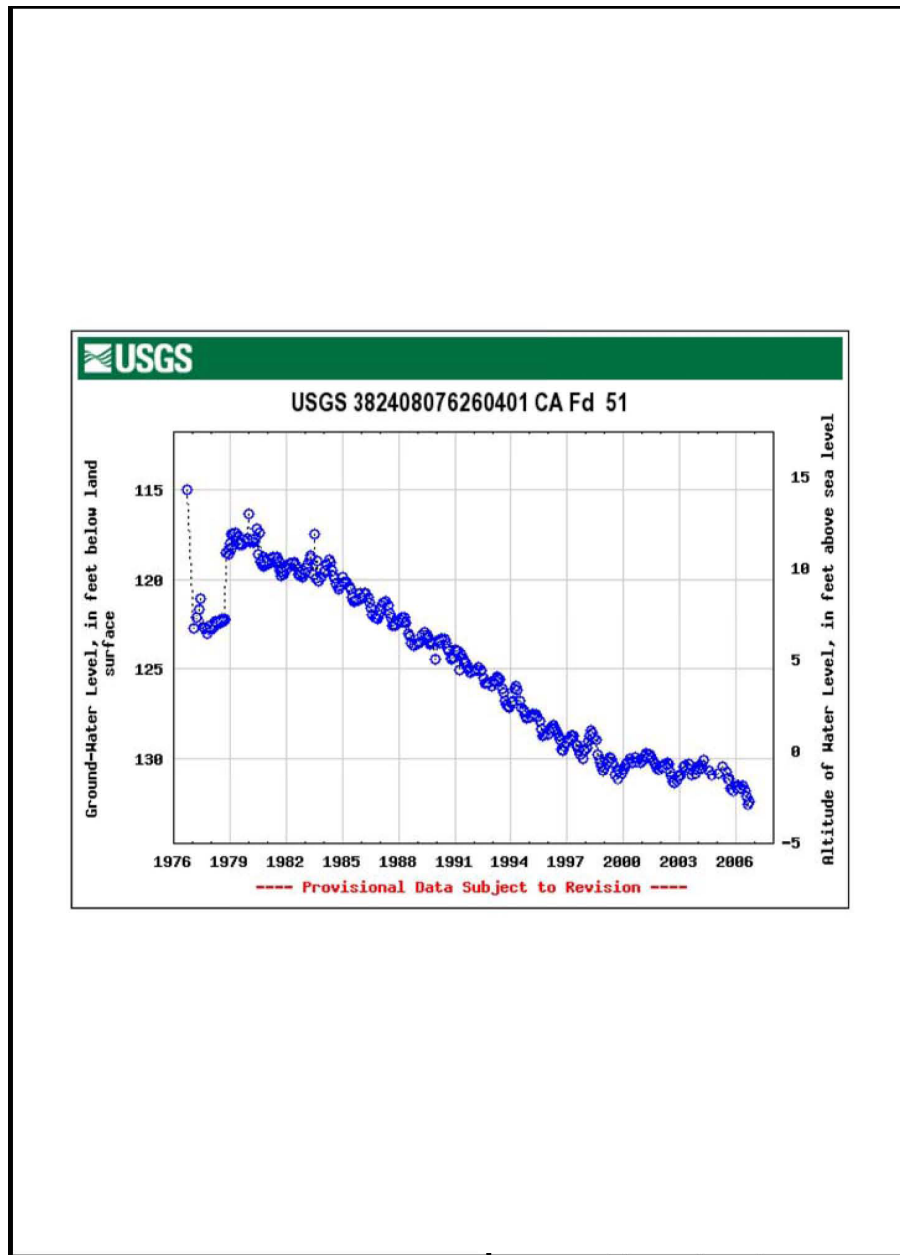
Figure 2.3-74—{Well Hydrograph for Monitoring Well CA Fd 51 Screened in the Piney Point – Nanjemoy Aquifer at Calvert Cliffs State Park}

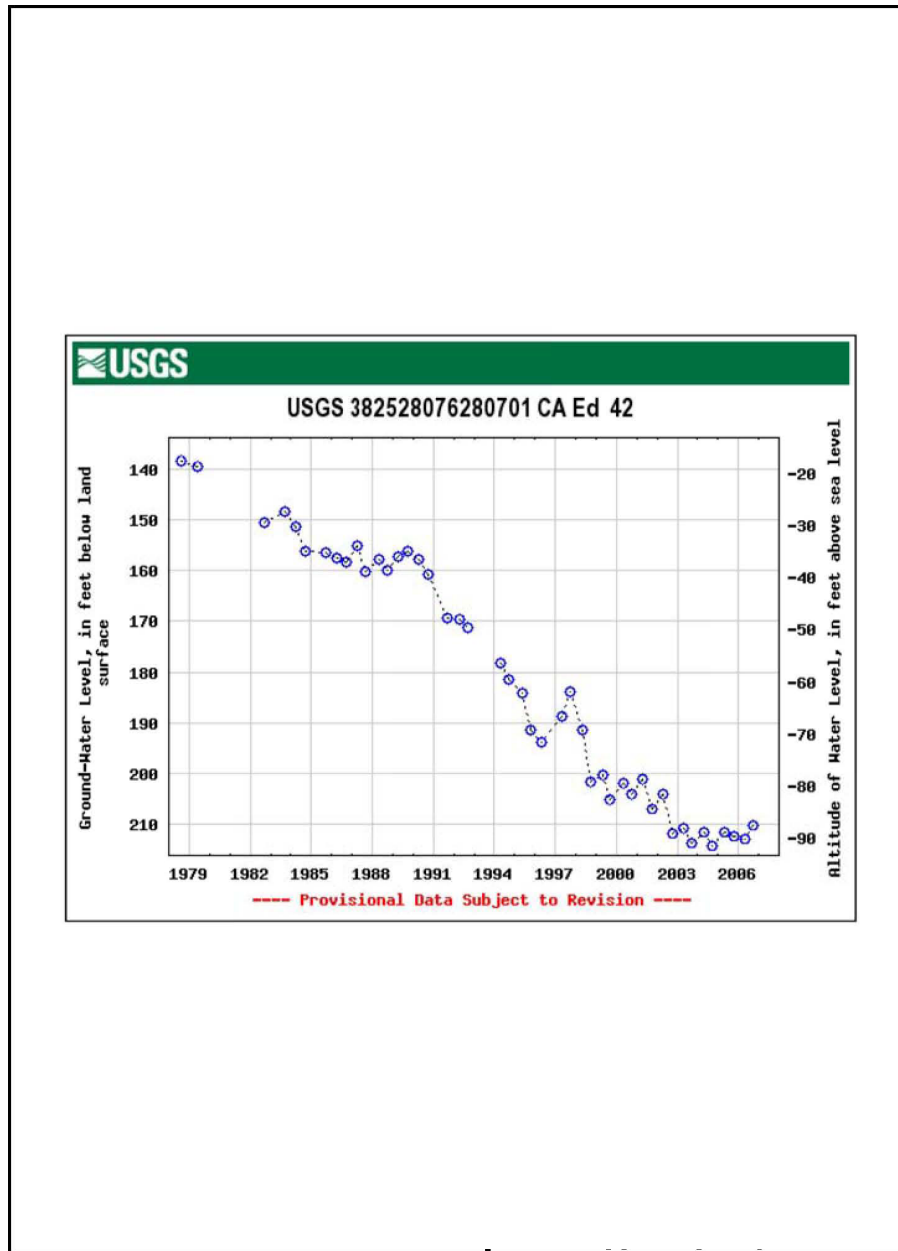
Figure 2.3-75—{Well Hydrograph Hydrograph for Monitoring Well CA Ed 42 Screened in the Aquia Aquifer at Calvert Cliffs Nuclear Power Plant}

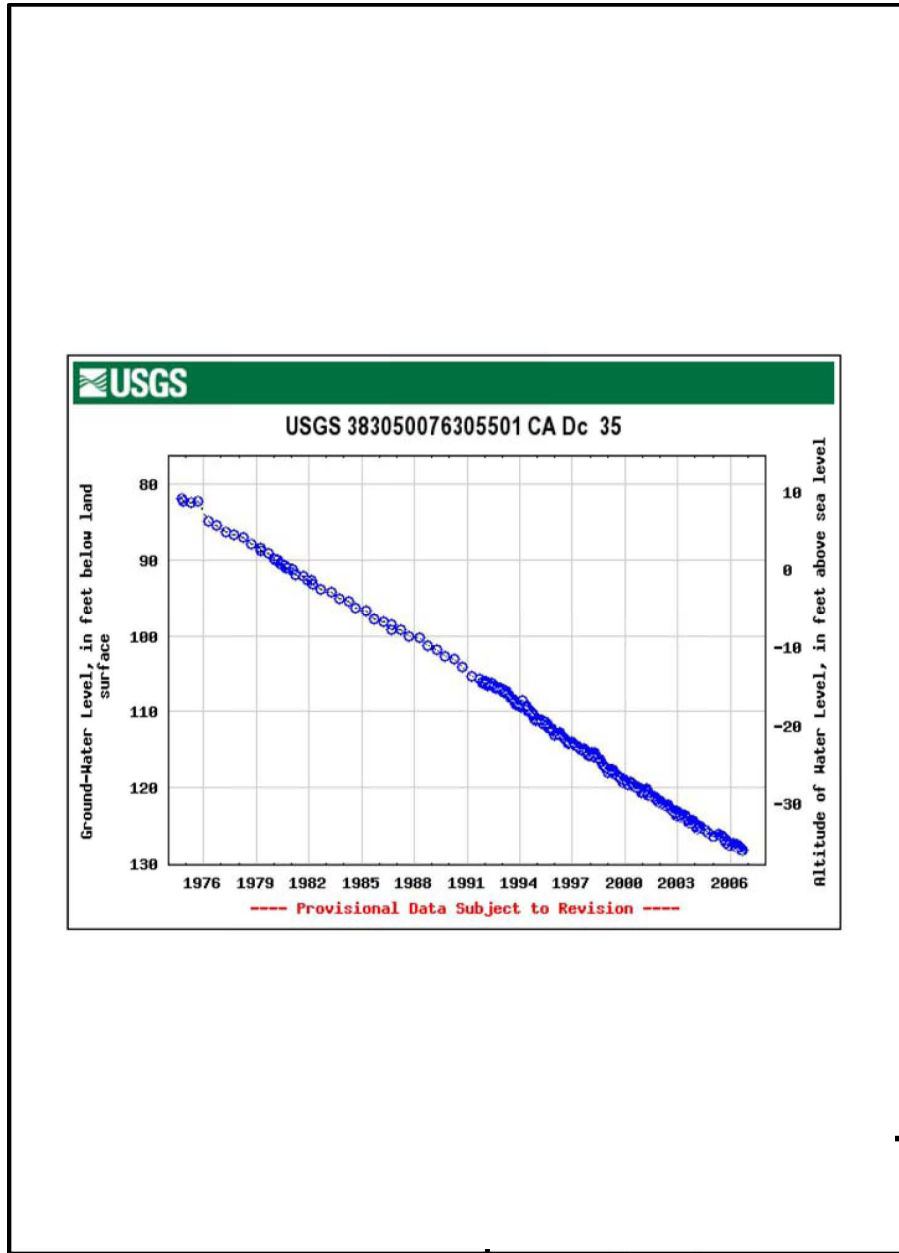
Figure 2.3-76—{Well Hydrograph Hydrograph for Monitoring Well CA Dc 35 Screened in the Magothy Aquifer at Scientits Cliffs}

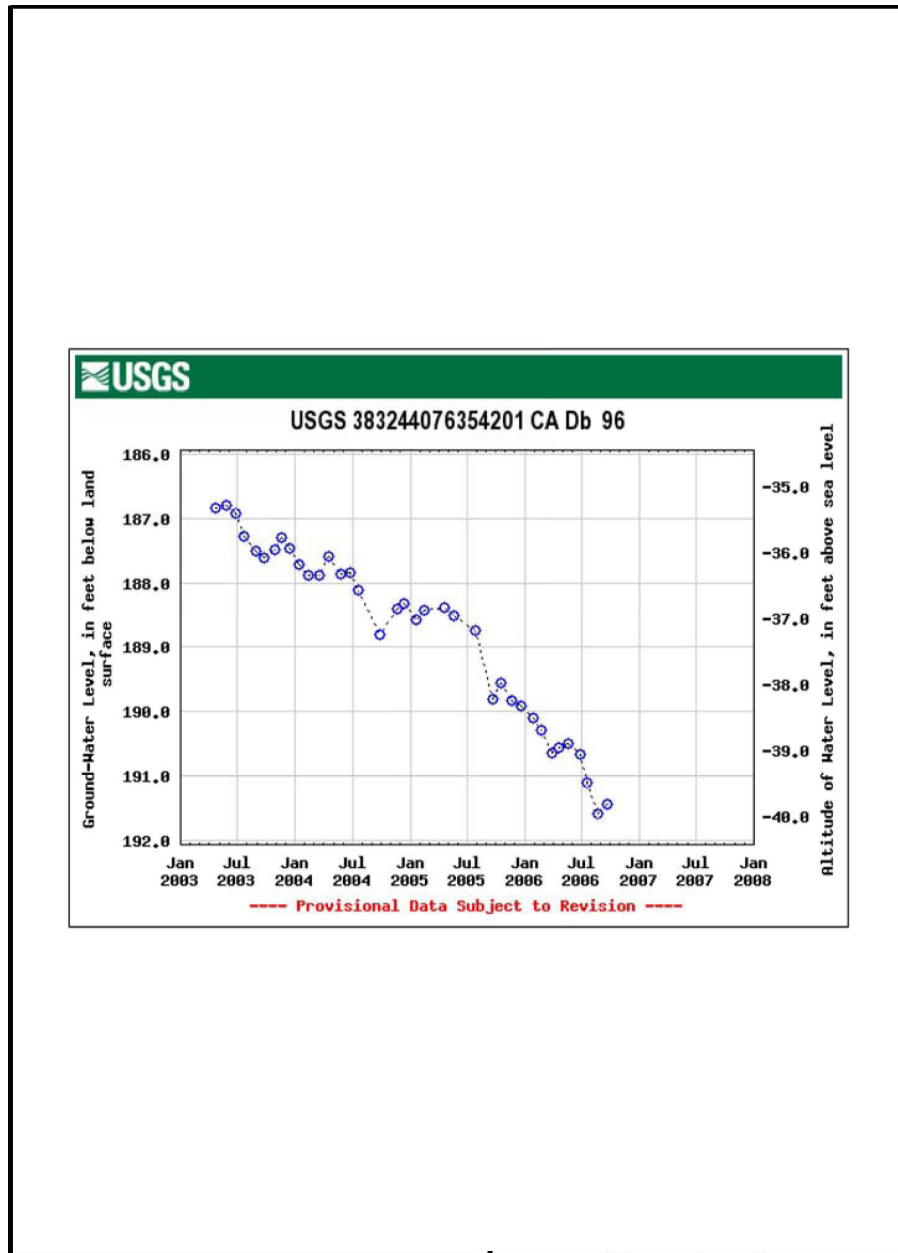
Figure 2.3-77—{Well Hydrograph Hydrograph for Monitoring Well CA Db 96 Screened in the Upper Patapsco Aquifer at Prince Frederick}

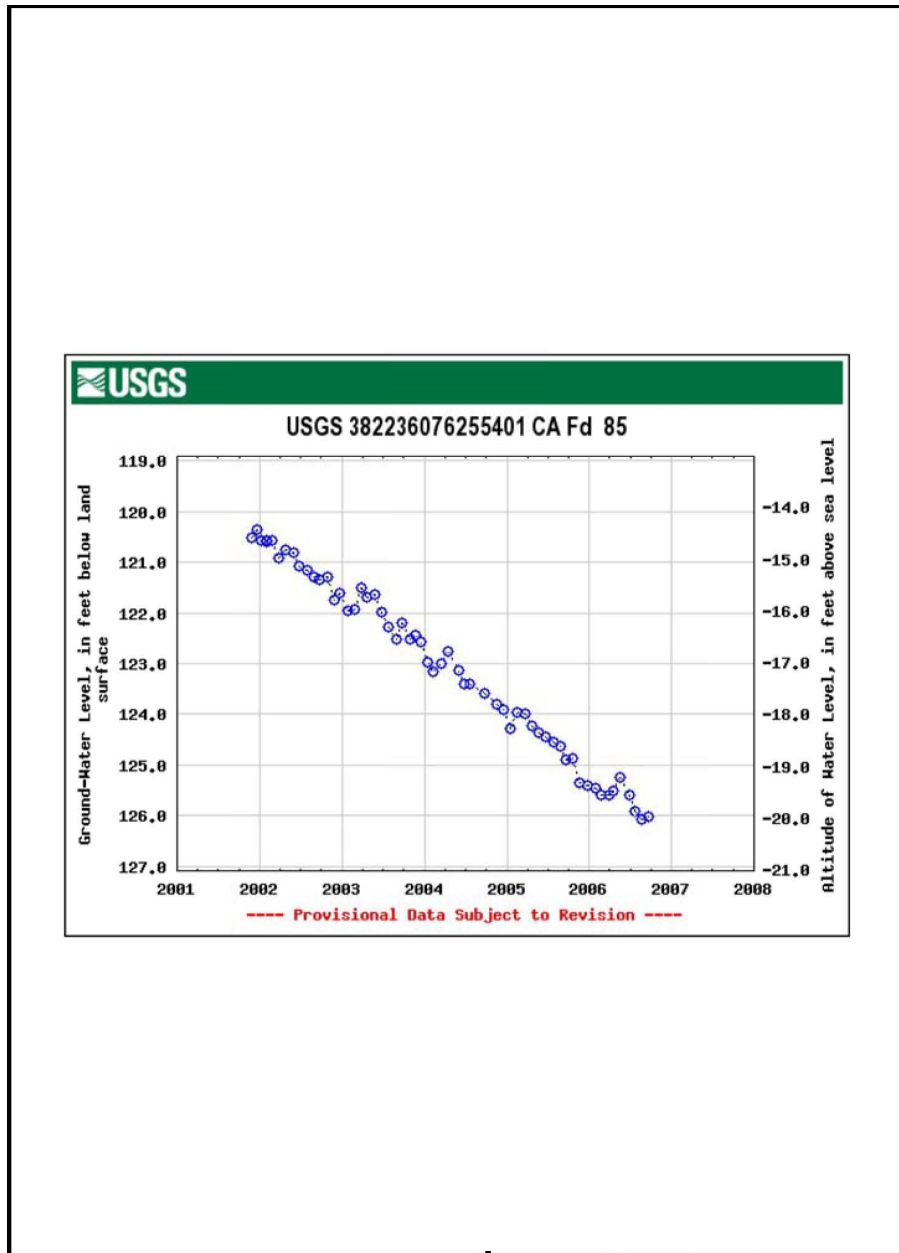
Figure 2.3-78—{Well Hydrograph Hydrograph for Monitoring Well CA Fd 85 Screened in the Lower Patapsco Aquifer at Chesapeake Ranch Estates}

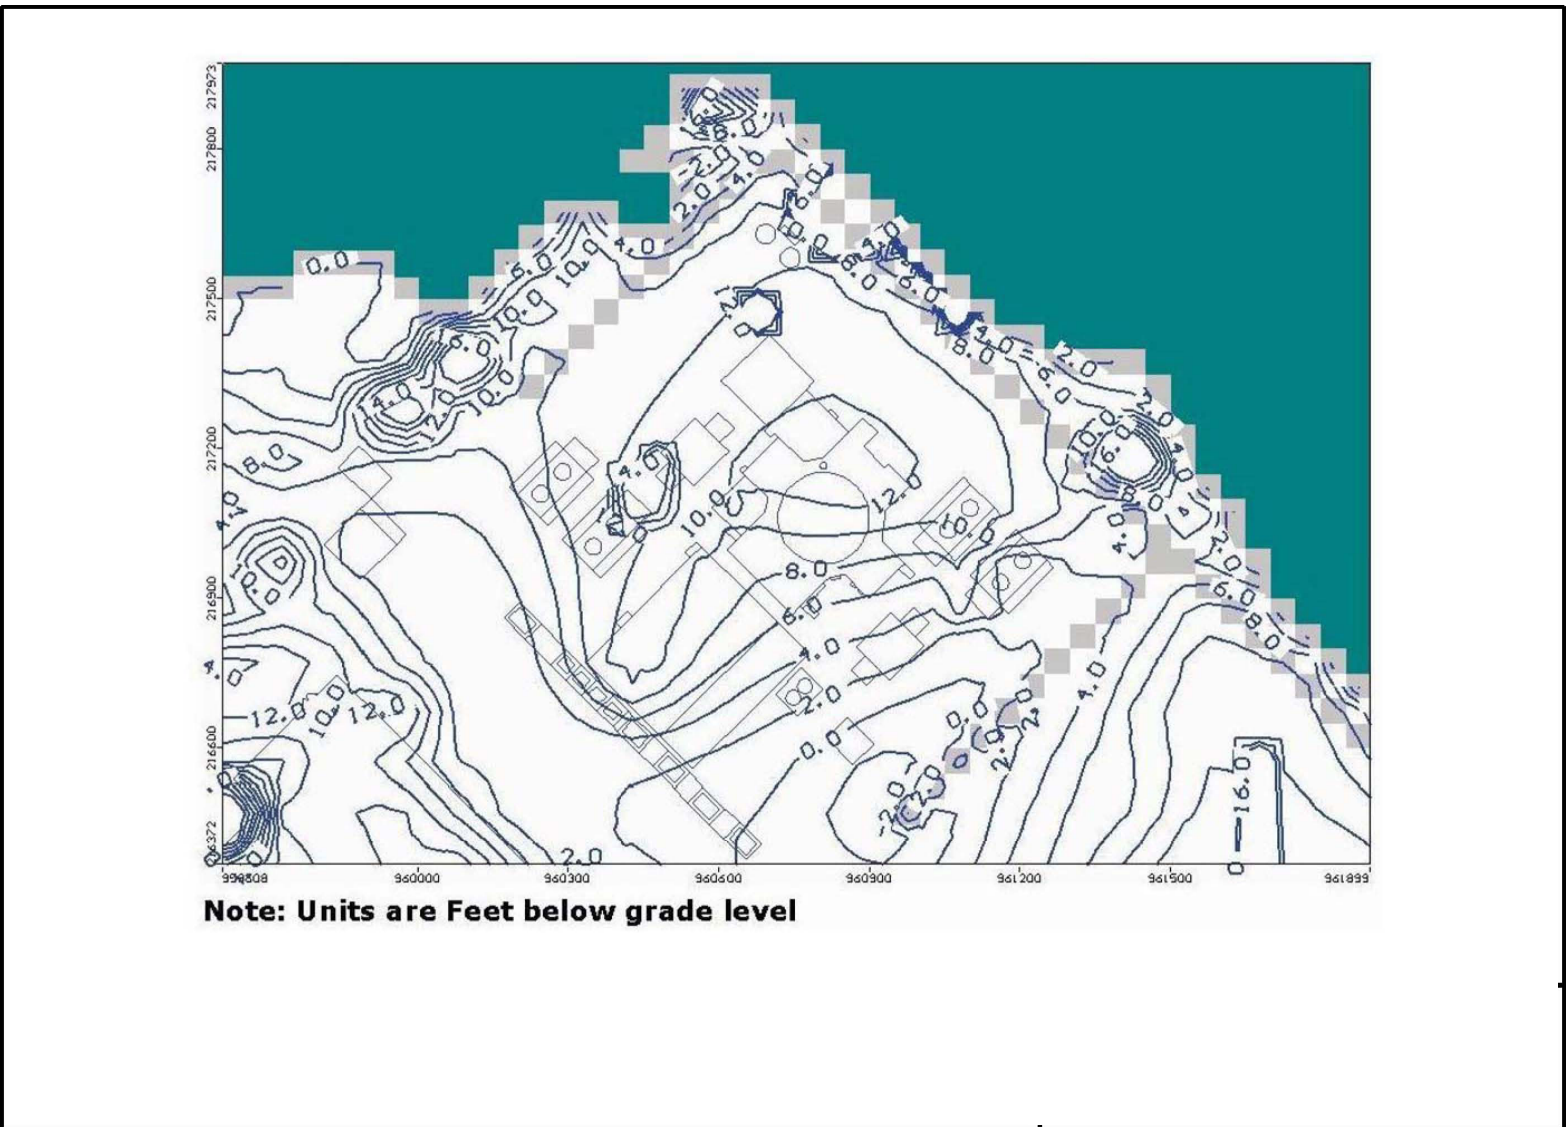
Figure 2.3-79—{Modeled Post-Construction Depth to Surficial Aquifer Water Table Around Power Block 3}
