SUBJECT: STAFF OBSERVATIONS OF TESTING FOR GENERIC SAFETY ISSUE  
191 AT WYLE LABORATORIES ON NOVEMBER 26/27, 2007

On November 26 and 27, 2007, Paul Klein and Leon Whitney of the Nuclear Regulatory Commission (NRC) staff traveled to the facilities of Wyle Laboratories (Wyle) in Huntsville, Alabama. The objective of the trip was to observe 30-day chemical effects head loss qualification test of an Enercon-design "top-hat" cylindrical passive strainer. The testing was intended to qualify strainer designs at the McGuire and Catawba nuclear plants.

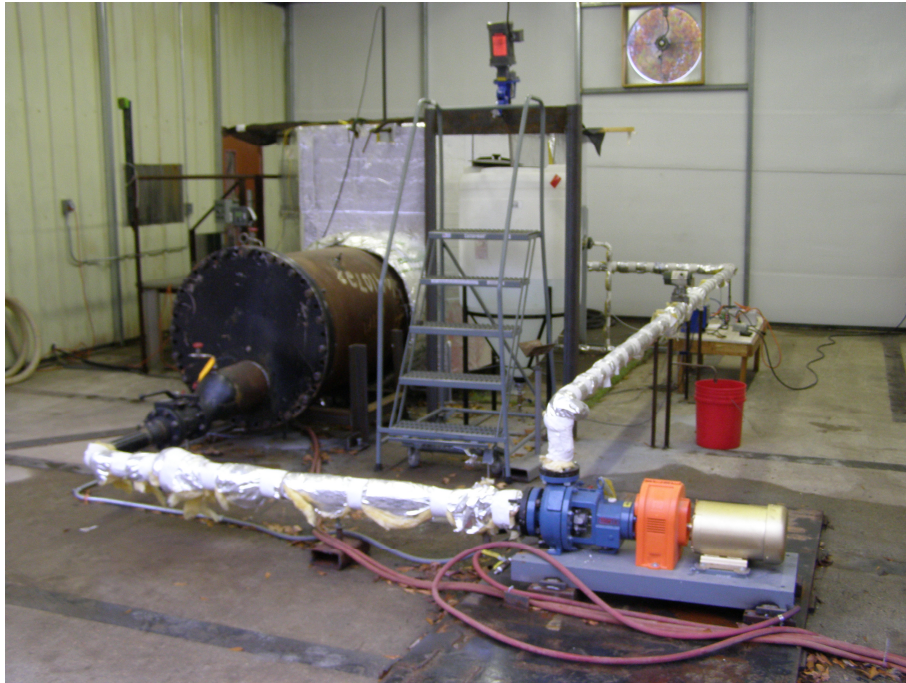
The Wyle Laboratory facilities contain a test loop designed to perform strainer head loss testing. Figure 1 shows the test loop that contains a pump, piping, and a tank sloped from the inlet towards the outlet and connected to a 36-inch diameter steel pipe attached at the tank outlet. A horizontally-mounted 8-inch diameter "top-hat" test strainer was housed within the 36-inch diameter pipe. Baffle walls were welded into the pipe section in an attempt to obtain representative side clearances between the strainer and the adjacent walls. In addition, the clearance between the top hat and the bottom of the pipe simulated the approximate 3-inch clearance between the strainers and the containment floor in the plant. The single strainer test configuration was non-prototypical since the strainer arrangements in the McGuire and Catawba plants typically have two horizontally-oriented strainers mounted one above the other along the waterbox. The original test design for two strainers mounted one above the other was changed in order to address issues with chemical concentrations. During the 30-day test, water flows down the ramp towards the open end of the "top-hat" strainer, while the flows approaching the strainers in the reactor plant may have a larger side-to-side or cross-axial flow component.

Figure 1. Test loop for 30-day integrated chemical effects head loss test.

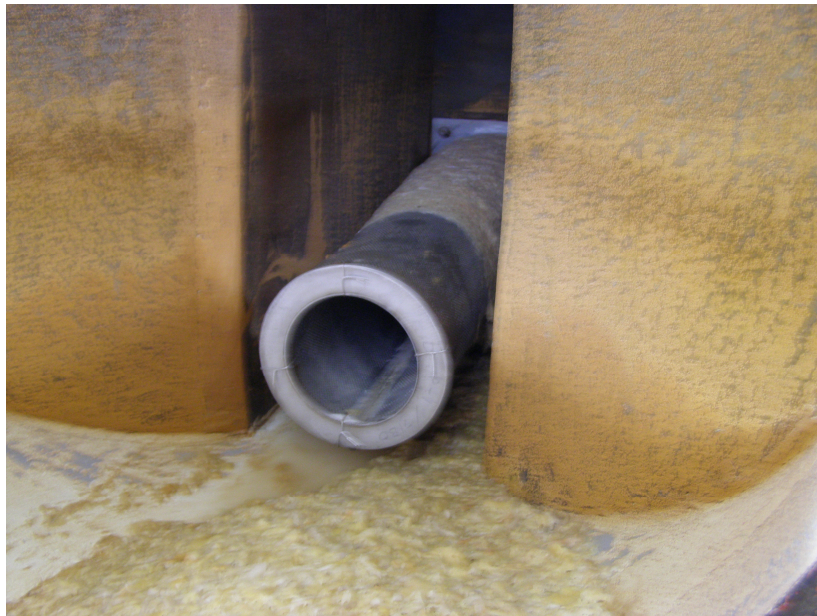
Following the final flow sweep, the pump was secured and the test loop was slowly drained. Figure 2 shows the post-test appearance looking into the 36-inch diameter pipe. A significant amount of fibrous debris had settled on the bottom of the pipe in the approximately 2.5 foot distance between the pipe inlet and the beginning of the top-hat test strainer. As seen in Figure 2, the outside surface of the top-hat strainer was essentially bare for the approximately 10 inches of screen furthest from the strainer suction end. The compressed fiber on the outer top-hat surface near the suction end was approximately one inch thick. The top-hat strainer internal surface was mostly clean except for a cylindrical "plug" of fiber approximately 8 inches long located at the suction end of the strainer. No hydrated precipitates similar to what has been observed during earlier NRC-sponsored work were visible in the fluid or on the debris bed following the test. Some fiber was observed on the downstream bypass eliminator mesh (mounted internal to the strainer cylinder) once it was removed, although the amount was not enough to raise any concern about debris bed formation on the bypass eliminator.

It could not be determined from the appearance of the fiber on the strainer module after the test whether the material was comprised of individual fibers, small pieces of fiber, or a mixture of the two. However, judging by (1) the apparent mixed nature of the material that went into the test flume, (2) the appearance of the estimated 20% to 40% of fiber lying in the strainer "near field" upstream of the strainer at the end of the test, (3) the sparse amounts of loose fibers on the downstream wire mesh "bypass eliminator" filter, and (4) the amount of clean screen area on the strainer module screen surfaces post-test, both the fiber material on the outside of strainer module and in the internal fiber "plug" were very likely comprised of a mixture of loose fibers and small pieces of fiber. Had the tested fiber distribution included more fiber "fines" (suspended and individual) fibers, a fiber bed may have formed over the entire screen surface because of

the ability of loose fibers to independently and freely transport in response to the suction forces at all locations on the strainer.

Figure 2. Post-test review of the top-hat strainer showing essentially bare strainer surface on the end opposite the suction side and a settled fiber pile on the pipe bottom upstream of the strainer.

Given the amount of fiber that settled the pipe section upstream of the strainer and the amount of bare surface on the inner and outer surfaces of the top-hat strainer, the NRC staff questioned whether the debris bed that formed during the test was representative of a debris bed that would form on the top-hat strainers in the sump following a LOCA.

An Enercon representative theorized that the approximately 8-inch "plug" of material at the "bottom" of the inner screen surface was comprised of a succession of fiber beds which had formed on the inner screen surfaces at that end of the strainer module and then collapsed, pulling away from the inner screen surface and being drawn towards the location where the strainer module was mounted to the exit plenum. This theory is consistent with post-test pictures that showed the "plug" would easily peel apart in apparent layers along its longitudinal axis.
