BELLEFONTE COMBINED LICENSE APPLICATION – RESPONSE TO REQUEST FOR  
ADDITIONAL INFORMATION – BASIC GEOLOGIC AND SEISMIC INFORMATION

Subject: Basic geologic and seismic information in the Final Safety Analysis Report

New Figure 2.5-209  
Soil Weathering Features in Pleistocene Terrace Deposits, Gadsden, Alabama

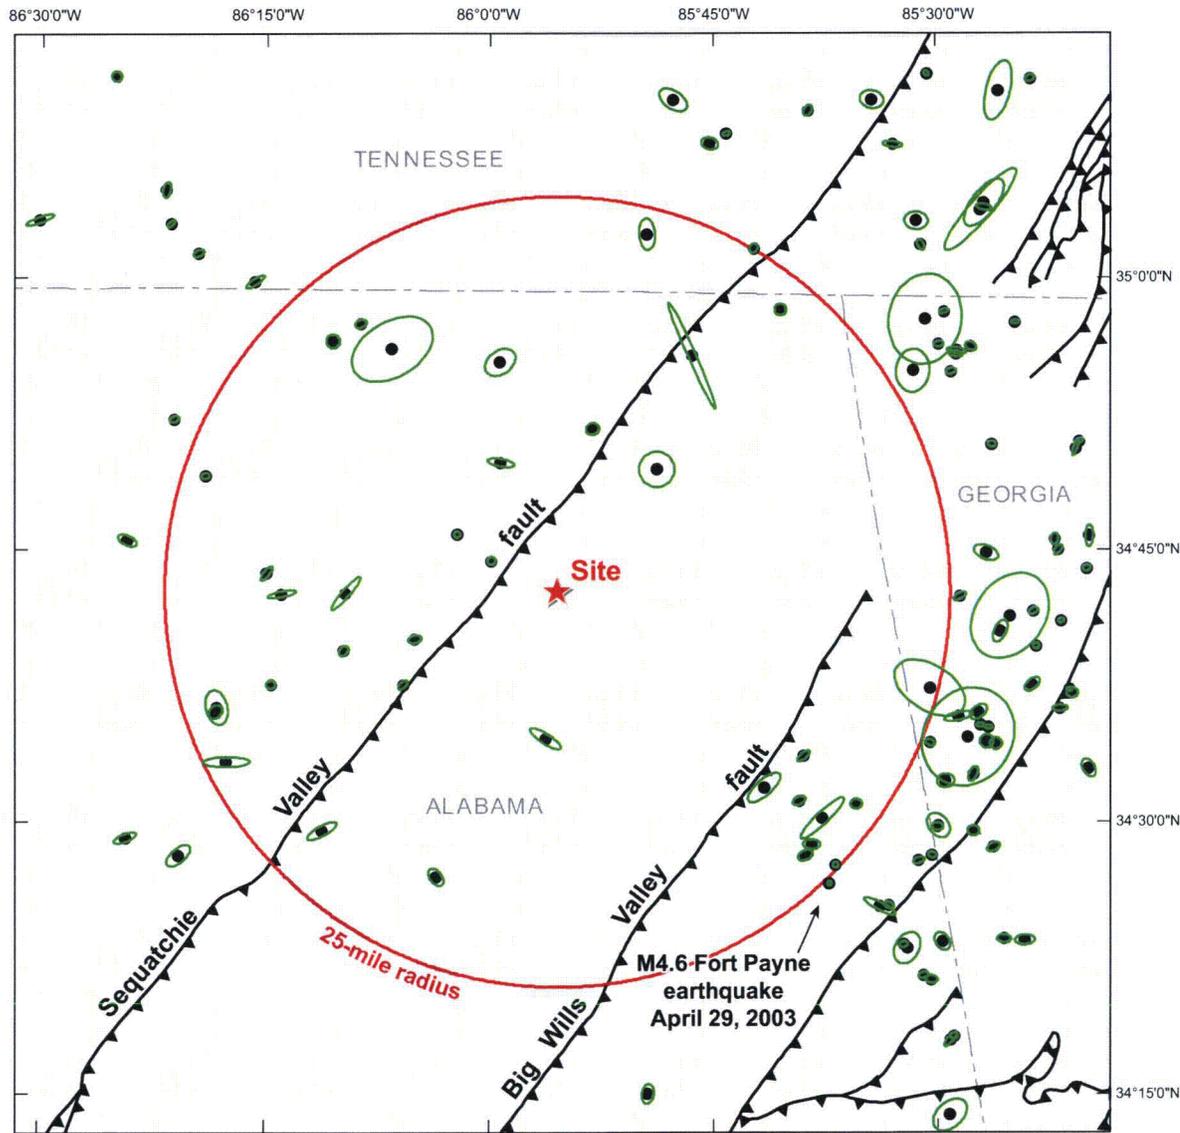
**FIGURE 1**  
 Location Uncertainty of Seismicity

Location uncertainty at 68% confidence level

Faults from Hibbard (2006)  
 Seismicity from Virginia Tech Seismological  
 Observatory Full Instrumental Catalog  
 1981-2006 (2007)

Figure 1 (Attachment 02.05.01-03A) shows the projections of the 68% hypocenter error ellipsoids in the horizontal plane for instrumentally located earthquakes in the site vicinity. The data are taken from the Southeastern United States Seismic Network Bulletins, 1973-2006 (Reference 3). Most earthquakes within 25 km of the site are located to the northwest of the surface trace of the Sequatchie Valley thrust, of Late Paleozoic age, which dips to the southeast. Figure 1 shows that the epicenter semi-major error ellipse axes (68% confidence) are on the order of 2 km or less for most of these events, suggesting that they are determined with sufficient accuracy to support the interpretation that the majority occurred to the northwest of the Sequatchie Valley fault and therefore, have no relation to that feature.

Earthquakes with computed epicenters to the southeast of the Sequatchie Valley fault trace could be, in principle, associated with that southeast-dipping Paleozoic fault, or other faults to the southeast shown in FSAR Figure 2.5-294. The critical issue in evaluating any potential association between these earthquakes and faults is the focal depth of the earthquakes. Figure 2 (Attachment 02.05.01-03A) shows a histogram of a focal depths for the 19 events shown in Figure 1 that have a 68% confidence vertical error ellipsoid projection of 5 km or less, and were recorded by at least one station within 20 km of the epicenter. These events represent the best-constrained hypocenter locations, and should have minimum bias in the focal depth estimates due to uncertainty in assumed velocity model. Therefore these events are the most appropriate subset to use in judging the depth distribution of earthquakes.

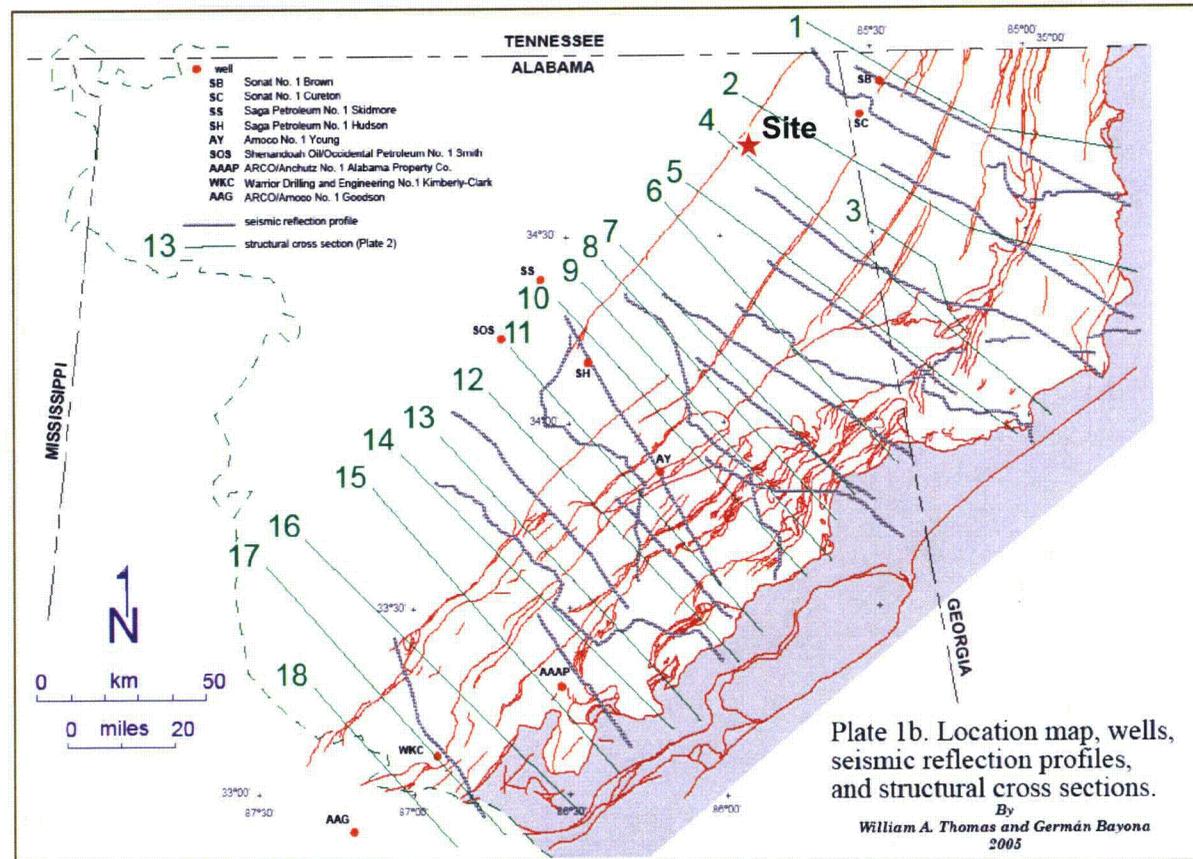
**FIGURE 1**  
 Location of Wells (red dots) and Seismic Reflection Profiles (wide gray lines), Used to Constrain the Structure of the Appalachian Thrust Belt. Thomas and Bayona (2005) Combine These Data with Geologic Mapping to Create 18 Structural Cross Sections (Numbered Green Lines)

The seismic reflection and well data used in these studies were generally collected by the petroleum industry. Eighteen parallel seismic reflection profiles, each approximately 50 miles long, cross the thrust belt and four deep wells penetrate the basement (Figure 1 of Attachment 02.05.01-04A). Geologic mapping of the Paleozoic rocks was conducted by a variety of researchers including the authors.
