North Anna COL Boring B-909 Acoustic Televiewer Dips Sheet 9 of 28

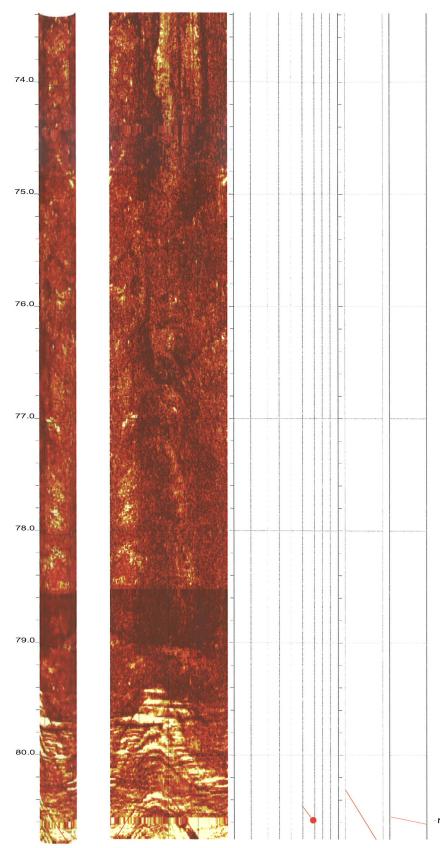
N323 58 Fracture Planar Weathered Open-fracture
