# Refined Conceptual Site Model

## Cimarron Site – Crescent, Oklahoma

August 2005

ENSR Report No. 04020-044, CSM

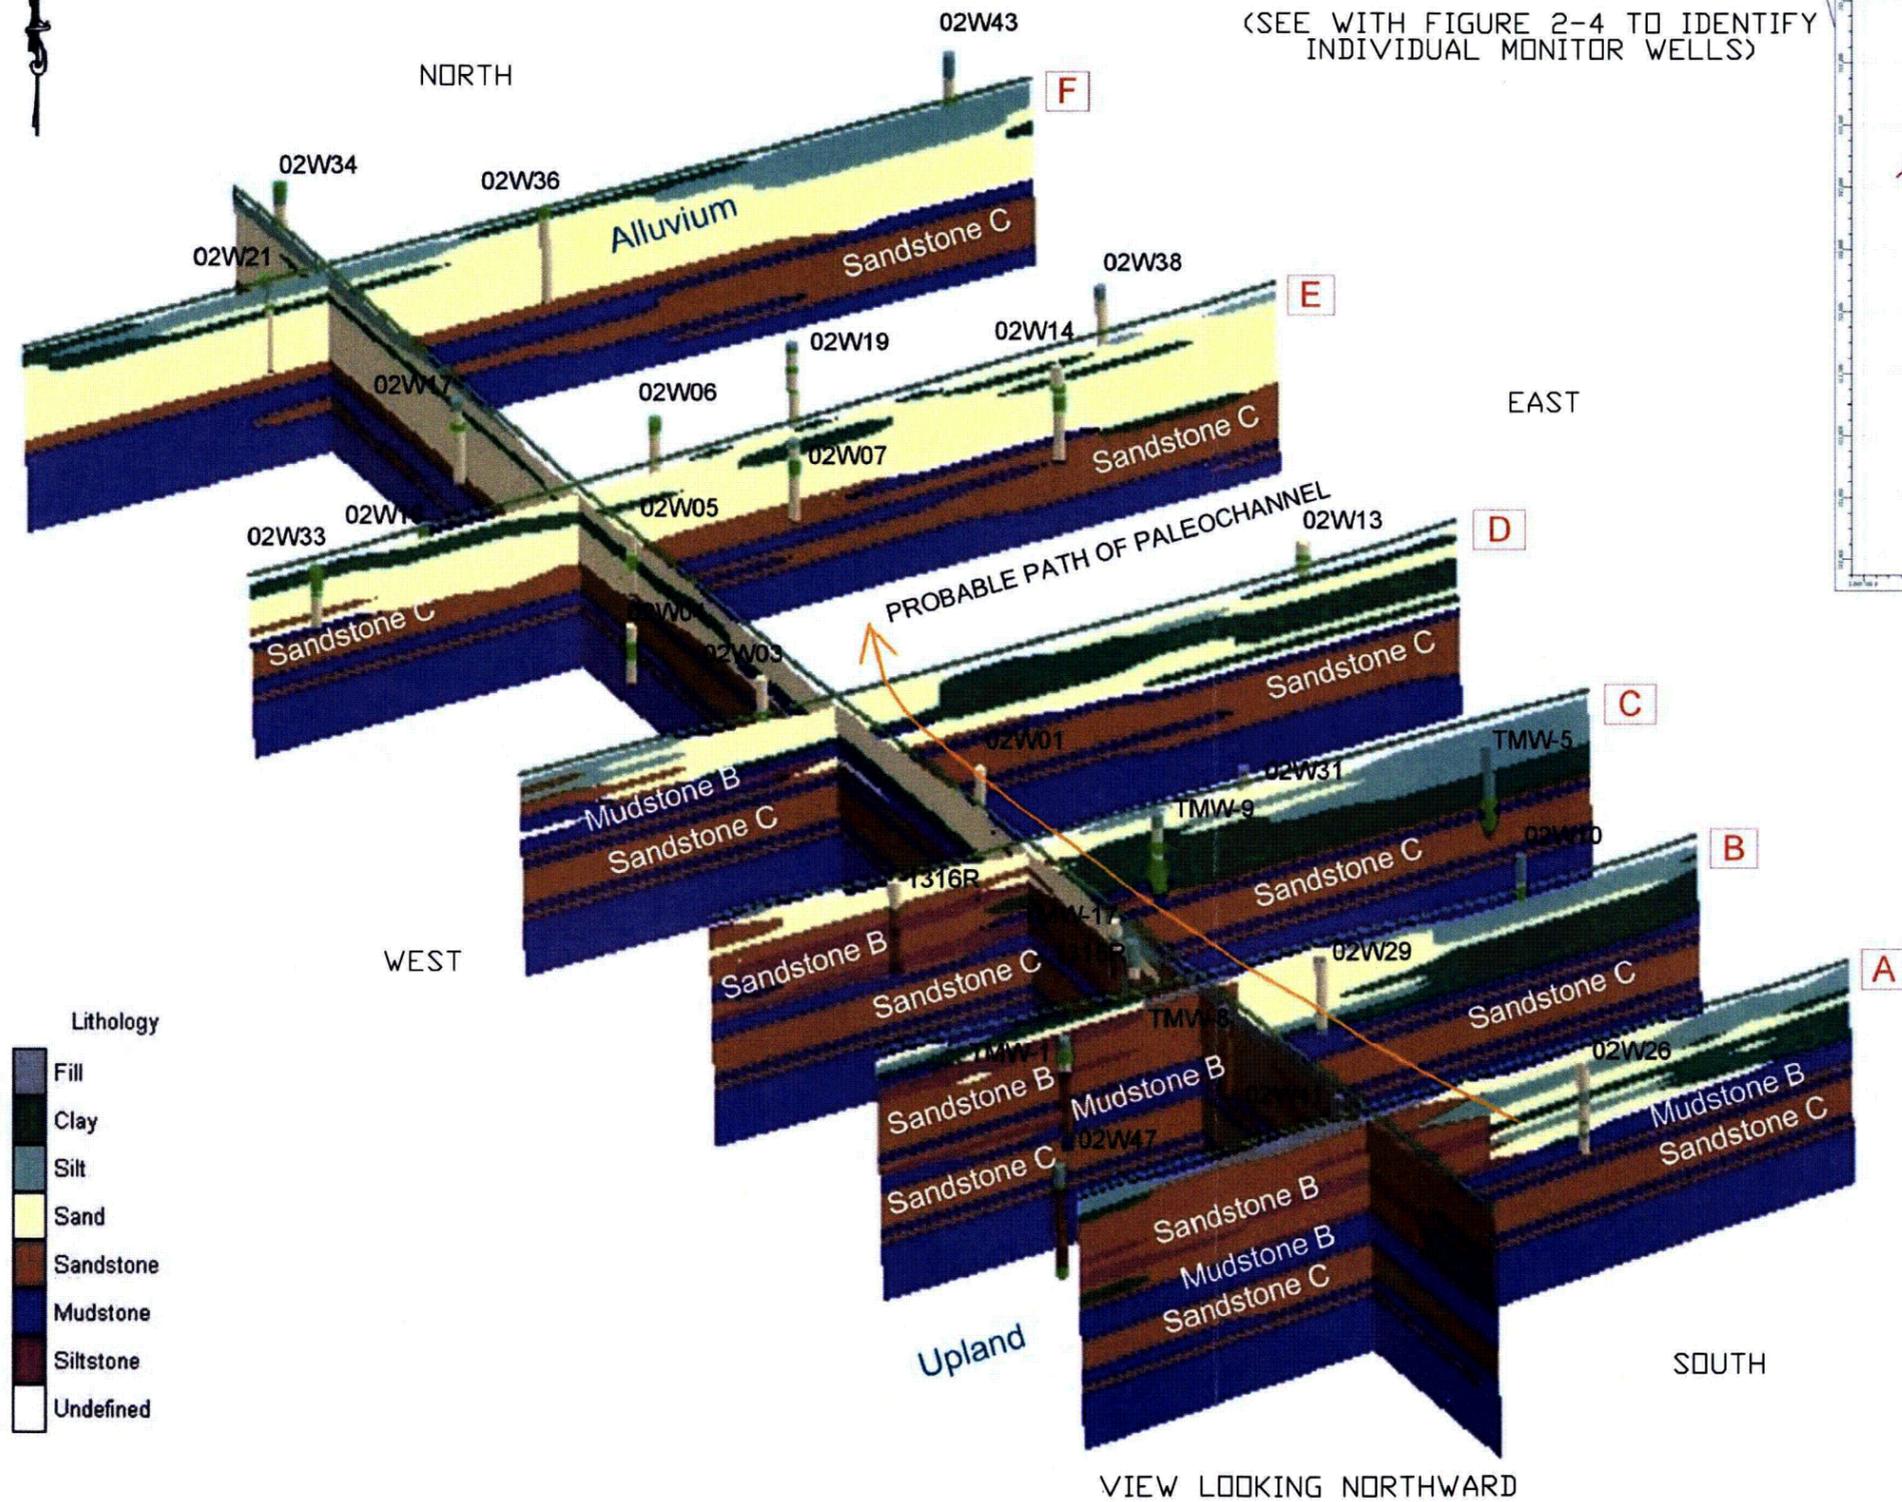
FIGURE NUMBER:	2-6
SHEET NUMBER:	1

**BURIAL AREA #1 FENCE  
DIAGRAM LOCATION LAYOUT**  
(SEE WITH FIGURE 2-4 TO IDENTIFY  
INDIVIDUAL MONITOR WELLS)

FIGURE 2-6		PROJECT NUMBER:	04020-044-200
BA #1 AREA FENCE DIAGRAM		DATE:	8/10/05
CIMARRON CORPORATION		SCALE:	
CRESCENT, OKLAHOMA

The upland is underlain by the Garber Formation. The sandstone units present in the BA #1 Area are mainly Sandstone B and Sandstone C. Sandstone A is eroded from most of the BA #1 Area and was observed to only be approximately 10 feet thick in a borehole (Well 1314) located south of the former disposal trenches. Mudstone A is present in the southern portion of the upland and Sandstone B and Mudstone B appears to be continuous across the upland (Figure 2-5).

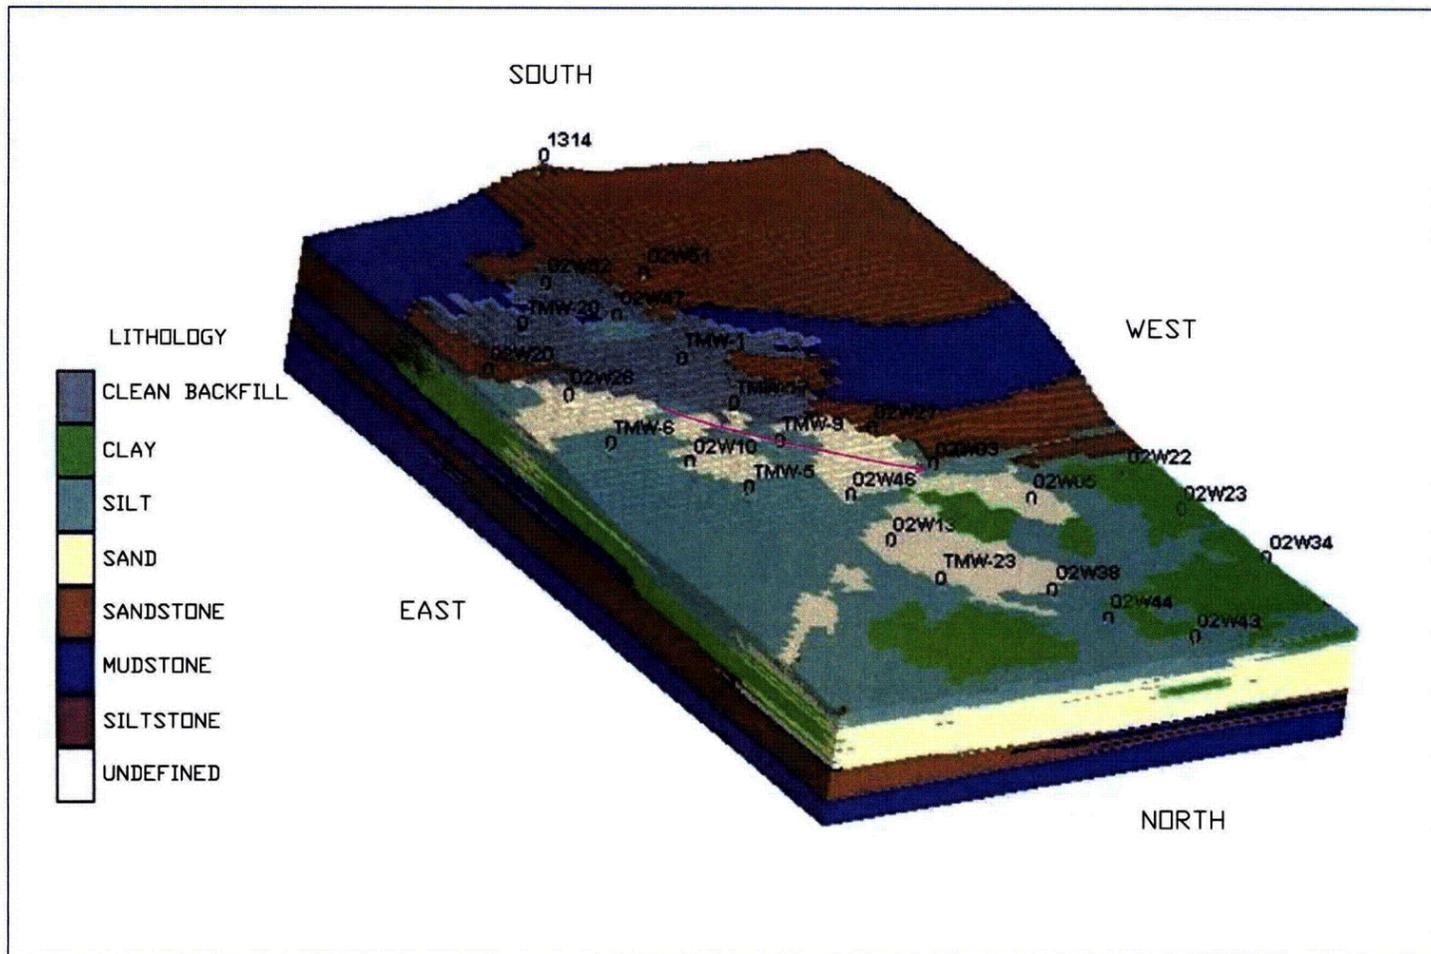
IMAGE 2-7A. Lithologic model of BA #1 Area before overburden sand was 'removed'. View from northeast.

In Figure 2-7, Image 2-7A illustrates the surface lithology of the BA #1 Area. A sand channel along the northeastern border of the upland can be observed. If the overburden sand and silt layers in Image 2-7A are electronically “removed,” a paleochannel is revealed as shown in Image 2-7B. The presence of

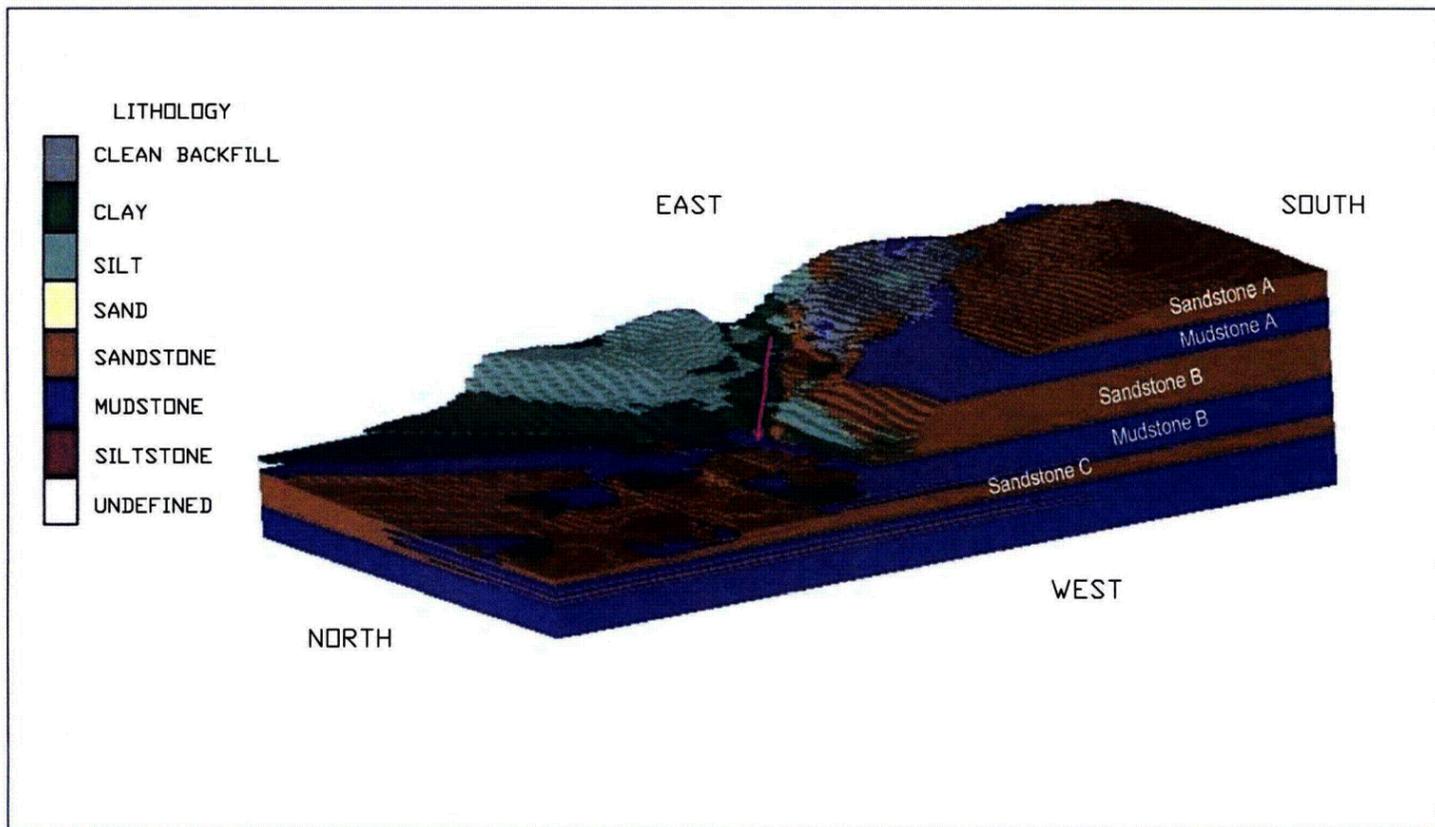
IMAGE 2-7B. Lithologic model of BA #1 Area after overburden sand was 'removed', revealing a paleochannel depicted as a valley in the figure. The curve with arrow head indicates probable path of the channel. View from northwest.

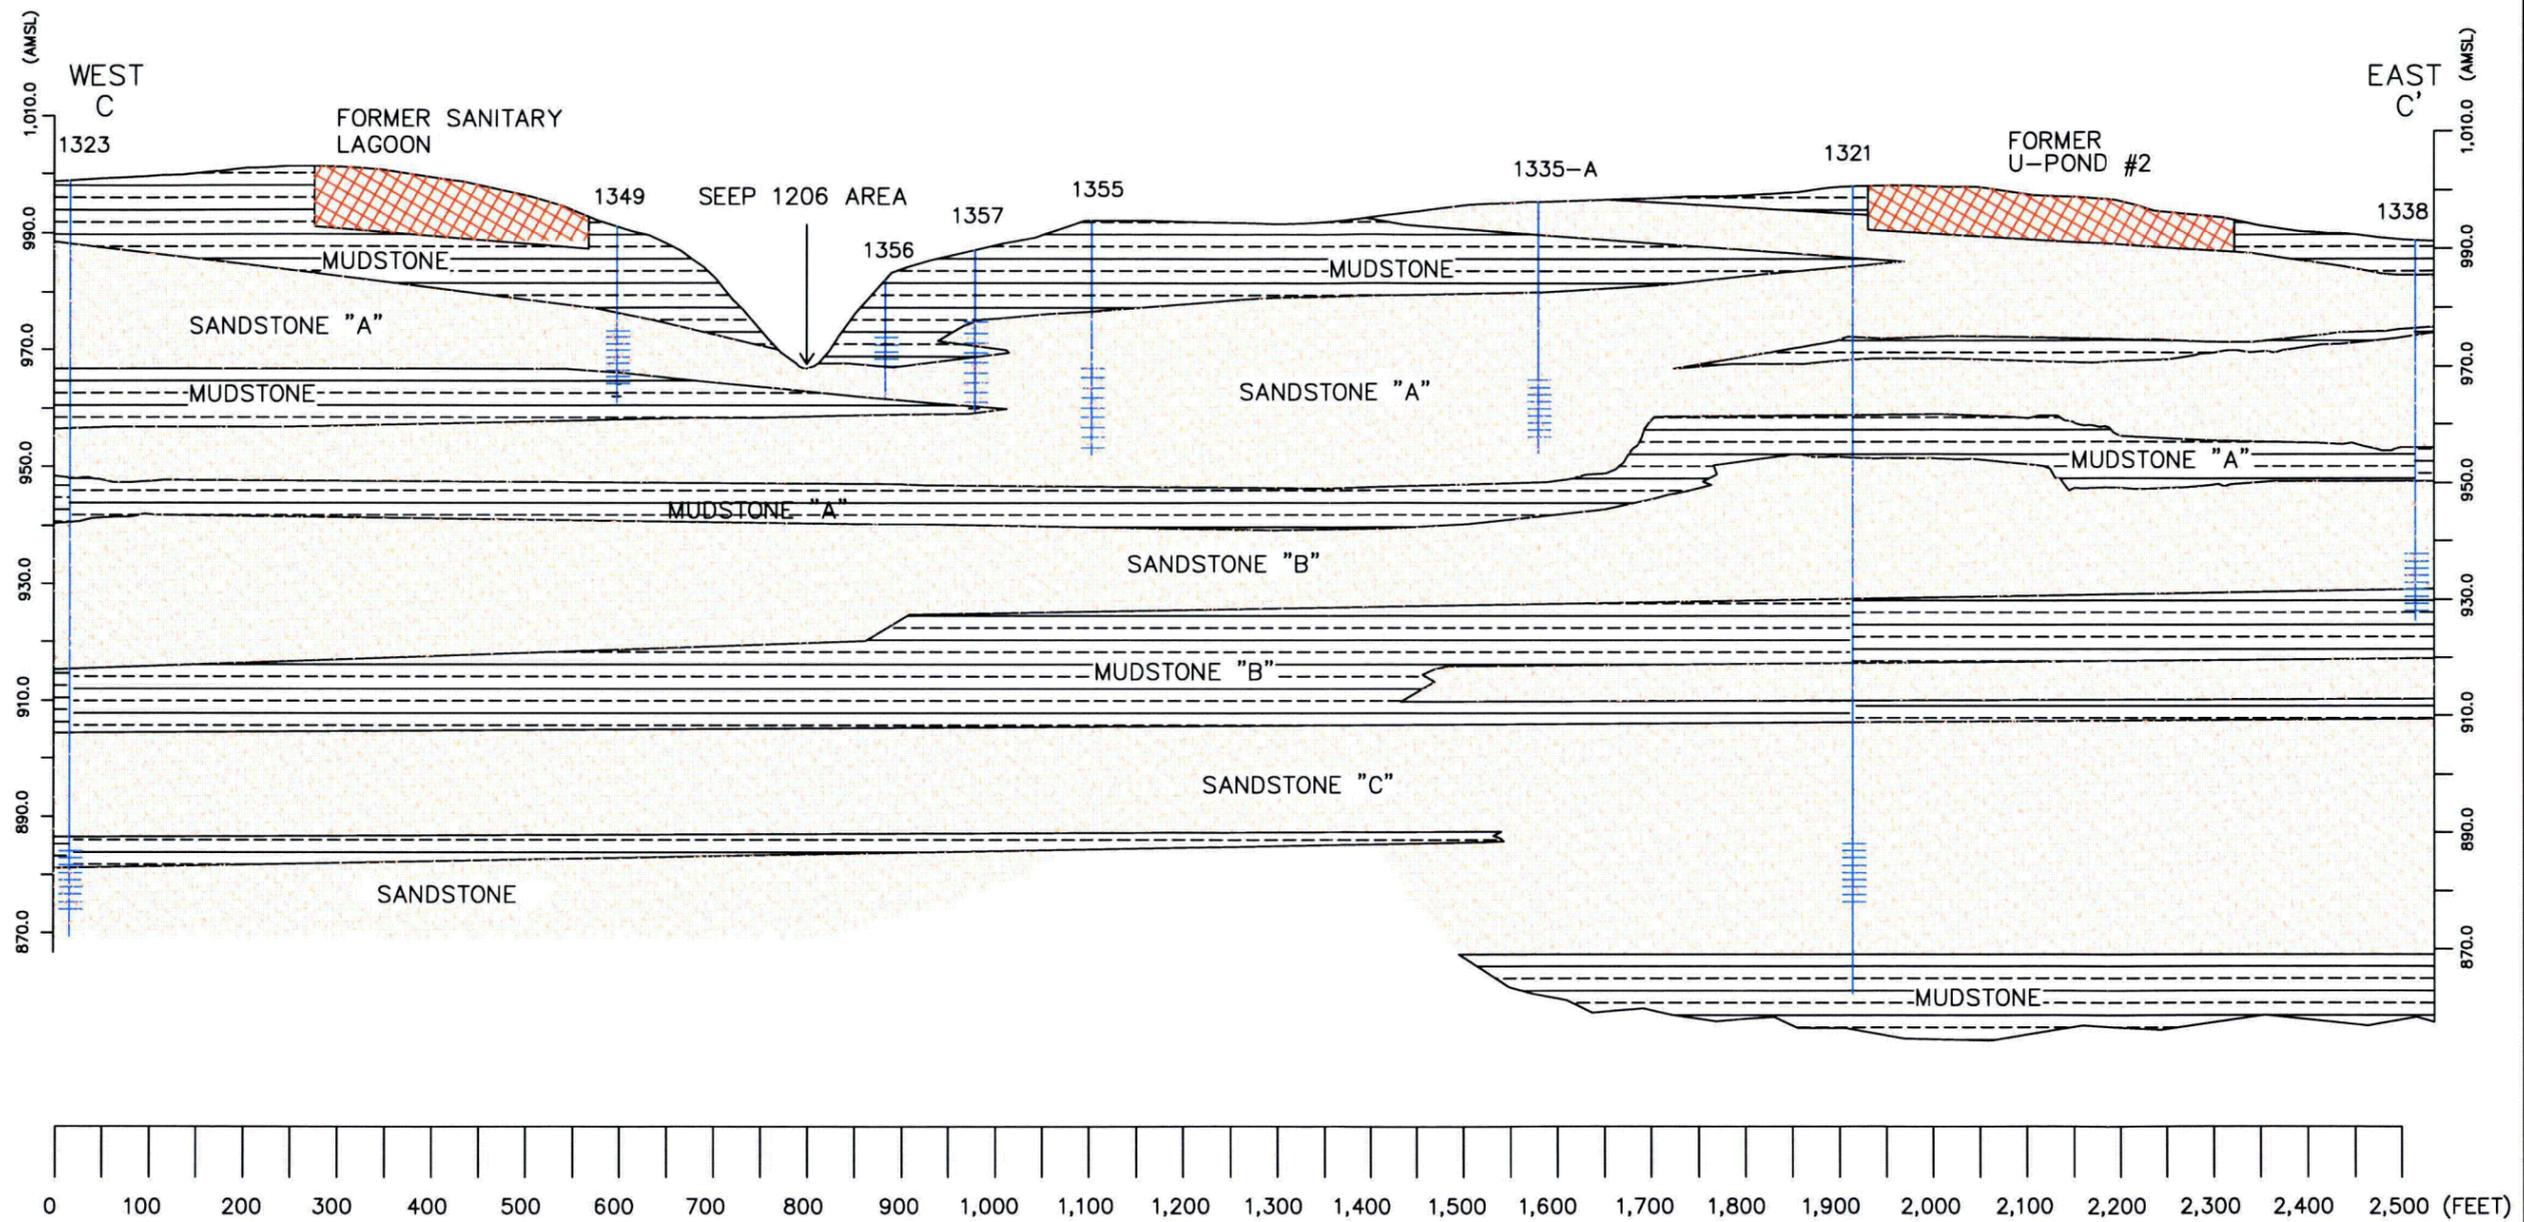
FIGURE NUMBER:  
2-10  
SHEET NUMBER:  
1

FIGURE 2-10  
GEOLOGICAL CROSS SECTION C-C'  
SANITARY LAGOON TO U-POND #2 AREA  
CIMARRON CORPORATION  
CRESCENT, OKLAHOMA  
SCALE: 1" = 190'  
DATE: 8/10/05  
PROJECT NUMBER: 04020-044-200

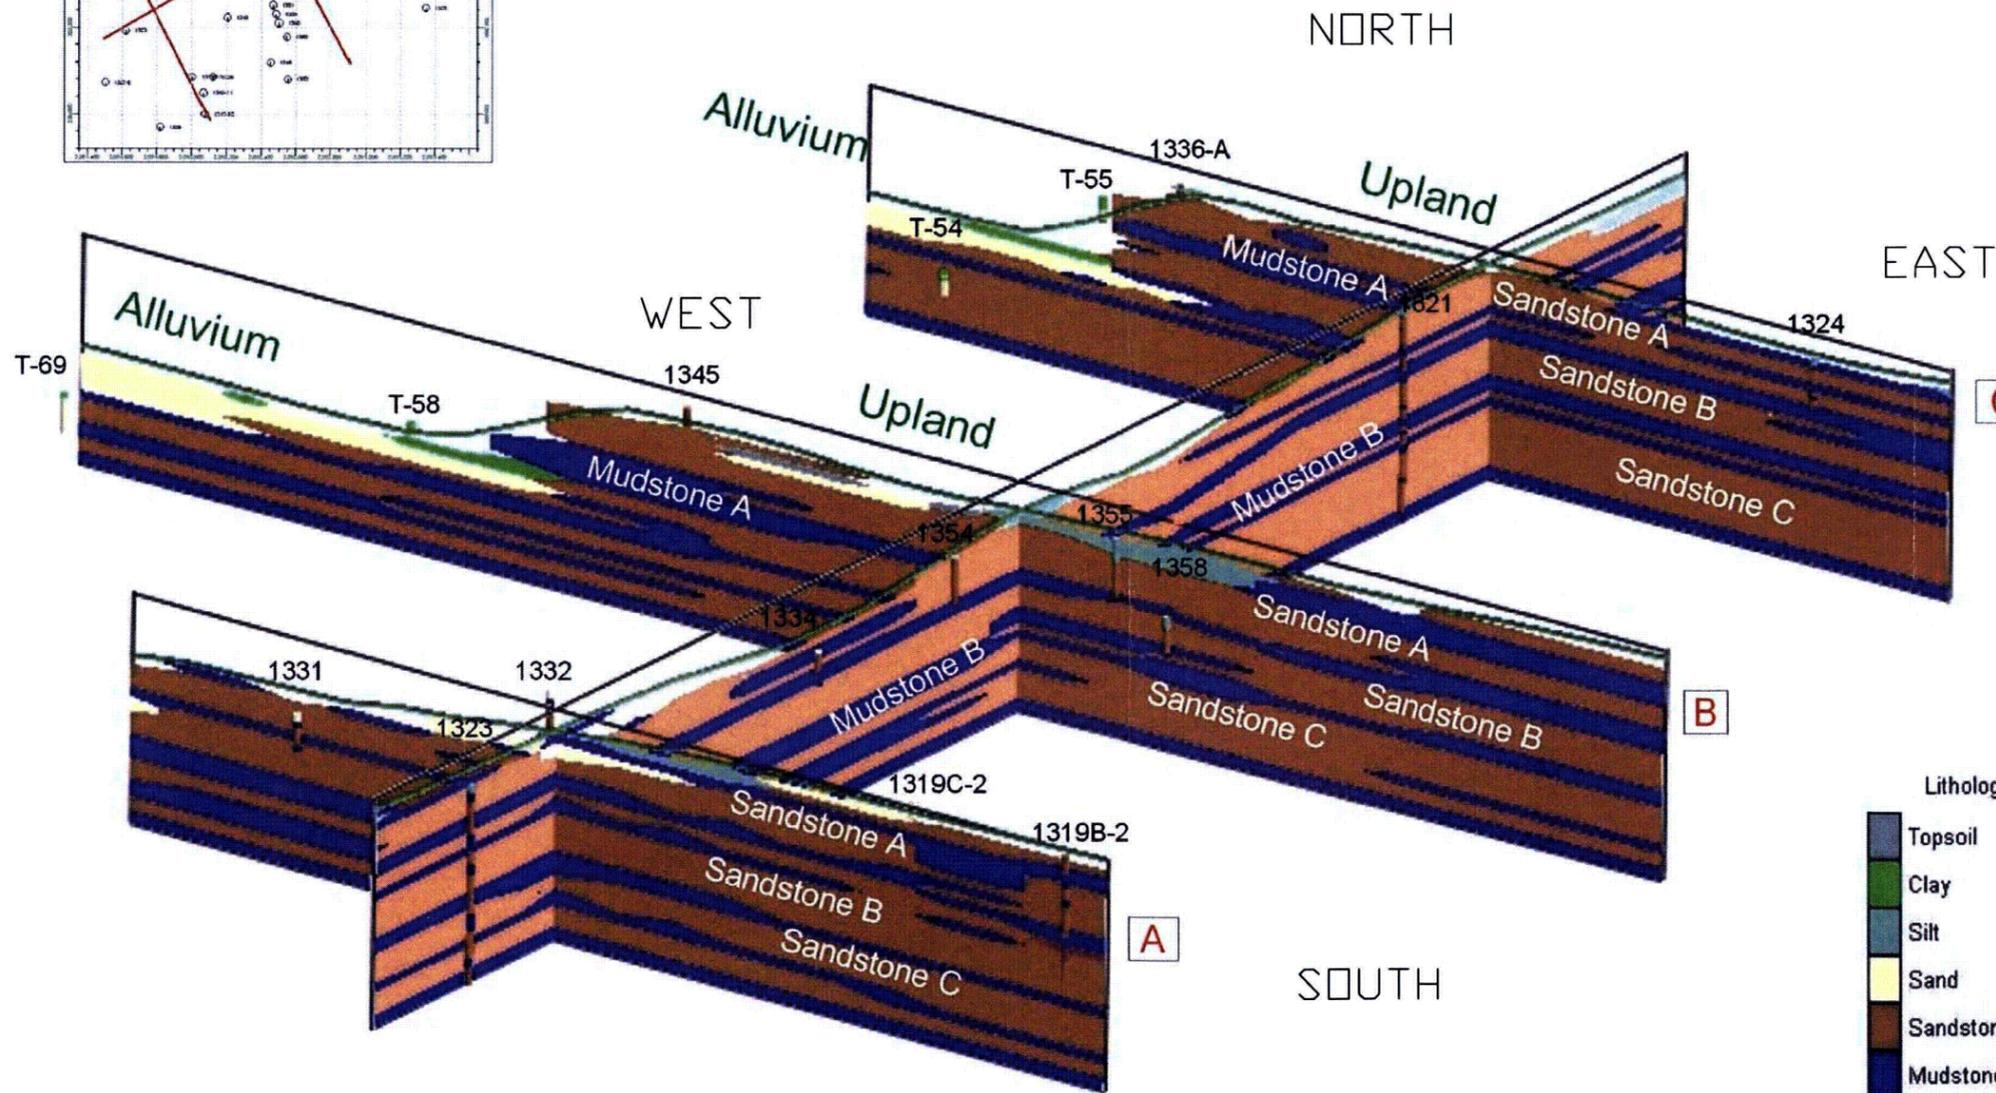
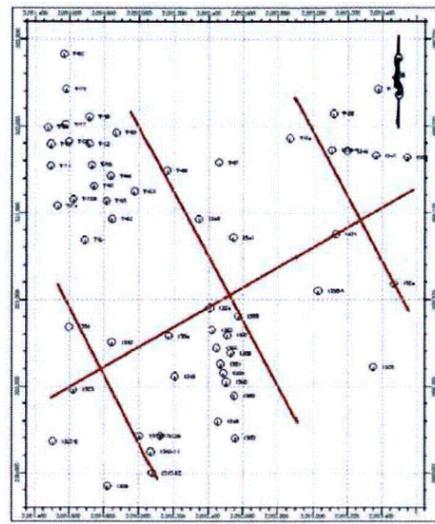
WESTERN UPLAND AND ALLUVIUM  
AREA FENCE DIAGRAM LOCATION LAYOUT  
(SEE WITH FIGURE 2-8 TO IDENTIFY  
INDIVIDUAL MONITOR WELLS)
