# Characterization of Slag and Related Materials in the Storage Yard

**Shieldalloy  
Metallurgical Corp.  
Newfield, NJ**

January 2009

**DECOMMISSIONING PLAN  
SHIELDALLOY METALLURGICAL CORPORATION  
NEWFIELD, NEW JERSEY**

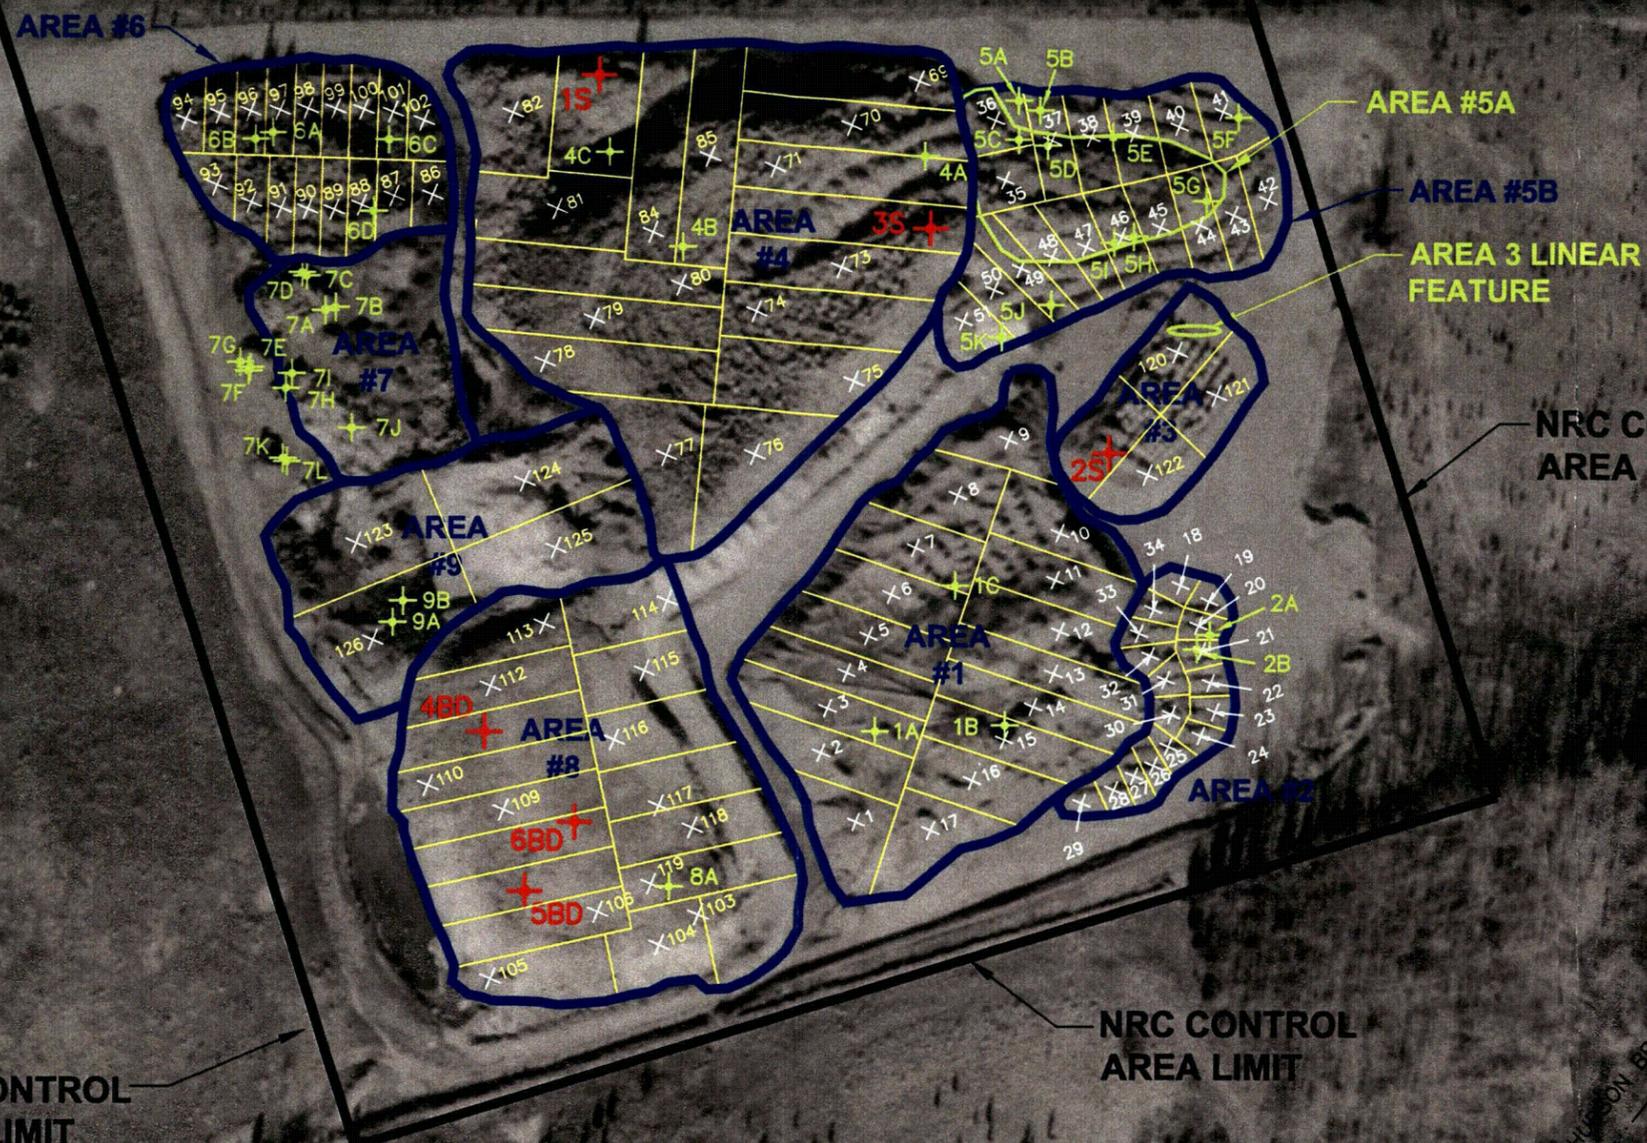
**NOTE:**  
 IN ADDITION TO THE INITIAL TEST SAMPLE LOCATIONS SHOWN IN RED, GRID-BASED SAMPLE 88 IN AREA 6 WAS ALSO BE SELECTED FOR INITIAL TESTING.

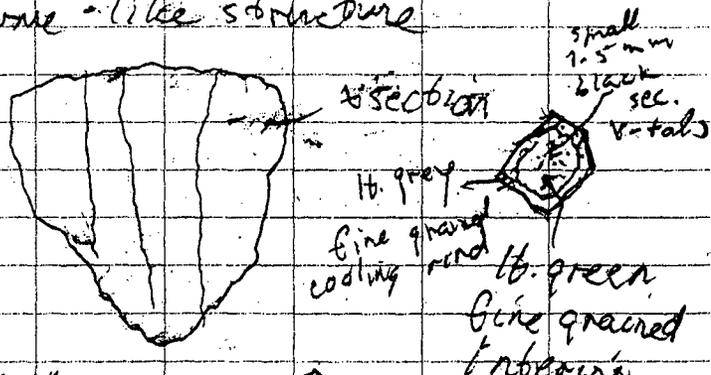
Find hexagonal-shaped slag  
which tapers to a 1-2" diameter  
on one end & 4-8" diameter on  
the other end. The hexagonal slag  
structures are contained w/in a larger  
dome-like structure

This "path" makes up  $\approx 5\%$  of entire Area 4 pile.  
1620 Collected sample of  
Hexagonal material #4-A
