Indian Point Energy Center

Daily Status Report

January 10, 2006

Indian Point Tritium Investigation

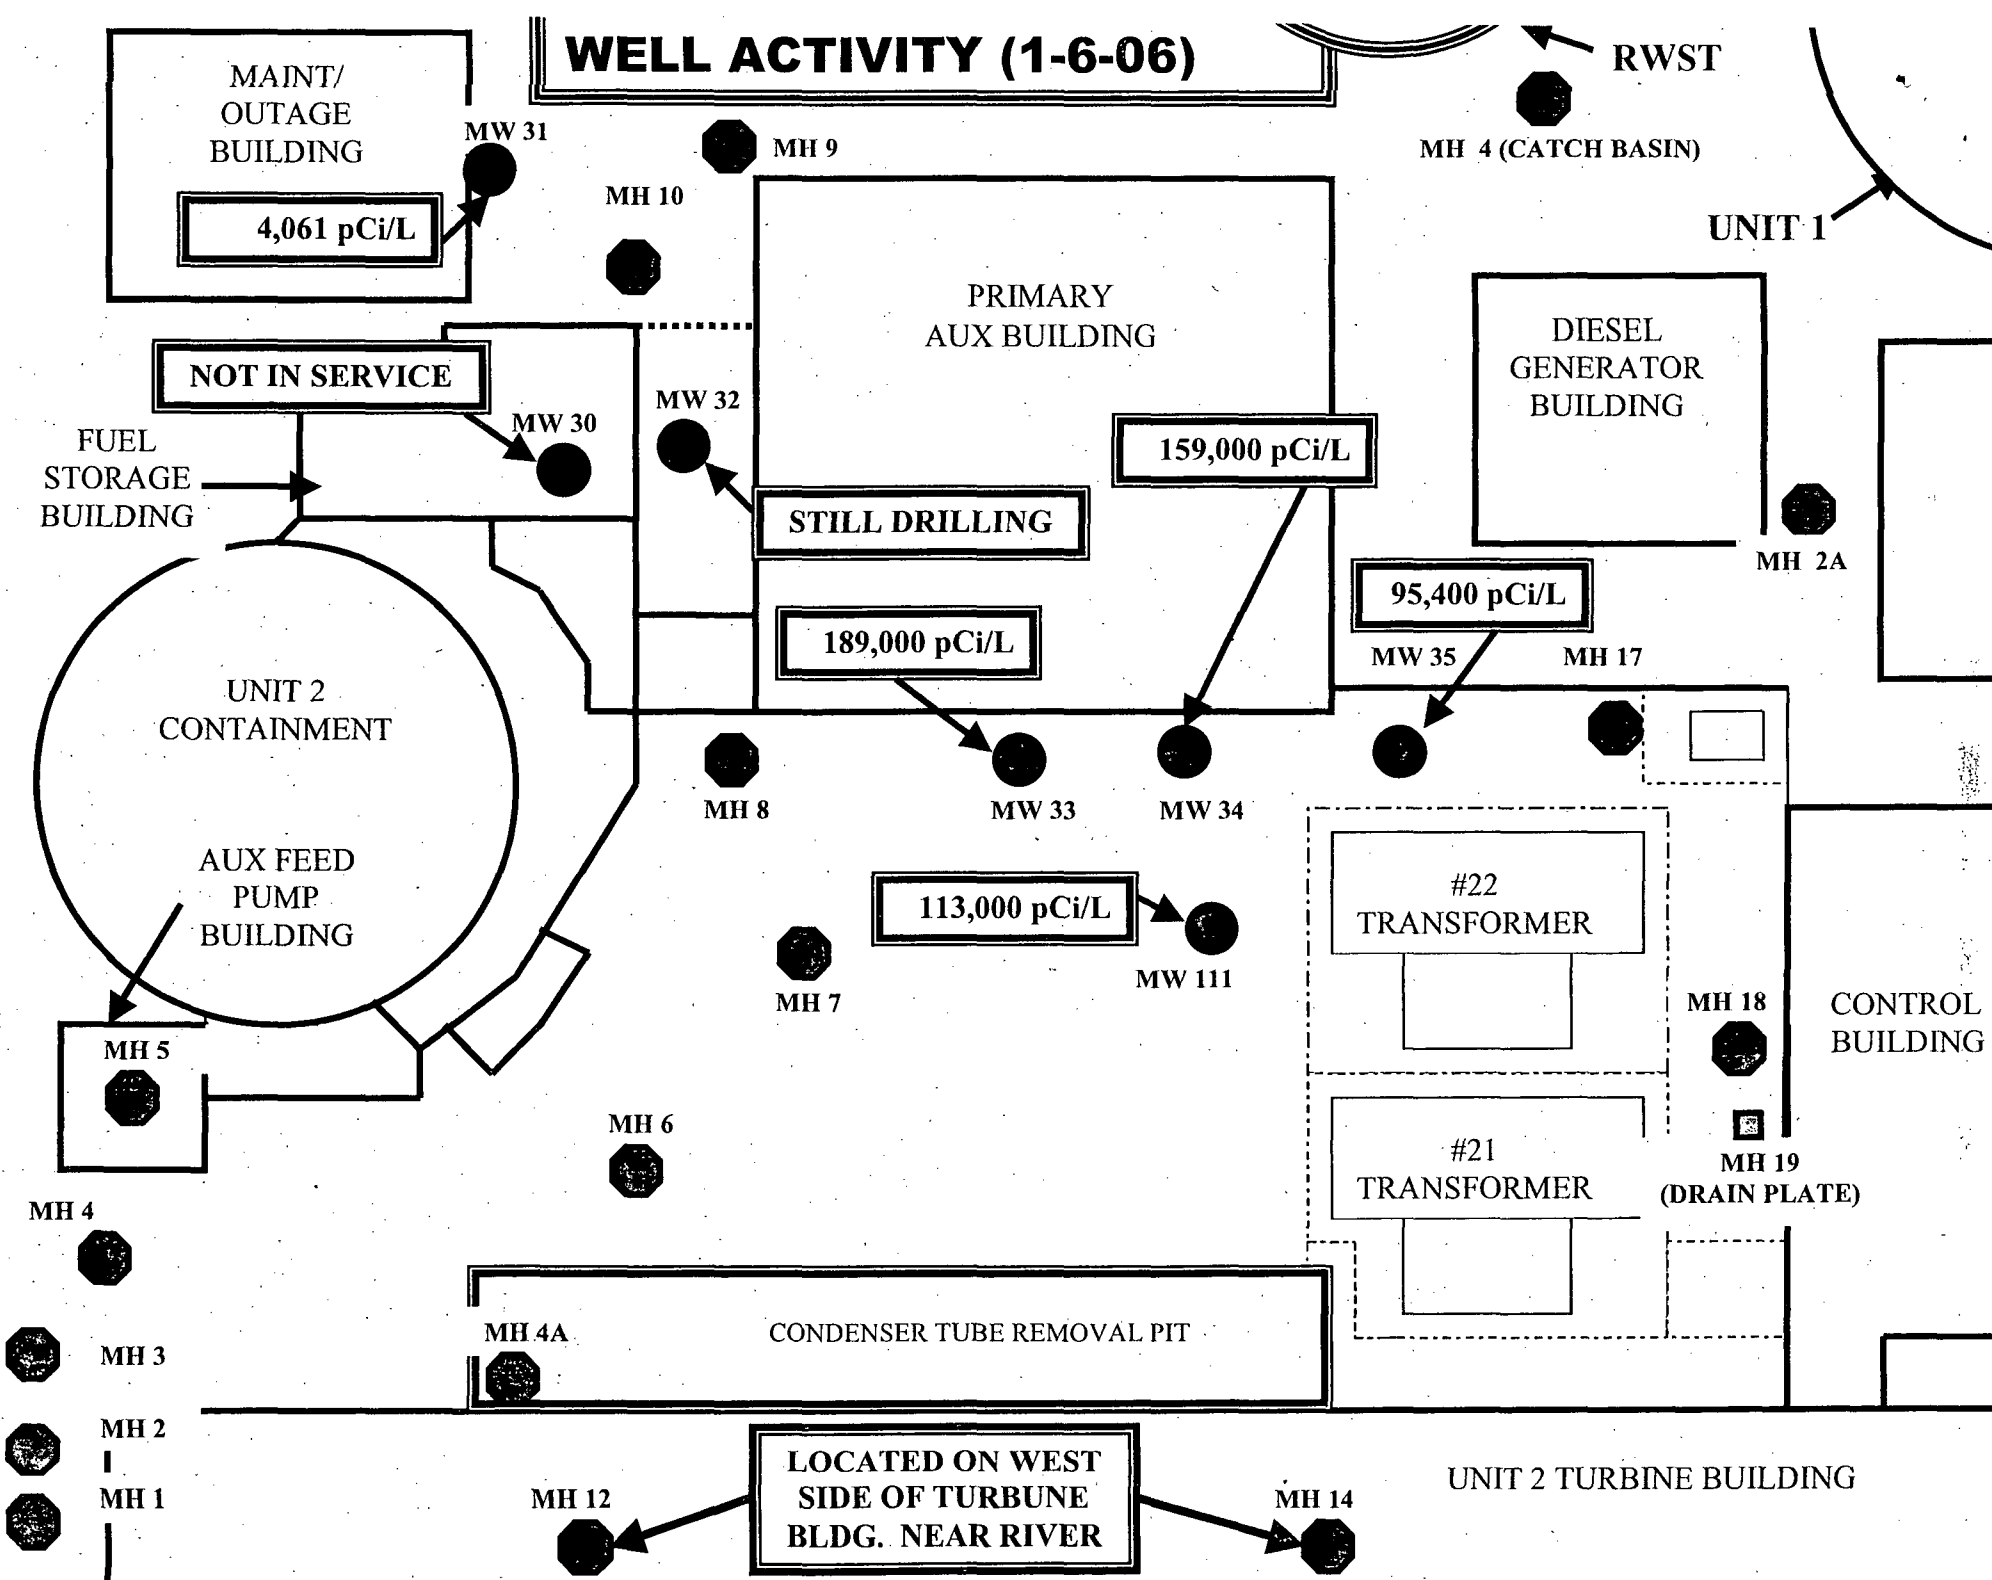
WELL ACTIVITY (1-6-06)

Test results from a number of sample locations in the storm drainage system on site have been obtained. The tritium investigation was expanded to include these sample sites as well as existing and new test wells. Sample locations are shown on the attached map.

The most recent test results (1/4/06) range from less than minimum detectable activity (MDA) along the riverfront to 13,100 pCi/L at MH-6 in the IP2 transformer yard. Generally, the higher readings are in the IP2 transformer yard (3,000-13,000 pCi/L) with lower levels on the south end of the site near IP3. The results follow the same general trend as the monitoring wells.
