**Rancho Seco**

**Final Status Survey Summary Report**

**0' Auxiliary Steam Support, Class 1 Area**

**Survey Unit F8132133**

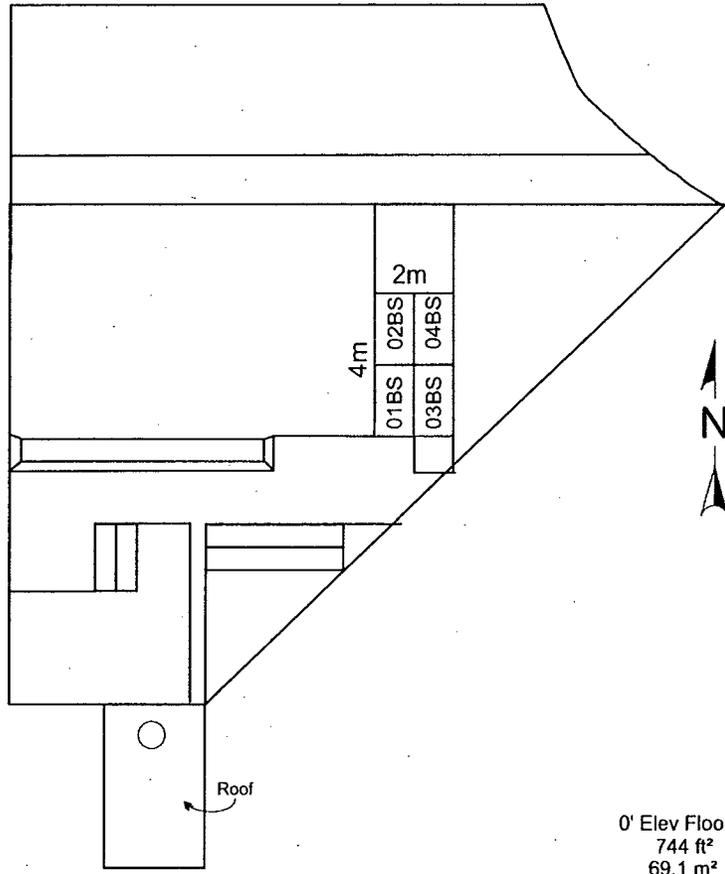
F8132133 - M1

F8132133 - Beta Scans

0'-0" ELEV. Auxiliary Steam Supports

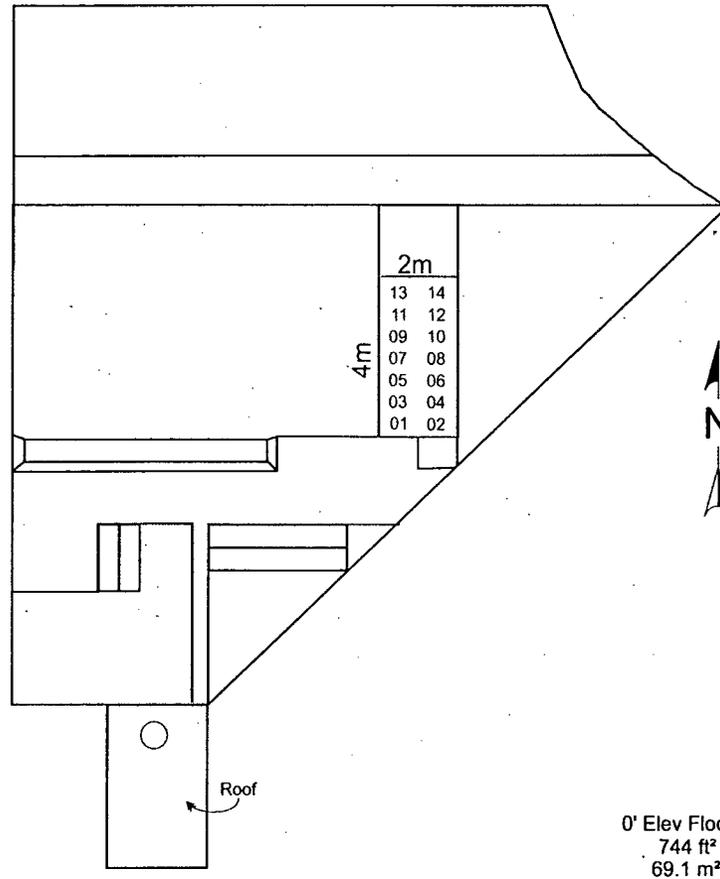
F8132133 - M2

F8132133 - Beta Direct

Gamma Backgrounds are obtained from the beta direct points 1 through 10 in order.

0'-0" ELEV. Auxiliary Steam Supports

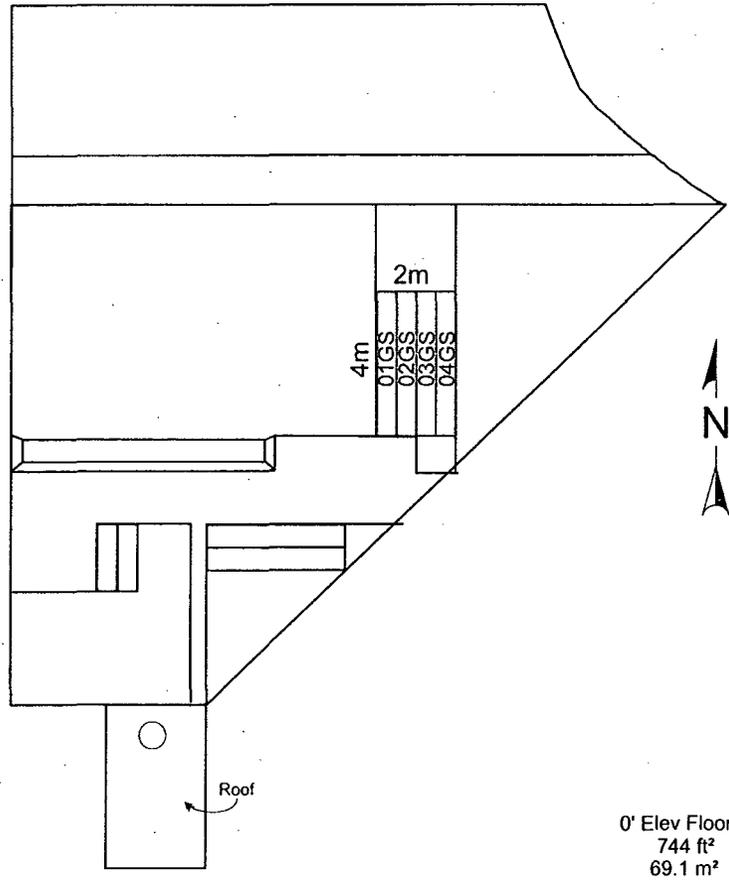
F8132133 - M3

F8132133 - Gamma Particle Scans

0' Elev Floor  
744 ft<sup>2</sup>  
69.1 m<sup>2</sup>

0'-0" ELEV. Auxiliary Steam Supports
