FIGURE 6
PLAN OF RECLAIMED
LARGE TAILING IMPOUNDMENT

HOMESTAKE MINING COMPANY
OF CALIFORNIA
GRANTS OPERATION

Prepared by:
AK GeoConsult, Inc.
Rev. 10/93

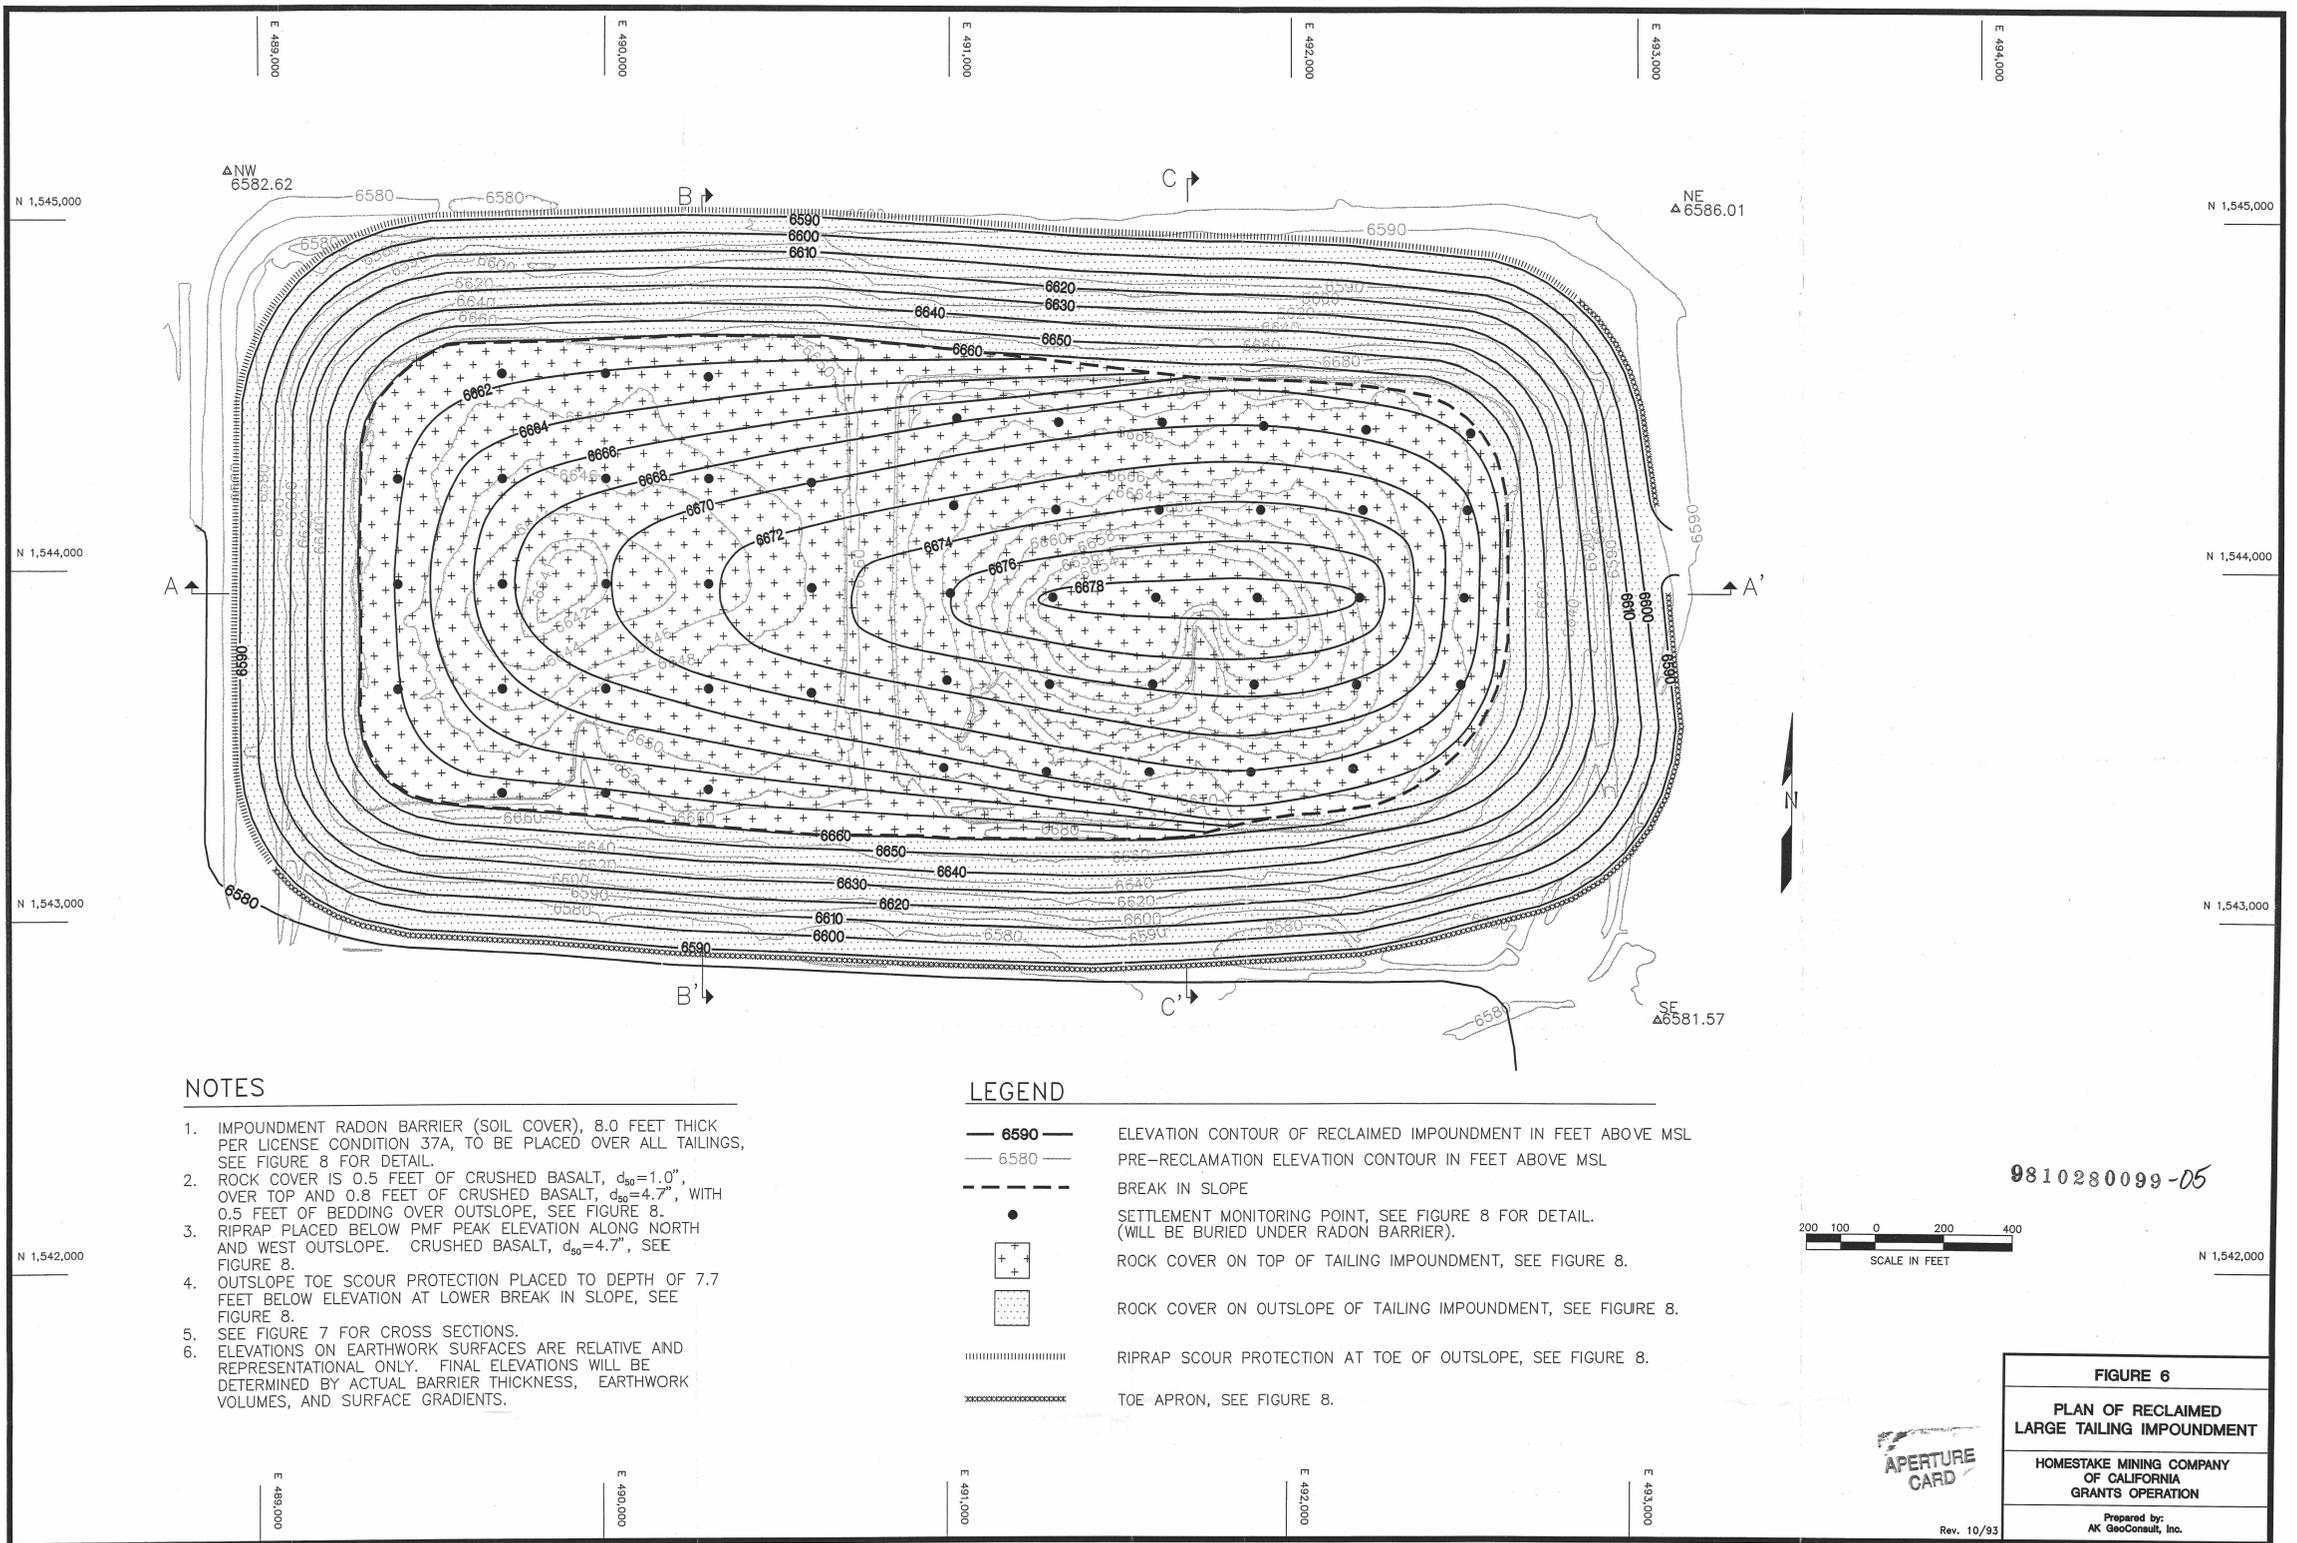
1. IMPOUNDMENT RADON BARRIER (SOIL COVER), 8.0 FEET THICK PER LICENSE CONDITION 37A, TO BE PLACED OVER ALL TAILINGS, SEE FIGURE 8 FOR DETAIL.
2. ROCK COVER IS 0.5 FEET OF CRUSHED BASALT, $d_{50}=1.0"$, OVER TOP AND 0.8 FEET OF CRUSHED BASALT, $d_{50}=4.7"$, WITH 0.5 FEET OF BEDDING OVER OUTSLOPE, SEE FIGURE 8.
3. RIPRAP PLACED BELOW PMF PEAK ELEVATION ALONG NORTH AND WEST OUTSLOPE. CRUSHED BASALT, $d_{50}=4.7"$, SEE FIGURE 8.
4. OUTSLOPE TOE SCOUR PROTECTION PLACED TO DEPTH OF 7.7 FEET BELOW ELEVATION AT LOWER BREAK IN SLOPE, SEE FIGURE 8.
5. SEE FIGURE 7 FOR CROSS SECTIONS.
6. ELEVATIONS ON EARTHWORK SURFACES ARE RELATIVE AND REPRESENTATIONAL ONLY. FINAL ELEVATIONS WILL BE DETERMINED BY ACTUAL BARRIER THICKNESS, EARTHWORK VOLUMES, AND SURFACE GRADIENTS.
