8.0 Burial Area #2 and North Field Drainage Area

CIMARRON CORPORATION
 CIMARRON FACILITY
 BURIAL GROUND NO. 2
 PRE-REMEDIATION SOIL SAMPLE RESULTS (1990)
 SOIL SAMPLE ALIQUOT: 6" - 1' DEEP
 CLIENT DRAWING NO.

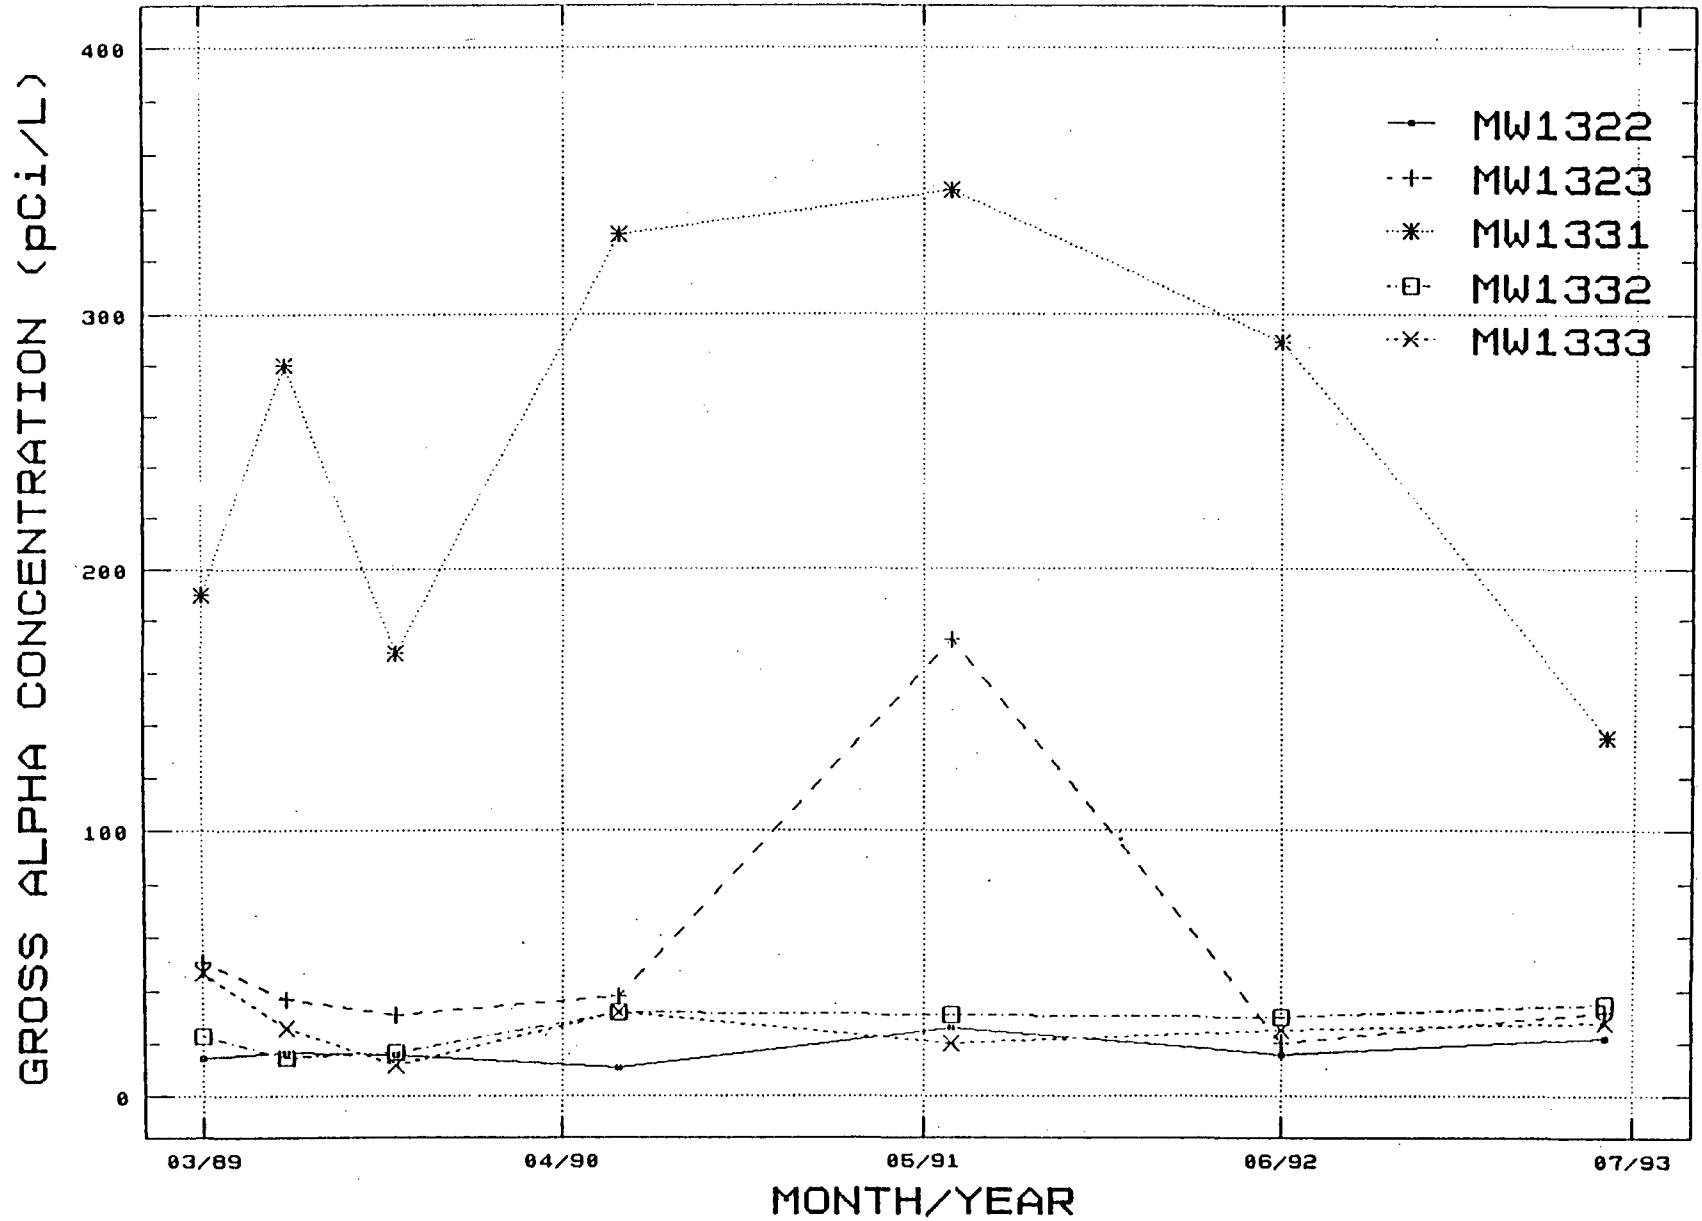
Figure 8.1

Gross alpha concentrations for these five wells are graphed in Figure 8.1. "Less than" values are plotted in figures at the upper bound concentration. Concentrations ranged from 11 pCi/L at well

KERR MCGEE--CIMARRON--GROSS ALPHA
WELLS 1322, 1323, 1331, 1332, AND 1333

#1322 in June, 1990 to 347 pCi/L in well #1331 in June, 1991. Gross alpha activity remained low throughout the 1989 through 1993 monitoring period at wells #1322, #1332, and #1333. Well #1323 peaked at 172 pCi/L in June, 1991, then decreased to near background in 1992 and 1993. Well #1331 remained elevated throughout the 1989 to 1993 monitoring periods.

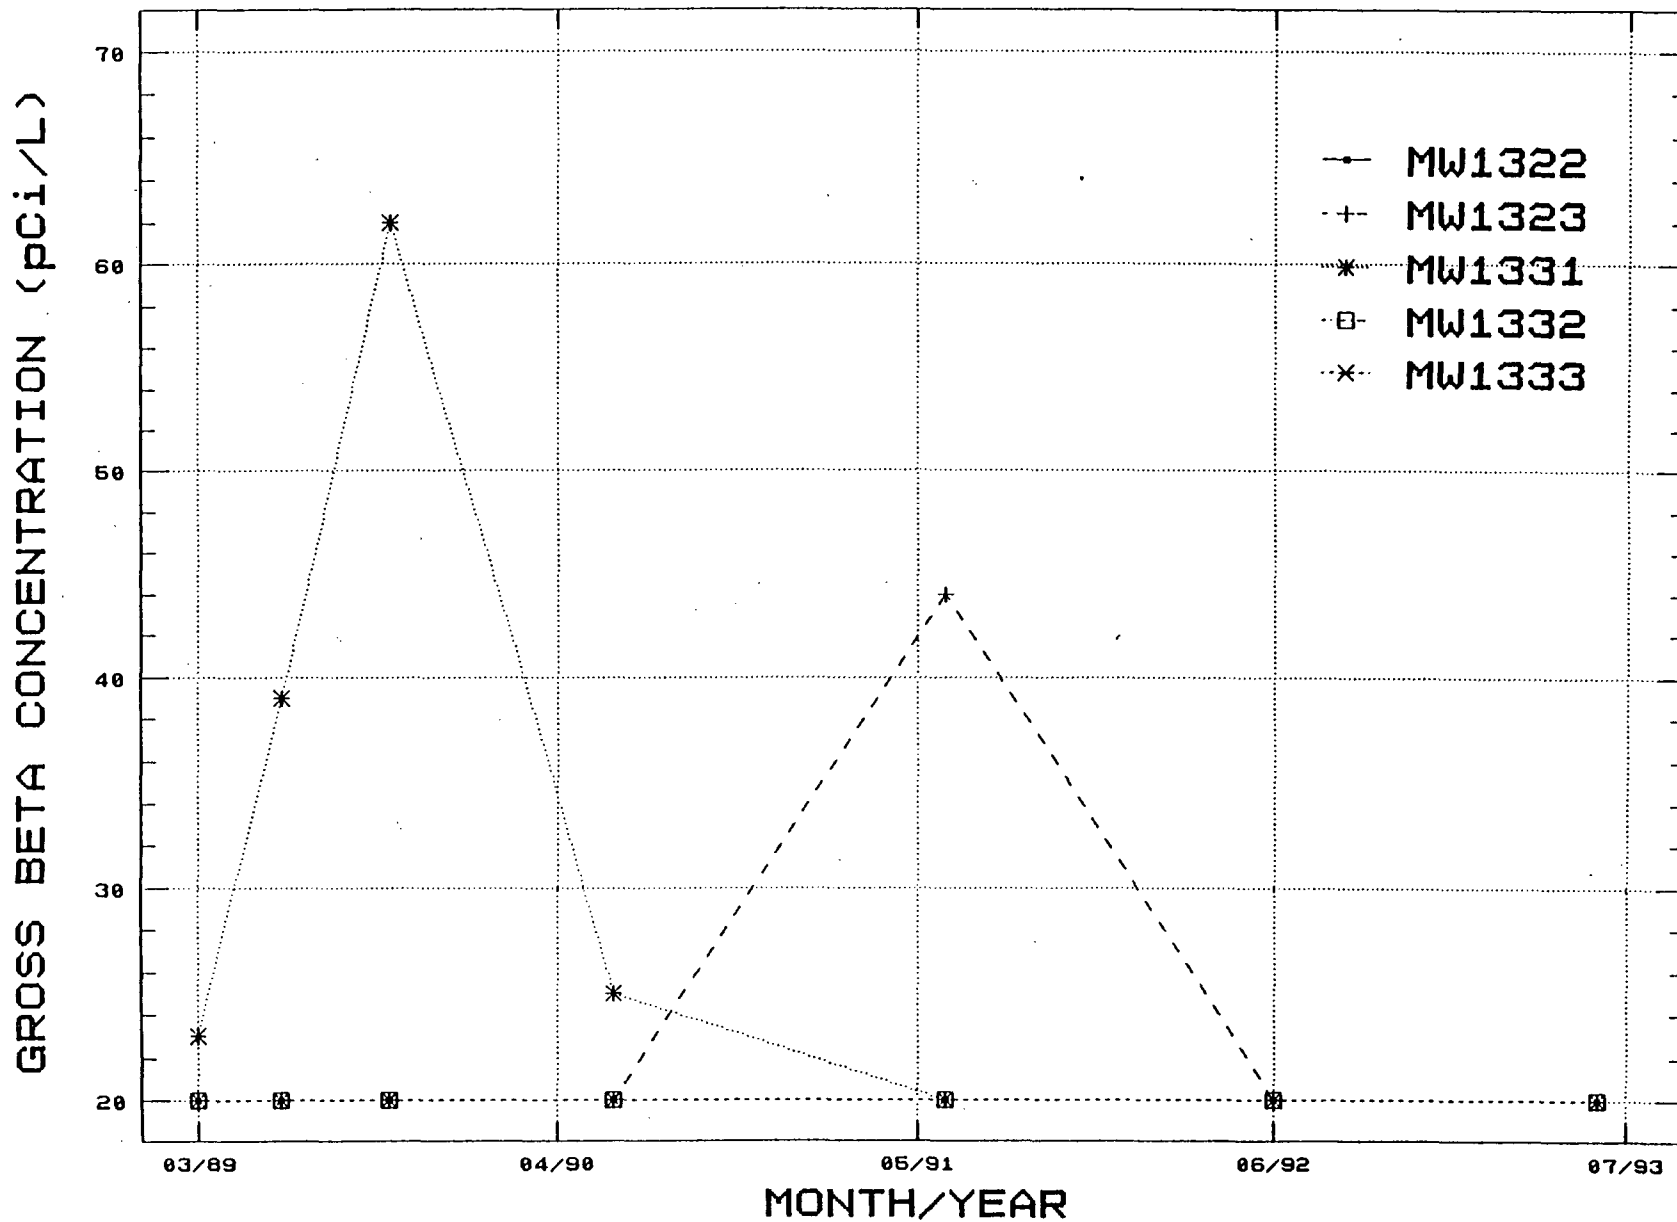
Figure 8.2 shows gross beta concentrations for wells #1322, #1323, #1331, #1332, and #1333. Concentrations were less than detectable or near background in wells #1322, #1323, #1332, and #1333. A maximum concentration of 62 pCi/L was observed in well #1331 (October, 1989). Concentrations in well #1331 decreased to less than detectable for the 1992 and 1993 monitoring periods.

KERR MCGEE--CIMARRON--GROSS BETA
WELLS 1322, 1323, 1331, 1332, AND 1333

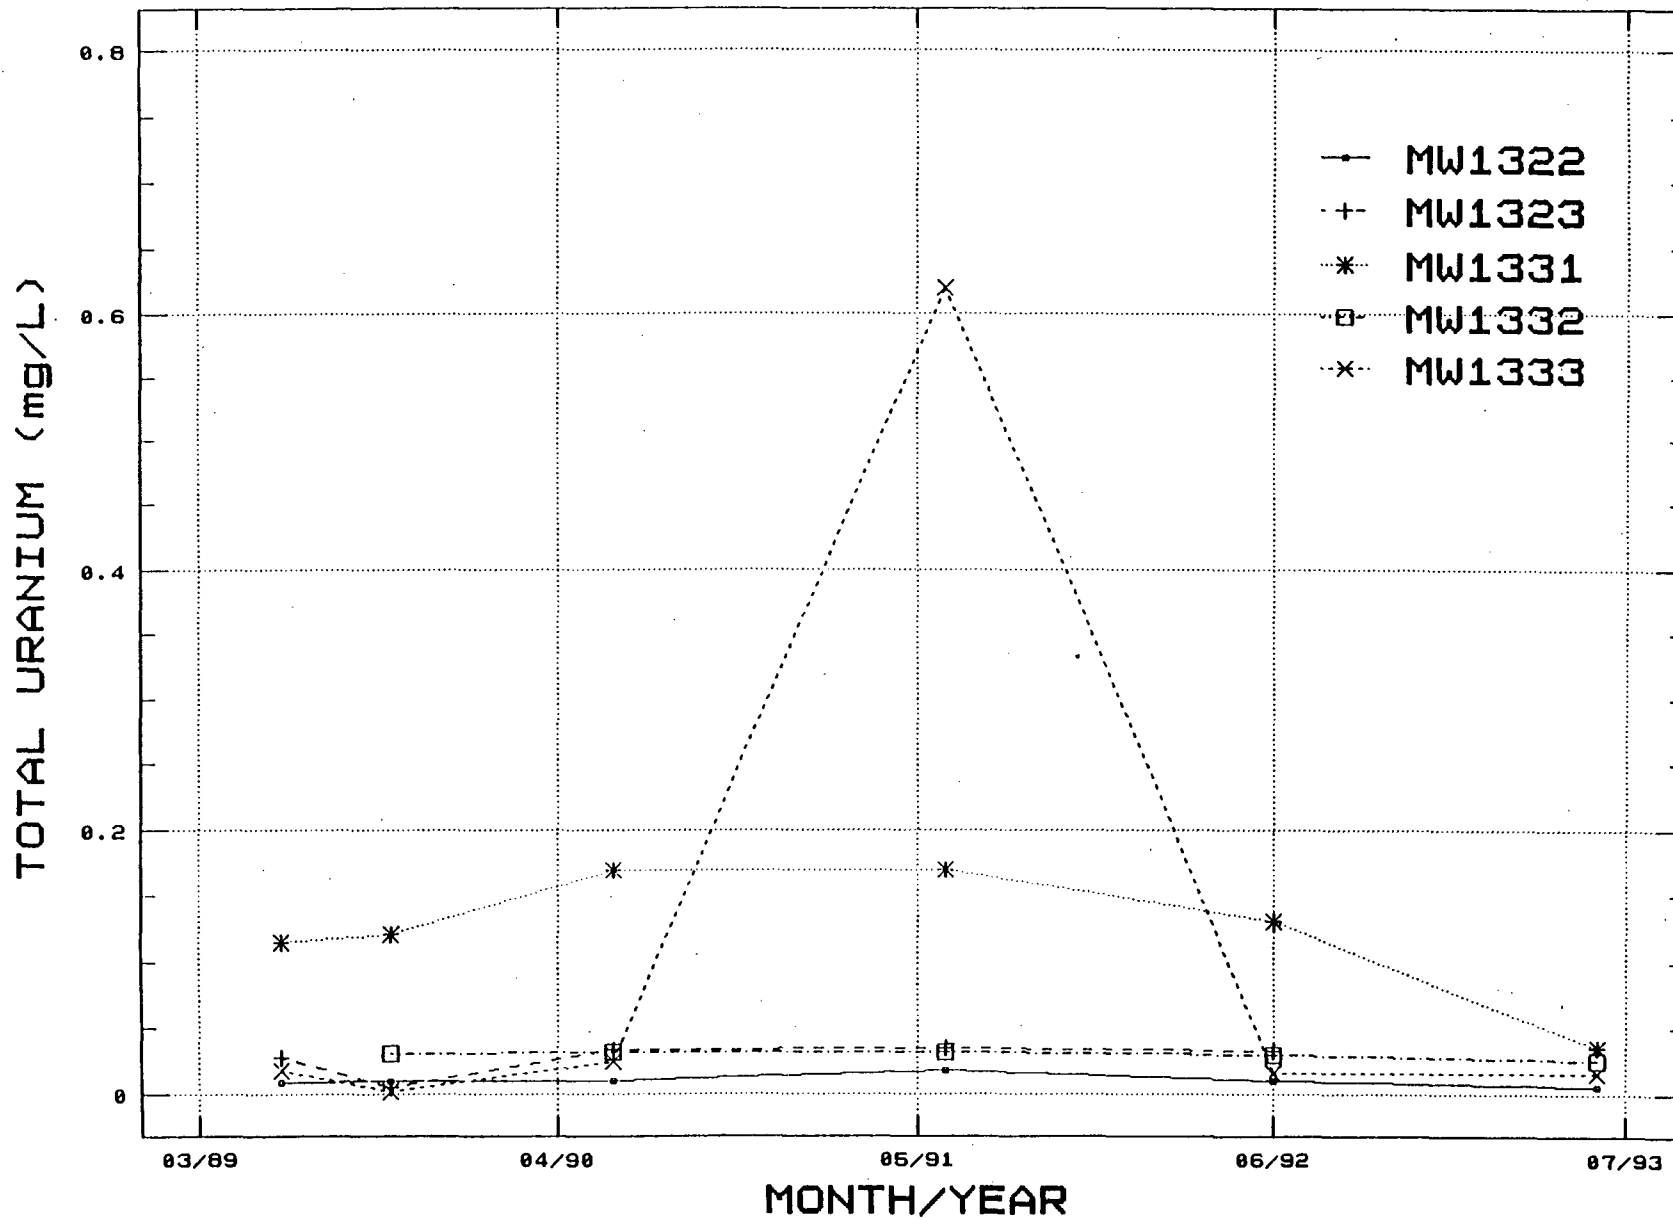
Figure 8.3

Graphs of total uranium activity versus time are shown in Figure 8.3. Total uranium reportedly ranged from less than 0.005 mg/L to 13.1 mg/L (well #1332, October, 1989). This value is suspect due to the reported isotopic uranium and gross alpha data. The result given for March, 1989 at well #1332 is also suspect. Total uranium data for other samples are reasonably consistent with results obtained via alpha spectroscopy. Total uranium in well #1331 appears to be trending toward background concentrations as of the 1993 monitoring period.

KERR MCGEE--CIMARRON--TOTAL URANIUM
WELLS 1322, 1323, 1331, 1332, AND 1333

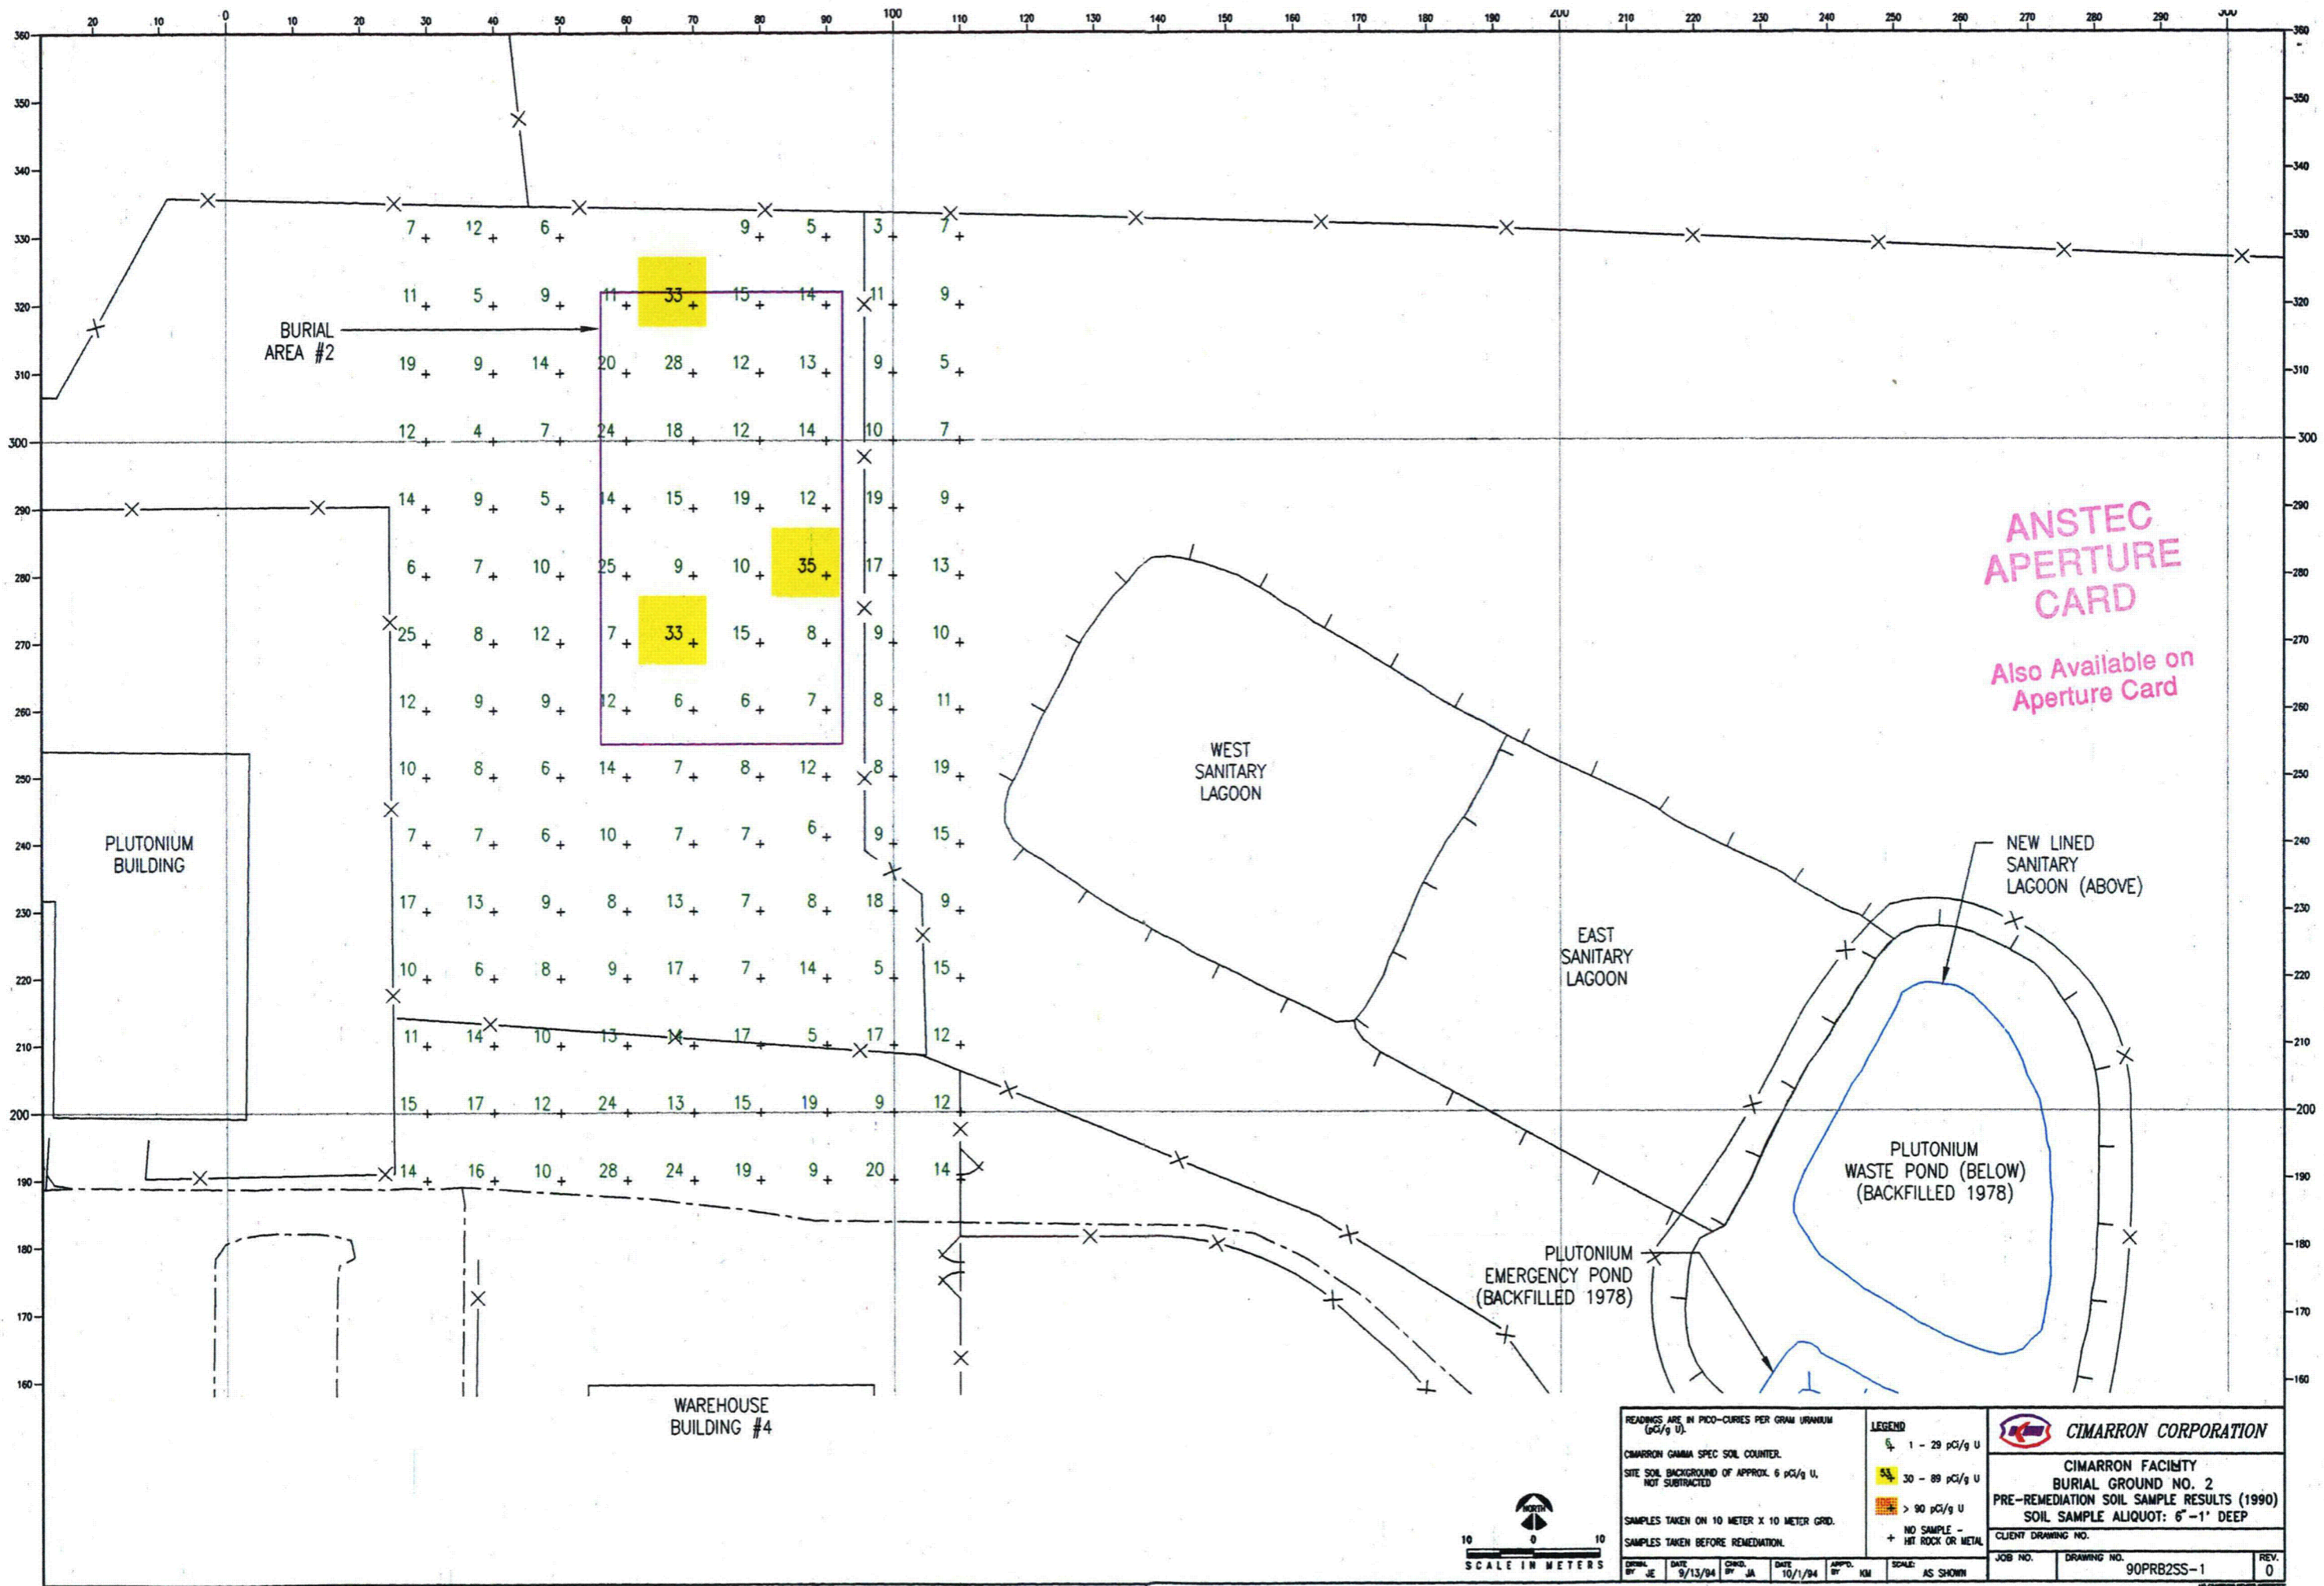
JOB NO. DRAWING NO. REV. 0
 90PRB2SS-1

Composited soil samples were collected in May, 1990 on the 10m x 10m grid at depths of 0 to 4 feet in one-foot intervals. The soil samples were analyzed at the Cimarron facility laboratory for total uranium. The sample results, shown on Drawings No. 90PRB2SS-0 through 90PRB2SS-4, indicated several areas requiring remediation. Fifteen soil samples had concentrations greater than the guideline value of 30 pCi/g total uranium (the highest being 373 pCi/g total uranium). As a result, a 5m x 5m grid was established for this same area and sampled to a depth of 6 feet. The samples were collected in one-foot increments and composited for analysis at the Cimarron Facility laboratory. The soil sample results are shown on Drawings No. 91PRB2SS-1 through 91PRB2SS-6. These soil samples were analyzed also for

total thorium. As noted on the drawings, numerous areas exceeded the guideline value of 30 pCi/g uranium, (4 areas exceeded 1,000 pCi/g). Additionally, a soil sample at grid 75E x 300N (0 to 1 ft. in depth) had a total thorium concentration of 14 pCi/g; 15 pCi/g for a sample from 1 to 2 feet, and 13 pCi/g for a sample from 4 to 5 feet in depth.

READINGS ARE IN PICO-CURIES PER GRAM URANIUM (pCi/g U).
CIMARRON GAMMA SPEC SOIL COUNTER.
SITE SOIL BACKGROUND OF APPROX. 6 pCi/g U, NOT SUBTRACTED.
SAMPLES TAKEN ON 10 METER X 10 METER GRID.
SAMPLES TAKEN BEFORE REMEDIATION.

Remediation in this area began in 1991. Approximately 20,000 ft³ of waste with an average activity of 300 pCi/g uranium was shipped off-site for disposal at a commercial LLRW disposal facility. The 20,000 ft³ of waste contained approximately 47 kg of U-235. Sample results from this area showed uranium present at greater than 5% enrichment and thorium concentrations up to 150 pCi/g. As stated above, these materials were removed and shipped off-site for disposal. Cimarron personnel believe that all Option #4 material has been removed from Burial Area #2. The maximum concentration for enriched uranium Option #4 material is 1000 pCi/g (soluble) and 2500 pCi/g (insoluble). Additionally, Cimarron has excavated the remaining Option #2 material and stockpiled the soil on site for anticipated on-site disposal. A final survey of this area is presently underway.

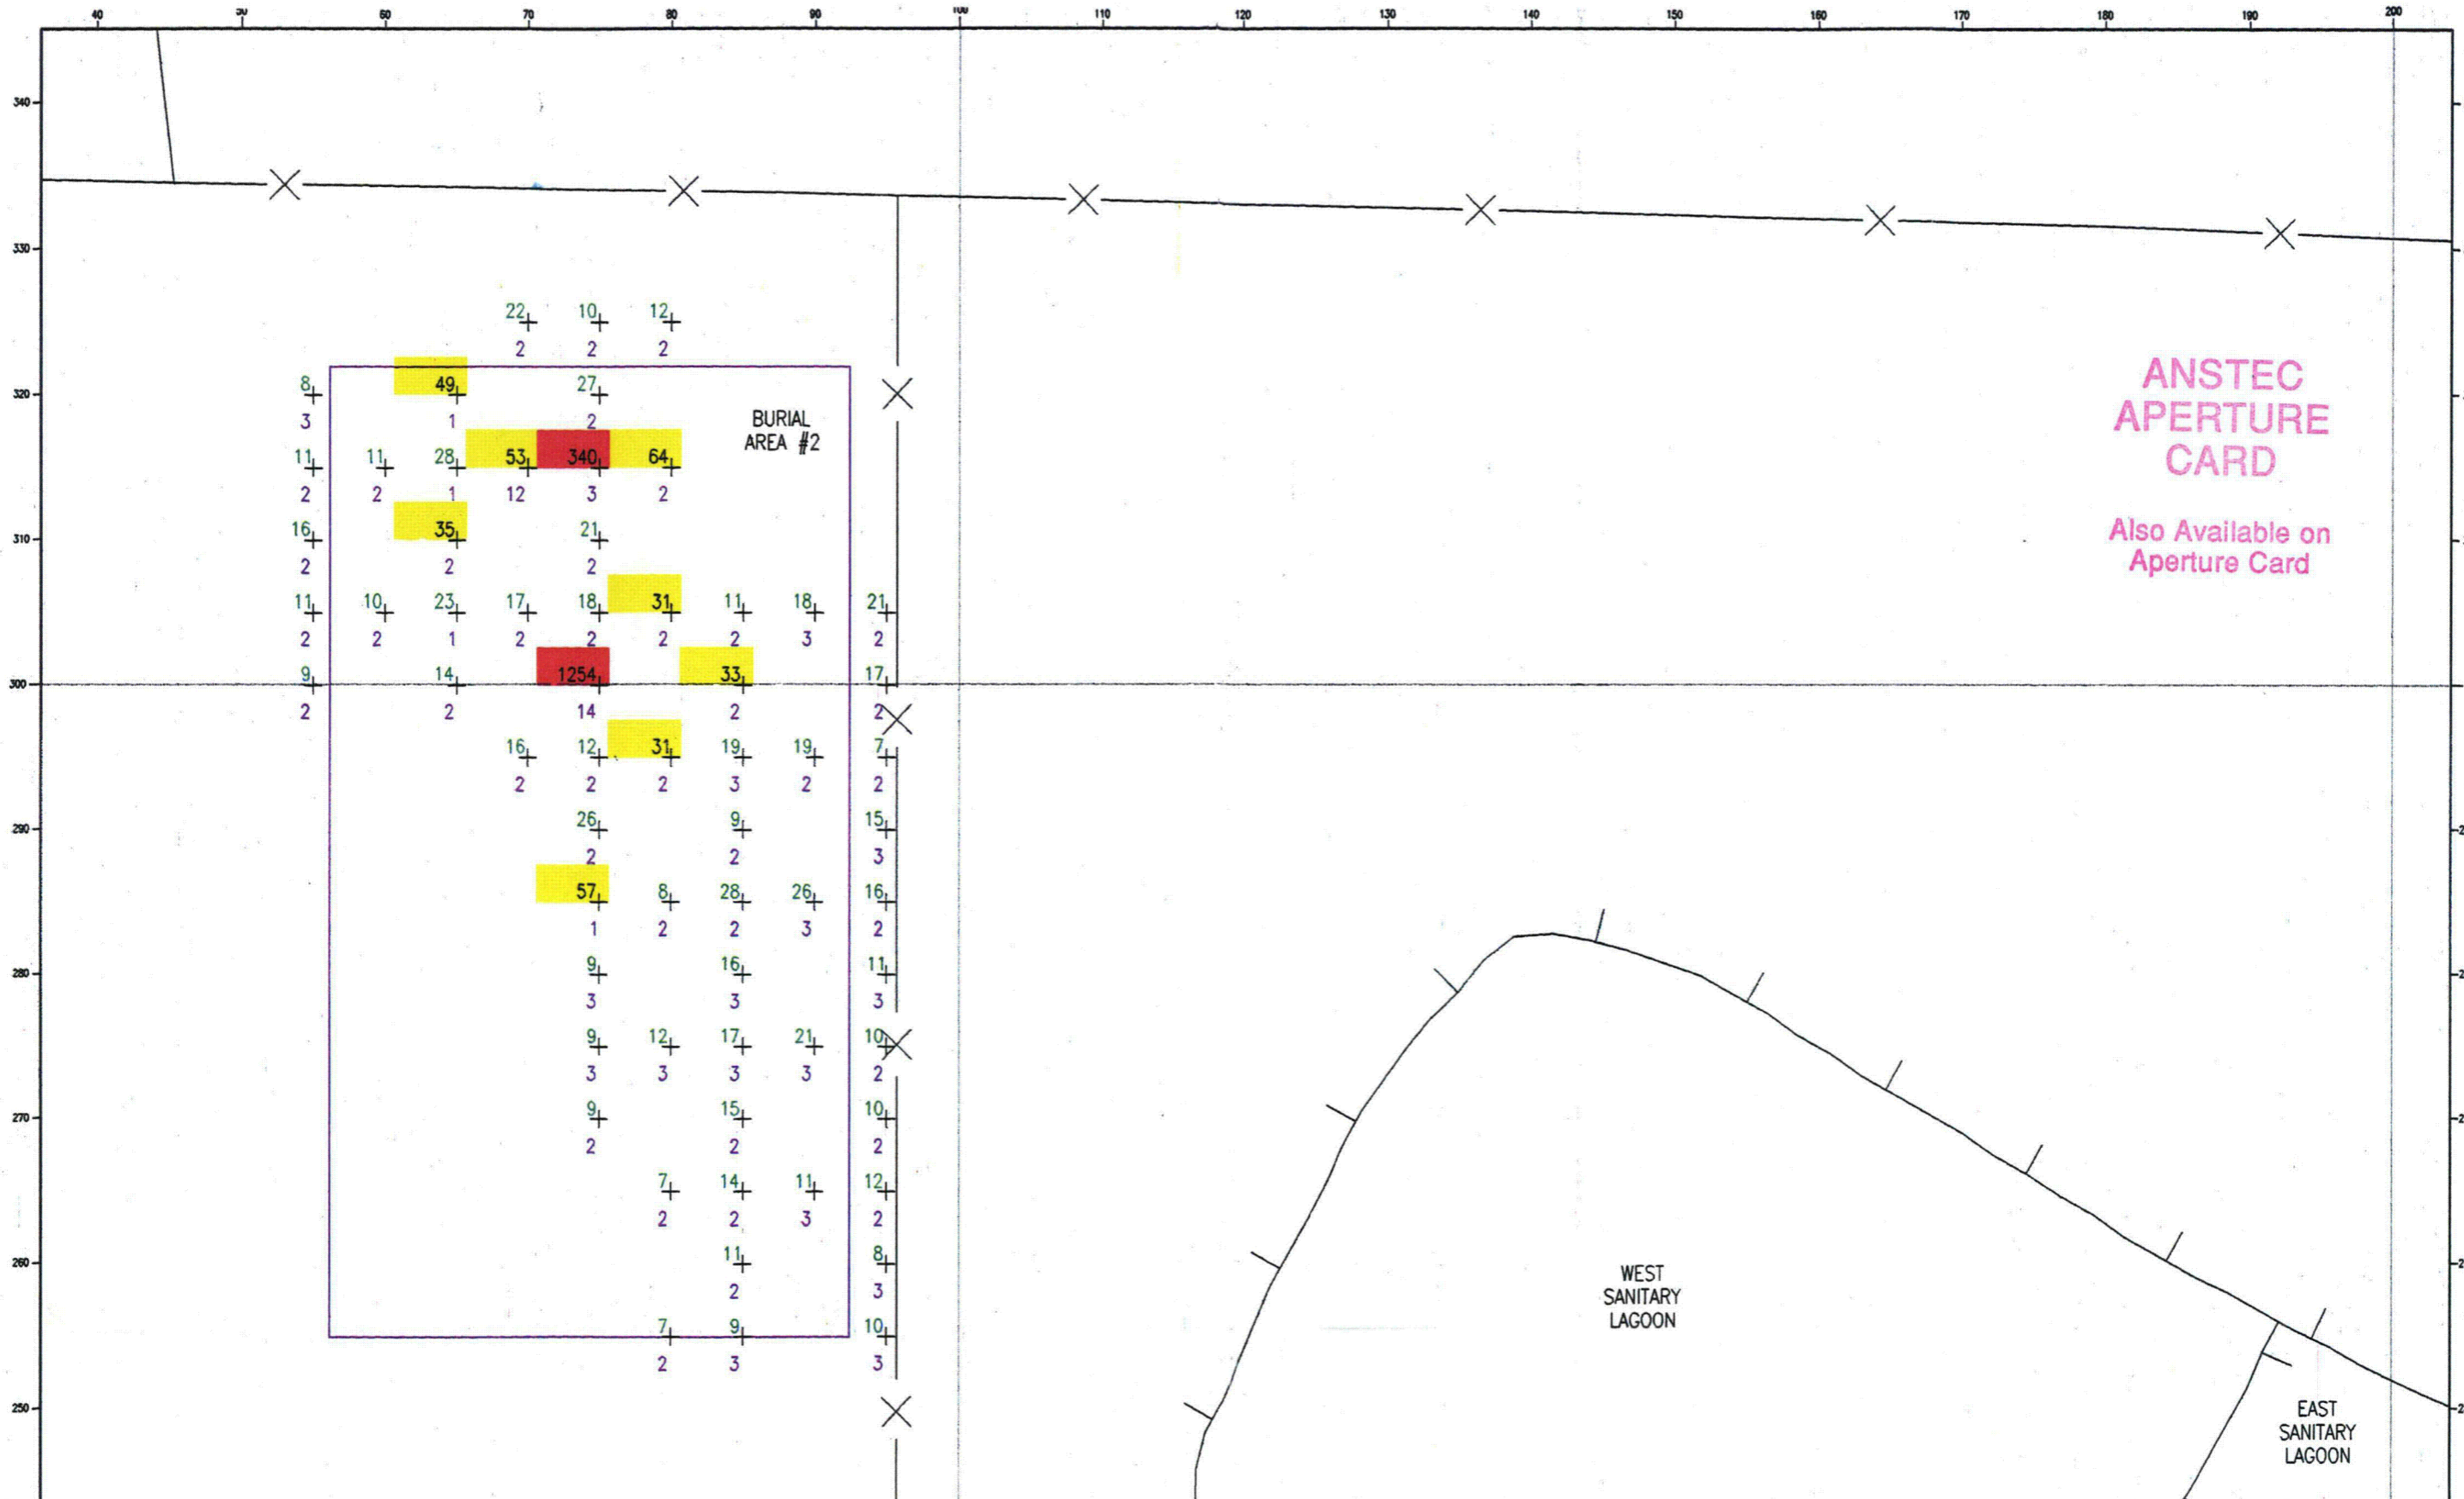
READINGS ARE IN PICO-CURIES PER GRAM URANIUM (pCi/g U) AND IN PICO-CURIES PER GRAM THORIUM (pCi/g Th). CIMARRON GAMMA SPEC SOIL COUNTER. URANIUM BACKGROUND OF 6 pCi/g, NOT SUBTRACTED. THORIUM BACKGROUND OF 1.5 pCi/g, NOT SUBTRACTED. SAMPLES TAKEN ON 5 METER X 5 METER GRID TO CLOSE IN AREAS ON 10 METER X 10 METER GRID. SAMPLES TAKEN BEFORE REMEDIATION.		LEGEND 6-1 - 29 pCi/g 54- 30 - 89 pCi/g 128- 90 - 250 pCi/g 251- > 251 pCi/g + THORIUM + HIT ROCK OR METAL - NO SAMPLE	CIMARRON CORPORATION CIMARRON FACILITY NORTH FIELD (BURIAL GROUND NO. 2) PRE-REMEDIATION SOIL SAMPLE RESULTS (1991) SOIL SAMPLE ALIQUOT: 0-1' DEEP CLIENT DRAWING NO.
DRAWN BY: JE DATE: 9/14/94 CHG'D BY: JA DATE: 10/1/94 APP'D BY: KM SCALE: AS SHOWN	JOB NO.	DRAWING NO. 91PRB2SS-1 REV. 0

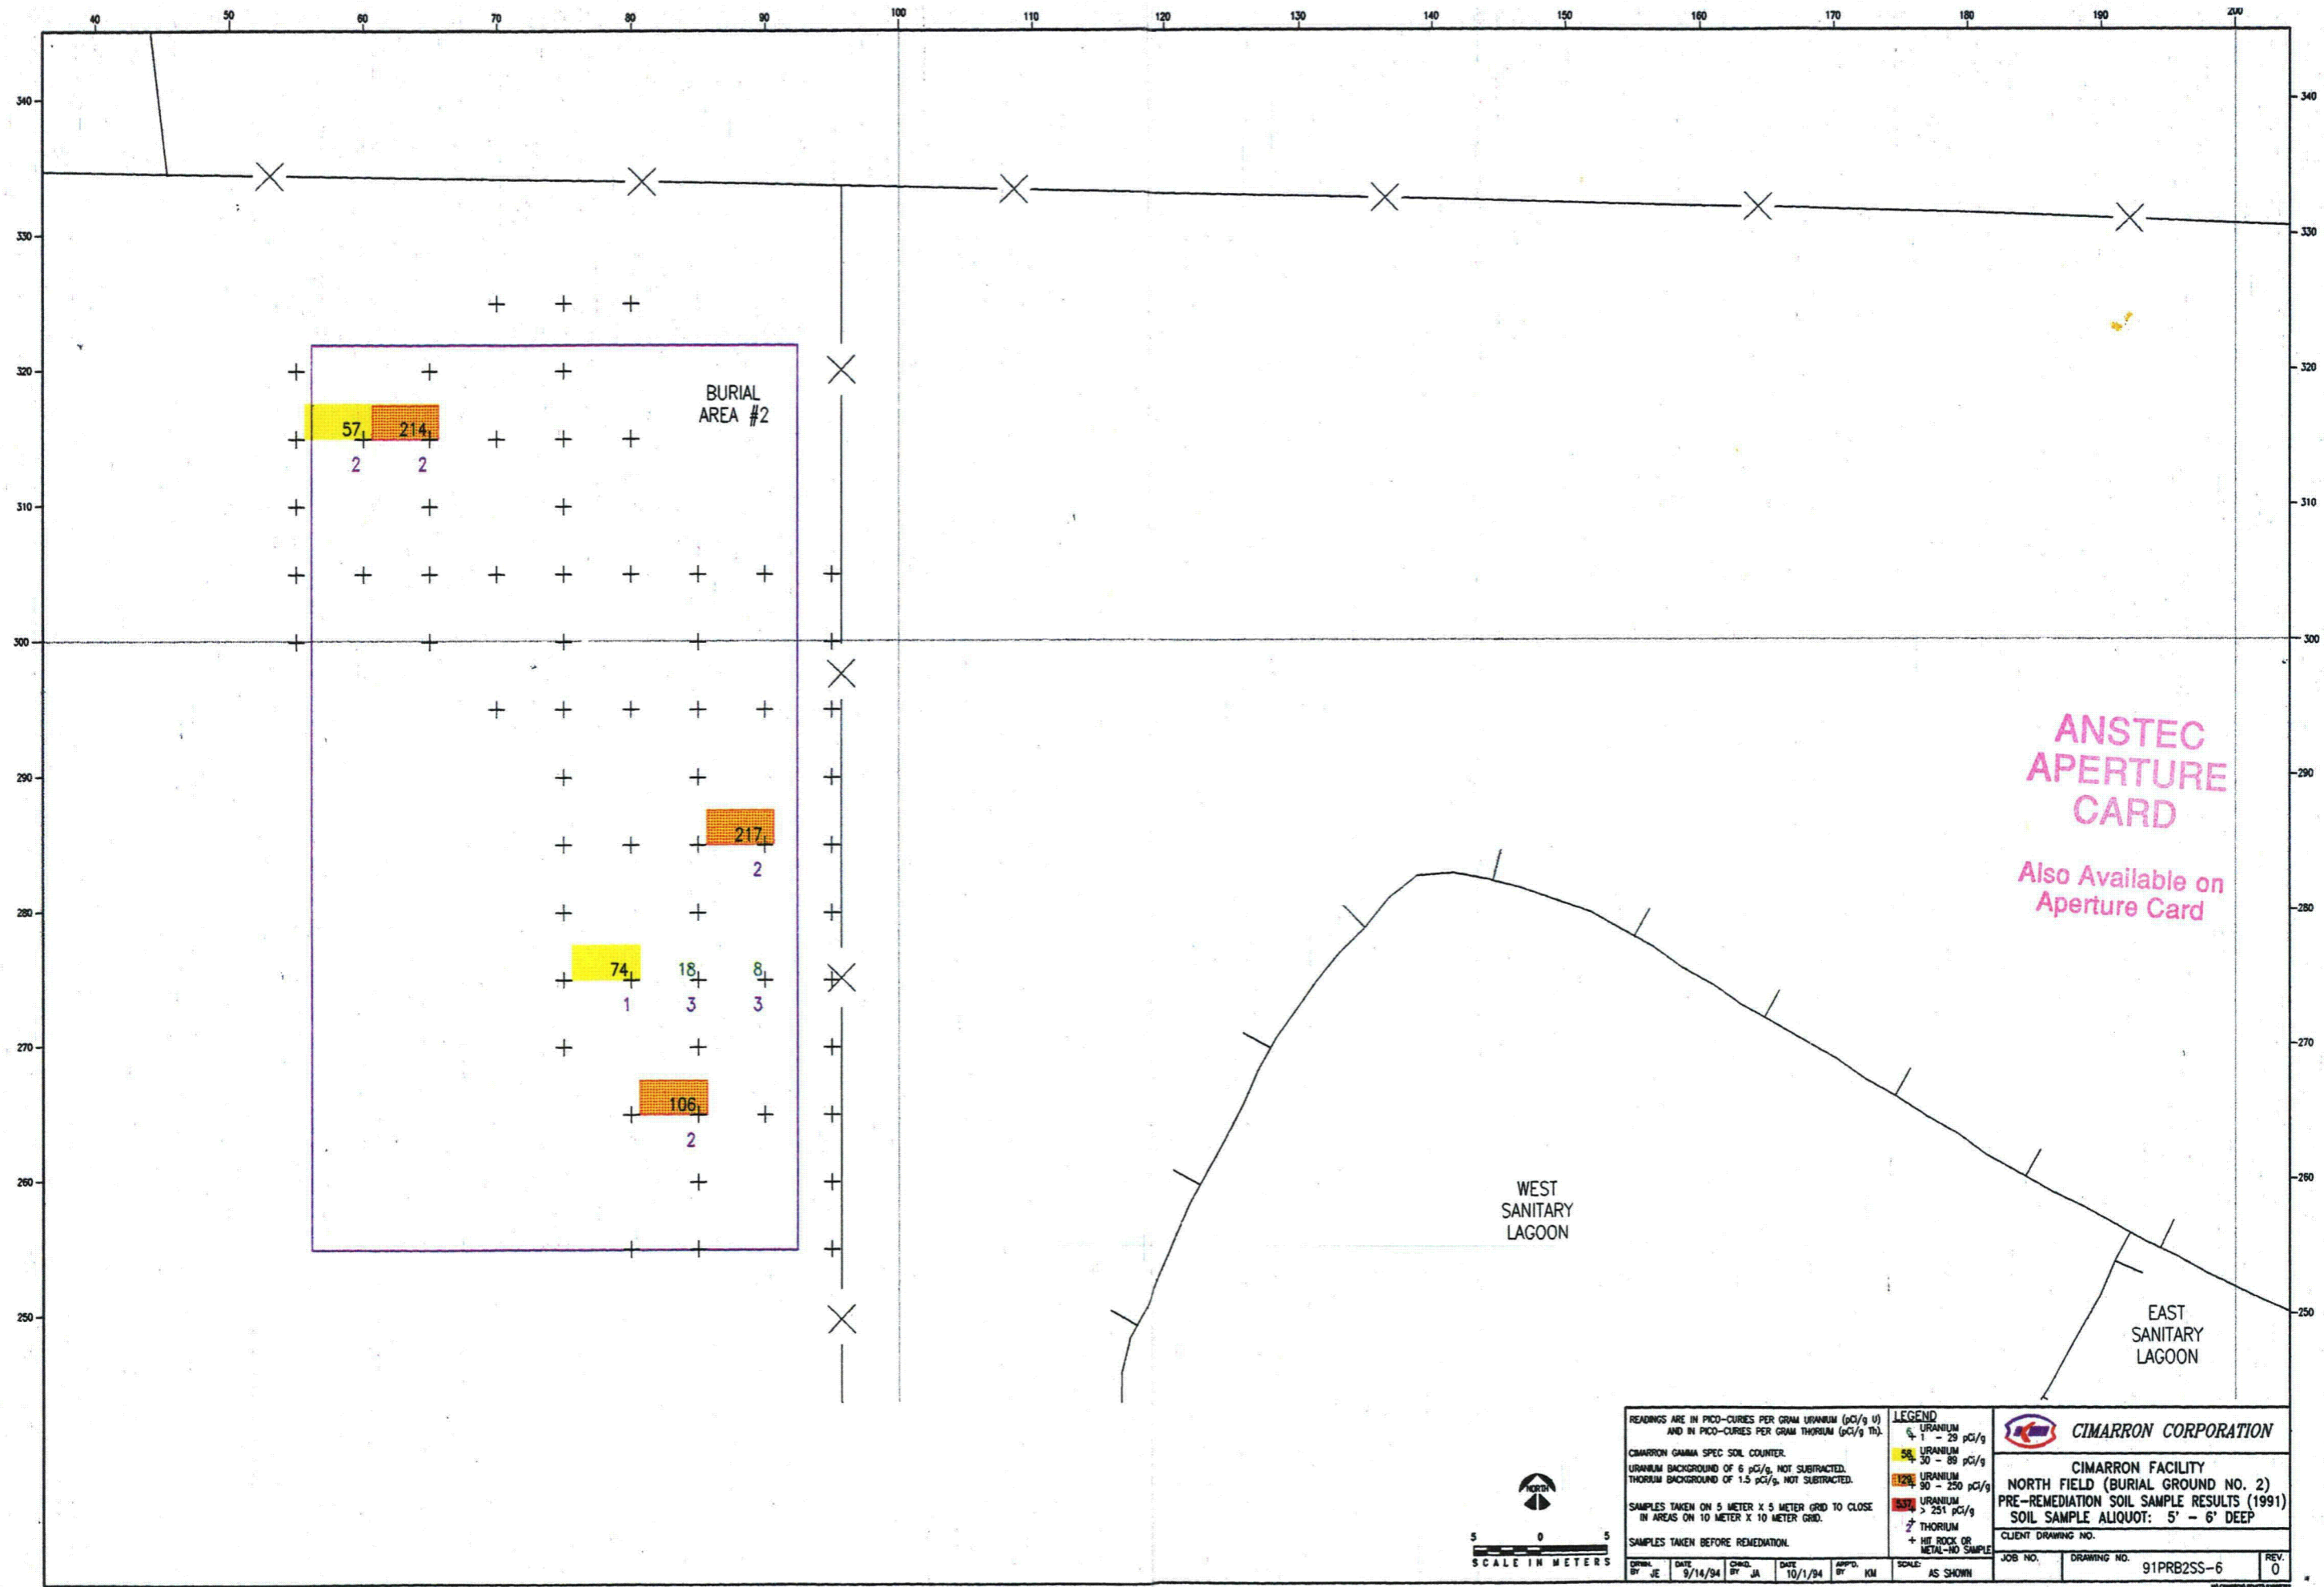
DESIGN BY	DATE	CHG. BY	DATE	APP'D. BY	SCALE	JOB NO.	DRAWING NO.	REV.
JE	9/14/94	JA	10/1/94	KM	AS SHOWN		91PRB2SS-6	0

SAMPLES TAKEN ON 5 METER X 5 METER GRID TO CLOSE IN AREAS ON 10 METER X 10 METER GRID.
 SAMPLES TAKEN BEFORE REMEDIATION.

CIMARRON CORPORATION
 CIMARRON FACILITY
 NORTH FIELD (BURIAL GROUND NO. 2)
 PRE-REMEDIATION SOIL SAMPLE RESULTS (1991)
 SOIL SAMPLE ALIQUOT: 5' - 6' DEEP
 CLIENT DRAWING NO.

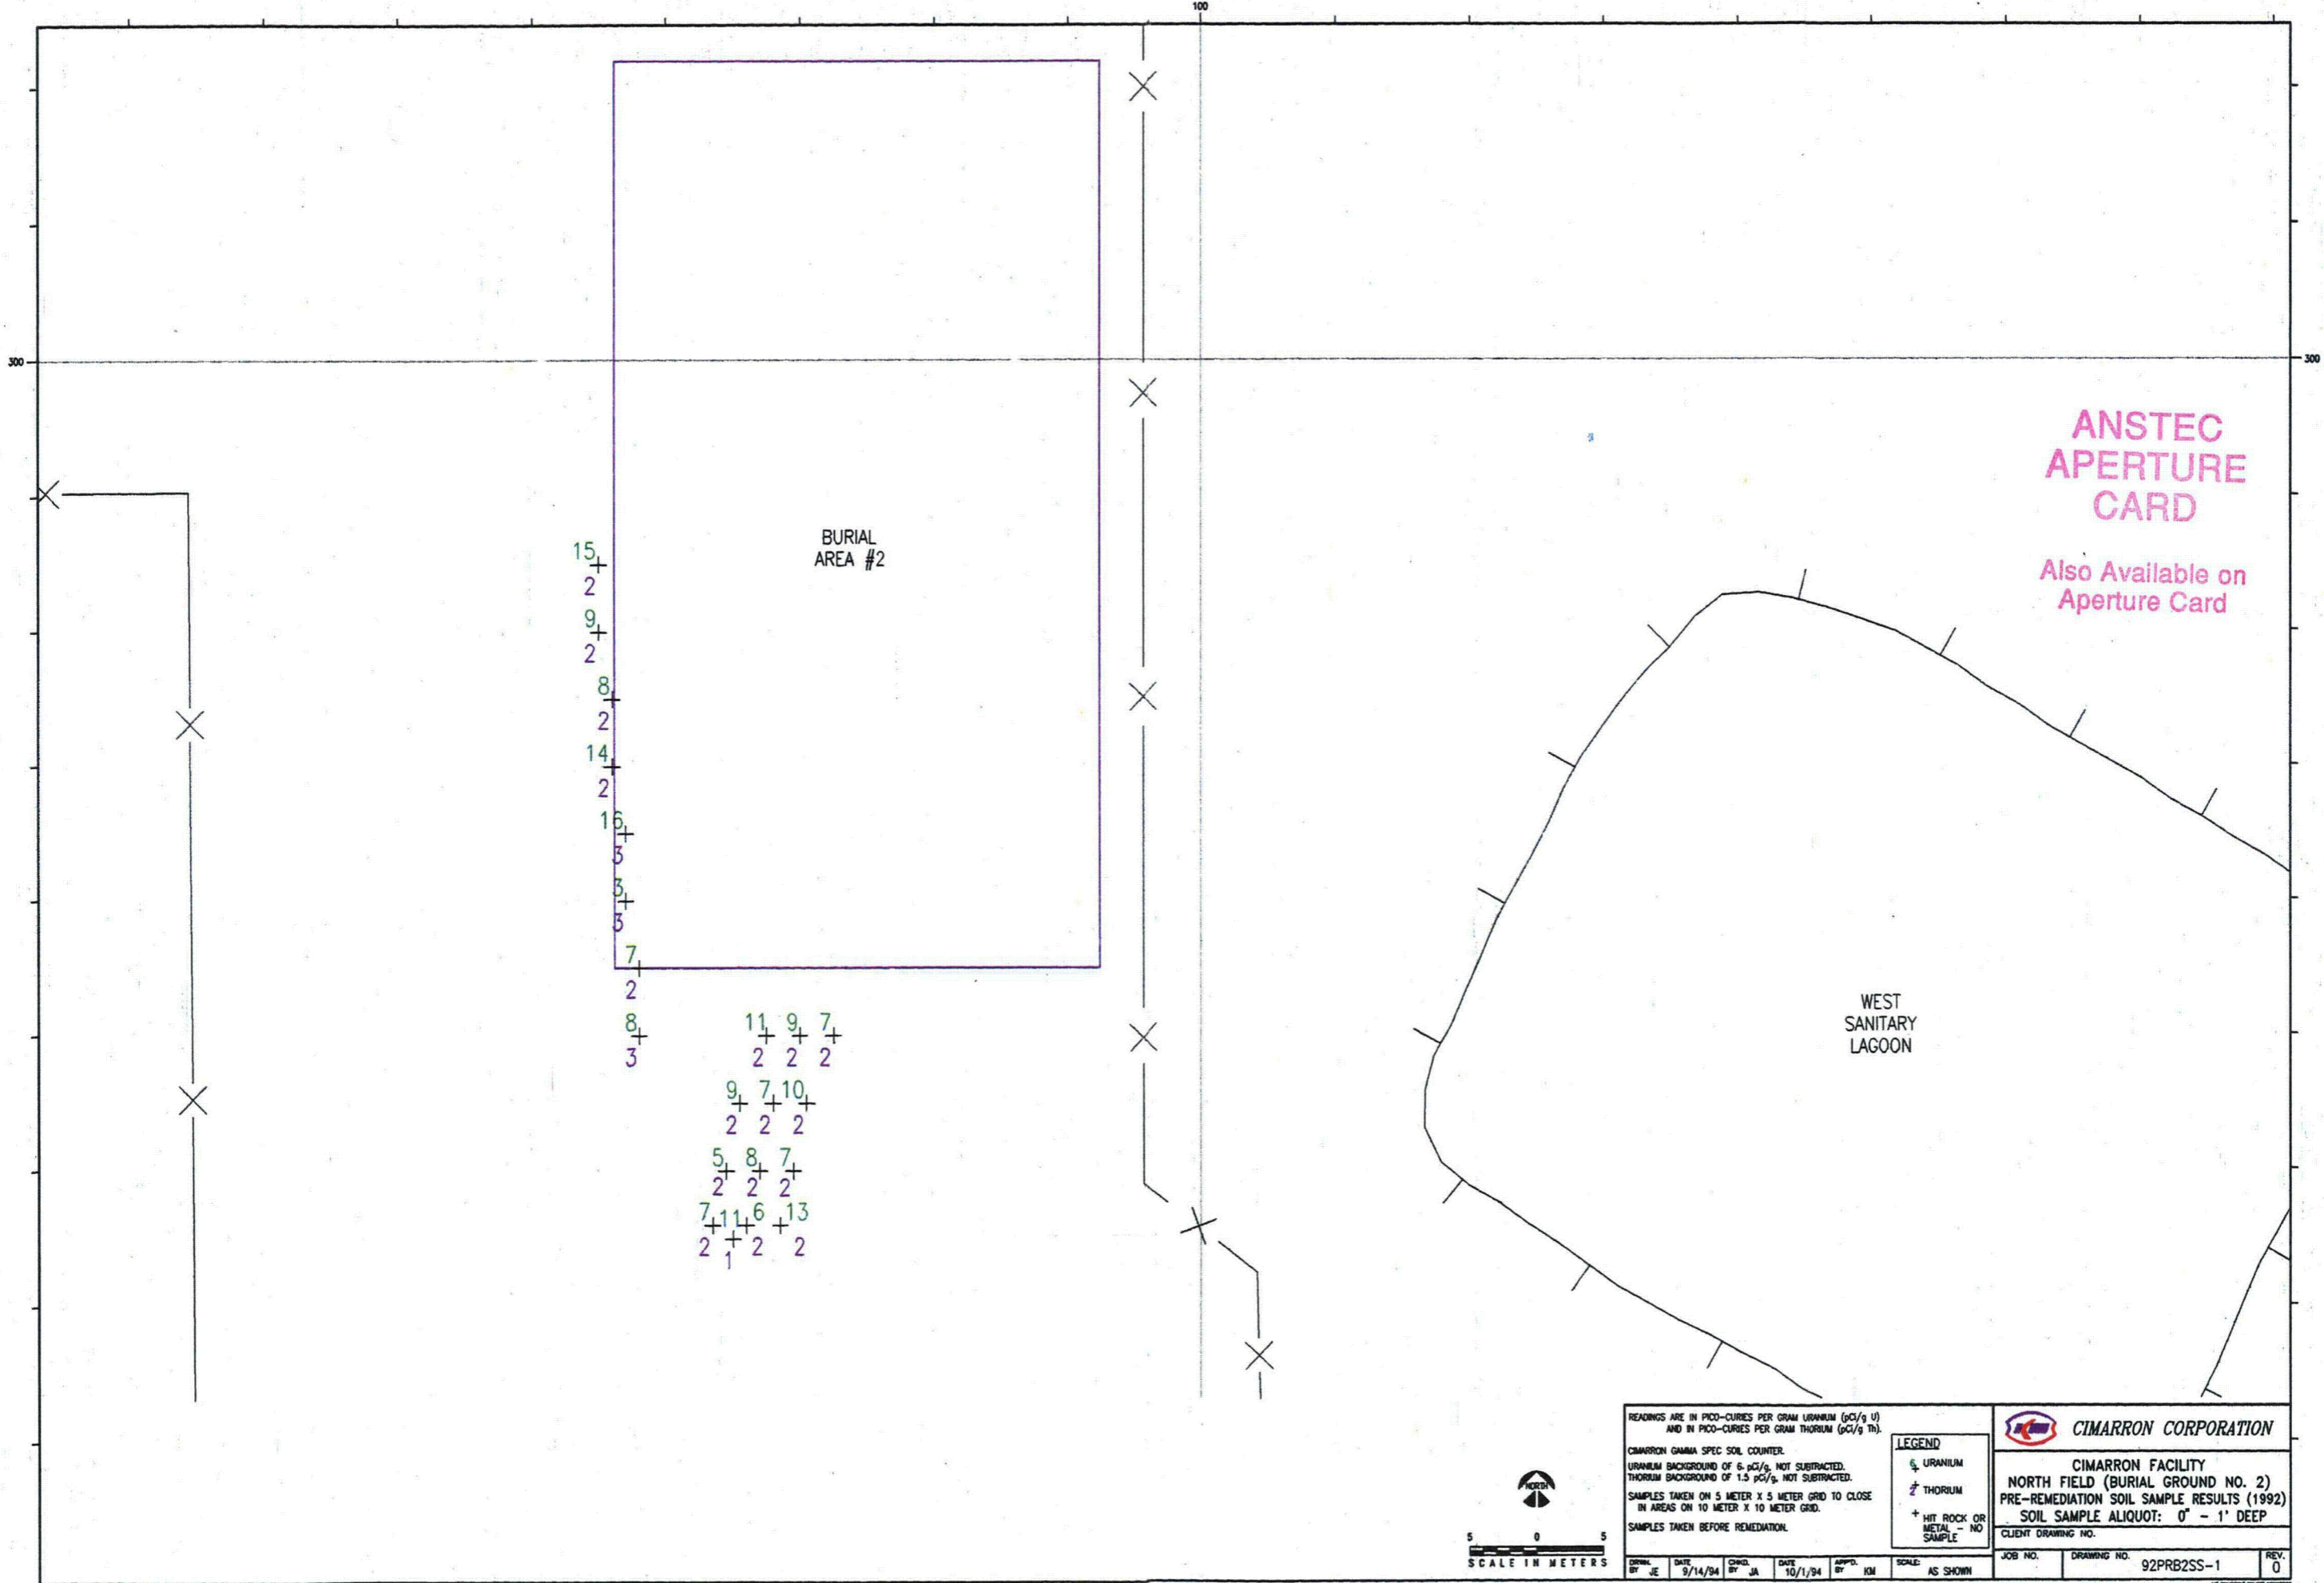
Cimarron personnel cored and sampled two other areas in the North Field Drainage Area in 1992 on a 5m x 5m grid; one area west of Burial Area #2 and the other area south of Burial Area #2. The corings were completed down to 6 ft.; the sample results are shown on Drawings No. 92PRB2SS-1 through 92PRB2SS-6. As noted on these drawings, all sample results were less than the maximum Option #1 guideline values for uranium and thorium.

READINGS ARE IN PICO-CURIES PER GRAM URANIUM (pCi/g U) AND IN PICO-CURIES PER GRAM THORIUM (pCi/g Th).		
CIMARRON GAMMA SPEC SOIL COUNTER. URANIUM BACKGROUND OF 6 pCi/g, NOT SUBTRACTED. THORIUM BACKGROUND OF 1.5 pCi/g, NOT SUBTRACTED. SAMPLES TAKEN ON 5 METER X 5 METER GRID TO CLOSE IN AREAS ON 10 METER X 10 METER GRID. SAMPLES TAKEN BEFORE REMEDIATION.		
LEGEND ☒ URANIUM ☒ THORIUM + HIT ROCK OR METAL - NO SAMPLE		CIMARRON CORPORATION NORTH FIELD (BURIAL GROUND NO. 2) PRE-REMEDIATION SOIL SAMPLE RESULTS (1992) SOIL SAMPLE ALIQUOT: 0" - 1' DEEP CLIENT DRAWING NO.
DRAWN BY: JE DATE: 9/14/94 CHECKED BY: JA DATE: 10/1/94 APPROVED BY: KIM	SCALE: AS SHOWN	JOB NO.: DRAWING NO.: 92PRB2SS-1 REV.: 0
