8.0 Burial Area #2 and North Field Drainage Area

CIMARRON CORPORATION
 CIMARRON FACILITY
 BURIAL GROUND NO. 2
 PRE-REMEDIATION SOIL SAMPLE RESULTS (1990)
 SOIL SAMPLE ALIQUOT: 6" - 1' DEEP
 CLIENT DRAWING NO.

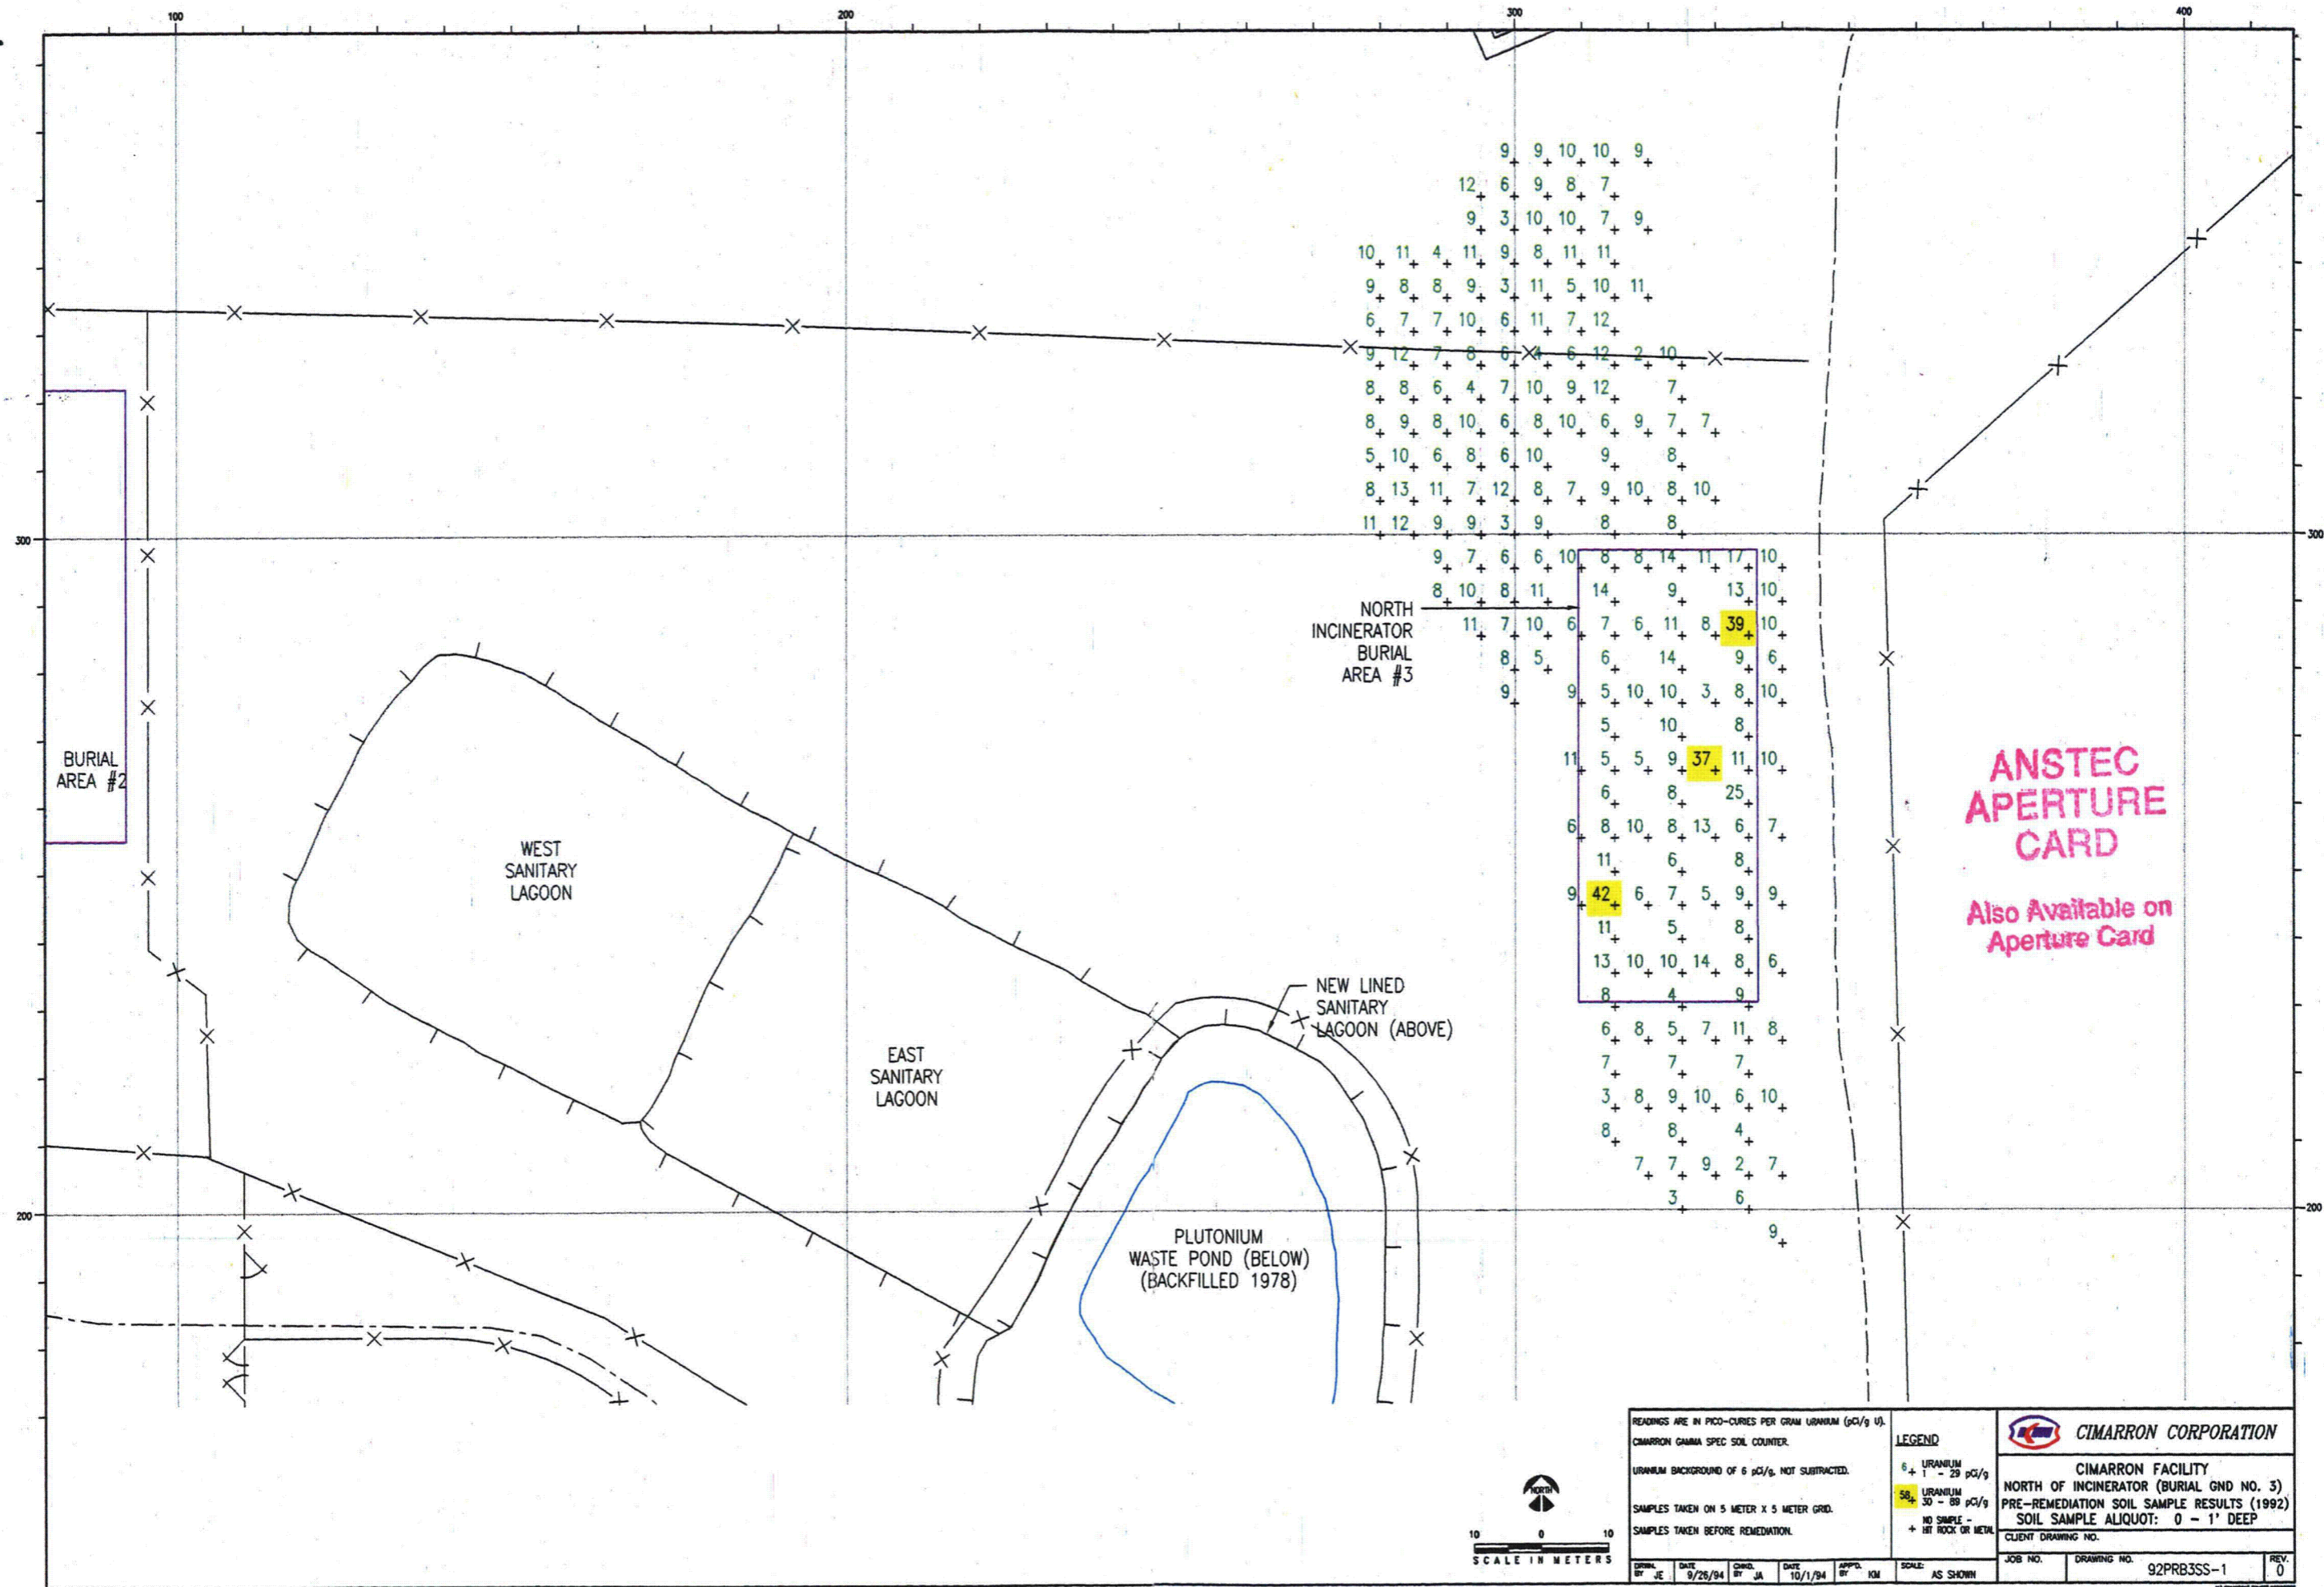
JOB NO. DRAWING NO. 92PRB3SS-1 REV. 0

This area was included in the Micro-R survey of the entire 1,100-acre site conducted in 1979 and is shown on Drawing No. 79PRSBUR-0. This drawing is included as an attachment to Section 6.0. The soil sampling that was performed in 1990 on a 10m x 10m grid included Burial Area #3. This sampling was performed to a depth of 4 ft. The results of the sampling, shown on Drawings No. 90PRB3SS-0 through 90PRB3SS-4, indicates five samples exceeding the Option #1 guideline value of 30 pCi/g total uranium. In March, 1992, a 5m x 5m grid was established for this area and additional soil samples were collected (this included grid intersects not previously sampled) at depths from 0 to 6 ft. The soil samples were analyzed for total uranium, and the results were placed on Drawings No. 92PRB3SS-1 through 92PRB3SS-6. This second round of sampling resulted in several additional areas where soil uranium concentrations exceeded the Option #1 limit of 30 pCi/g total uranium. A random soil sampling program consisting of 30 samples was conducted in this area to supplement the existing data. This round of sampling also showed soil samples exceeding the Option #1 limit.

CIMARRON FACILITY
NORTH OF INCINERATOR (BURIAL GND NO. 3)
PRE-REMEDIATION SOIL SAMPLE RESULTS (1992)
SOIL SAMPLE ALIQUOT: 0 - 1' DEEP
CLIENT DRAWING NO.

The soil sampling that had been completed prior to April, 1992 indicated several areas requiring remediation. Remediation of this area began in April, 1992, with radioactive waste materials found in drums of resin and on several pieces of scrap metal. These items were removed, packaged and transported off site to a licensed LLRW disposal facility. Approximately 100 ft³ of LLRW was disposed of off site containing total uranium concentrations in the range of 1,500 pCi/g to 6,000 pCi/g. A limited volume of Option #2

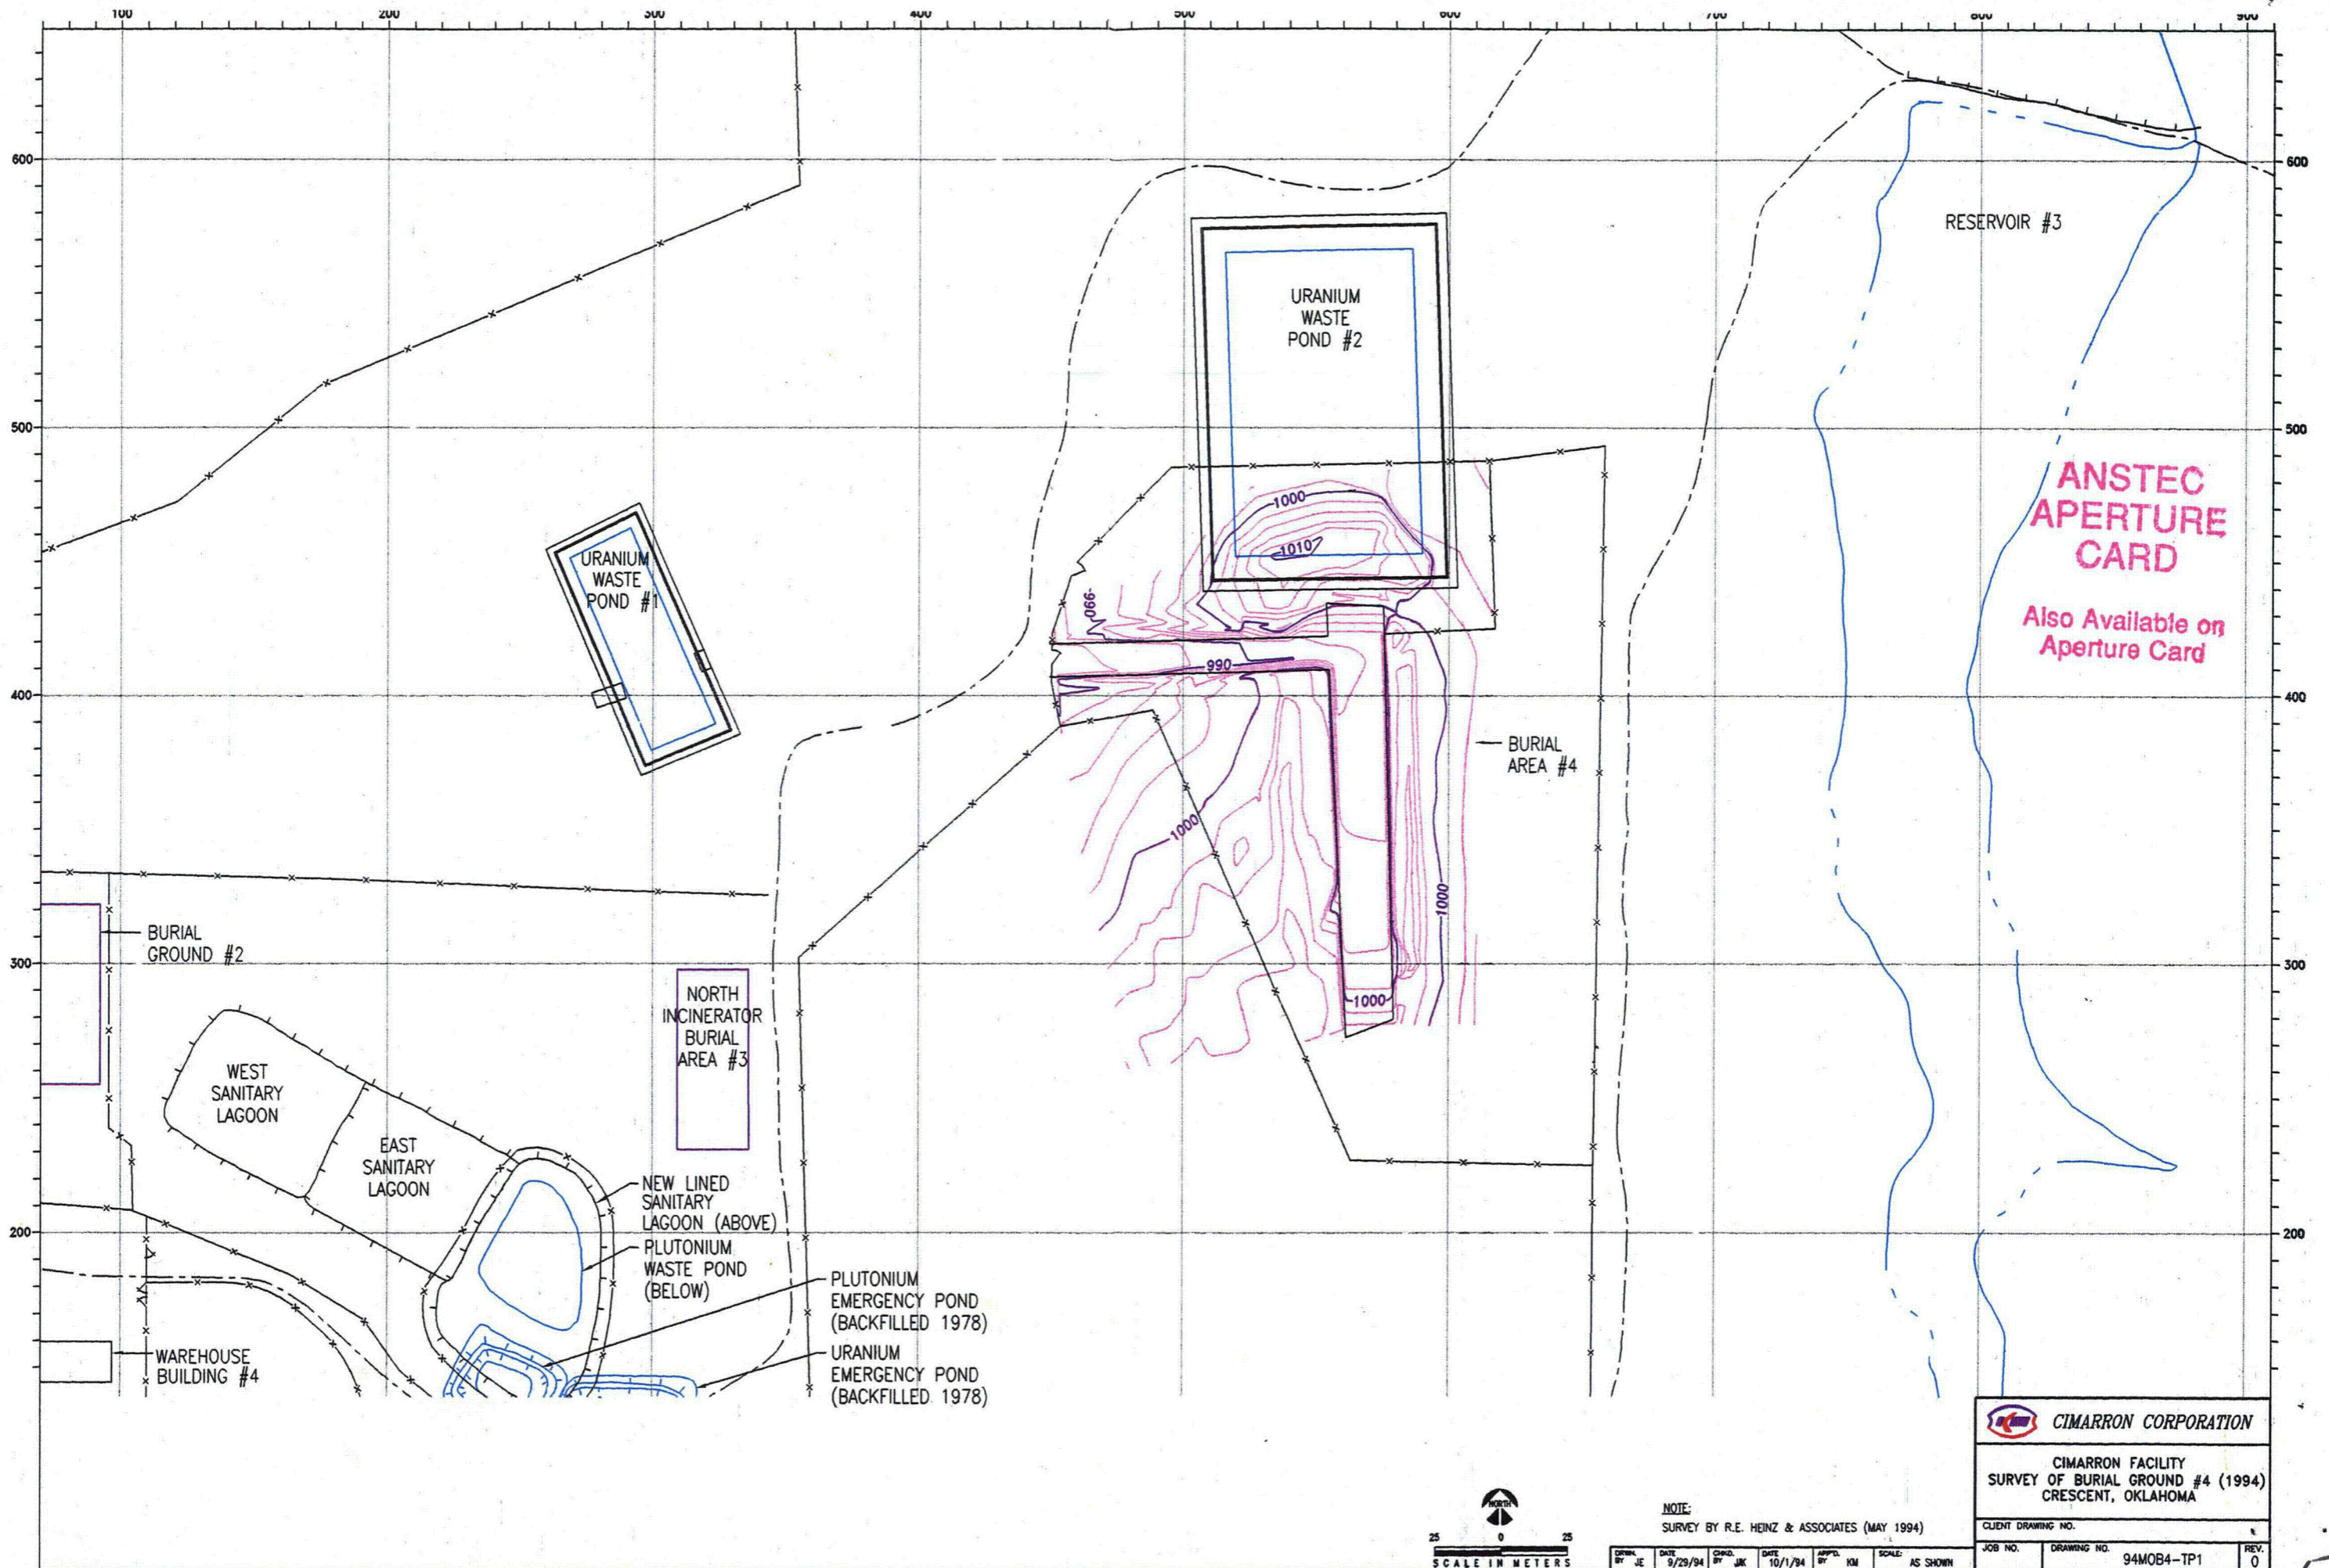
CLIENT DRAWING NO. _____
 JOB NO. _____ DRAWING NO. 94MOB4-TP1 REV. 0

A new trench was constructed for the on-site disposal of the excavated Option #2 materials. The as-built drawing for this burial area is shown on Drawing No. 94MOB4-TP1. The area designated for disposal was hydrologically characterized in 1989. The data generated from the field investigation was compiled in the 1989 "J.L. Grant & Associates Investigation Report", with responses to NRC interrogatories completed in 1990.

CIMARRON FACILITY
 SURVEY OF BURIAL GROUND #4 (1994)
 CRESCENT, OKLAHOMA
