NUREG/CR-6791
Revision 1
ANL-08/30

Eddy Current Reliability Results from the Steam Generator Mock-up Analysis Round-Robin

This report discusses a study conducted by Argonne National Laboratory (ANL) under contract with the U.S. Nuclear Regulatory Commission (NRC), Office of Nuclear Regulatory Research (RES). RES initiated this study as part of the agency's Steam Generator Tube Integrity Program. Through this work, RES aims to support the NRC's Office of Nuclear Reactor Regulation (NRR) in evaluating licensee inspection programs that utilize eddy current examination technology. Inspection reliability is important to properly assess the condition of steam generator tubes.

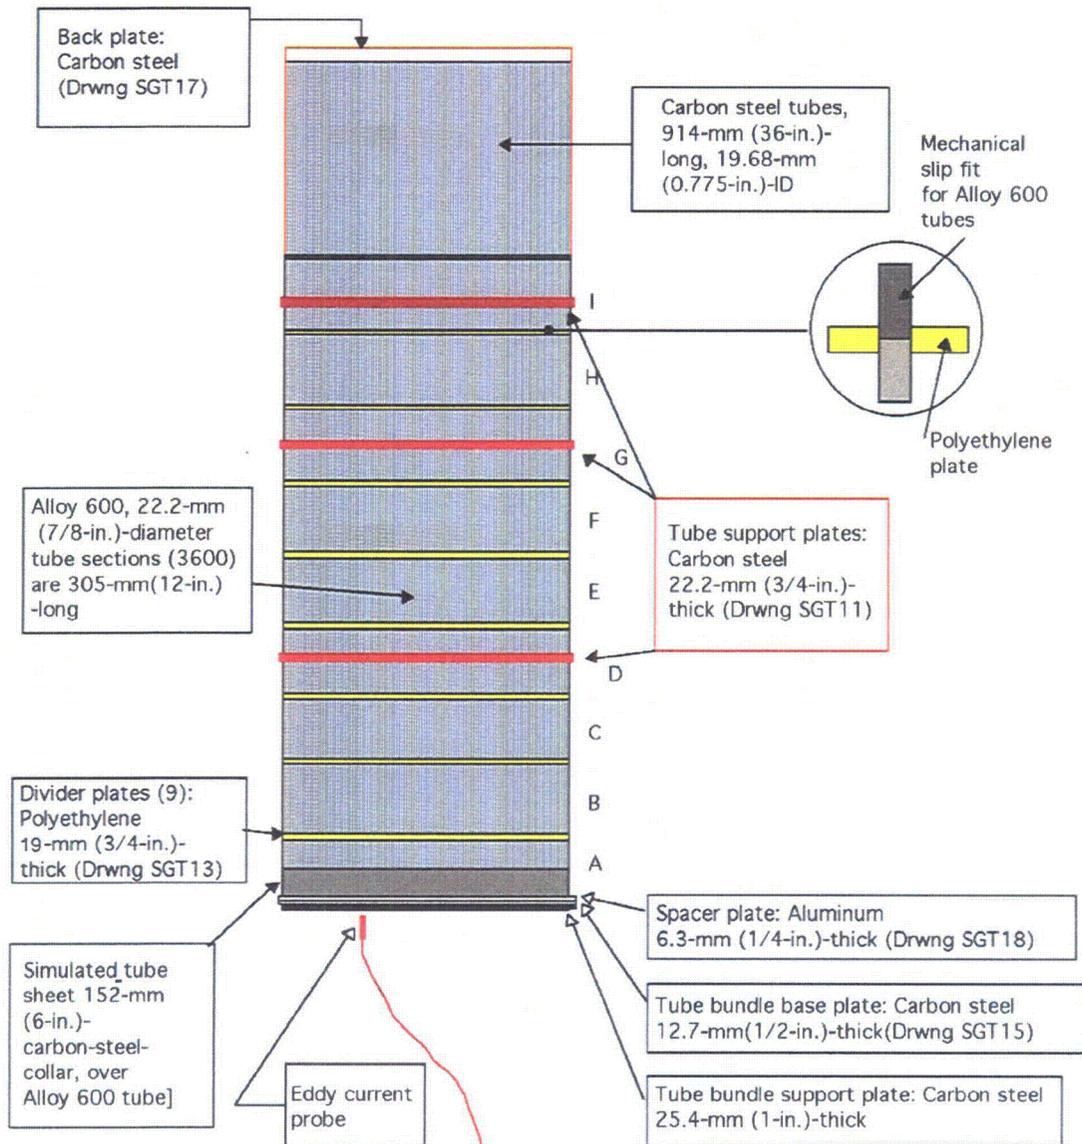
Figure 2.1. Schematic representation of steam generator mock-up tube bundle.

The mock-up tube bundle consists of 400, 22.2-mm (0.875-in)-diameter, Alloy 600 tubes consisting of 9 test sections, each 0.3 m (1 ft) long. The tube sections are arranged in nine levels with 400 tubes at each elevation. The centers of the tubes are separated by 3.25 cm (1.28 in). Tie rods hold the test sections together. The ends of each test section are pressed into 19-mm (0.75-in)-thick high-density polyethylene plates that hold it in alignment. One end of each tube is spring-loaded. The lowest level (A) has a roll transition zone (RTZ) and simulates the tube-sheet, while the 4th, 7th, and 9th levels simulate intersections of the drilled hole tube support plate (TSP). The other five levels are free-span regions. Above the 9th level is a 0.91-m (3-ft)-long probe run-out section. See Fig. 2.1 for the tube bundle diagram, and Fig. 2.2 for a photograph of the mock-up. Debris generated during assembly (e.g., shavings from the polyethylene plates) was cleared to assure that the eddy current probes could travel unobstructed through all test sections.

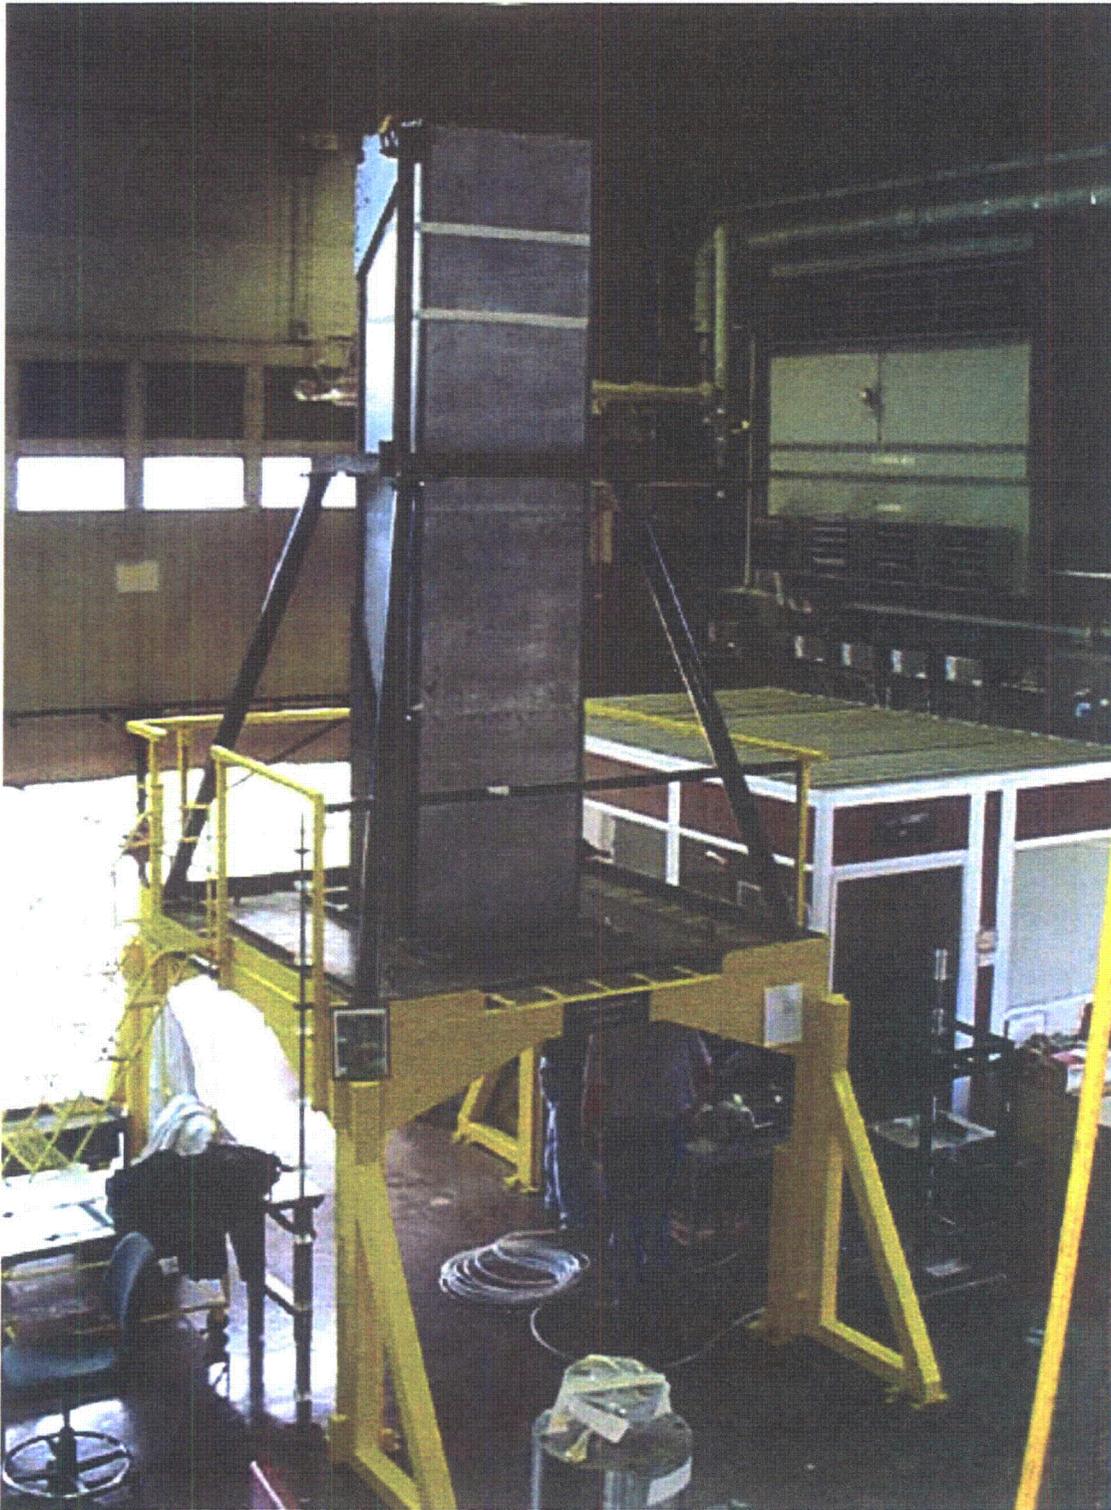
Figure 2.2. Photograph of mock-up during acquisition of eddy current data.

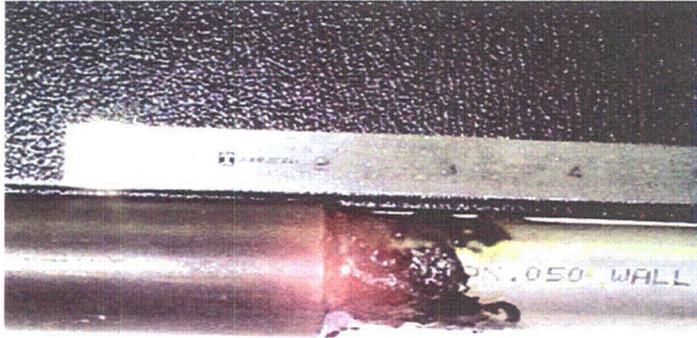
Figure 2.3.
Photograph of sludge on a tube-sheet test section. Many test sections with and without flaws had sludge deposits.

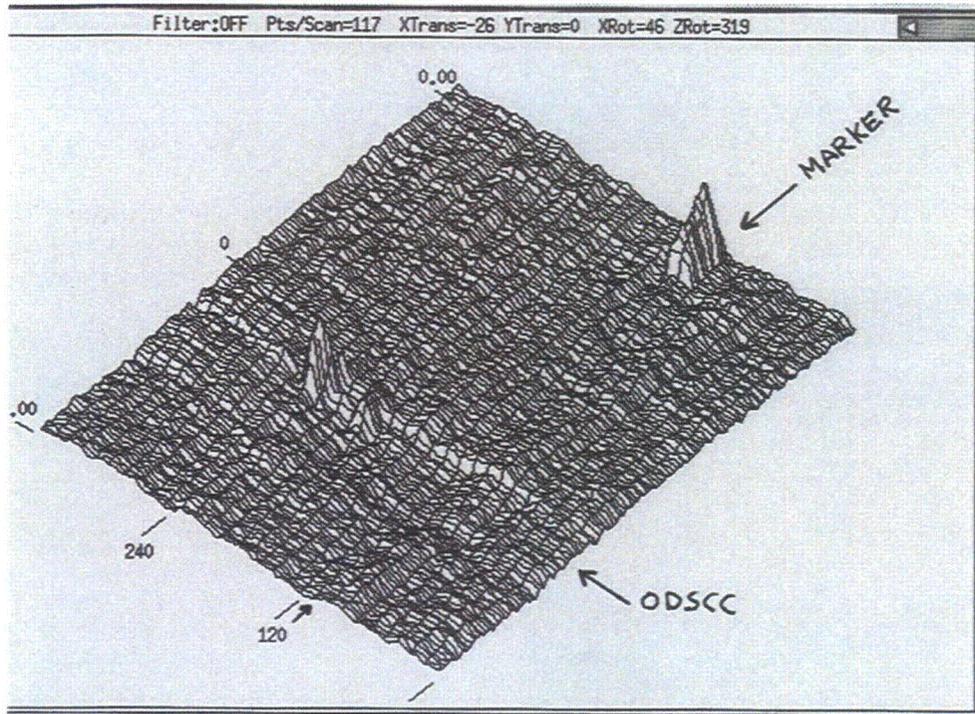
Figure 2.5. Isometric plot (c-scan) showing eddy current response from axially oriented, magnetite-filled epoxy marker located on ID side at end of 22.2-mm (0.875-in) Alloy 600 tube. The dimensions of the markers are 400- μm (0.016-in) wide by 250- μm (0.010-in) thick by 25-mm (1-in) long.

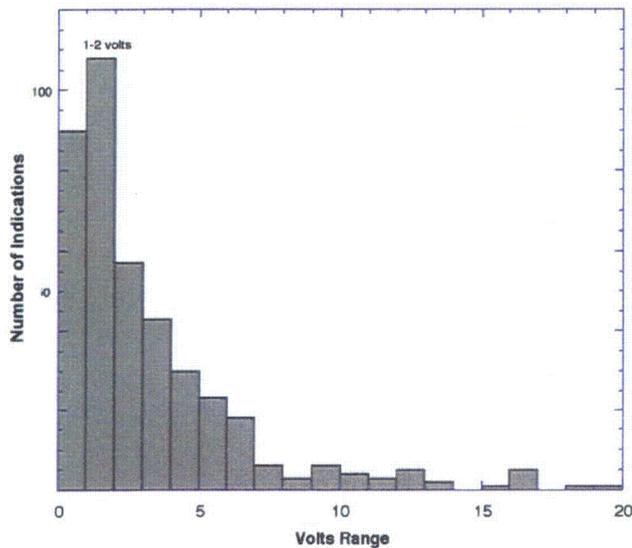
Figure 2.6. Bobbin coil voltage histogram for mock-up flaws and other conditions, e.g., dents

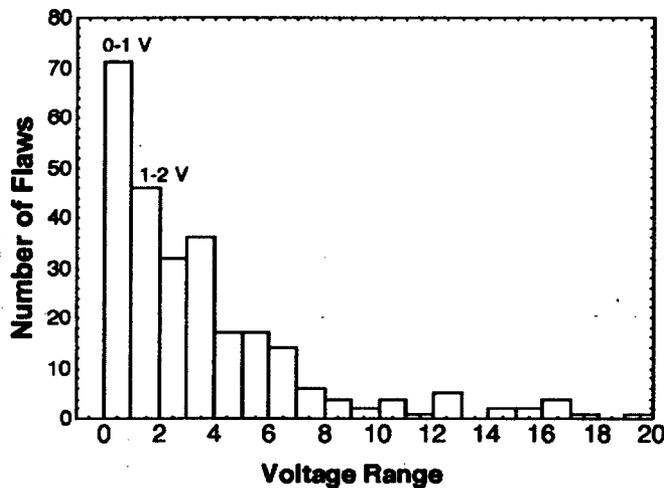
Figure 2.7.
Bobbin coil voltage histogram for
mock-up flaws

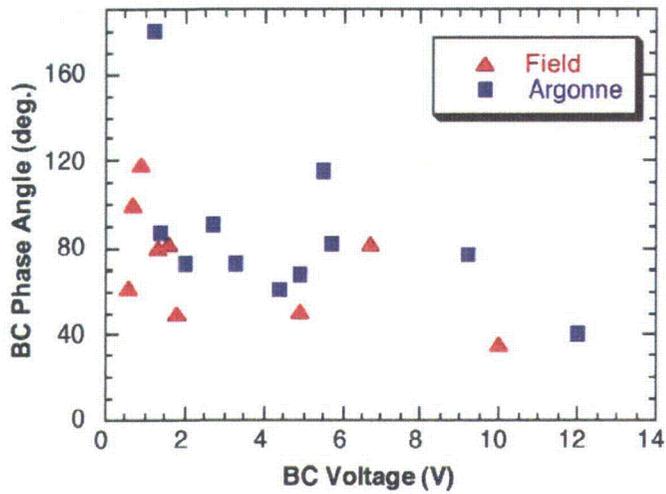
Figure 2.8. Bobbin coil voltage and phase angle for representative cracks in mock-up and field data. Phase/voltage relationships are similar.

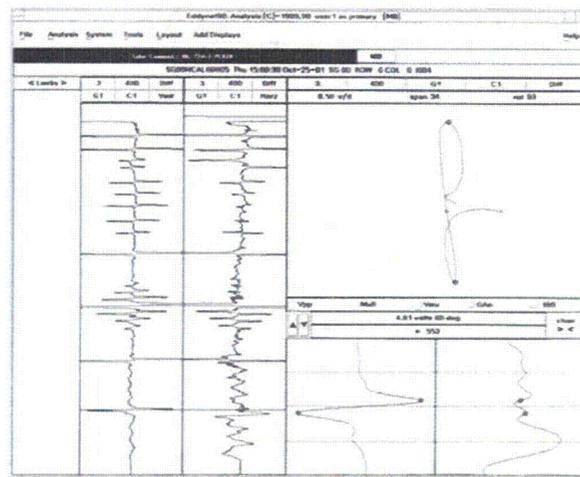
Figure 2.9. Differential bobbin coil Lissajous figure at 400 kHz from LODSCC7243. EC data were taken from a pulled tube using Argonne's NDE glove-box facility.

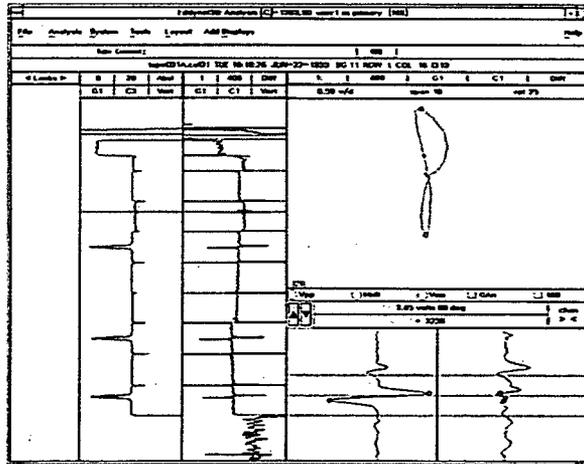
Figure 2.11. Differential bobbin coil Lissajous figure at 400 kHz from Argonne-grown mock-up crack LODSCC300. The BC signal shape, amplitude, and phase are similar to those of the field flaw LODSCC 7243 on Figure 2.9.

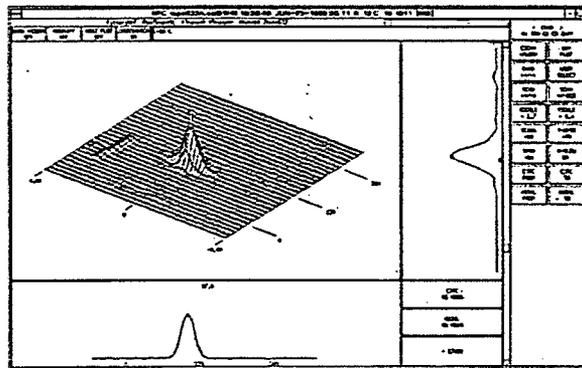
Figure 2.12. Isometric plot of signal amplitude vs. position for +Point coil at 300 kHz from Argonne-grown mock-up crack LODSCC300. The EC +Point signal shape, amplitude, and phase are similar to those of the field flaw LODSCC 7243 on Figure 2.9..

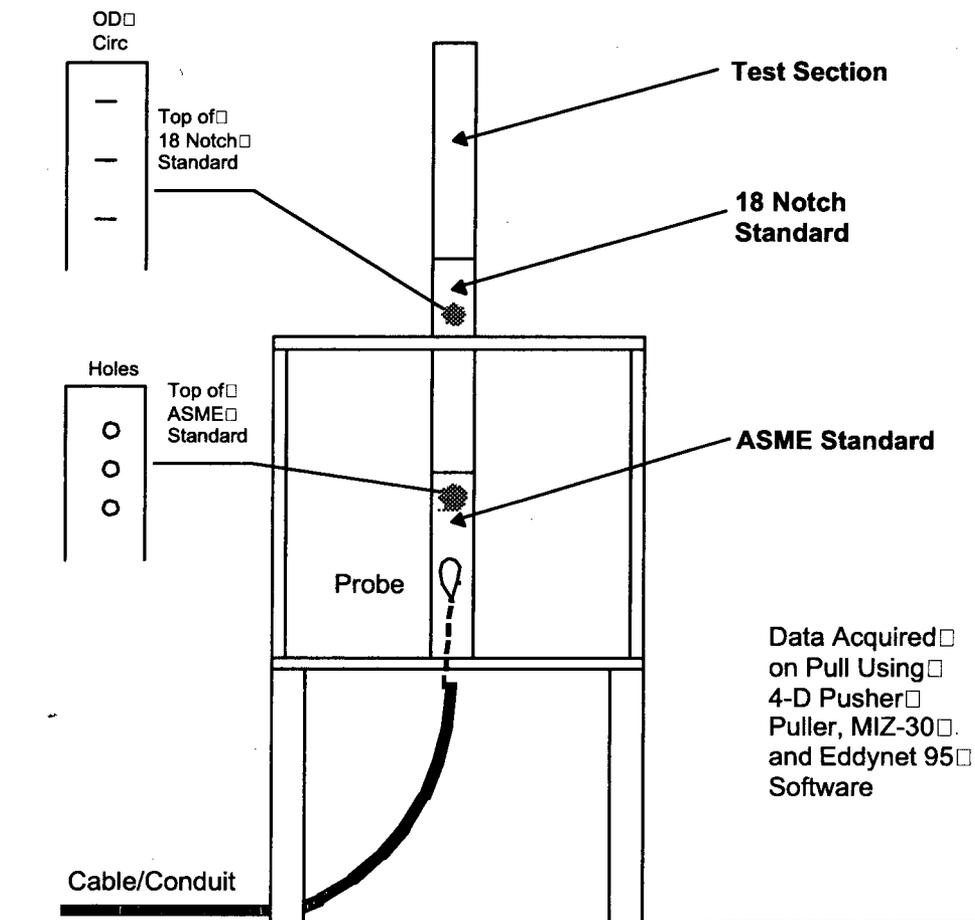
Figure 2.13. Schematic drawing showing configuration of stand, standards, and degraded test section during an eddy current inspection of a single test section.

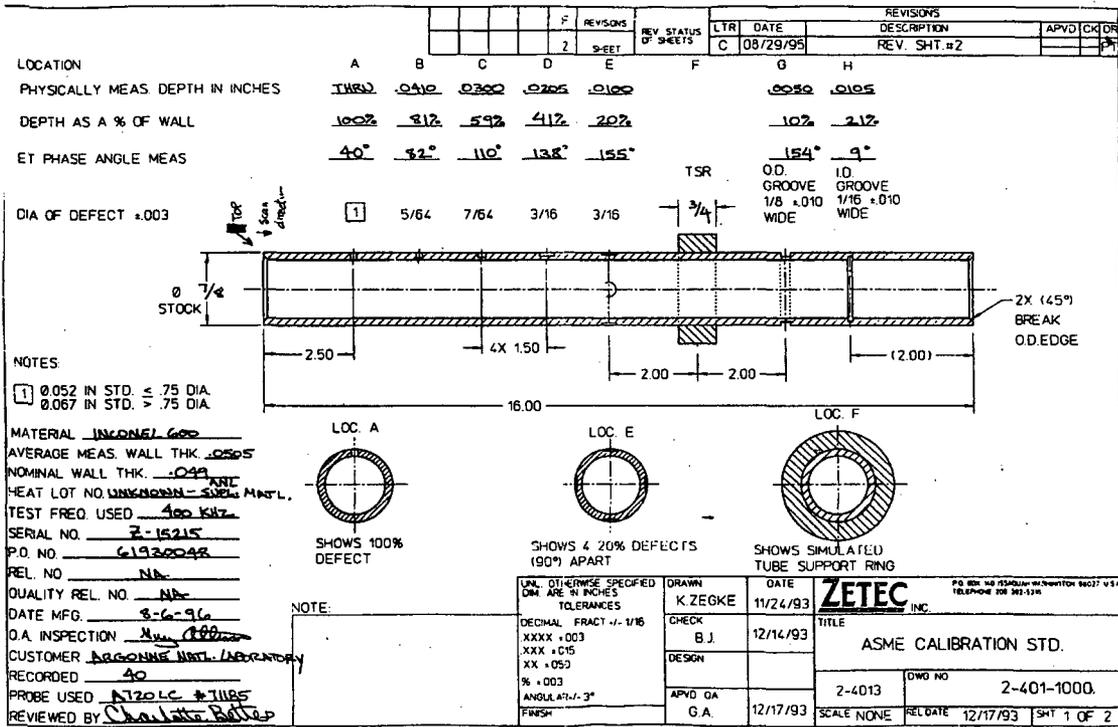
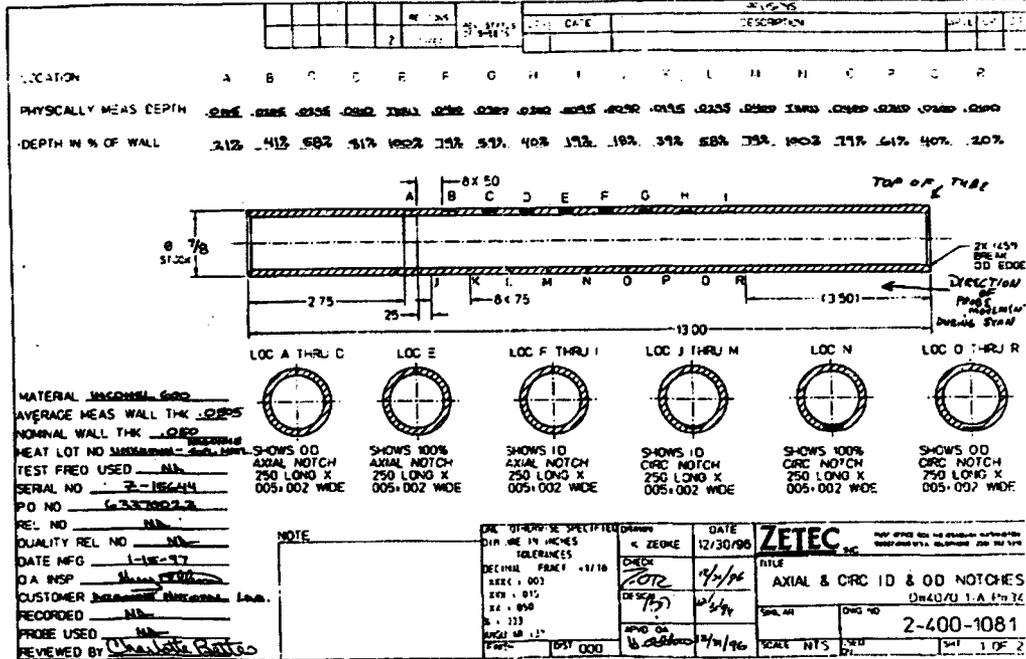
Figure 2.14. Schematic drawing of ASME (top) and 18-notch standard (bottom) used when scanning degraded test sections and mock-up tubes.

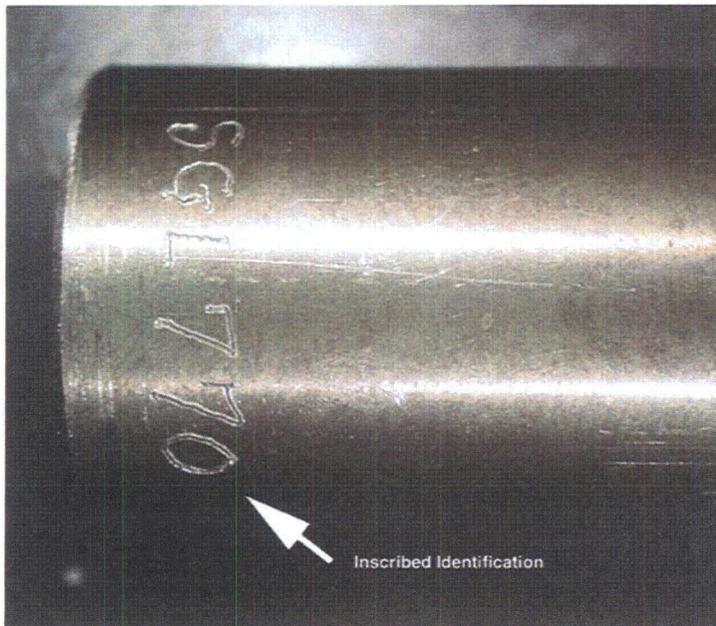
Figure 2.15.
Inscribed identification of tube specimen.

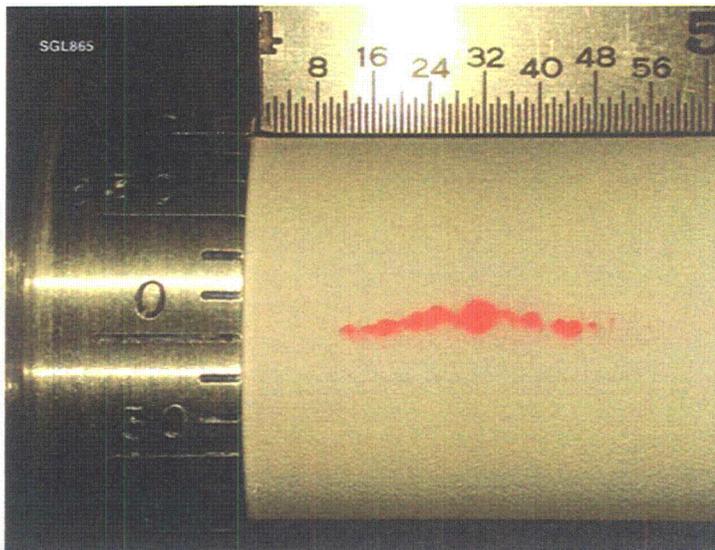
Figure 2.16.
Dye penetration examination of tube specimen SGL865 showing an LODSCC.

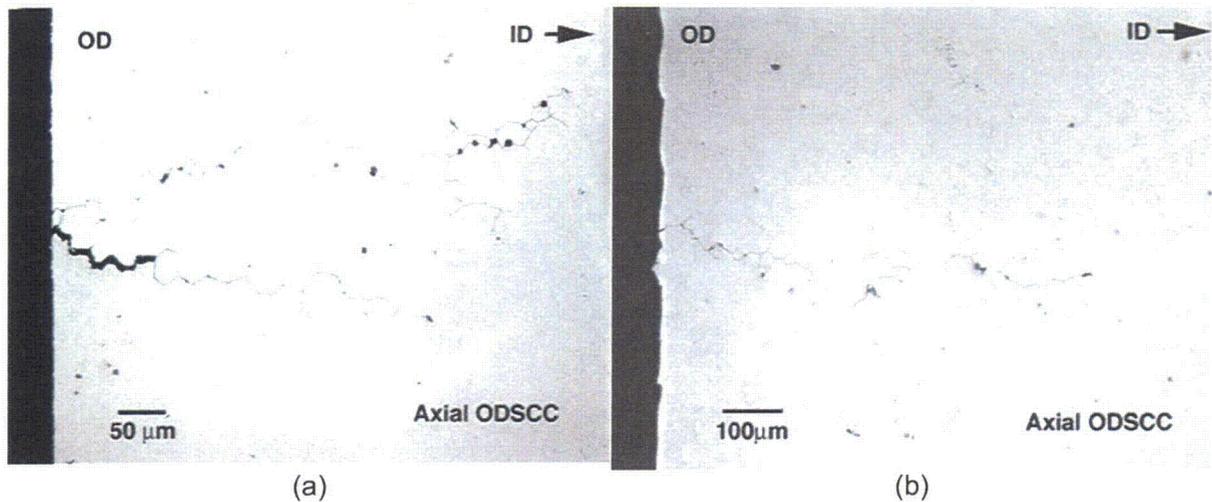
Figure 2.17. Cross-sectional optical metallography for (a) branched LODSCC and (b) LODSCC.

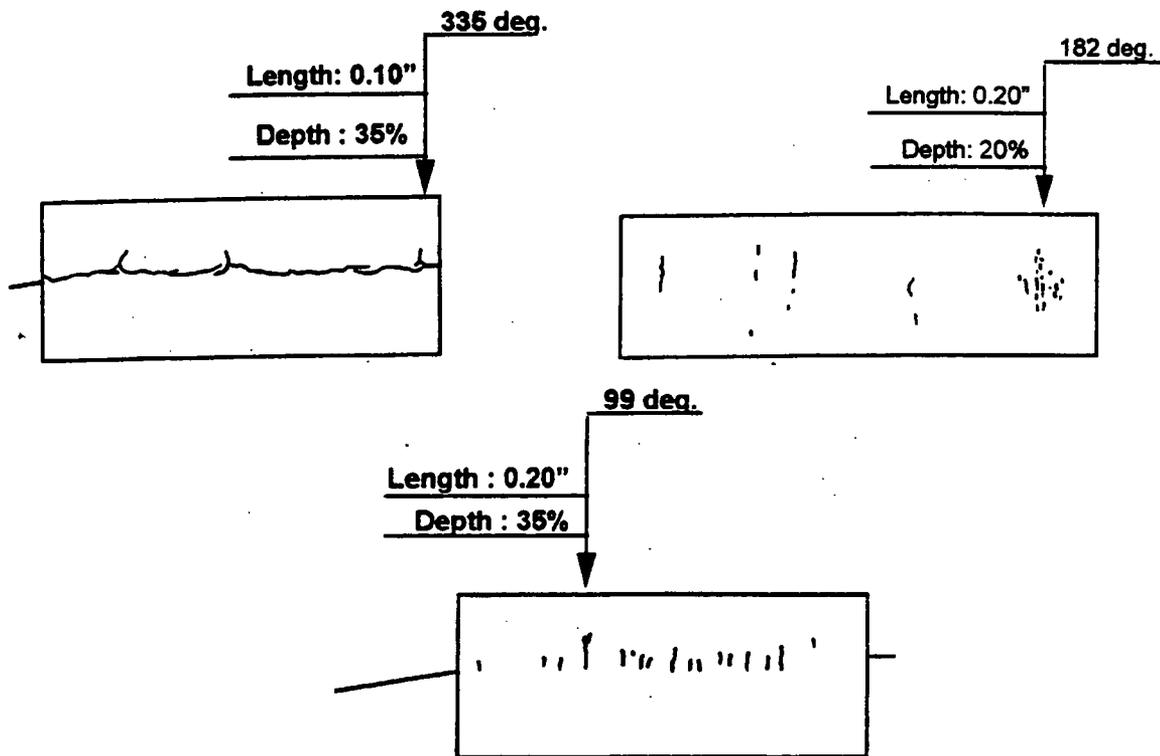
Figure 2.18. Sketch of dye penetrant images of three outer-diameter SCCs in mock-up. Test section axis is vertical. Top-left SCC is circumferential; top-right and bottom sketches show numerous LODSCCs distributed around the circumference. Bottom sketch shows a series of LODSCCs at the roll transition.

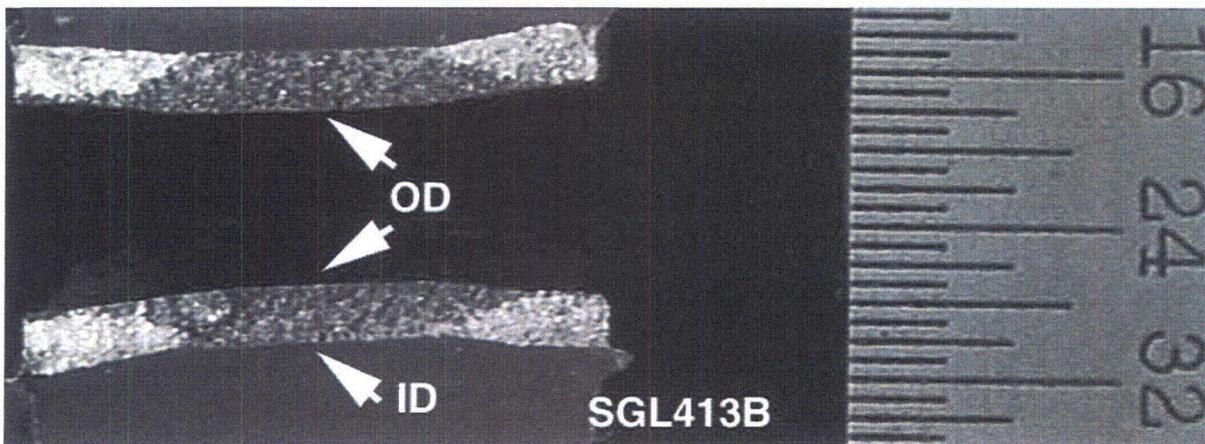
Figure 2.19. Fractography of tube specimen SGL413.

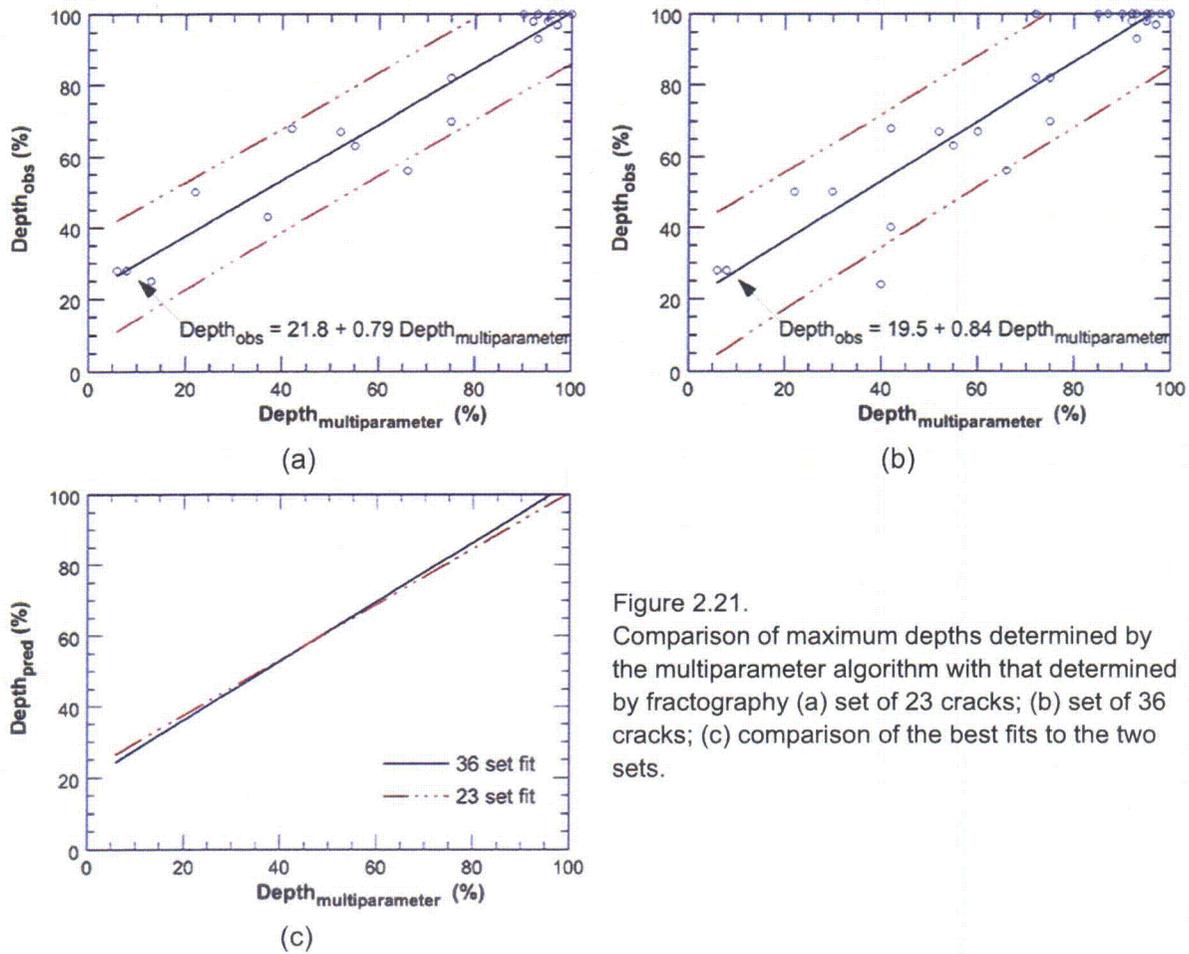
Figure 2.21. Comparison of maximum depths determined by the multiparameter algorithm with that determined by fractography (a) set of 23 cracks; (b) set of 36 cracks; (c) comparison of the best fits to the two sets.

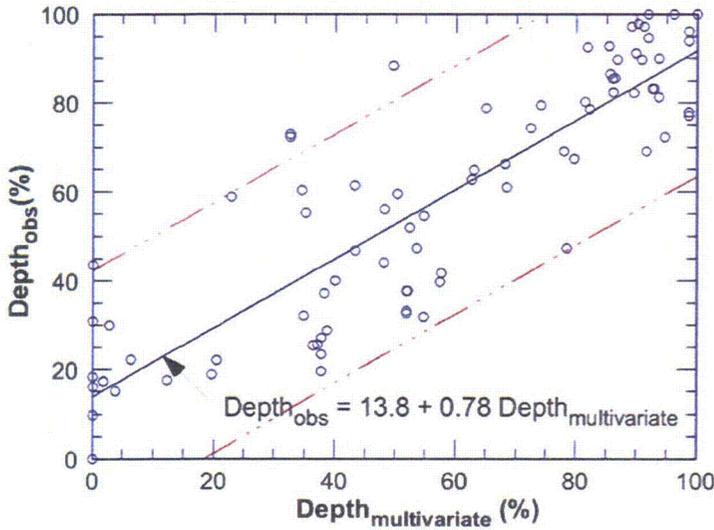
Figure 2.22. Comparison of depths (% TW) determined by the multiparameter algorithm with those by fractography and regression fit and estimated 95% bounds for the observed depth as a function of the multiparameter depth estimate. Multiple observations from a single crack.

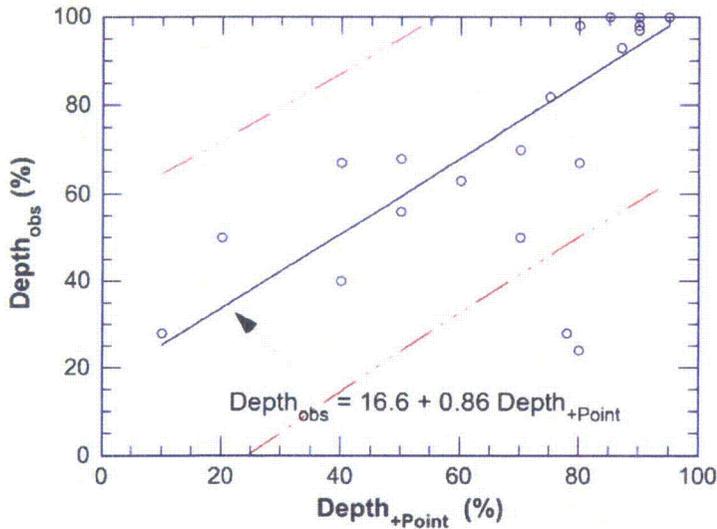
Figure 2.23. Comparison of maximum depths (% TW) determined by the phase analysis of +Point data with those by fractography. A regression fit and estimated 95% bounds for the observed depth as a function of the +Point depth estimate are also shown

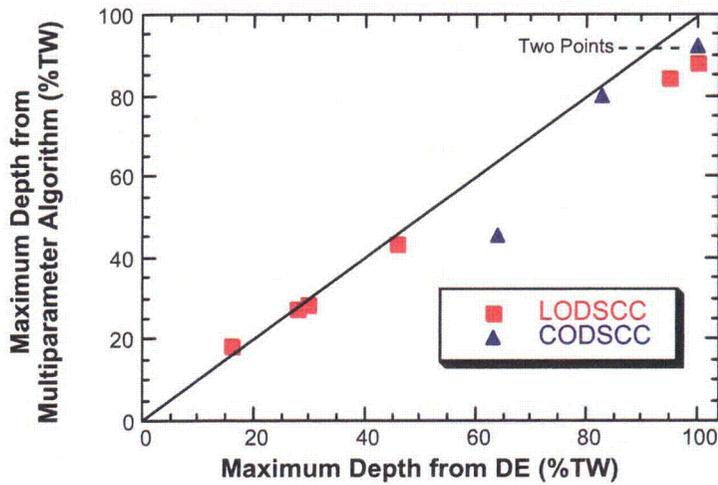
Figure 2.24. Comparison of maximum depth determined by the multiparameter algorithm with metallographic results for the ten specimens that were destructively analyzed. Destructive evaluation (DE) was carried out using metallographic sectioning techniques.

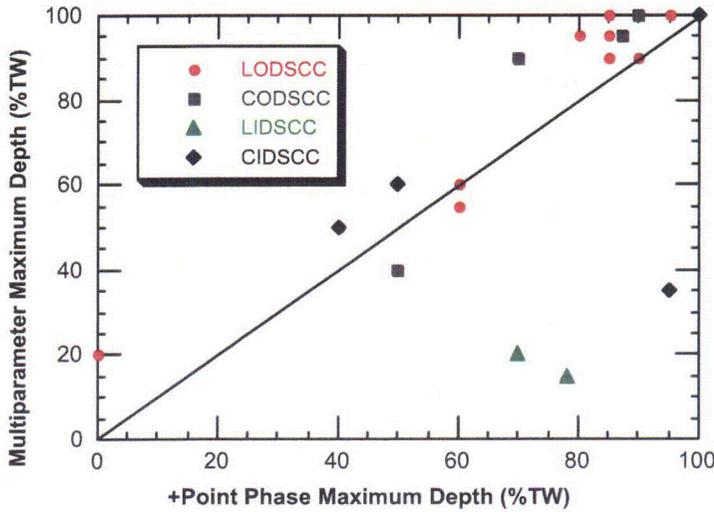
Figure 2.25. Estimates of maximum crack depths by the multiparameter algorithm compared with estimates using +Point phase analysis at 300 kHz.

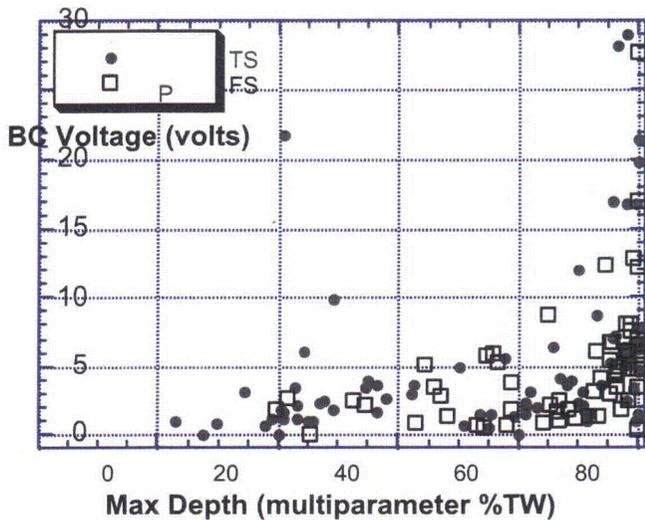
Figure 2.26. Maximum bobbin coil voltage as a function of maximum crack depth for FS and TSP SCC in the mock-up. The eddy current multiparameter algorithm was used to profile the crack and determine the maximum depth.

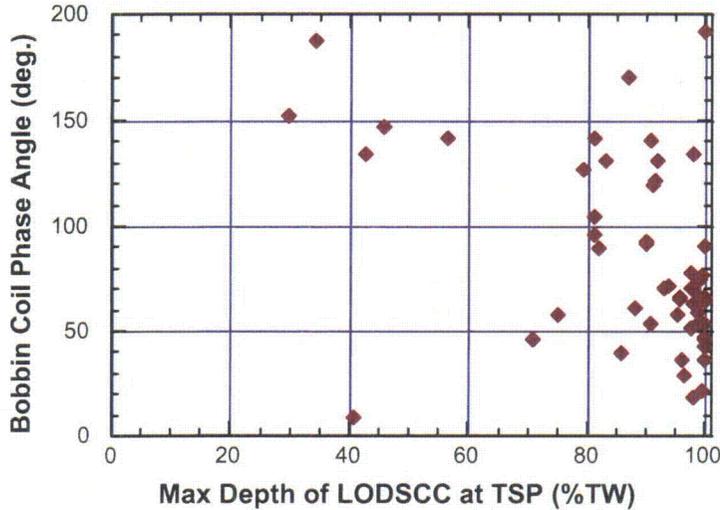
Figure 2.27. Bobbin coil phase-angle as a function of maximum crack depth for LODSCC at TSPs in the mock-up. The eddy current multiparameter algorithm was used to profile the crack and determine the maximum depth.

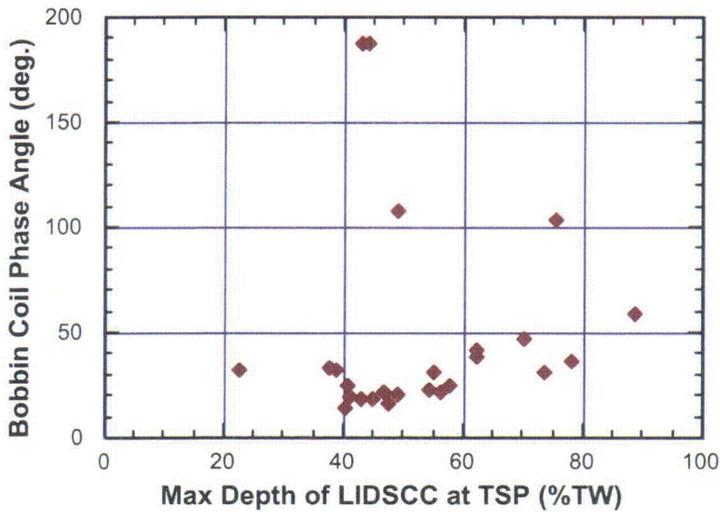
Figure 2.28. Bobbin coil phase-angle as a function of maximum crack depth for mock-up TSP LIDSCC. The eddy current multiparameter algorithm was used to profile the crack and determine the maximum depth.

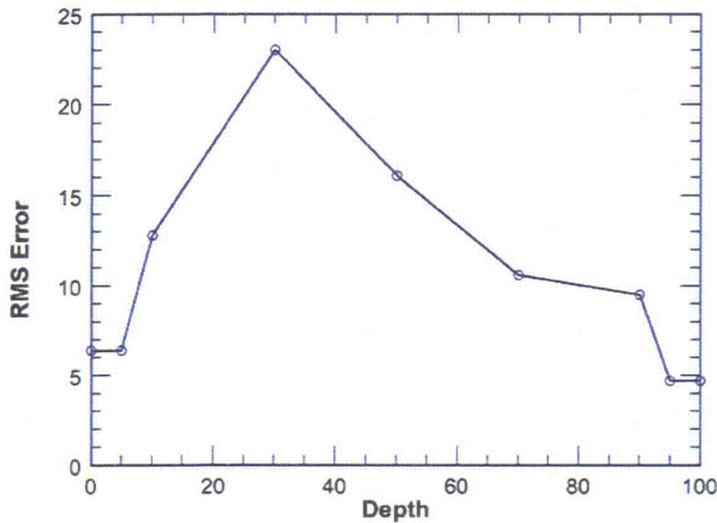
Figure 2.29. Standard deviation in percent throughwall as a function of predicted maximum depth.

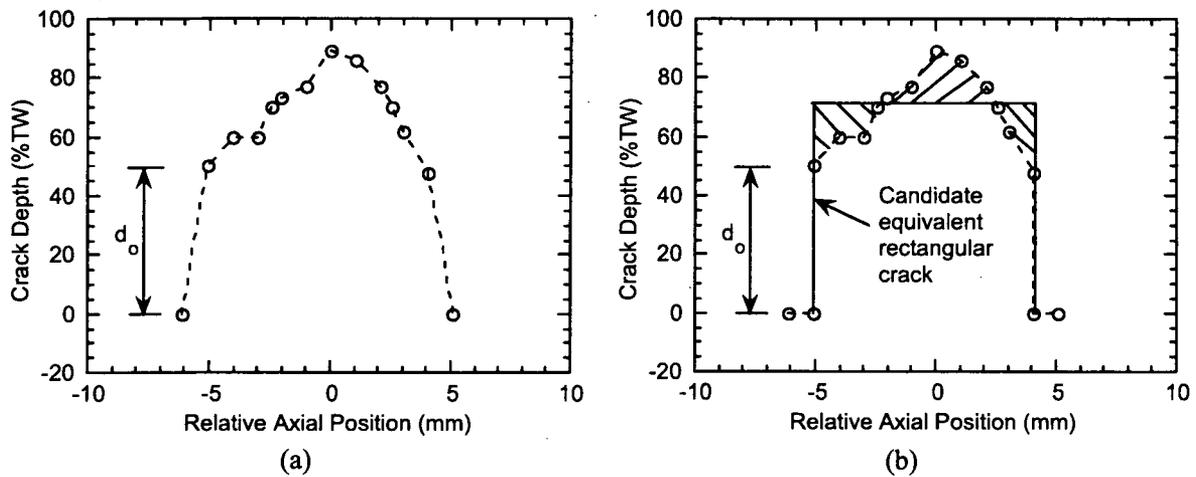
Figure 2.30. (a) Crack depth profile measured by eddy current and (b) a candidate equivalent rectangular crack corresponding to depth $d_0 = 50\%$ and $L_0 = 10$ mm (0.39 in).

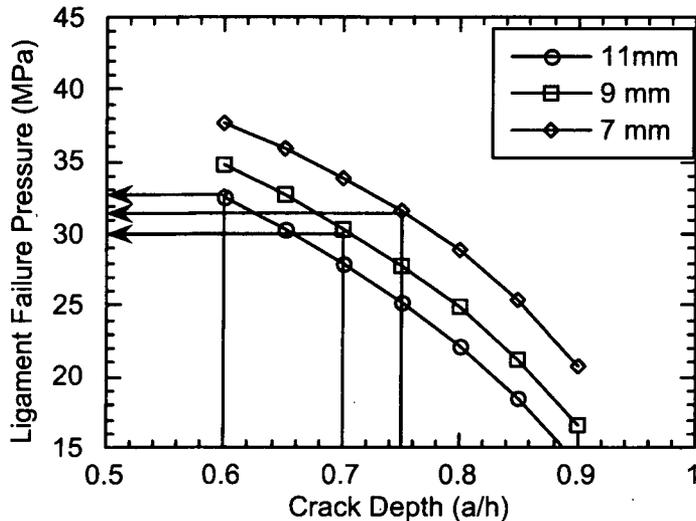
Figure 2.31. Ligament rupture pressures corresponding to three candidate equivalent rectangular cracks, 11 mm (0.43 in) by 60%, 9 mm (0.35 in) by 70%, and 7 mm (0.28 in) by 75%. The equivalent rectangular crack is 9 mm (0.35 in) by 70% because these values correspond to the lowest ligament rupture pressure (30 MPa or 4.35 ksi).

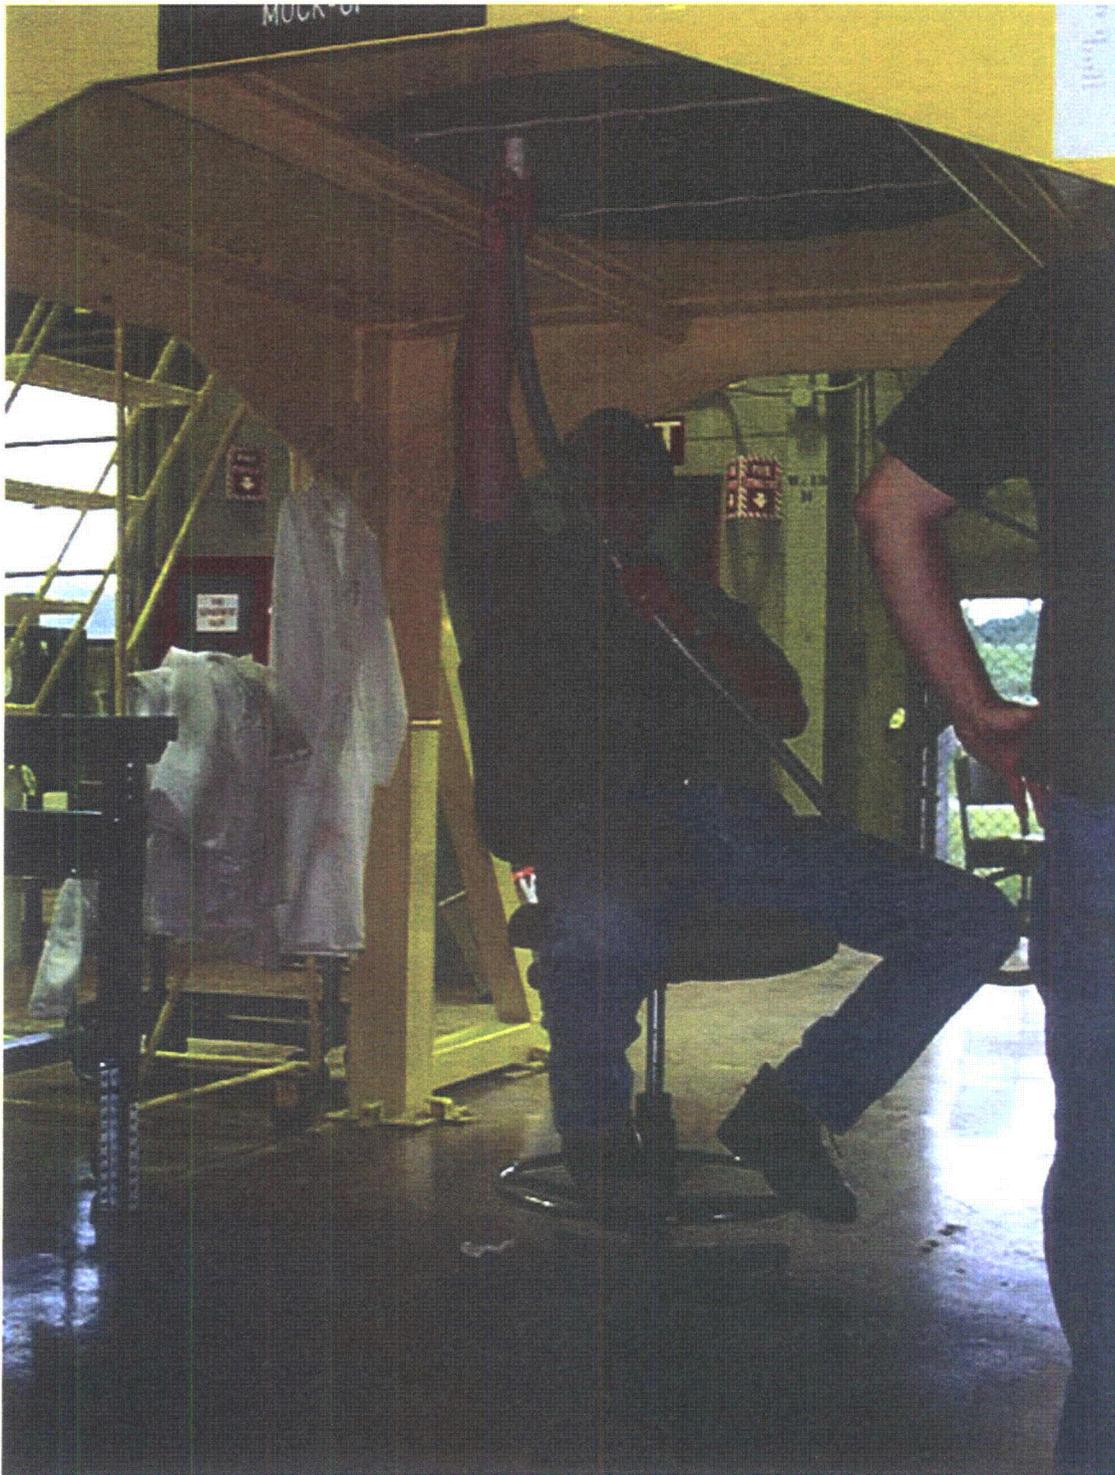
Figure 2.32. Photograph of underside of tube bundle. Conduit carrying the EC probe is shown being positioned under a tube.

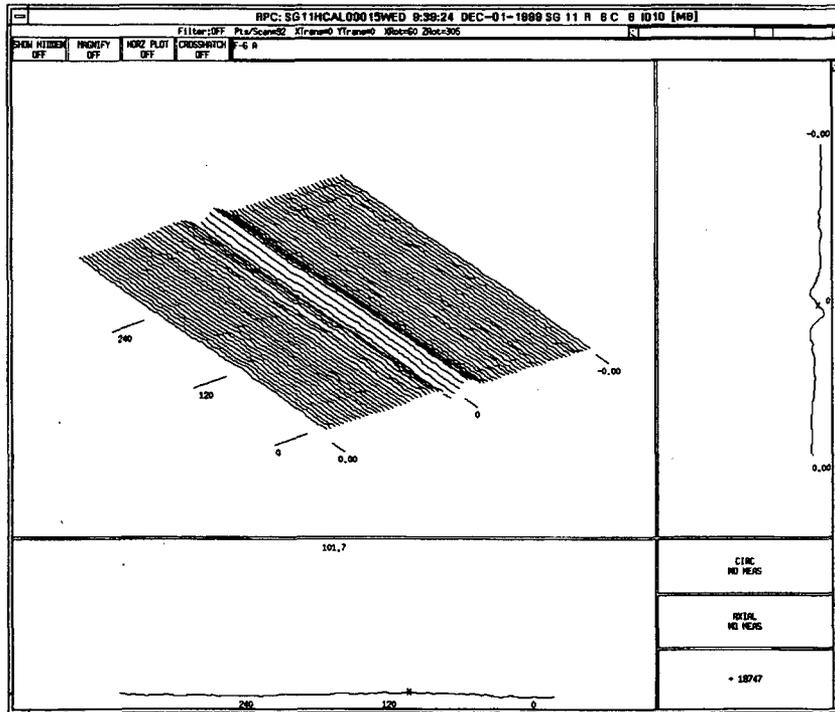
Figure 2.33. Isometric plot of mock-up roll transition collected with a rotating +Point coil at 300 kHz (example 1).

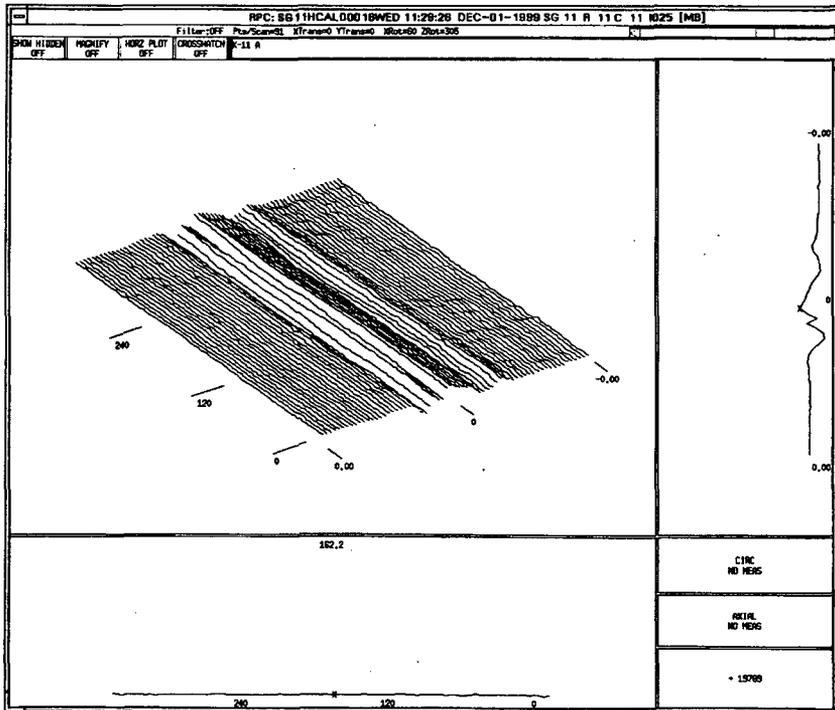
Figure 2.34. Isometric plot of mock-up roll transition collected with a rotating +Point coil at 300 kHz (example 2).

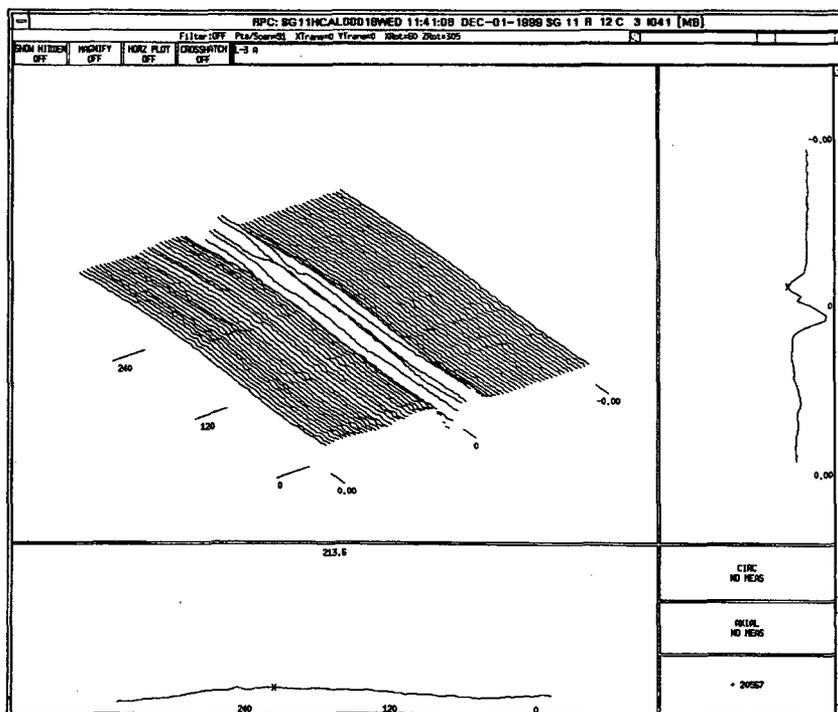
Figure 2.35. Isometric plot of mock-up roll transition collected with a rotating +Point coil at 300 kHz (example 3).

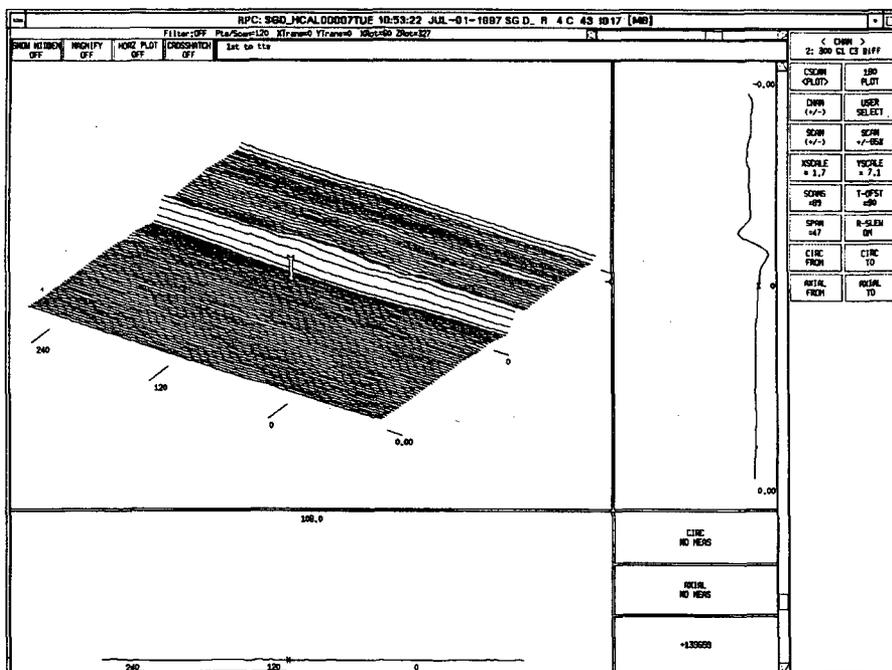
Figure 2.36. Isometric plot of roll transition from a retired steam generator.

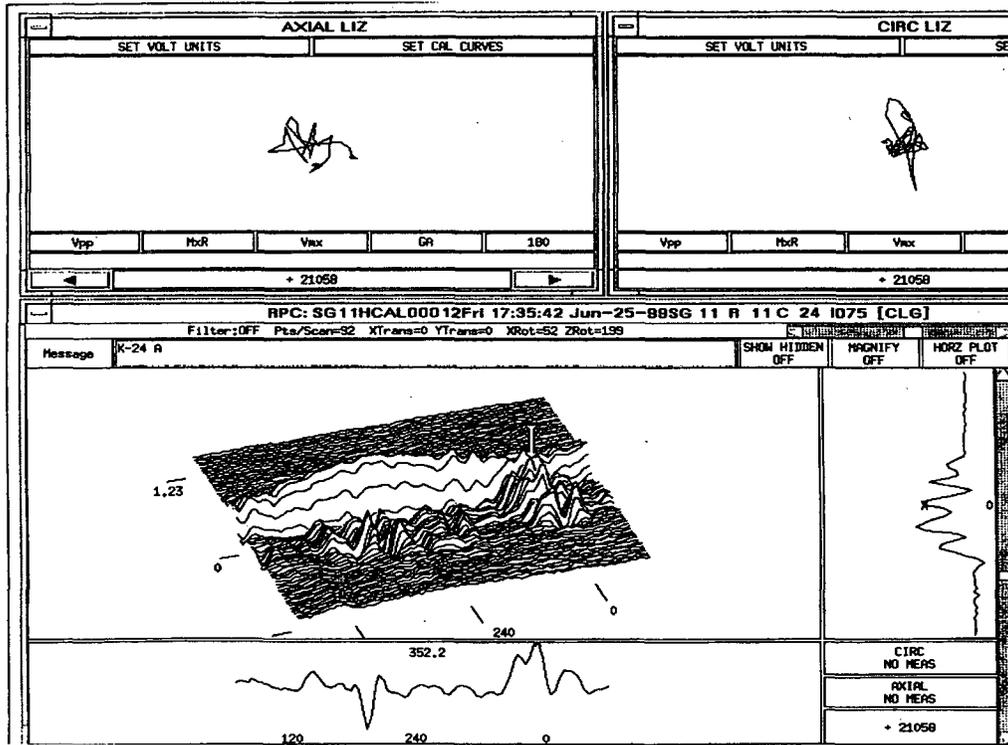
Figure 2.37. MRPC data plotted for LODSCC at TS with sludge.

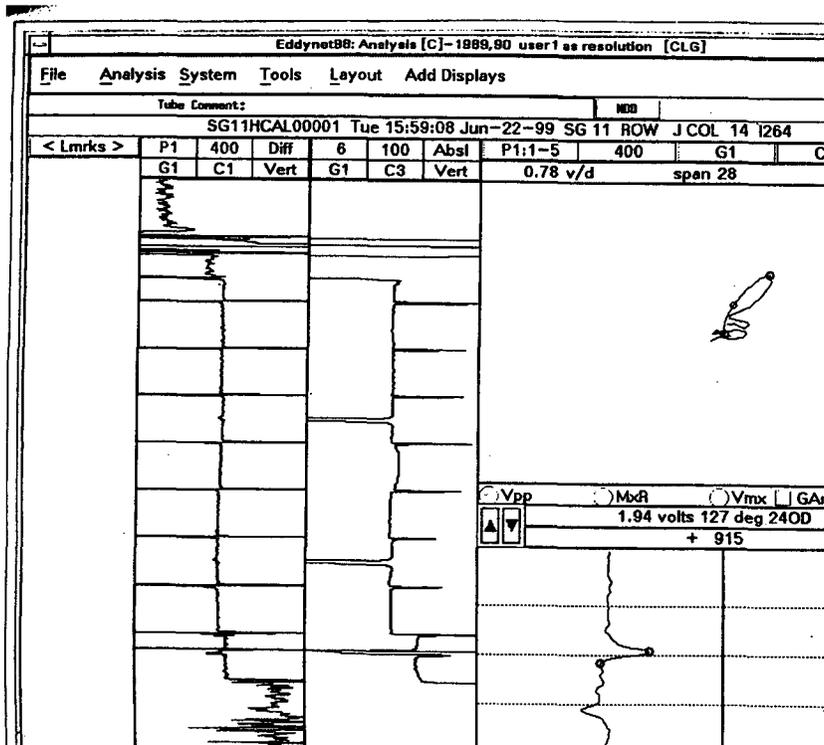
Figure 2.38. BC data plotted for LODSCC at TSP.
