NUREG/CR-6791
Revision 1
ANL-08/30

Eddy Current Reliability Results from the Steam Generator Mock-up Analysis Round-Robin

This report discusses a study conducted by Argonne National Laboratory (ANL) under contract with the U.S. Nuclear Regulatory Commission (NRC), Office of Nuclear Regulatory Research (RES). RES initiated this study as part of the agency's Steam Generator Tube Integrity Program. Through this work, RES aims to support the NRC's Office of Nuclear Reactor Regulation (NRR) in evaluating licensee inspection programs that utilize eddy current examination technology. Inspection reliability is important to properly assess the condition of steam generator tubes.

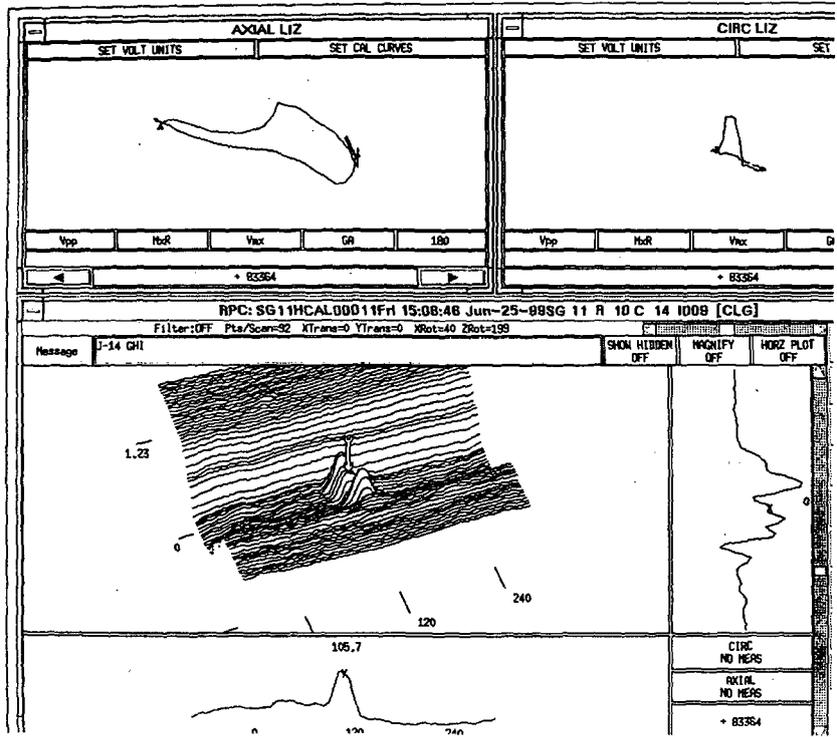
Figure 2.39. MRPC data plotted for LODSCC at TSP.

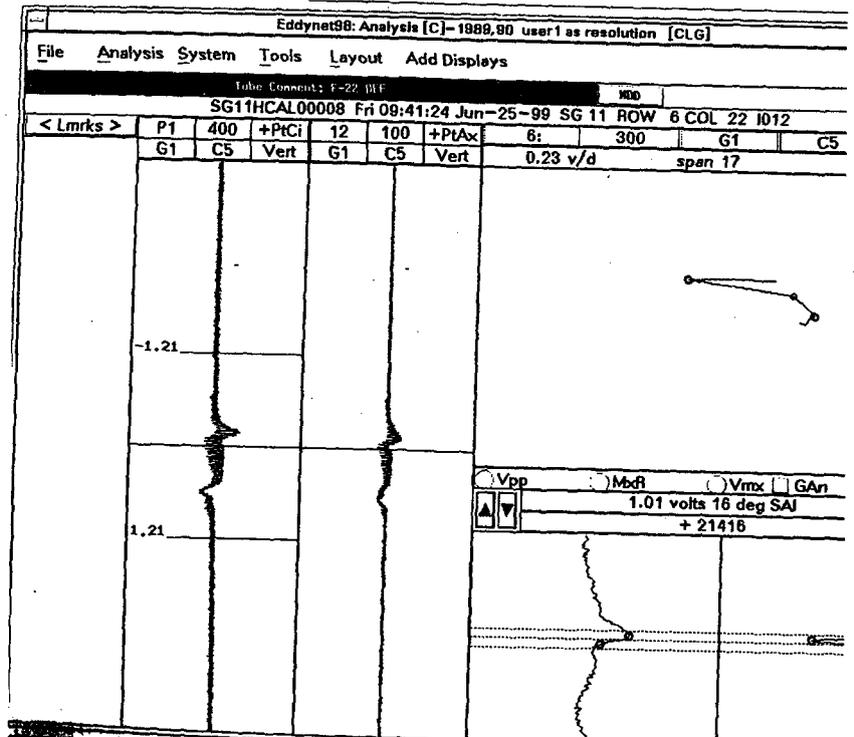
Figure 2.40. BC data plotted for LIDSCC in dent at TSP.

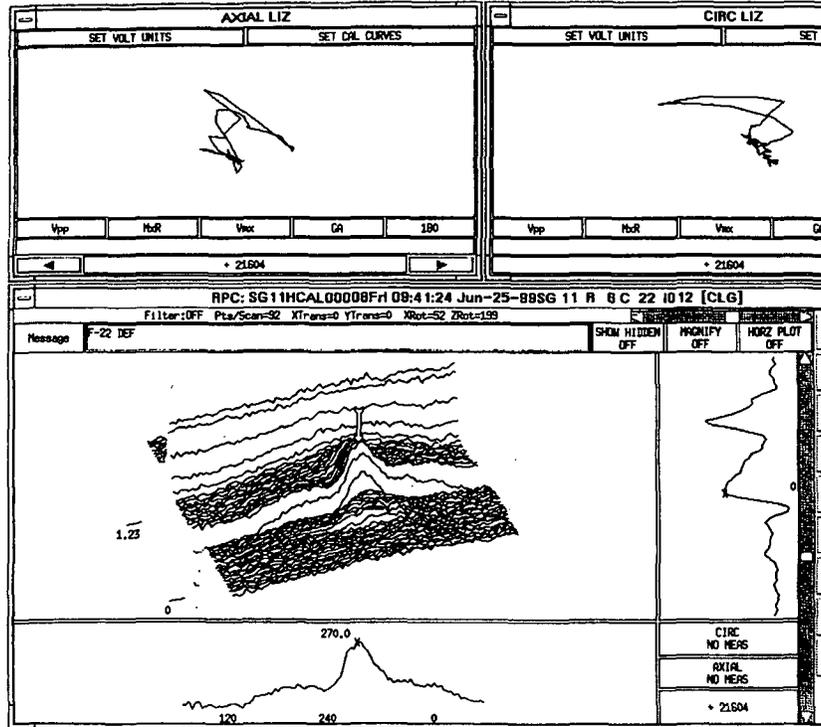
Figure 2.41. Isometric plot for LIDSCC in dent at TSP.

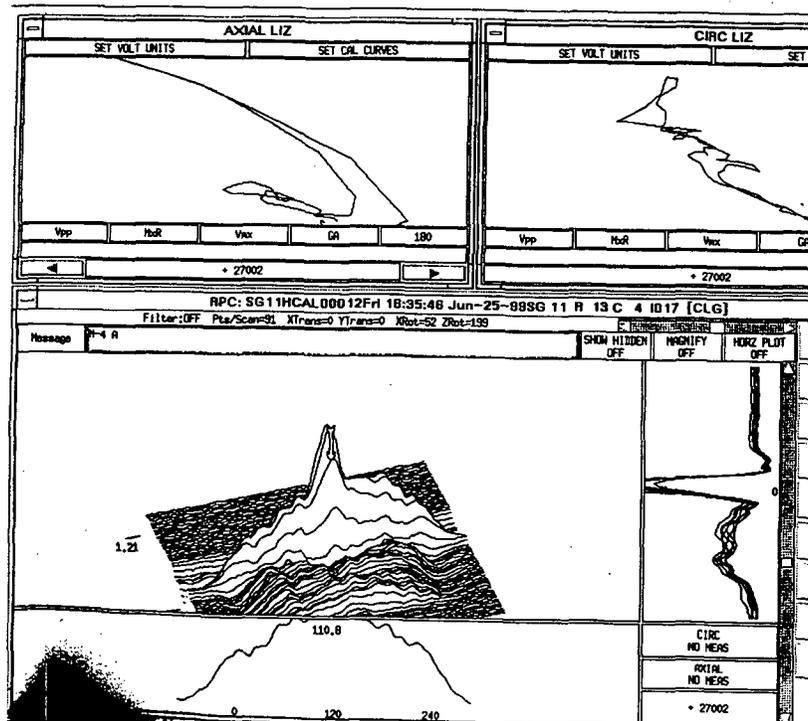
Figure 2.42. Isometric plot for CIDSCC at TS with sludge.

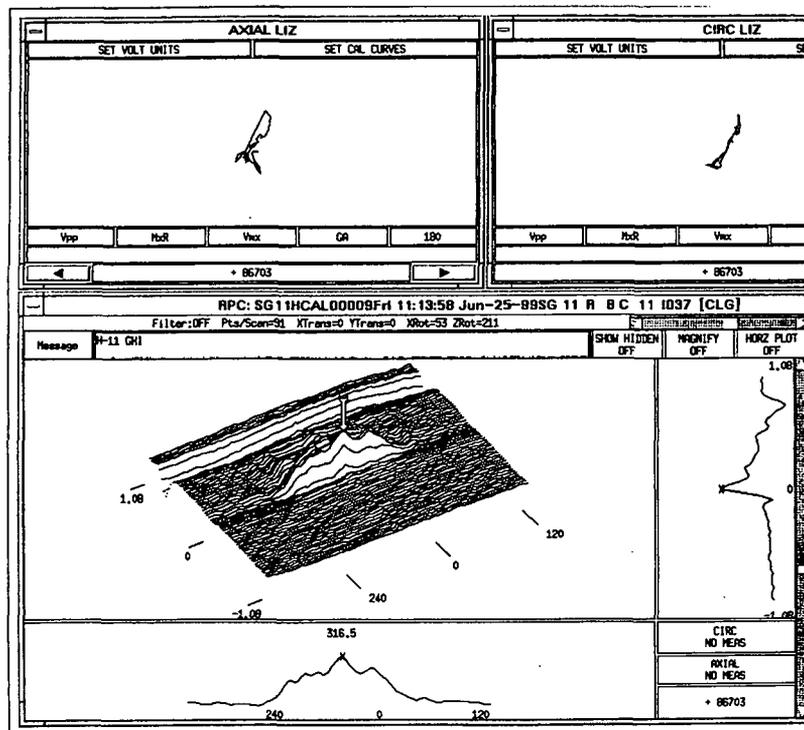
Figure 2.43. RPC data plotted for IGA at TSP.

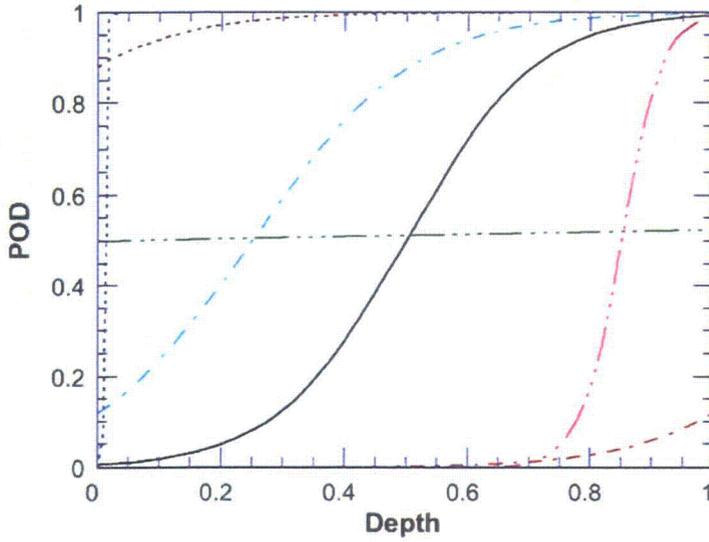
Figure 2.44
Range of POD curves represented by linear-logistic functions with varying values of the parameters a and b .

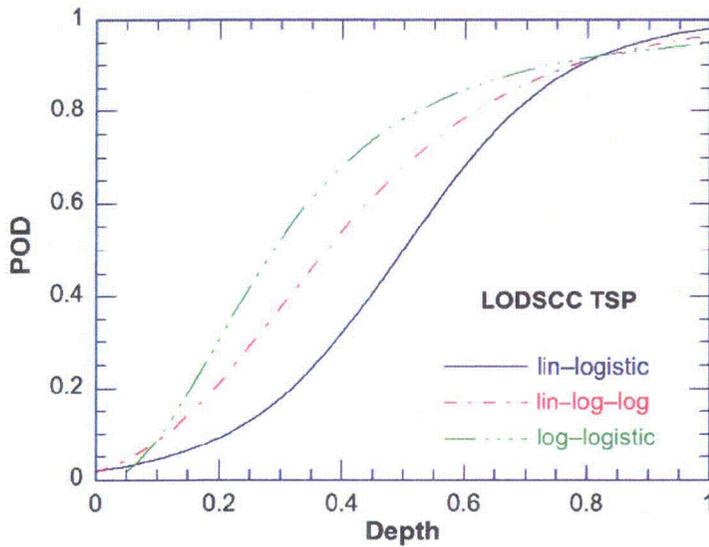
Figure 2.45
Linear-logistic, log-logistic, and linear-log-log fits to mockup inspection data for longitudinal OD SCC at tube support plates.

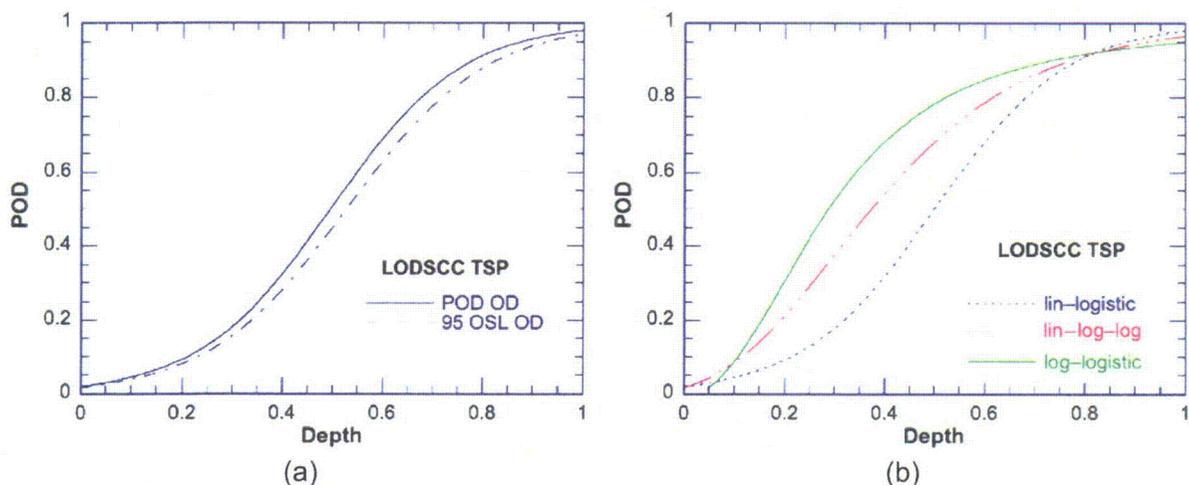
Figure 2.48. BC POD for TSP data as a function of maximum depth for LODSCC and LIDSCC using maximum likelihood fits; (a) linear-logistic fit and the one-sided 95% confidence limit (OSL) including uncertainty in the maximum depth; (b) linear-logistic, linear log-log, and log-logistic fits for LODSCC. The solid curve in each figure is the best-fit to the data.

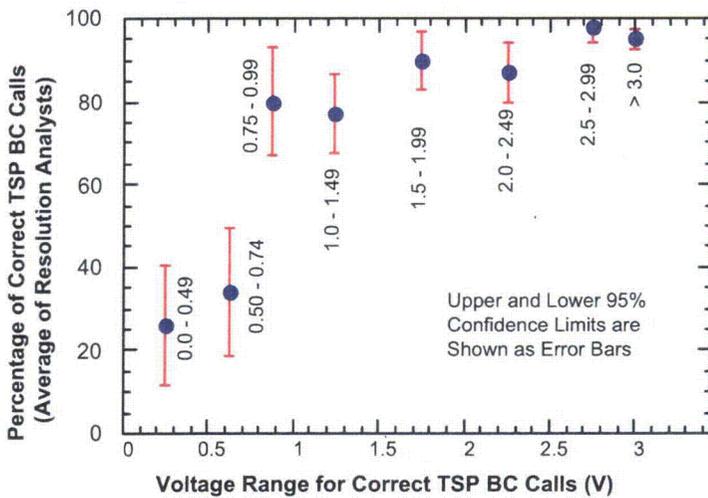
Figure 2.52.
Round-robin resolution analysts' results as a function of BC voltage for TSP crack. The BC POD has been evaluated for LODSCC at the TSP.

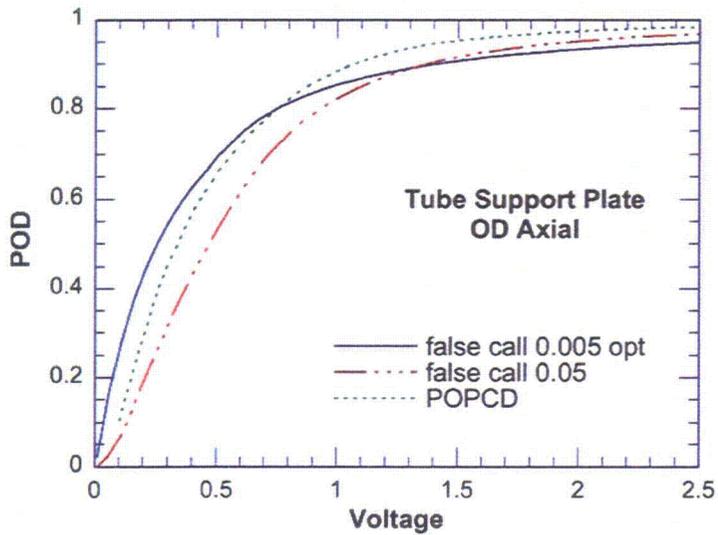
Figure 2.53. Log-logistic fits for BC POD as a function of voltage for LODSCC in TSP. POPCD is a voltage-based POD curve developed by industry.

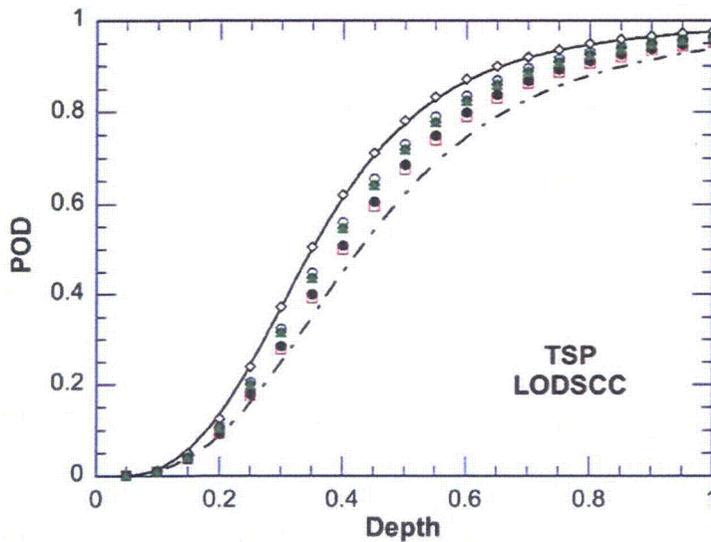
Figure 2.54. BC POD by team for free-span and TSP LODSCC combined as a function of depth. The maximum crack depth (as fraction of wall) was determined by the multiparameter algorithm. The highest solid line represents the best team, the lowest dashed line represents the worst team, and the other symbols represent the remaining teams.

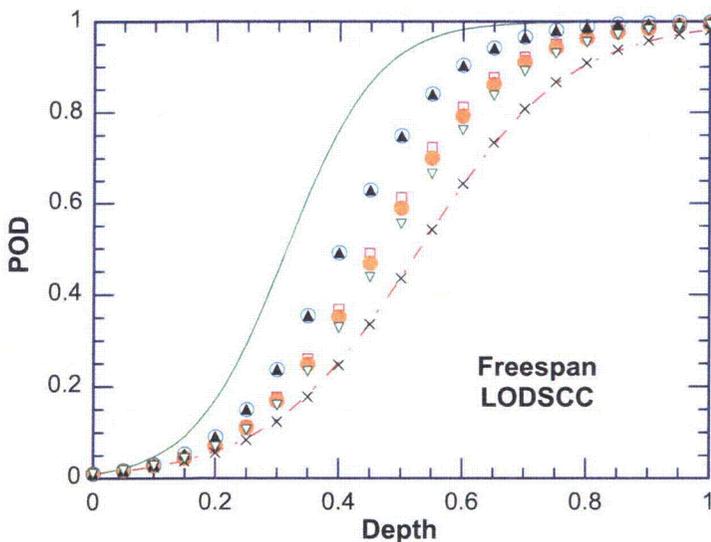
Figure 2.55. BC POD by team for free-span LODSCC as function of depth. The maximum crack depth (as fraction of wall) was determined by the multiparameter algorithm. The solid line represents the best team, while the symbols and dashed line represent the remaining teams.

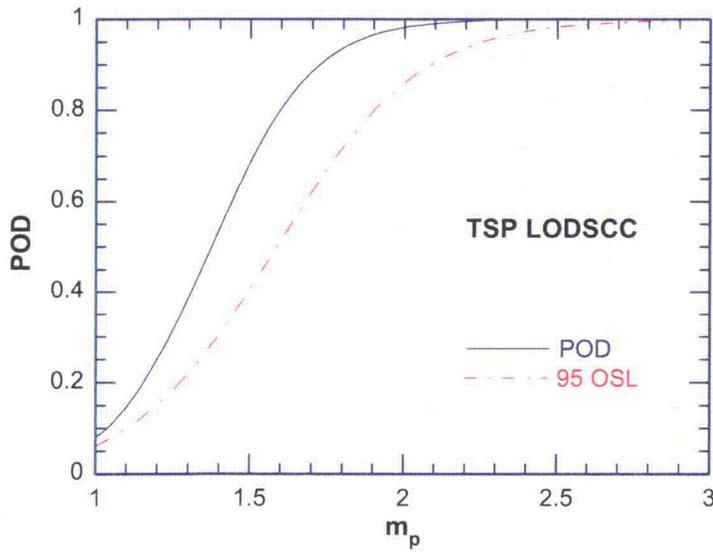
Figure 2.56.
BC POD for TSP LODSCC as a function of m_p . Curves derived by maximum likelihood fit and an estimate of the one-sided 95% confidence limit. The values of m_p are derived by using depths from the multiparameter algorithm.

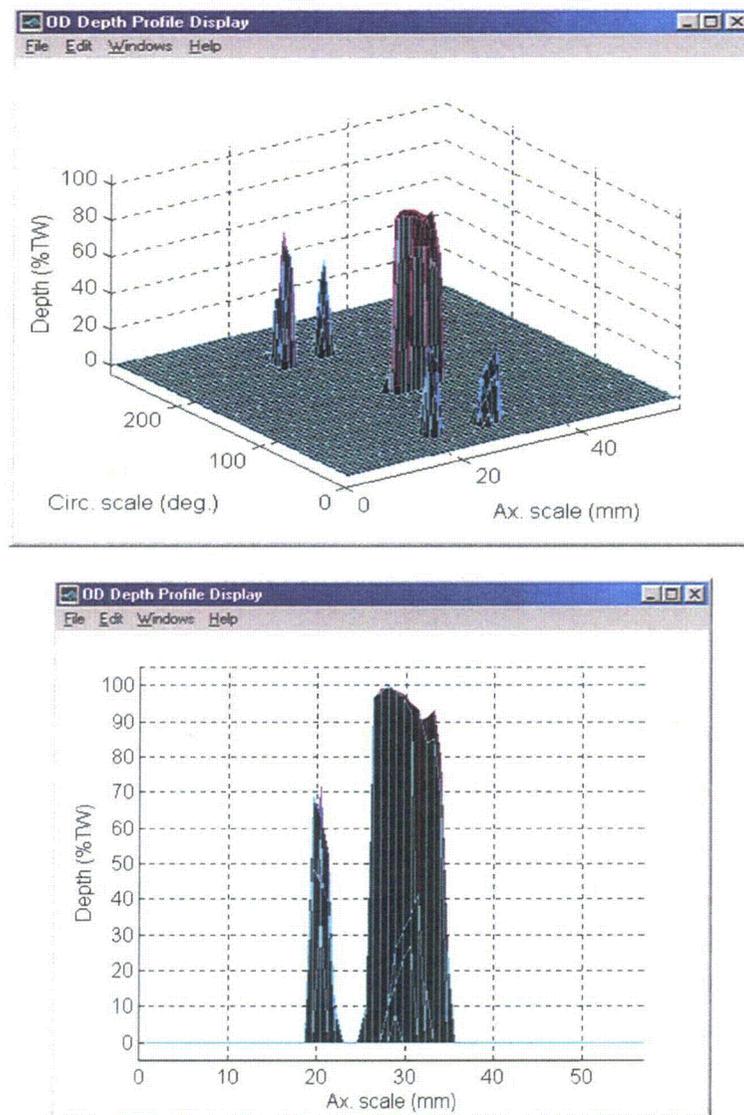
Figure 2.64. Depth profiles of TSP LODSCC with maximum depth of 99% TW that was missed by all teams analyzing MRPC data. The largest piece of the segmented crack has a length of about 10 mm (0.4 in). The lower part of the figure shows the crack along the test section axis.

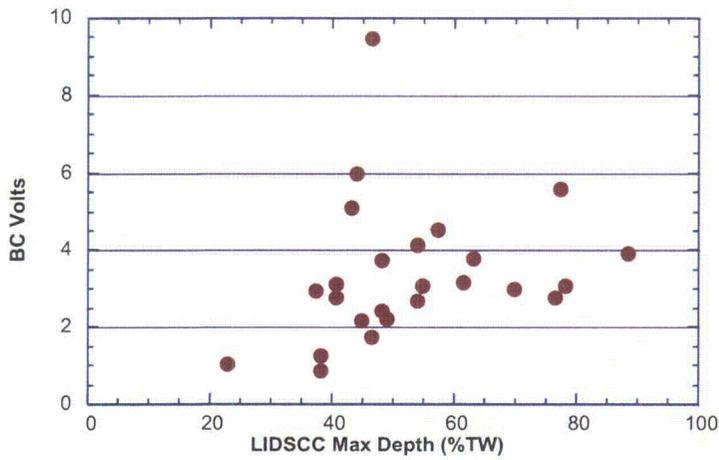
Figure 2.65. Bobbin coil voltage as a function of maximum depth of LIDSCC in a TSP dent. These data show no correlation between BC voltage and LIDSCC depth. The depth was determined by application of Argonne's multiparameter algorithm to MRPC data.

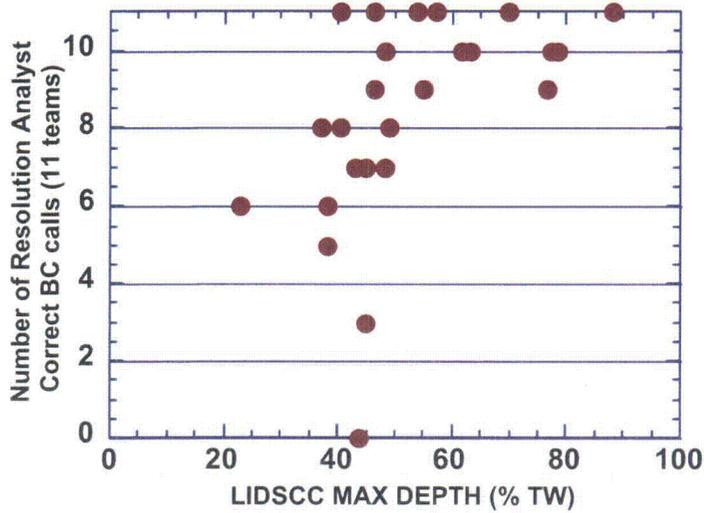
Figure 2.66. Number of teams out of 11 correctly calling LIDSCC in a TSP dent from mock-up bobbin coil data (using resolution analyst reports) as a function of maximum crack depth. The depth was determined by application of Argonne's multiparameter algorithm to MRPC data.

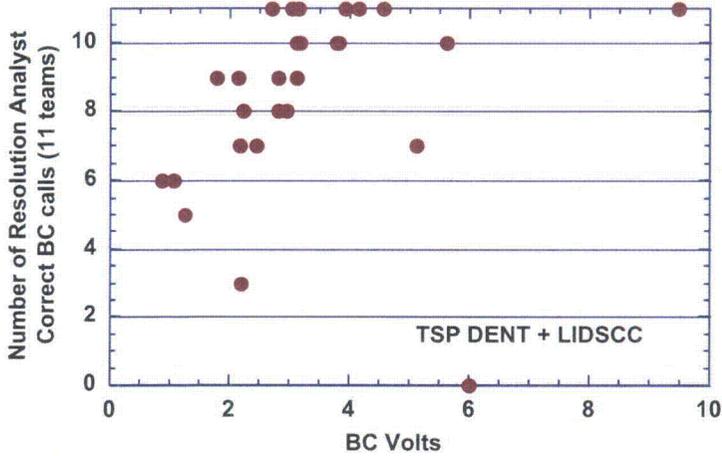
Figure 2.67. Number of teams out of 11 correctly calling LIDSCC in a TSP dent from mock-up bobbin coil data (using resolution analyst reports) as a function of BC voltage.

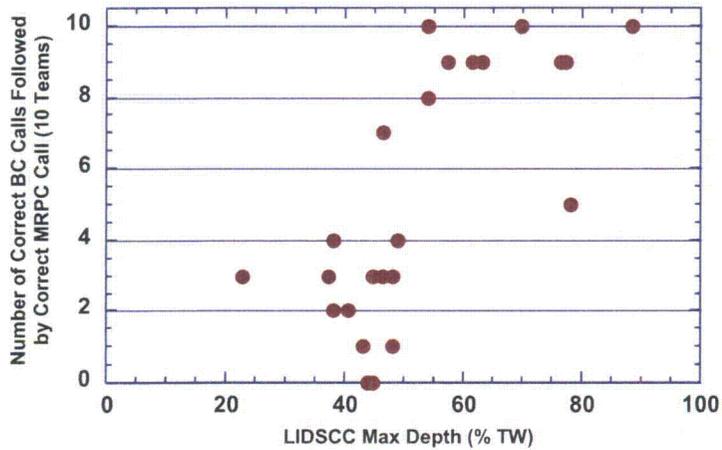
Figure 2.68. Number of teams out of 10 correctly calling an LIDSCC in a dented TSP from mock-up bobbin coil data followed by a correct call for that crack using MRPC data (from resolution analyst reports) as a function of maximum crack depth. The depth was determined by application of Argonne's multiparameter algorithm to MRPC data.

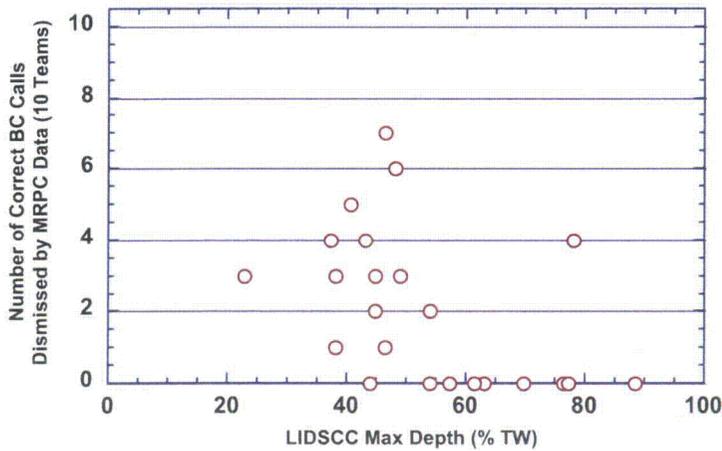
Figure 2.69. Number of teams out of 10 correctly calling an LIDSCC in a dented TSP from bobbin coil data followed by dismissing that crack using MRPC data (from resolution analyst reports) as a function of maximum crack depth. The depth was determined by application of Argonne's multiparameter algorithm to MRPC data.

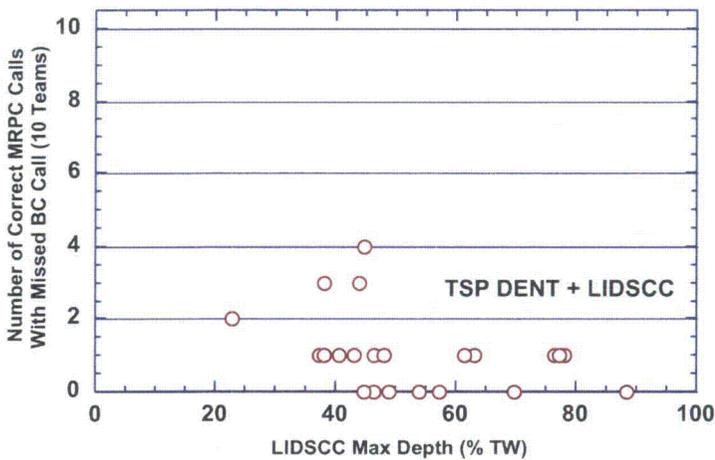
Figure 2.70. Number of teams out of 10 missing an LIDSCC in a dented TSP from bobbin coil data followed by a correct call using MRPC data (from resolution analyst reports) as a function of maximum crack depth. The depth was determined by application of Argonne's multiparameter algorithm to MRPC data.

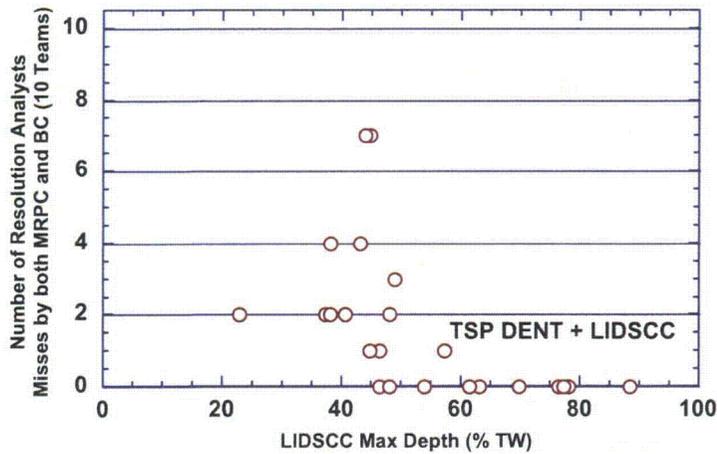
Figure 2.71. Number of teams out of 10 missing an LIDSCC in a dented TSP with both bobbin coil and MRPC data (from resolution analyst reports) as a function of maximum crack depth. The depth was determined by application of the multiparameter algorithm to MRPC data.

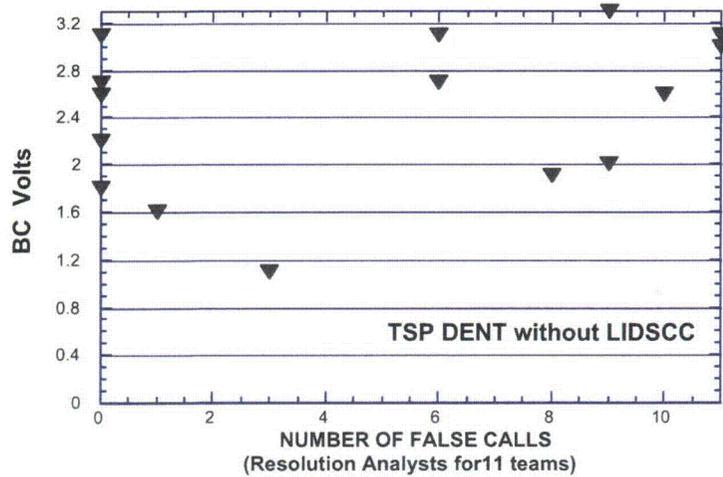
Figure 2.72. Number of false calls in dented TSP test sections as a function of BC voltage (0.1–V window).

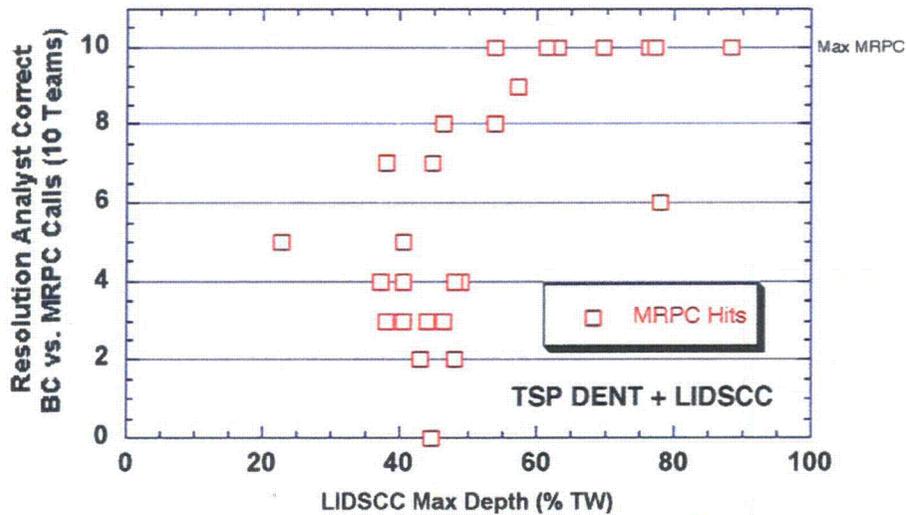
Figure 2.73. Number of teams correctly calling an LIDSCC in a dented TSP using MRPC data (from resolution analyst reports) as a function of maximum crack depth. The depth was determined by application of Argonne's multiparameter algorithm to MRPC data.

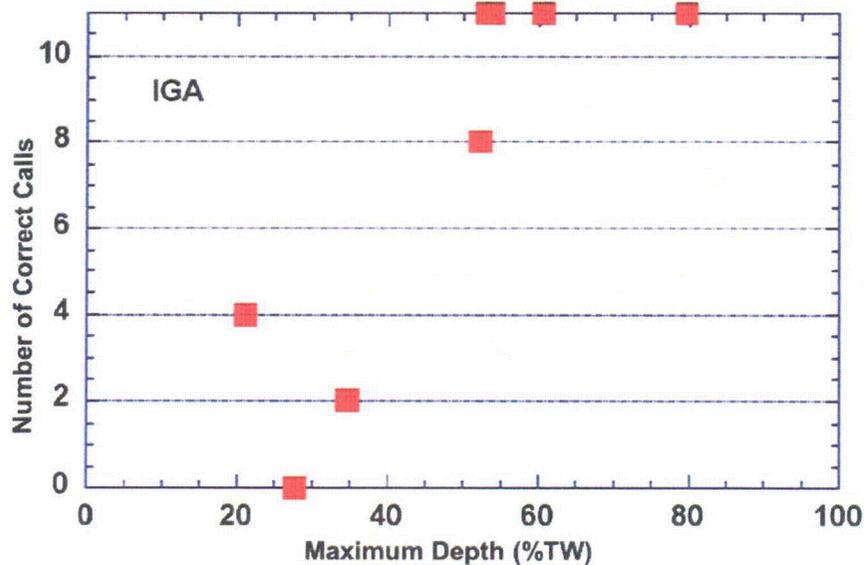
Figure 2.74. Number of teams out of 11 correctly calling IGA from bobbin coil data (using resolution analyst reports) as a function of maximum flaw depth. The depth was determined by application of Argonne's multiparameter algorithm to MRPC data.

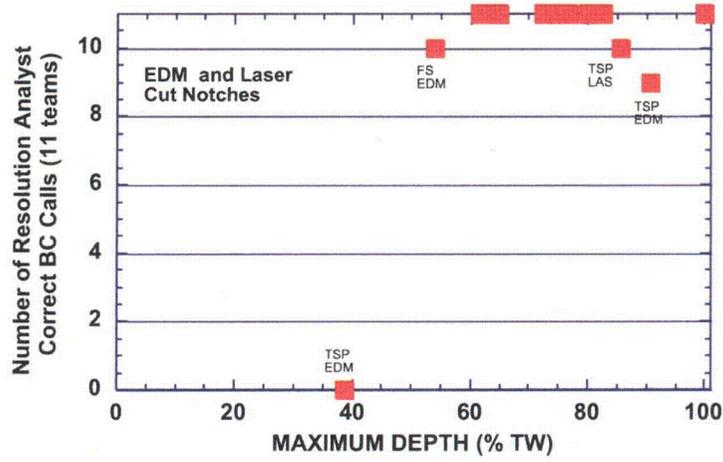
Figure 2.75. Number of teams out of 11 correctly calling EDM and laser cut slots (LAS) from bobbin coil data (using resolution analyst reports) as a function of maximum depth. The location and type of notch missed is indicated in the graph.

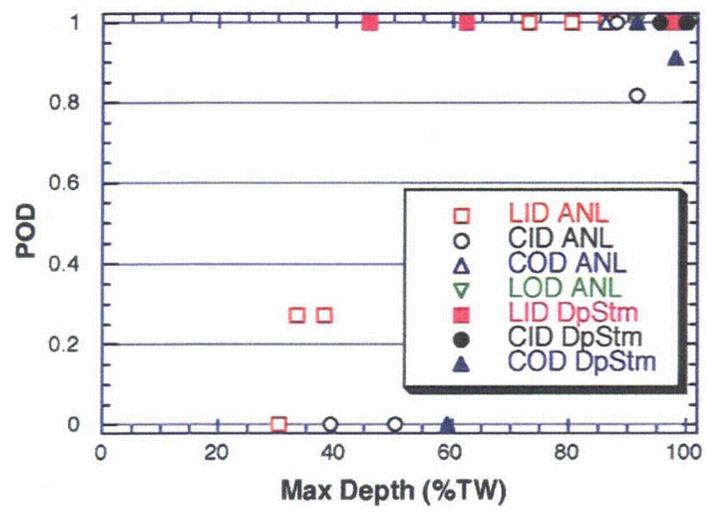
Figure 2.76. POD for Tube-sheet MRPC as a function of maximum depth (as fraction of wall) for axial and circumferential IDSCC and ODSCC grown at Argonne and cracks grown using doped steam technique. Depths are determined with the multiparameter algorithm.

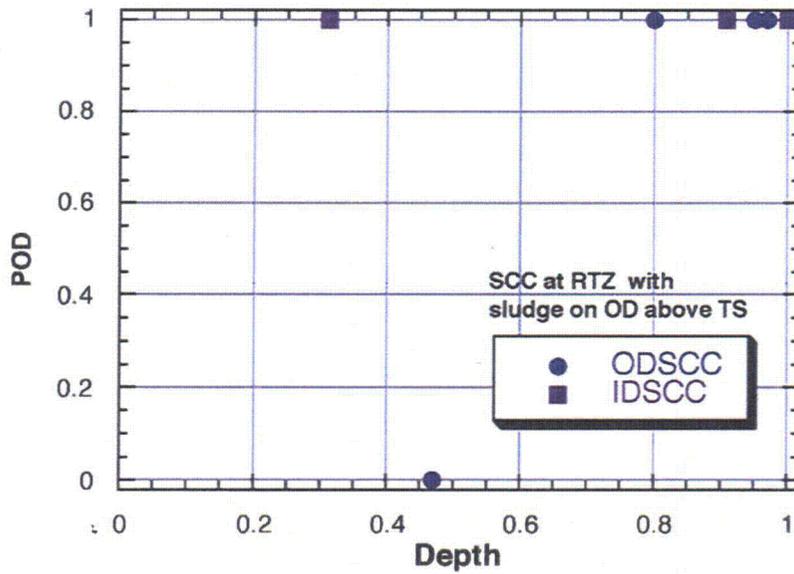
Figure 2.78 POD using MRPC data for OD and ID SCC at the RTZ with sludge above the tube-sheet.

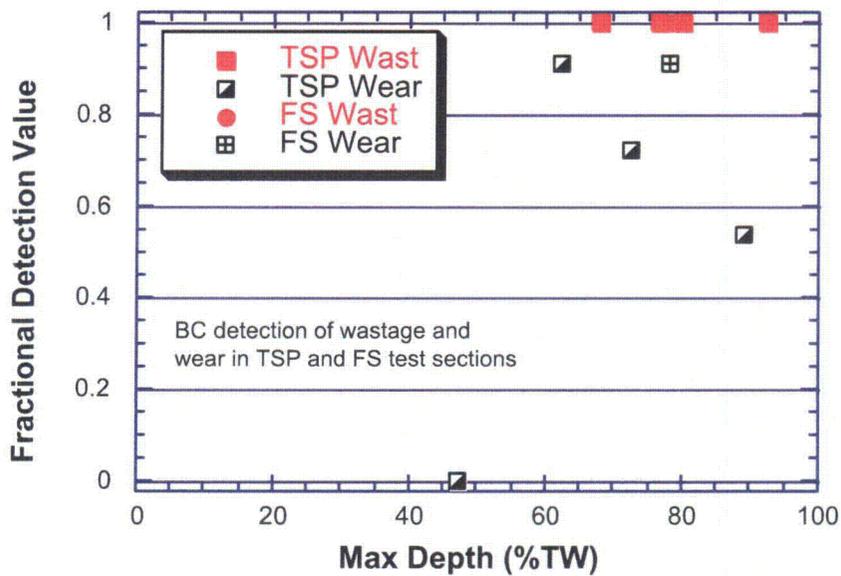
Figure 2.79. Fractional detection rate for wastage and wear using bobbin coil data.

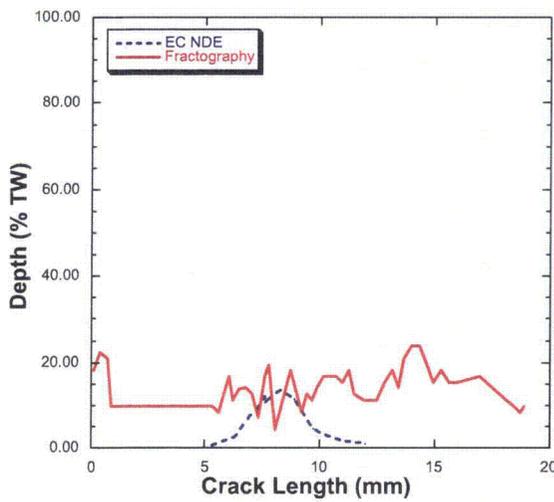
Figure A23.
 AGL 8162 LIDSCC:
 EC NDE depth versus position using
 the multiparameter algorithm (dotted
 curve) and fractography depth versus
 position (smooth curve).

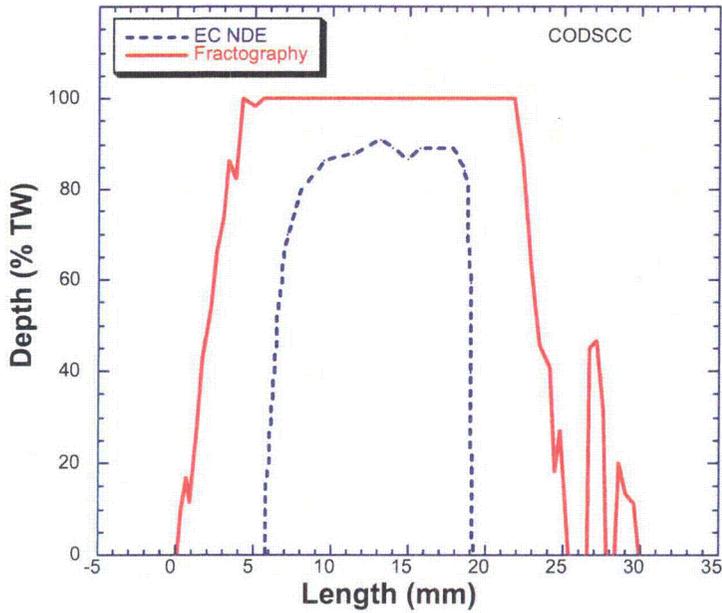
Figure A24.
Test section 42 removed from mock-up with a CODSCC. EC NDE depth versus position using the multiparameter algorithm (dotted curve) and fractography depth versus position (smooth curve).

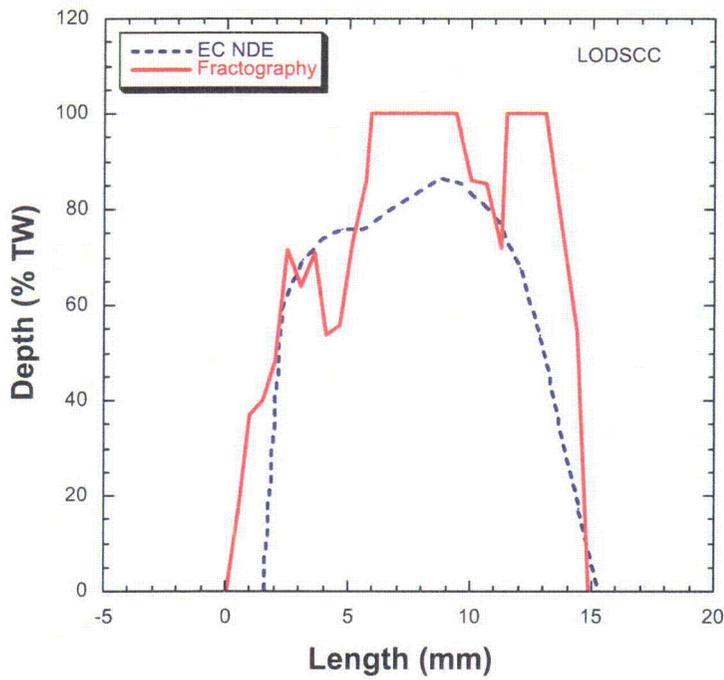
Figure A29.
 Test section 48 removed from mock-up with an LODSCC. EC NDE depth versus position using the multiparameter algorithm (dotted curve) and fractography depth versus position (smooth curve).

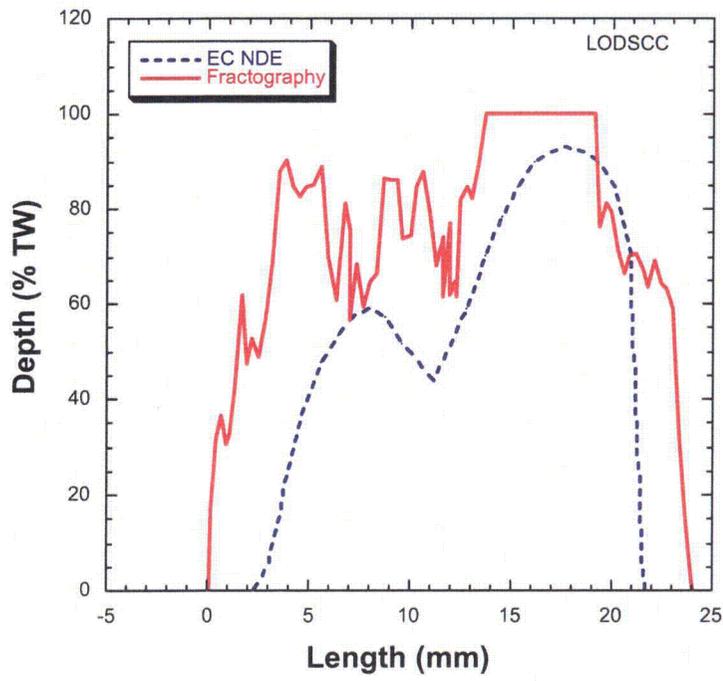
Figure A30.
 Test section 49 removed from mock-up with an LODSCC. EC NDE depth versus position using the multiparameter algorithm (dotted curve) and fractography depth versus position (smooth curve).
