**Safety Analysis Report
for
Century Industries
Versa-Pac Shipping Container**

**Revision 1
October, 2009**

**Designed and Submitted By:
Century Industries,
Bristol, Virginia**

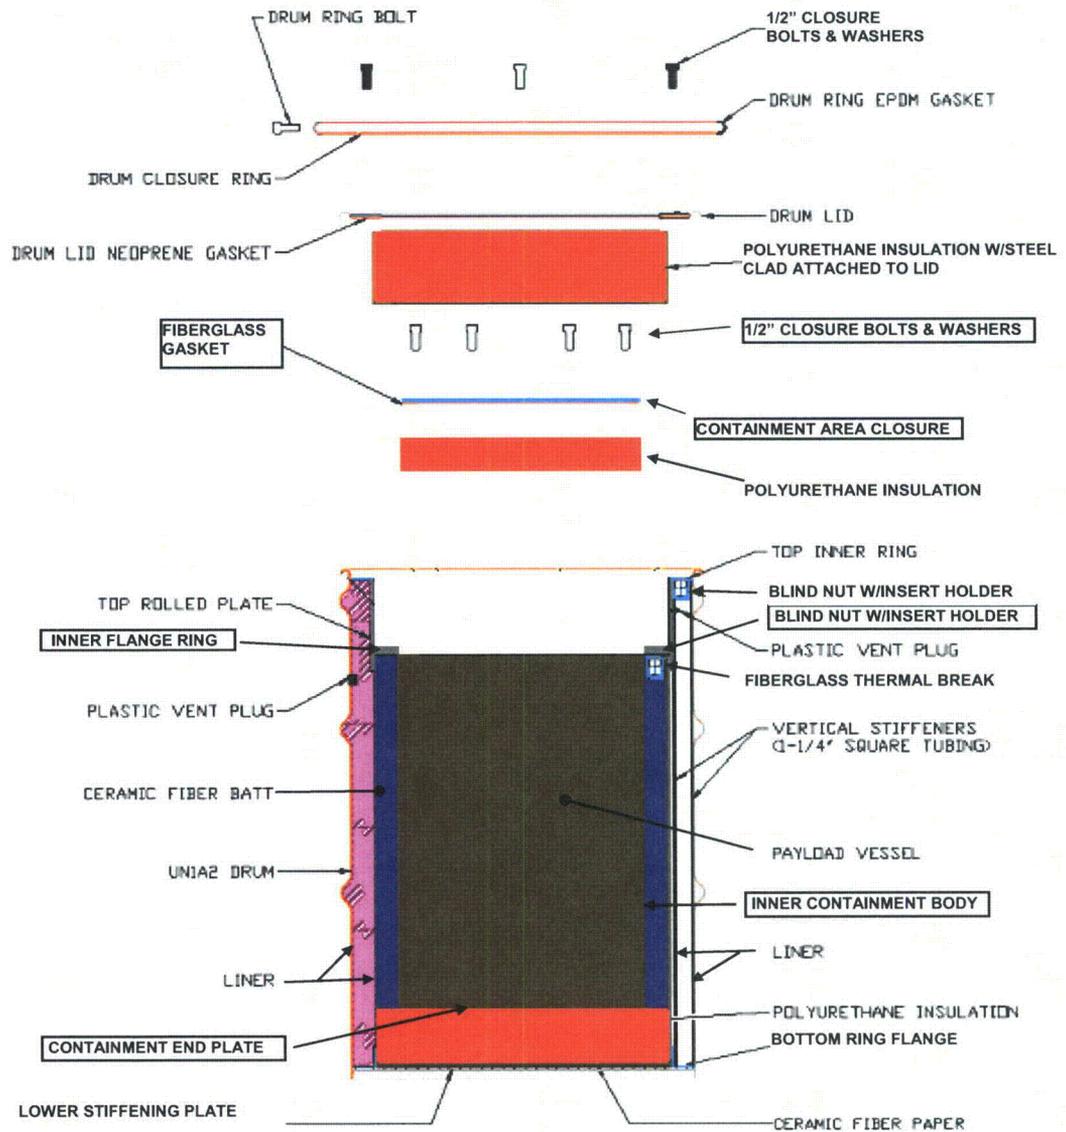
Figure 1-1 Versa-Pac Component Illustration

(Containment boundary components, as indicated in Section 1.2.1.7, are described in text boxes)

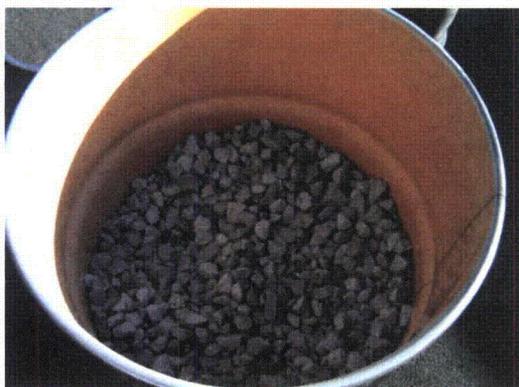
30 Gallon Drum Loaded With 260 Pounds of Loose Gravel

The 30 gallon drums were closed and the bolt closure ring of each container was torqued to 60 ft/lbs. and lowered into the containment cavity and the loose sand placed onto the top of the drum within the containment cavity. The 1/8" thick silicone coated fiberglass gasket and 3/16" thick containment flange were placed into position and the bolts inserted and hand tightened. The flange bolts were then tightened using an alternating method and torqued to 40 ft/lbs. The top gasket and outer closure, which includes the attached encased polyurethane foam insulation top plug, was installed on each of the test articles and the top outer bolts installed and torqued using the same alternating method to a tension of 40 ft/lbs. The outer drum closure rings were then installed and tightened to a torque of 60 ft/lbs.

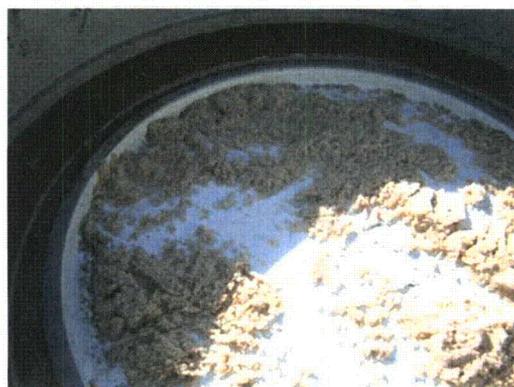
1-1/2 Pounds of Sand on Top of Containment Payload

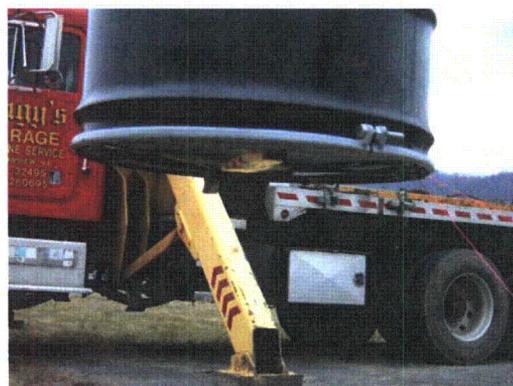
Damage from NCT 4' Drop

There were no tears or openings to the drum surface. All bolts remained in tact.

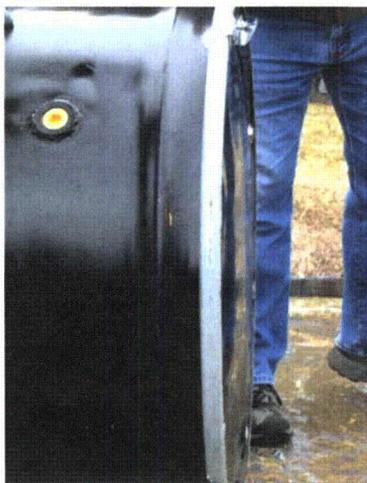
Upon impact to the top end of the package the overall height was reduced by 1/4" inch and the diameter was increased by 1/16 inch. The closure ring and all bolts remained in tact and secure.

Side View – Top End Drop Damage
Century Industries
Bristol, Virginia

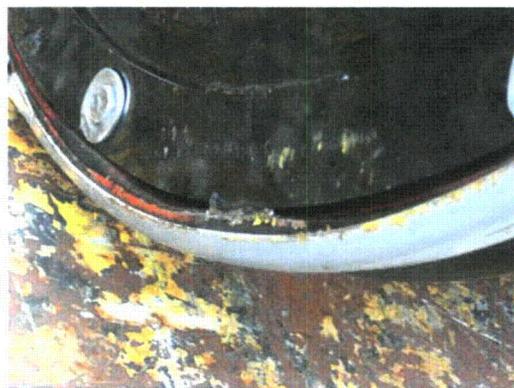
Close-up – Damage to Closure End
Versa-Pac Shipping Container Test Report
March 25, 2009

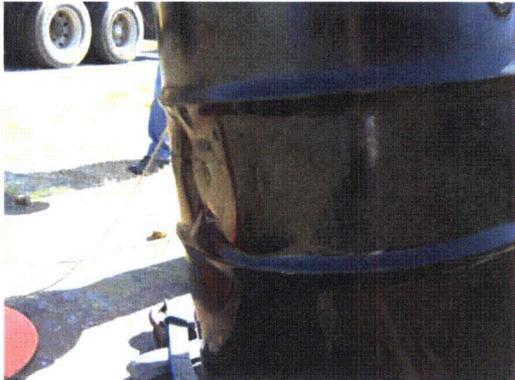
Upon impact a deformation in the side of the test article was measured at a depth of 3/8 inch. There were no tears as a result of the puncture drop. The results were recorded and photographed.

**Close-up Damage from Puncture
Between the Vertical Stiffeners**

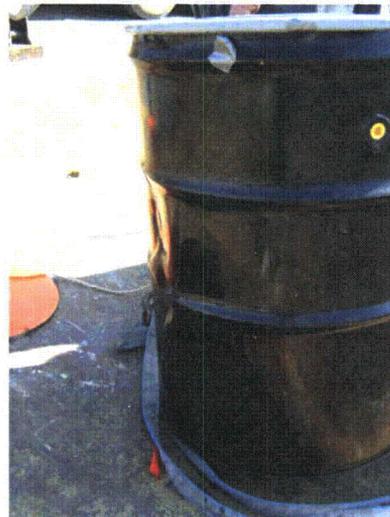
**Side View – Horizontal Puncture
Damage**

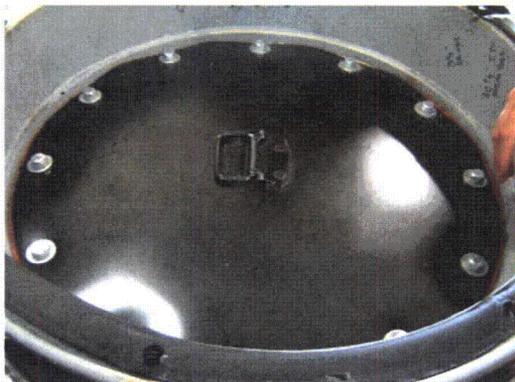
As a result of this test series the outer closure bolts recorded a post test torque of 30 ft/lbs. The outer lid was removed exposing a bulge in the inner containment flange. The bulge allowed sand which was placed on the top of the inner containment payload 30 gallon drum to be forced under the containment gasket. The bulge was caused by the impact of the inner payload and the secondary piston impact of the internal payload within the drum itself. Containment flange bolts were torqued prior to removal and recorded at 20 ft/lbs. The gaskets and the internal cavity of the containment were found to be in good condition with no damage. The conclusion of this test series is that corrections were needed to the blind flange seal and closure and that additional testing would be required.

Internal Blind Flange Bulge

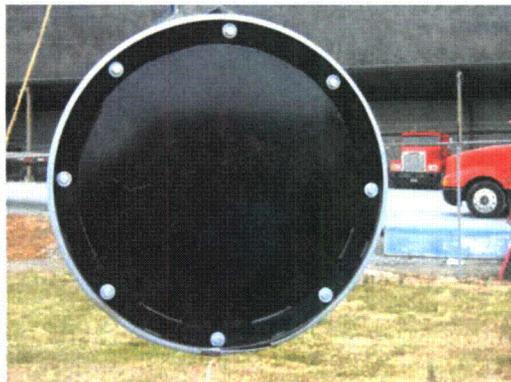
The resultant impact to the exterior surface allowed the bolted closure ring to push into the side wall approximately 5/8 inch deep. There was no reduction in the diameter or height of the package. No bolts were broken and there were no tears or broken welds. Damage was documented and photographed.

Post-Test – End View of Damage

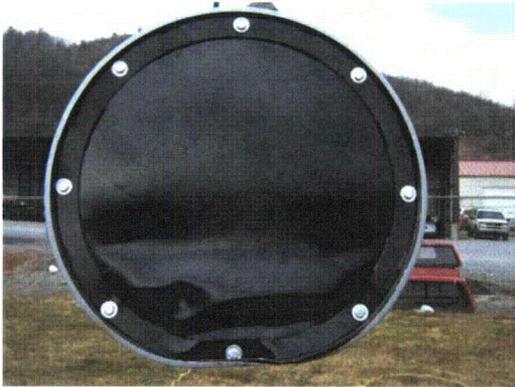
The damage from this drop produced a buckle around the closure bolt area and on the lid, along with a decrease in the diameter of 1 inch in the direction of impact through the bolt. There was no loss of bolts or closure and all welds remained in tact. The damage was recorded and photographed.

**Post-Test HAC 30' Drop
End View of Damage**

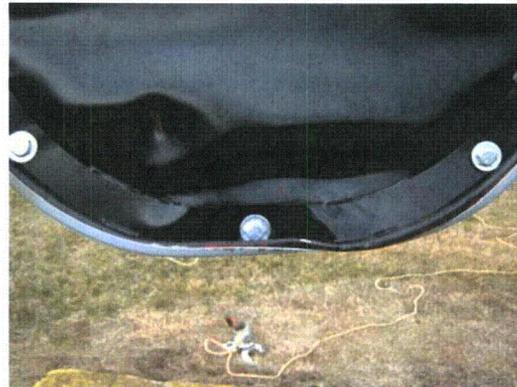
**Close-Up HAC 30' Horizontal Side Drop
Damage**

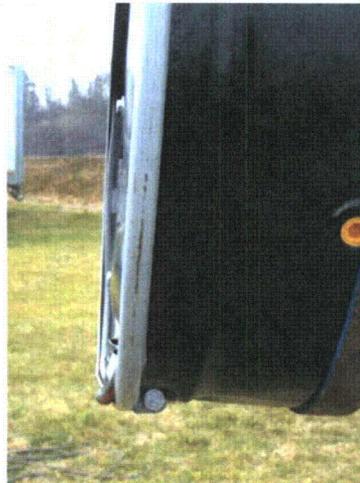
**Side View – Top End Closure Ring Bolt
30' HAC Horizontal Drop Damage**

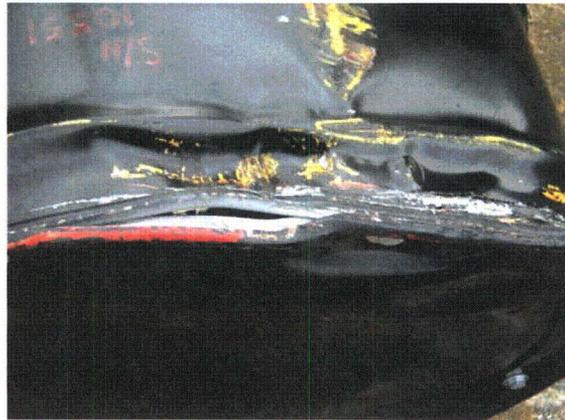
Close-up Top End Damage 1/4" x 1-1/14" Gap - Metal to Metal Seal No Opening

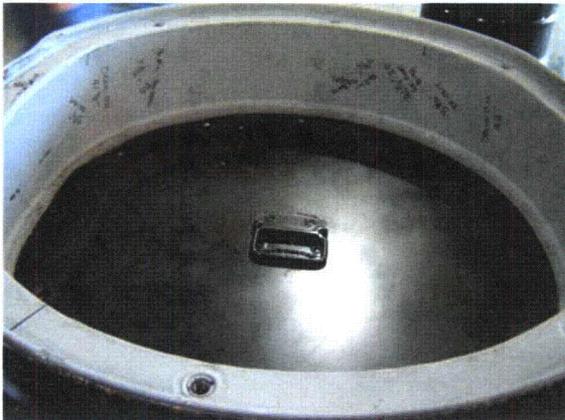
As result of this series of testing the outer closure bolts were torqued prior to removal and found to be at a reading of 25 ft/lbs. Upon removal of the outer closure lid a slight deformation of the inner wall was noted. There was no loss of containment contents found within the inner well area. The inner containment blind flange remained in good condition and sealed. The interior bolts were torqued with readings at 25 ft/lbs. The gaskets were intact with minimal damage. The payload drum did exhibit some crumpling at the lid but all of the payload materials remained within the drum and payload cavity as required. The inner cavity upon inspection showed no visible damage. The results of this series proved to be acceptable.

Post Test – No Loss of Payload Contents

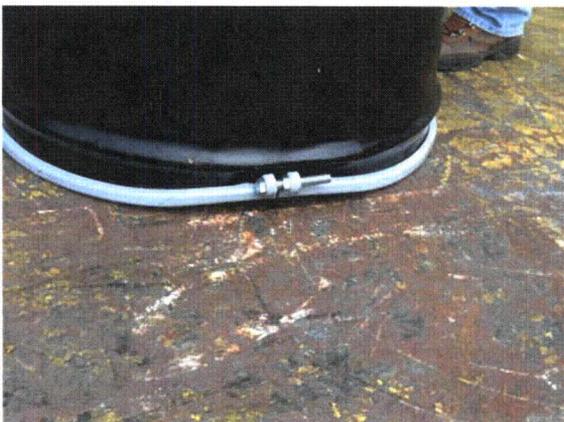
The impact resulted in a deformation on the drum side at the closure bolt measuring 1-1/16 inch deep by 2 inches long. The diameter of the test article was decreased by 1/8 inch. All welds, bolts and closures remained in tact with no tearing of the outer structural components.

Post Drop Damage to Top Closure

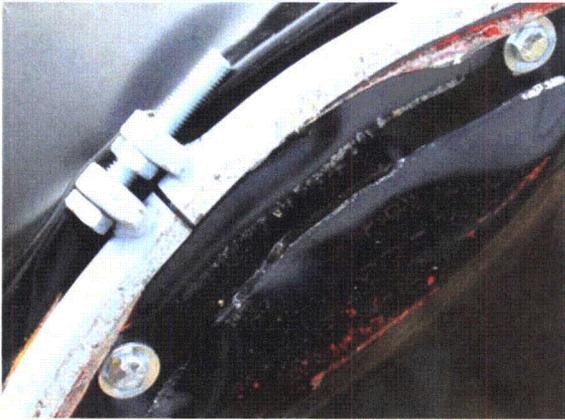
The impact resulted in a depression 11/16 inch deep into the lid and caused additional side deformation totaling 2-1/2 inches deep by 20 inches long. All welds, bolts and closures remained intact.

**Close-up Damage from Center of Gravity
Drop onto Top Closure Ring**

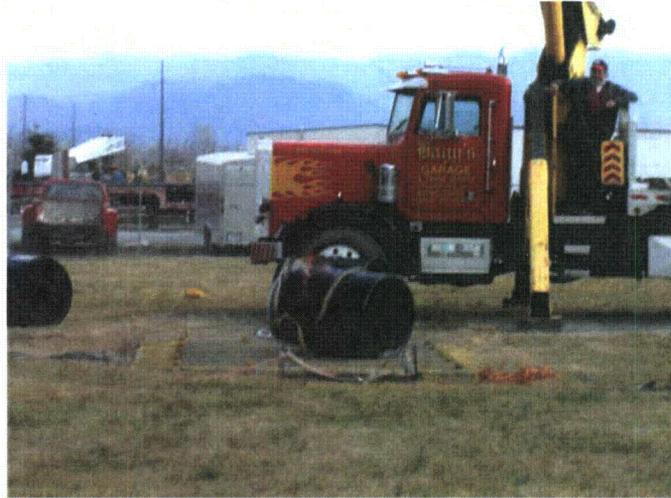
Shallow Angle Drop Impact

The damage to the exterior package surface produced a tear at the exterior drum side to bottom rim connection point measuring $3/16$ inch at its widest point by 7 inches in length. Although this slit to the outer drum sheet meet metal occurred, no internal breach of the inner liner occurred and the package remained completely sealed from the exterior atmosphere due to the design of the Vera-Pac with its inner liner directly in contact with the outer drum surface. Additional deformation at the bolted closure ring affected an area measuring $2-15/16$ inches deep with a 1 inch crumple in the lid closure. The diameter of the package was reduced in the direction of the impact through the bolt by approximately 3 inches. The test article bolts and seals remained in place. Measurements of the damage were recorded and photographed.

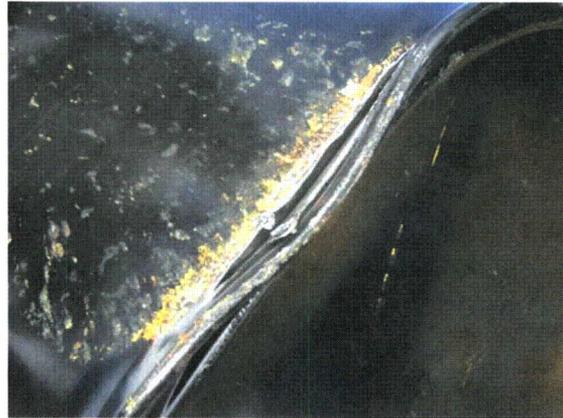
**Bottom Slit at Drum Rim Showing
Inner Metal Re-enforcing Sheet
In Place with No Openings**

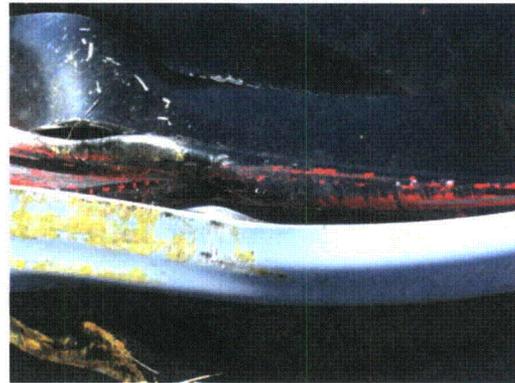
The impact upon the puncture ram produced additional damage to the side of the drum at the closure bolt with a small opening of $\frac{1}{4}$ inch by 3 inches long at the drum closure lid and drum rim interface. The opening was again sealed by a metal to metal contact between the flange and the drum lid insulation sheet metal cover and the top flange gasket which remained in tact. All welds, bolts and closures remained in place.

Close-up View of $\frac{1}{4}$ " Wide x 3" Long Gap – Sealed by Metal to Metal Contact and Top Flange Gasket

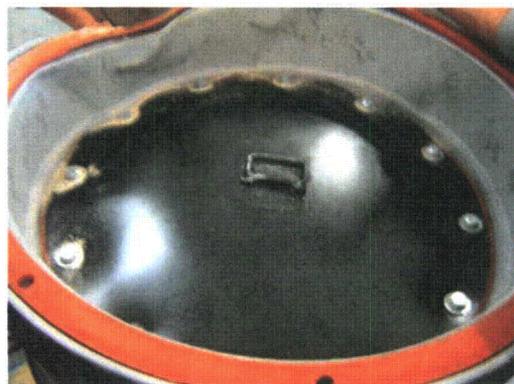
As a result of this series of testing the outer closure bolts recorded a torque at less than 20 ft/lbs. Upon removal of the outer closure lid a bulge in the containment blind flange was discovered with some sand from within the containment cavity found. A deformation at the impact point to the inner wall was also recorded. The bolts of the inner containment flange were torqued with a reading of less than 20 ft/lbs recorded. Once the flange and payload had been removed inspection of the inner containment cavity found no visible damage. The inner gaskets were in good condition with only minimal damage to the outer closure gasket.

Bulge in Containment Blind Flange Showing Loose Sand from Containment Cavity

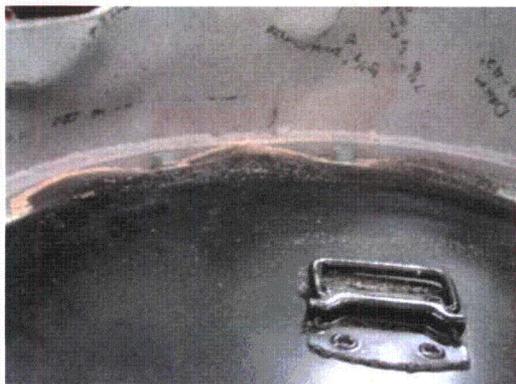
**Side Wall Damage and
Bulge of Containment Flange**

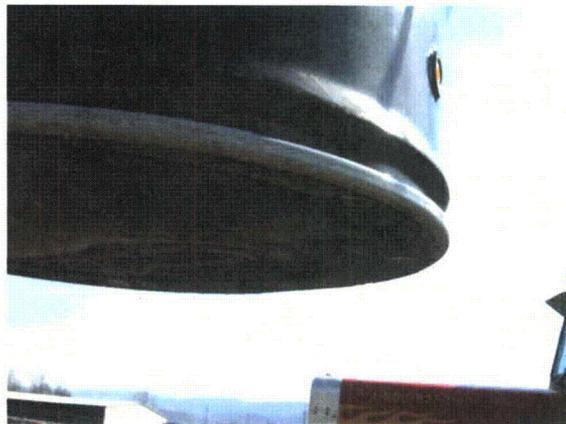
Post test inspection of the outer surface found that the overall height had been reduced by 7/16 inch and that three of the top bolts had been impacted, but all bolts remained in place and sealed. There was no damage to any welds and no tears were found during the inspection.

**Post Test View of Damage
Total Package Drops – 2 NCT,
3-HAC 30' Drop, 1-wCrush Plate Drop**

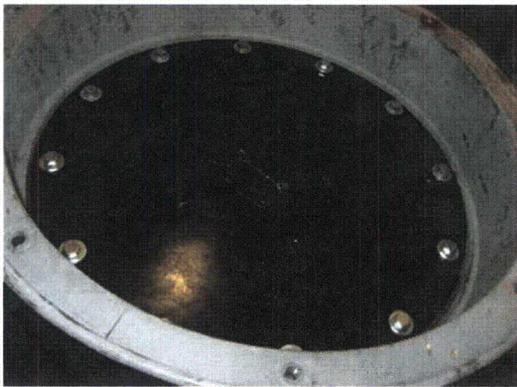
The conclusion of this series is that the design changes of increasing the flange thickness, increasing the torque requirement and the reinstallation of the flange inside pad were found to be successful.

**½" Thick Inner Blind Flange Post Test
Flat & No Loss of Payload Contents**

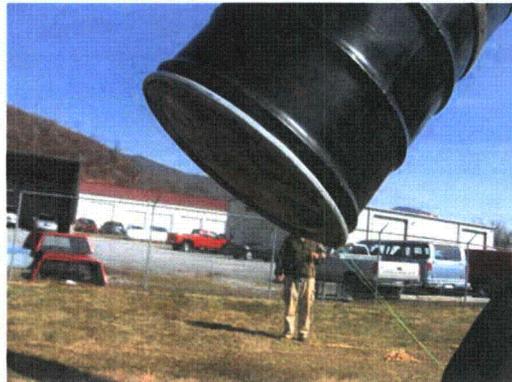
The impact resulted in a deformation on the closure bolt area with measurements of 1-3/16 inch deep by 2-1/4 inches long. All welds, bolts and closures remained intact. Damage was recorded and photographed.

NCT Post Test Damage View

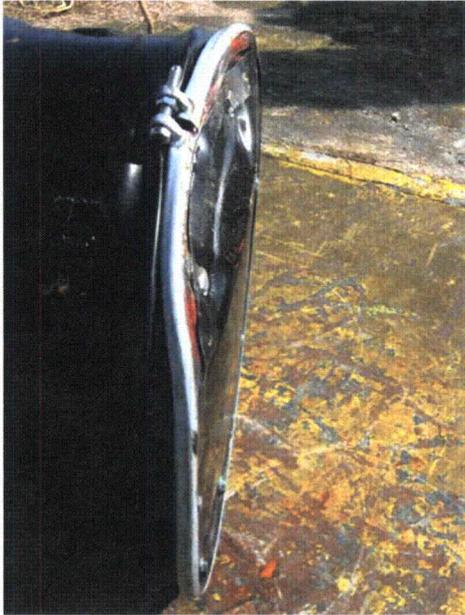
As a result of the impact a deformation on the closure bolt area totaling 2-9/16 inches deep by 20-1/2 inches long was recorded. The diameter of the package was reduced by 5/16 inch. All welds, bolts and closures remain in place. There were no tears or openings found on the package.

**Side View – Impact Damage from
30' Center of Gravity Drop**

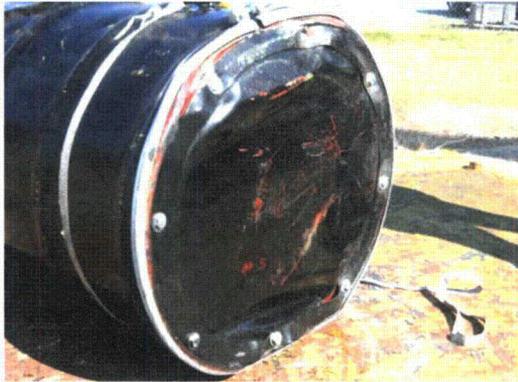
The damage to the exterior surface produced deformation on the initial top closure, measuring 2-5/16 inches deep with a 1 inch crumple of the outer closure lid. The secondary impact produced damage measuring 5 inches in length on the bottom rim of the test article. The diameter of the package in the direction of the impact was reduced by approximately 1 inch. There was no damage to any bolts, welds or closures and there were no tears found on inspection of the package.

End View of Top Damage from Initial Impact of Shallow Angle Drop

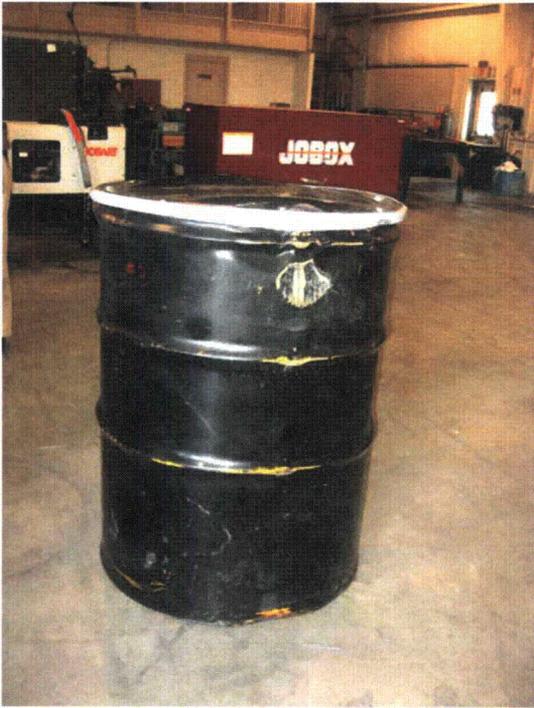
The conclusion of this series is that again, the design changes of increasing the flange thickness, increasing the torque requirement and the reinstallation of the flange inside pad were found to provide acceptable results.

**Post Series Side View—Package Drop Total
2- NCT Drops, 3-HAC 30' Drops &
1-Puncture Drop**

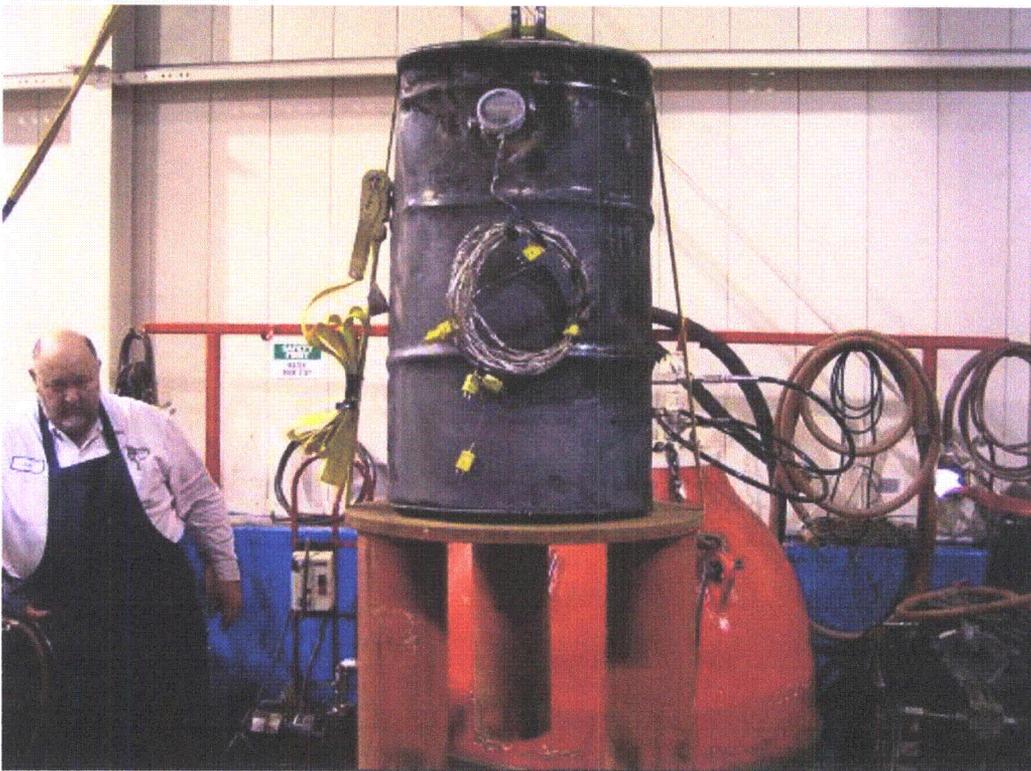
Pages 15 and 16 of the Champion Safety Analysis Report are provided as pages 5 and 6 to Appendix 2.5.3. The test results indicate that immersion testing of a damaged prototype package to a pressure of 23.0 ± 1.0 psig during a 15-minute produce no additional damage.

Figure 2.5.3-2 Champion Package during Immersion Testing Phase
