Transmittal of Information to Support
License Amendment Request 241, Alternative Source Term
Seismic Evaluation Guidelines for HVAC Duct and Damper Systems

Seismic Evaluation Guidelines for HVAC Duct and Damper Systems

Revision to 1007896

Seismic Evaluation Guidelines for HVAC Duct and Damper Systems: Revision to 1007896.
EPRI, Palo Alto, CA: 2006. 1014608.

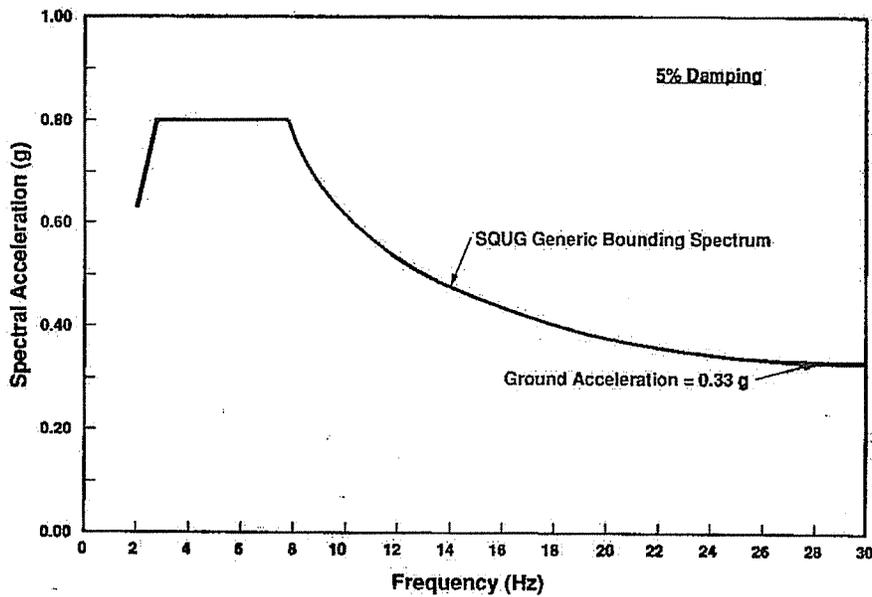
Figure 2-1
Seismic Motion Bounding Spectrum

The guidelines are applicable to any HVAC duct and damper system at any elevation in a plant where the nuclear plant free-field ground motion 5% damped seismic design spectrum does not exceed the Seismic Motion Bounding Spectrum of Reference [1] and the horizontal zero period acceleration (ZPA_h) of the in-structure response spectra at the HVAC support anchorage does not exceed 2.0g. The Bounding Spectrum is shown in Figure 2-1. The 2.0g ZPA_h restriction is from Reference [16].

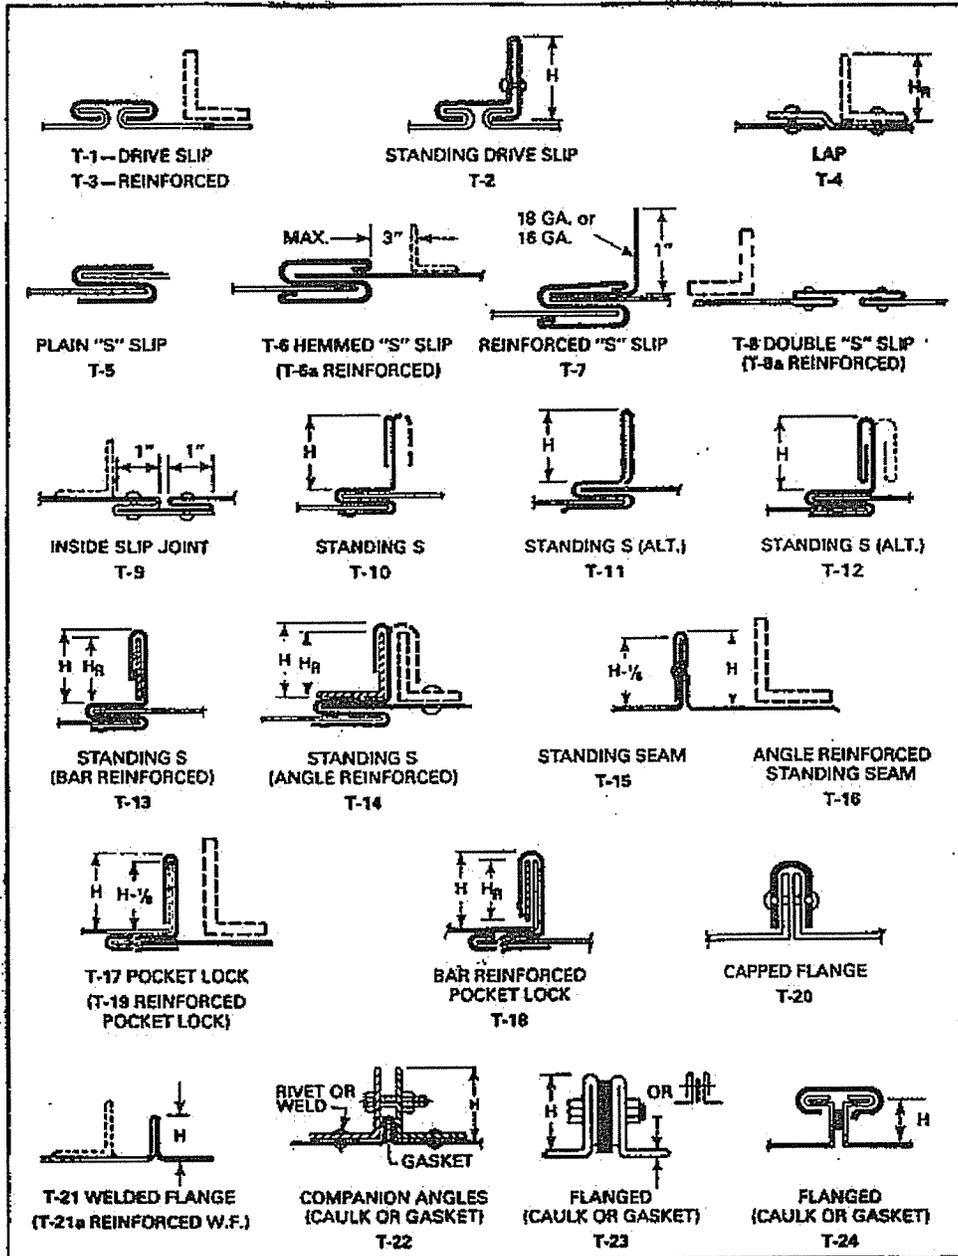
Figure 3-1
SMACNA Duct Joints

HVAC joints should be visually inspected to verify their structural integrity. Joints (including connected tees and elbows) that are observed to be loose, incomplete, corroded, or otherwise suspect (such as those repaired with duct tape or fiberglass, or missing rivets, screws, etc.) should be reviewed in detail. Seismic experience data have shown that such joints are often the point of excessive leakage or failure of HVAC systems in an earthquake. A corroded riveted duct joint failed at the Caxton Paper Mill as a result of the 1987 New Zealand earthquake (see Appendix A, Section A.2.1). In addition, HVAC without pressure boundary requirements and with runs consisting of slip joints without pocket locks, rivets or screws should be reviewed to assure that the differential displacement between the two adjoining ducts due to seismic loading will not cause joint separation. Figure 3-1 shows different SMACNA duct joints as described in Reference [4] to aid in identifying slip-type joints.

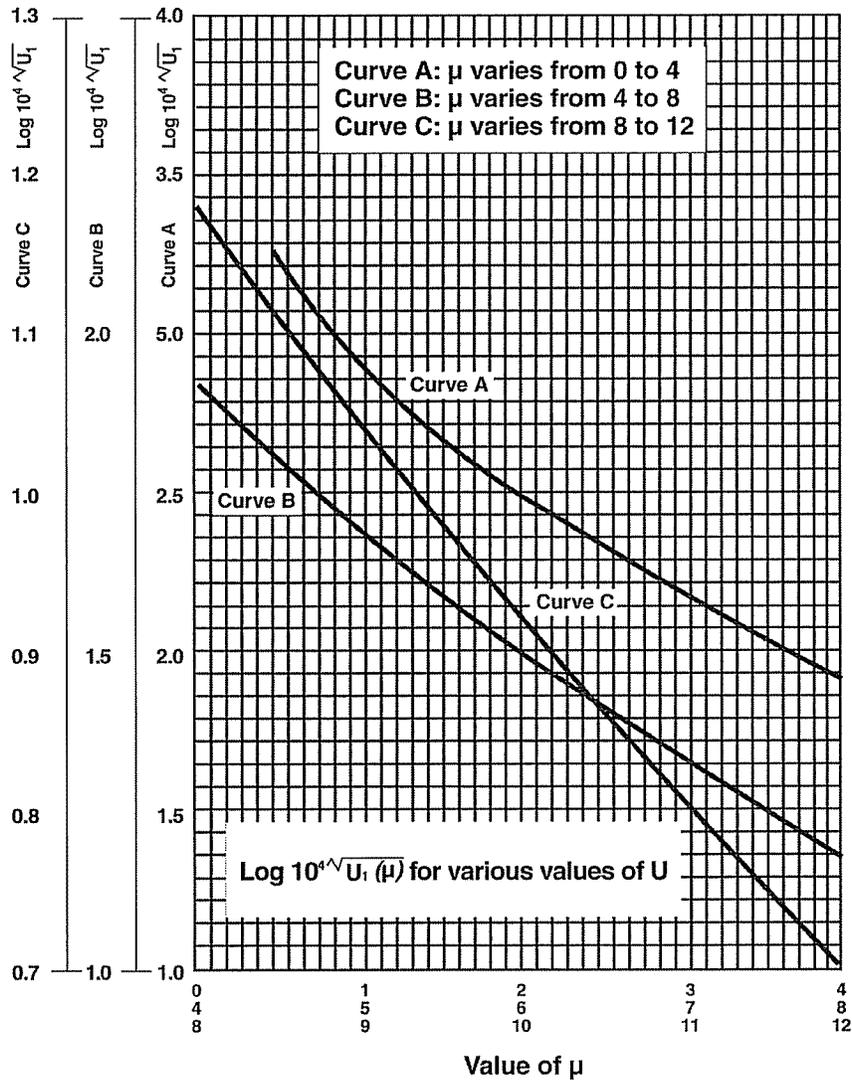
Figure 4-2
Value of u for Rectangular Ducts [15]

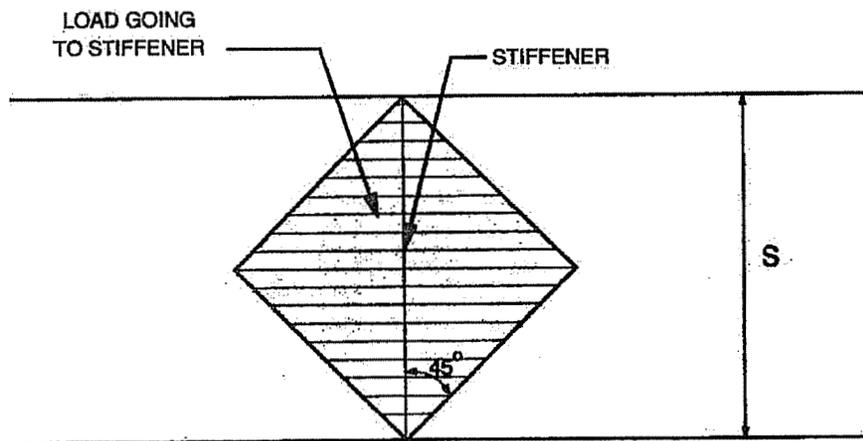
Figure 4-3
Load Going to Stiffener on a Rectangular Duct When $L/S \geq 10.0$ [6]

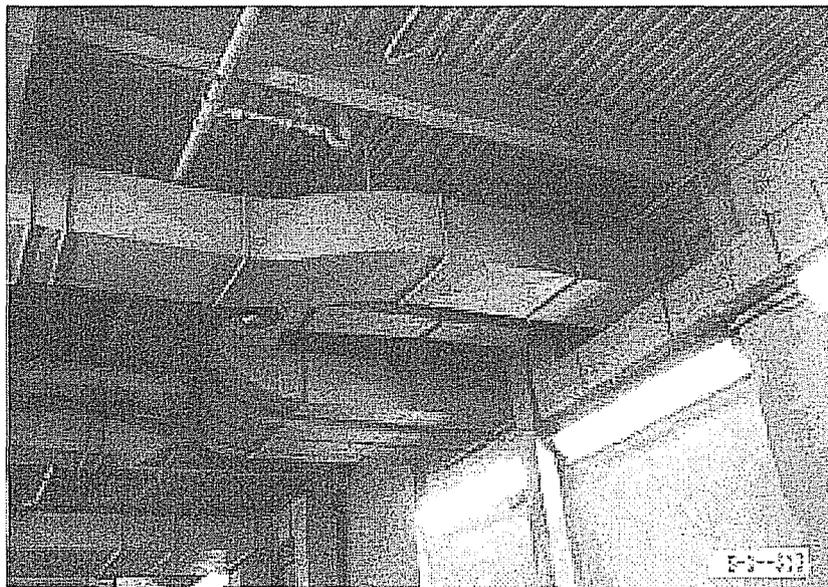
Figure A-1
Sylmar Converter Station, 1971 San Fernando Earthquake. Strap-Hung and Wall-Mounted Duct With Wall Penetrations

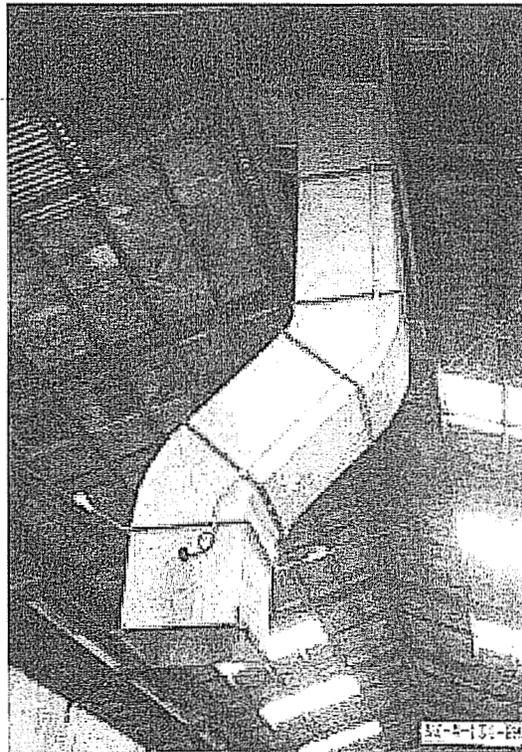
Figure A-3
Bay Milk Products, 1987 New Zealand Earthquake. Long Vertical Cantilever Supported by the Roof at One End and Guy Wires at the Other

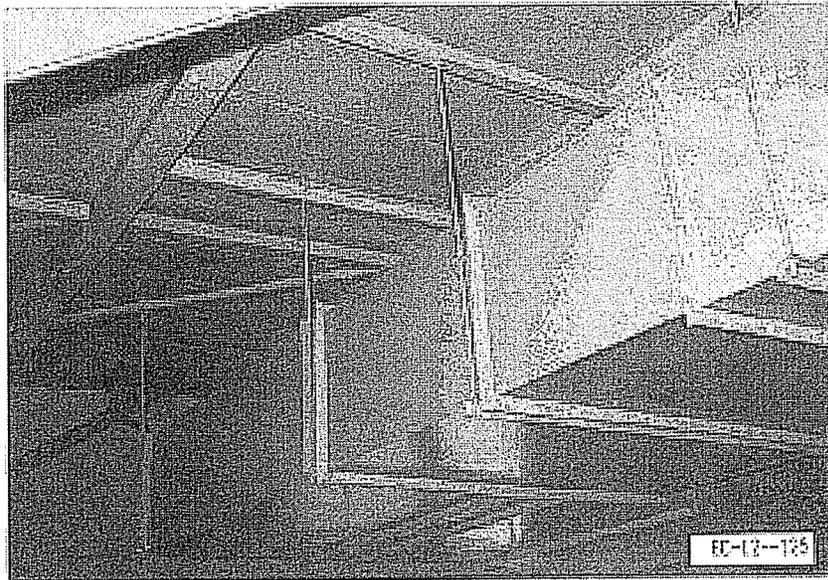
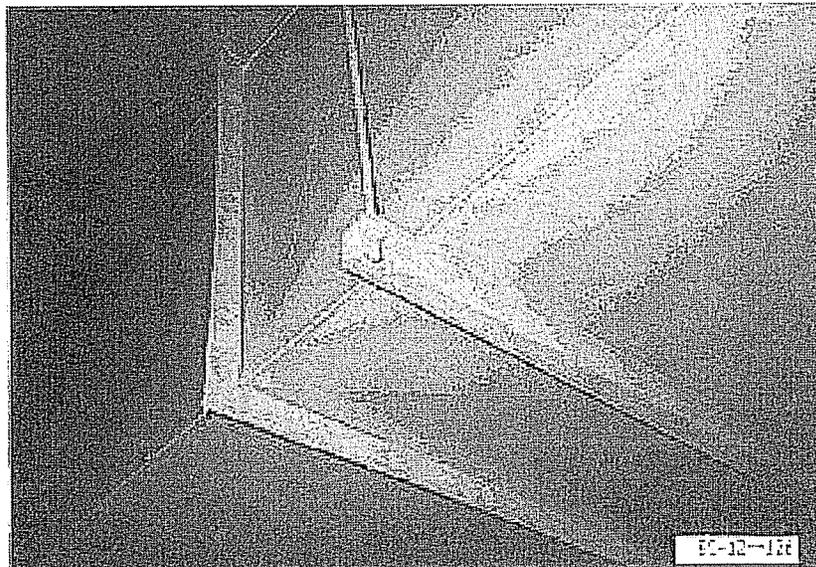
Figure A-4
El Centro Steam Plant, 1979 Imperial Valley Earthquake. Trapeze Rod-Hung Rectangular Duct With Close Up of the Trapeze Detail

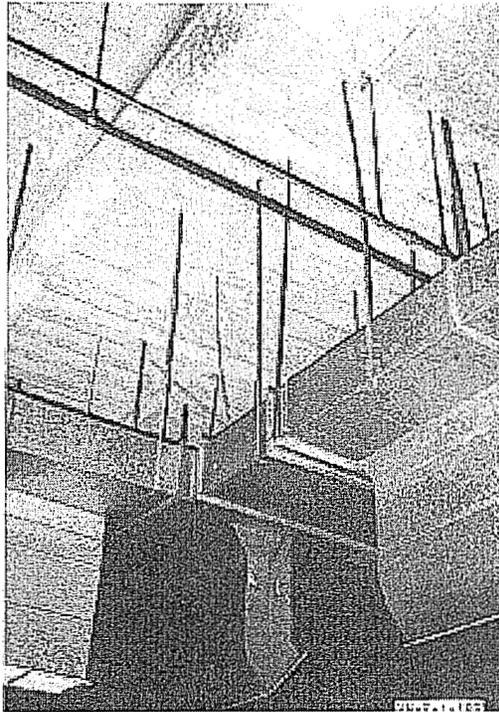
Figure A-5
California Federal Bank Facility, 1987 Whittier Earthquake. Typical Strap-Hung Rectangular Duct With Vertical Cantilevers and Diffusers

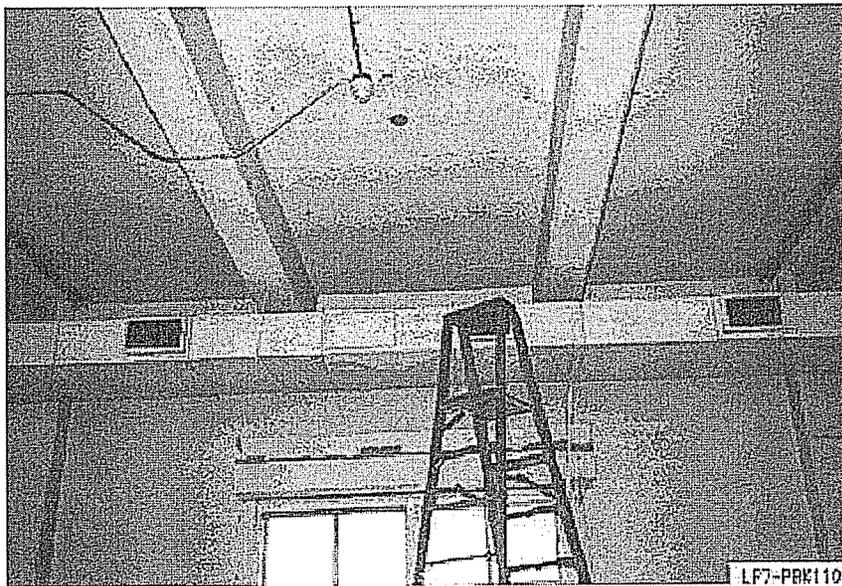
Figure A-7
Pacific Bell Watsonville, 1989 Loma Prieta Earthquake. Run of Trapeze Rod-Hung Rectangular Duct

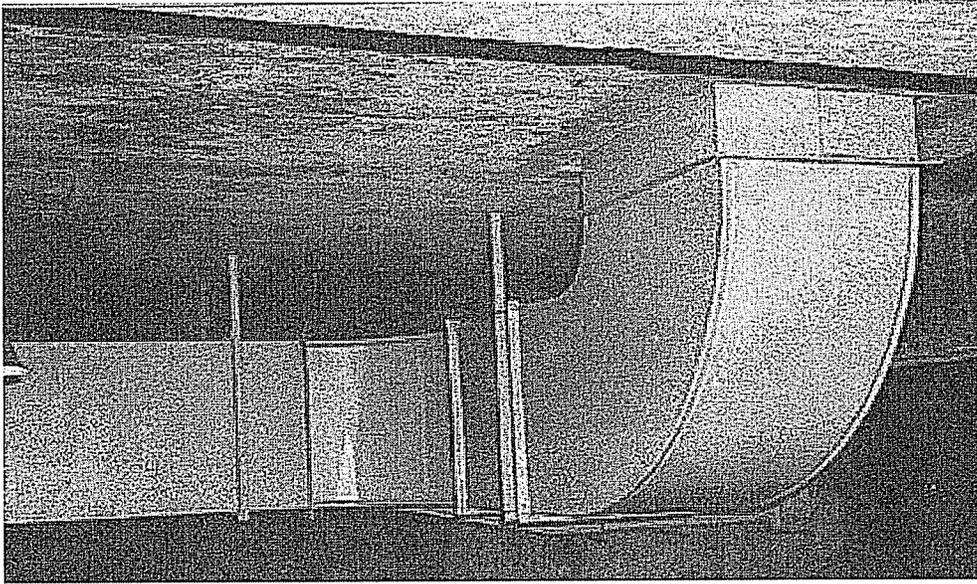
Figure A-9
Drop IV Hydro Plant, 1979 Imperial Valley Earthquake. Ceiling Mounted Ducting

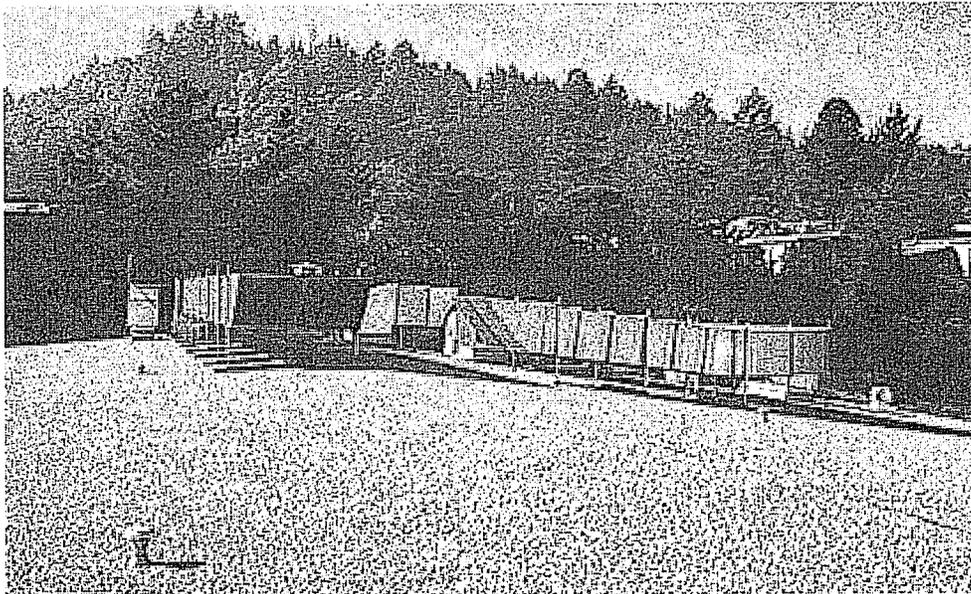
Figure A-10
Watkins-Johnson, 1989 Loma Prieta Earthquake. HVAC Ducting Atop Roof Level

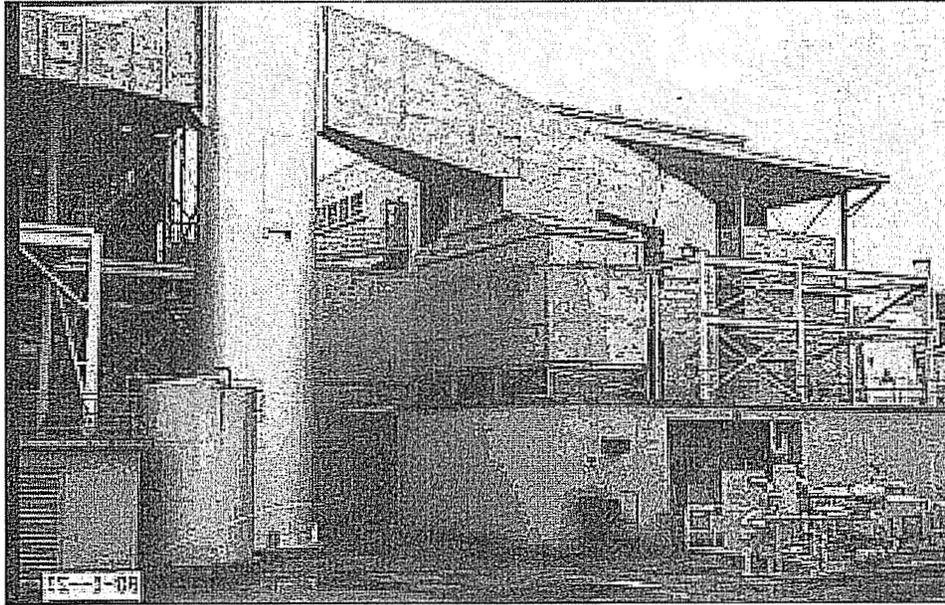
Figure A-11
Magnolia Plant, Burbank, Ducting at Induced Draft Fan, 1971 San Fernando Earthquake

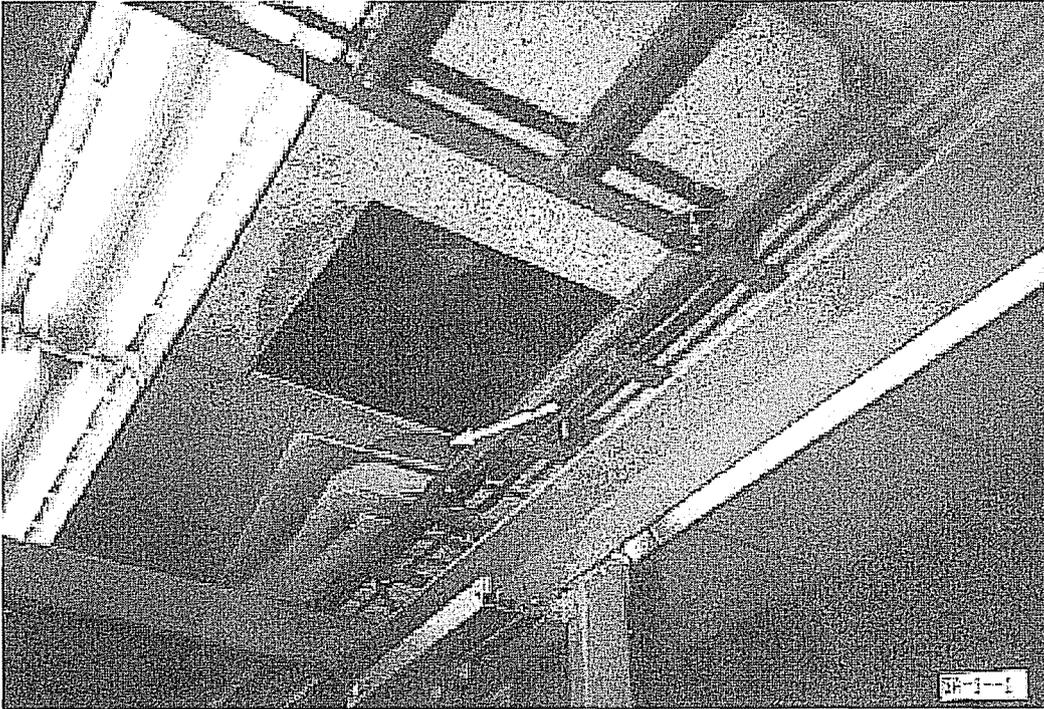
Figure A-13
Gates Substation, 1983 Coalinga Earthquake. A HVAC Diffuser Fell From the Suspended Ceiling

During the earthquake, a HVAC diffuser fell from a suspended ceiling. The diffuser was slipped into place and supported from the ceiling, but was not attached to the HVAC ducting (see Figure A-13).

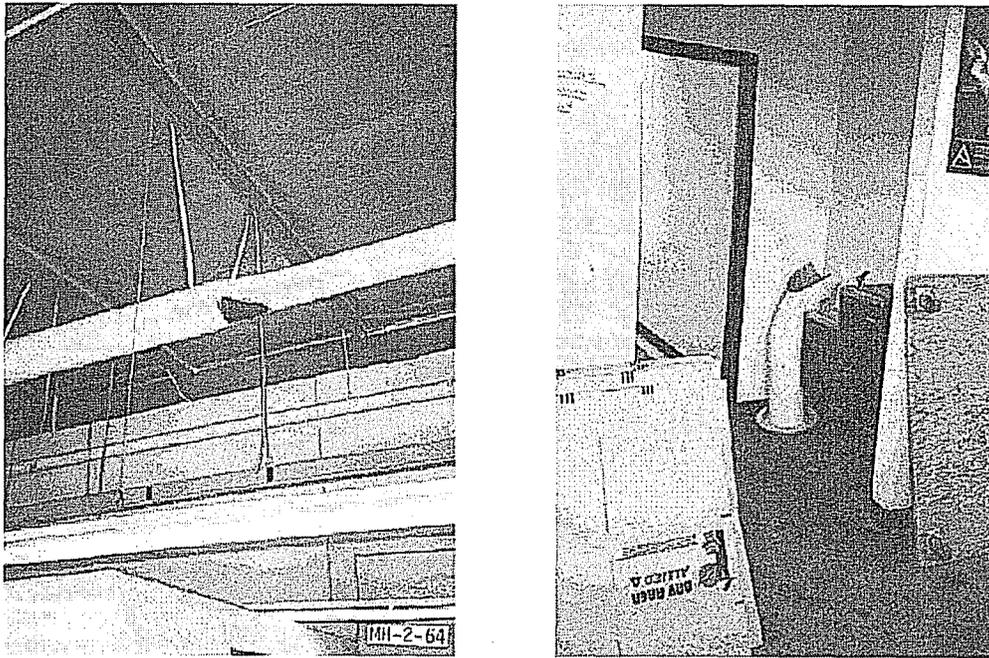
Figure A-14
Wiltron Facility, 1984 Morgan Hill Earthquake. A 4-Foot Long Vertical Cantilever Broke From its Supporting Header and Fell

At the Wiltron Facility, a four foot long vertical cantilevered section of HVAC ductwork broke from its supporting header and fell to the floor (see Figure A-14). The round duct was constructed of riveted lap joints which failed under the cantilever's inertial loads.

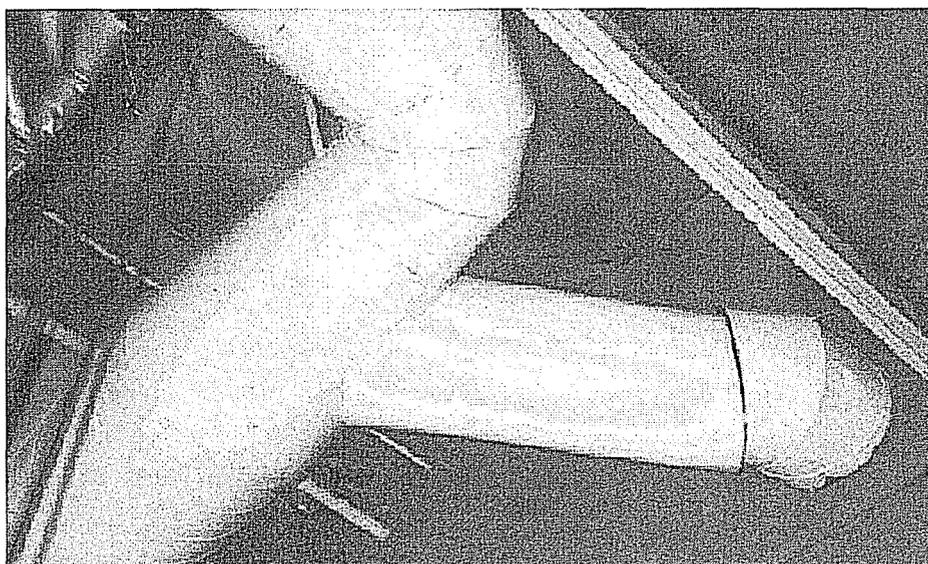
Figure A-15
Wiltron Facility, 1984 Morgan Hill Earthquake. A Branch Line Tore at a Wall Penetration
Due to Flexible Header Motion

Another section of HVAC duct at the same facility split a seam where a branch line entered a wall penetration (see Figure A-15). The damaged section was approximately ten inches in diameter, branching off of an estimated twenty inch diameter header. The seam pulled apart near the wall, approximately four feet from the branch point. The branch apparently was not flexible enough to accommodate the header motion, and the seam was too weak to resist the imposed differential displacement.

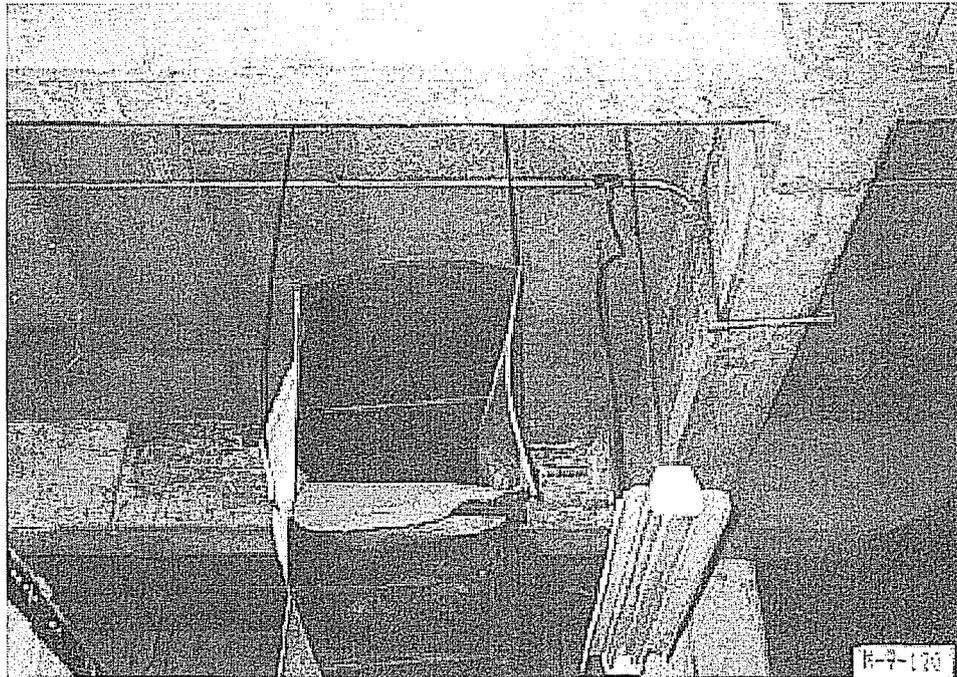
Figure A-16
Fertimex Packaging Plant, 1985 Mexico Earthquake. A section of Duct Tore when the Duct Jumped off the Final Support in a Long Run

HVAC ducting was damaged on the second floor of the packaging plant's switchgear building. The second floor slab is approximately fifteen feet above grade. The two-story concrete-frame structure is about 120 feet long, fifty feet wide, and has eccentric rigidity due to the asymmetric location of brick in-fill and partial concrete walls. The eccentricity created high torsional accelerations in some regions of the structure. In one of these areas, the last section in a long duct run jumped off the final support. The resulting cantilever failed at an adjacent support (see Figure A-16). The HVAC duct section was of pocket lock construction and was not positively attached to the rod hung trapeze support. Had it been attached, the damage would likely have been avoided. Also in the same area, one of the duct's rod supports pulled its expansion anchor from the concrete ceiling. The concrete quality was questionable and the ribs on the non-drilling shell anchor's cone expander were flat rather than slanted.

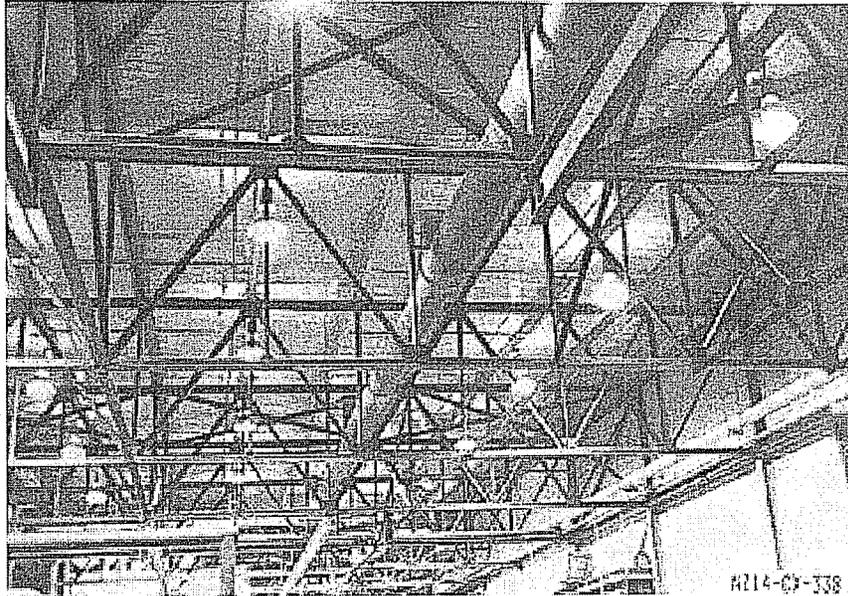
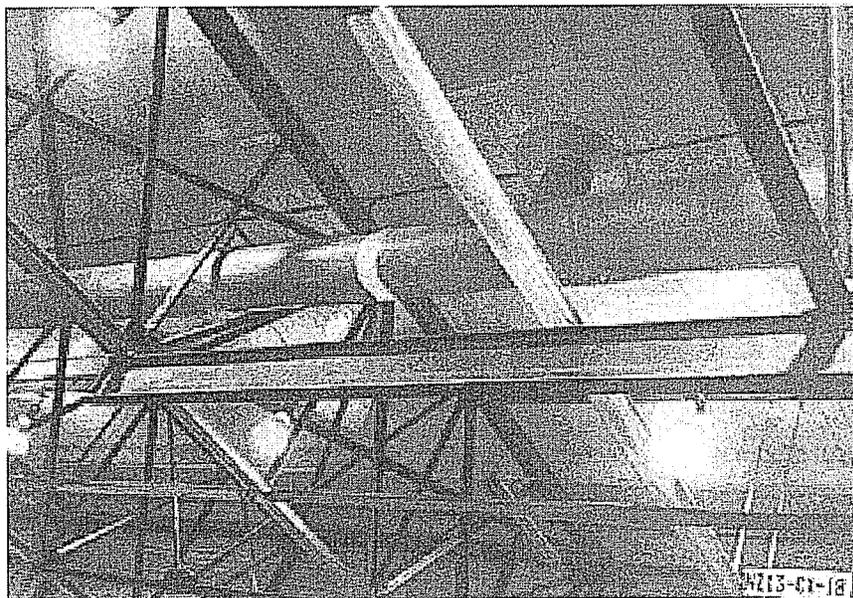
Figure A-17
Caxton Paper Mill, 1987 New Zealand Earthquake. A long, Unrestrained Run of Duct
Constructed of Riveted Lap Joints (Top) and a Taped Repair of a Sheared Joint (Bottom)

At Paper Machine Building No. 2, there were several instances of sheared ductwork joints; however, no sections fell to the floor. The circular duct was mounted near the ceiling and constructed of riveted lap joints (see Figure A-17).

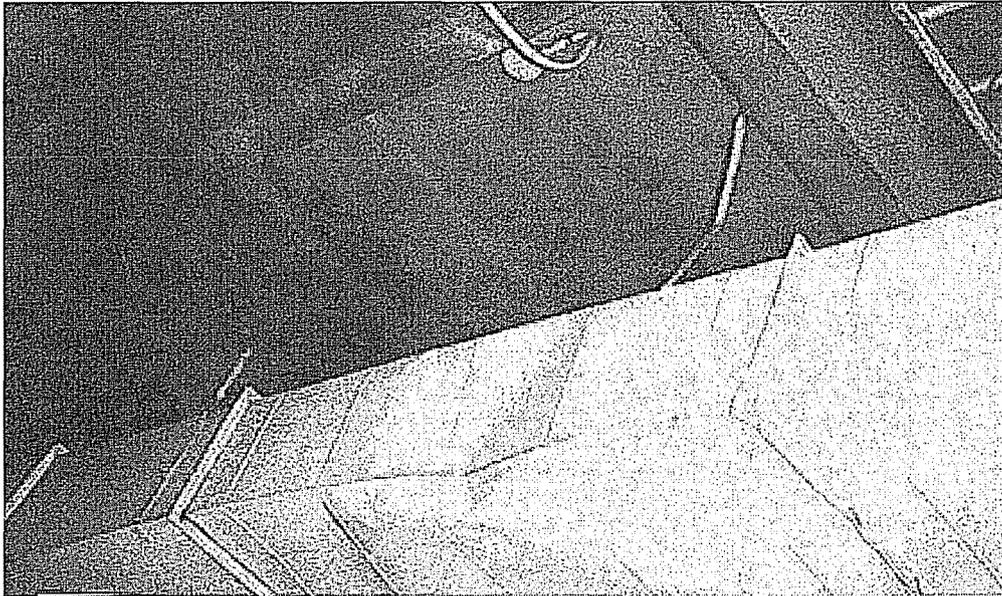
Figure A-18
SCE Rosemead Headquarters, 1987 Whittier Earthquake. HVAC Dented From Sway
of Adjacent Fixtures

The main office of the Southern California Edison (SCE) Headquarters is located within a mile of the epicenter and has ground motion equipment located on site. The four-story concrete shear wall structure endured a PGA of 0.42g and sustained the most significant structural damage of the three buildings in the complex. A HVAC fan in this building dislodged from its spring isolators and displaced enough to tear the flexible bellows coupling to the duct on its discharge side. A HVAC duct was dented, but not torn, by impact from adjacent fixtures (see Figure A-18).

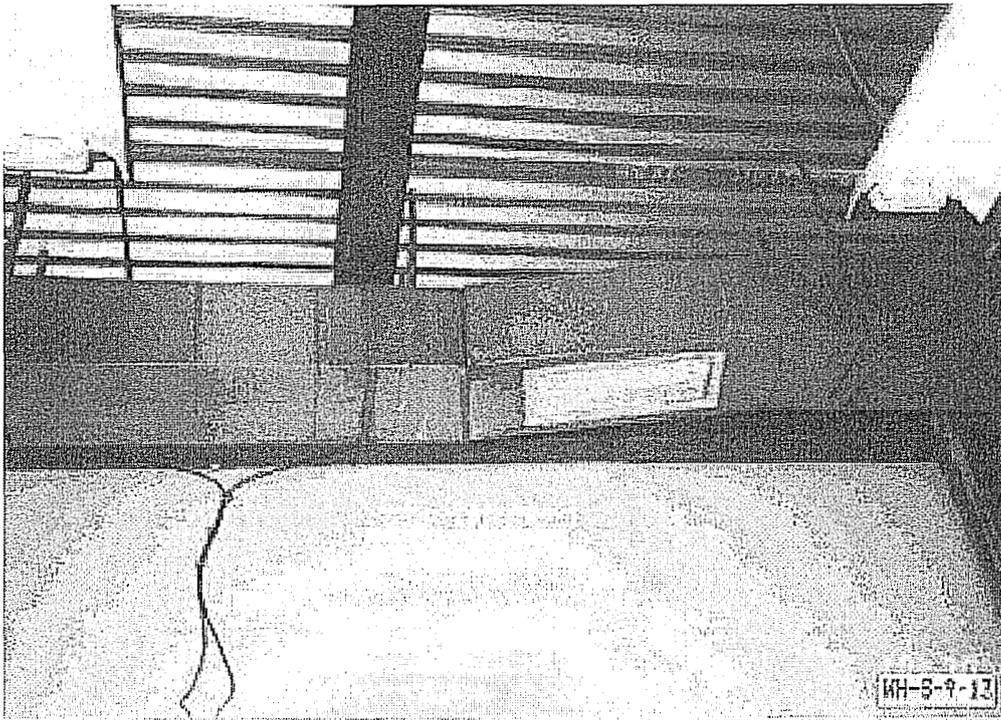
Figure A-20
Sanwa Data Processing Center, 1987 Whittier Earthquake. A Duct above the Battery Racks Deformed at the Joints of an Angled Offset Section

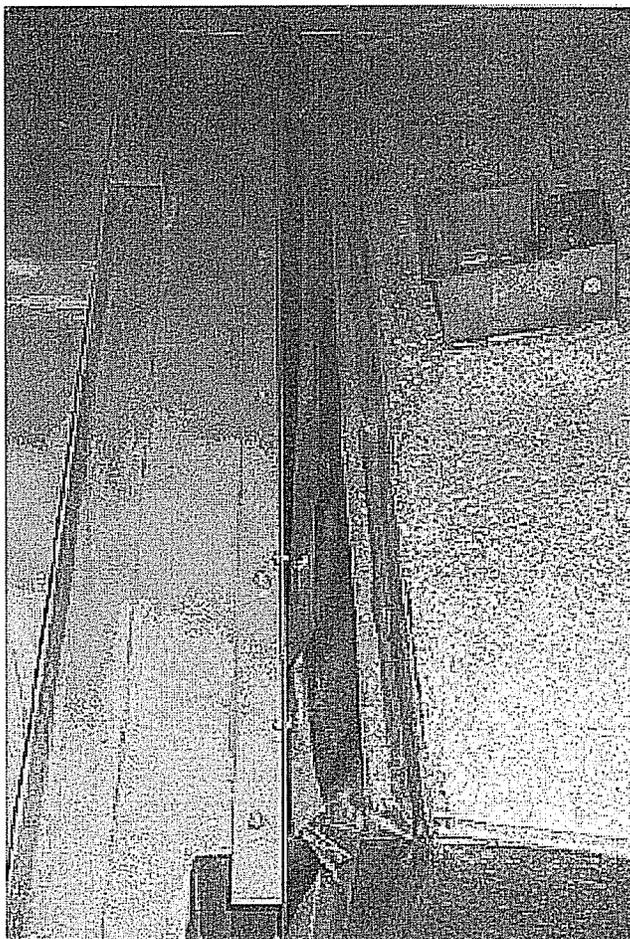
Figure A-21
East Ridge Mall, 1988 Alum Rock Earthquake. A Flexible Bellows Tore Due to the Motion of Attached Air Handlers on Vibration Isolation Mounts

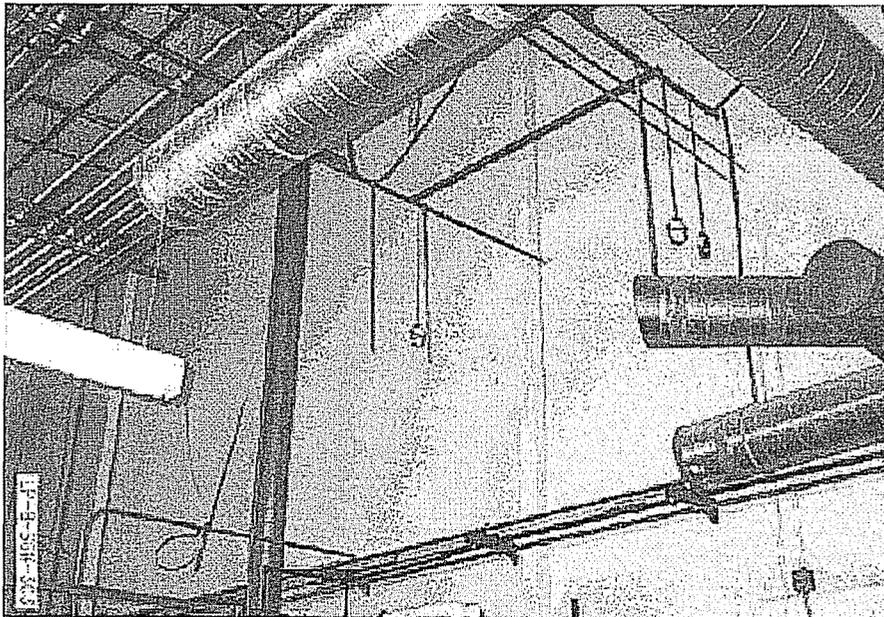
Figure A-22
Seagate Technology, 1989 Loma Prieta Earthquake. A Strap Support Broke and the Attached Duct Fell to the Floor

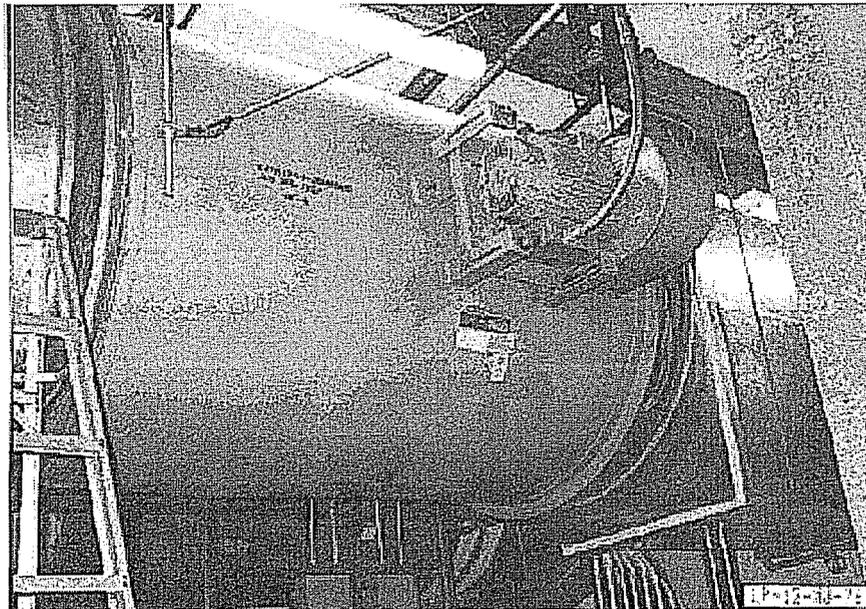
Figure A-23
Watkins-Johnson Instrument Plant, 1989 Loma Prieta Earthquake. The Flexible Bellows Connecting HVAC Ducting to an In-Line Axial Fan Tore

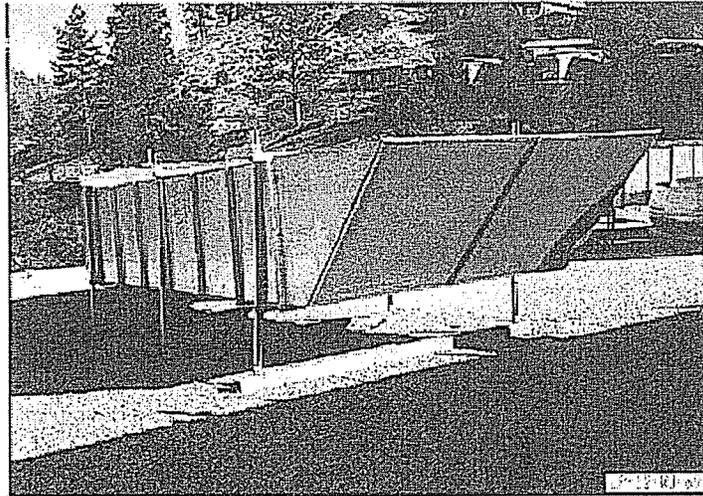
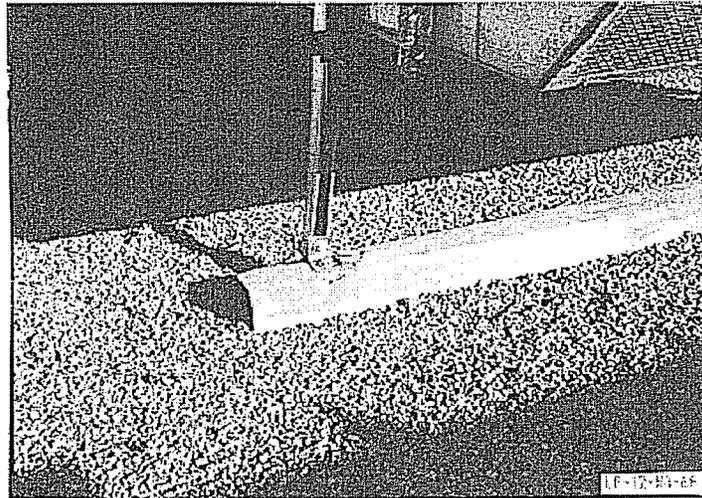
Figure A-24
Watkins-Johnson Instrument Plant, 1989 Loma Prieta Earthquake. The Support Anchorage for a Roof-Mounted Duct Was Distressed

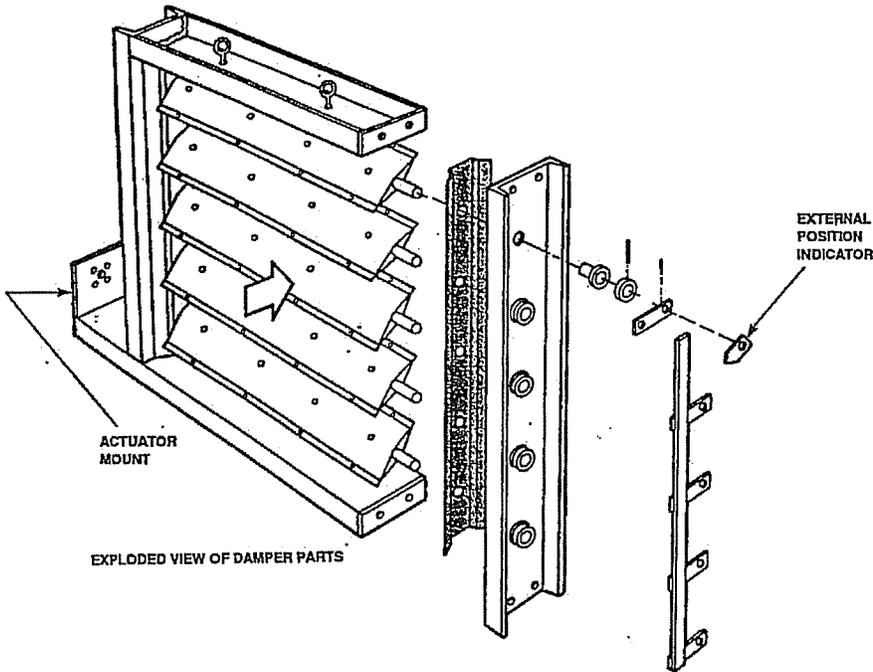
Figure B-1
Exploded View of a Typical Damper

Figures B-1 through B-3 show typical components of dampers.

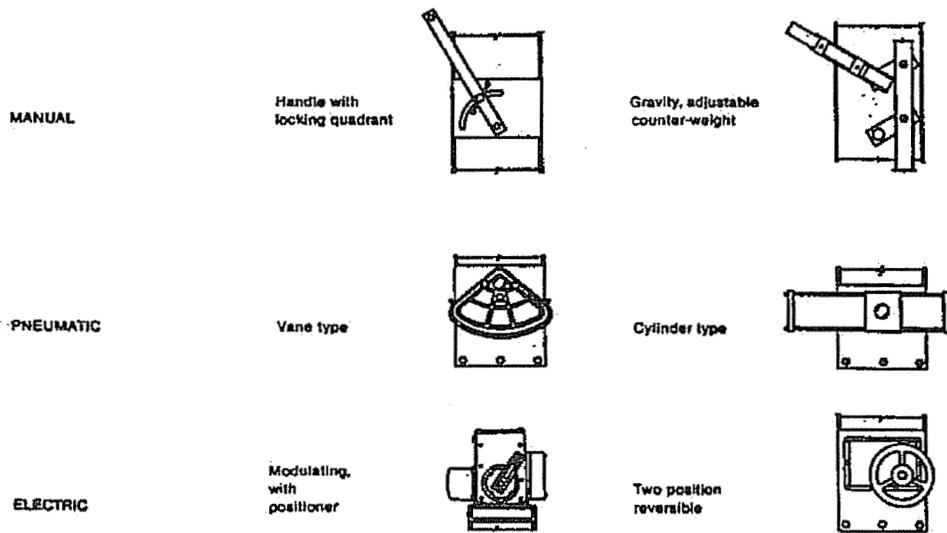
Figure B-3
Typical Damper Actuators

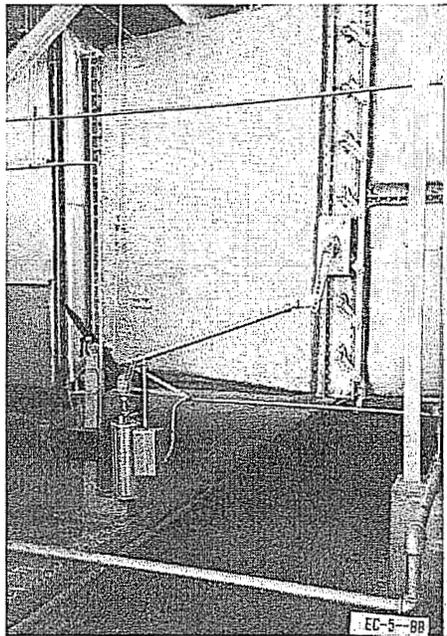
Figure B-4
Pneumatic Damper at El Centro Steam Plant Subjected to the 1979 Imperial Valley Earthquake

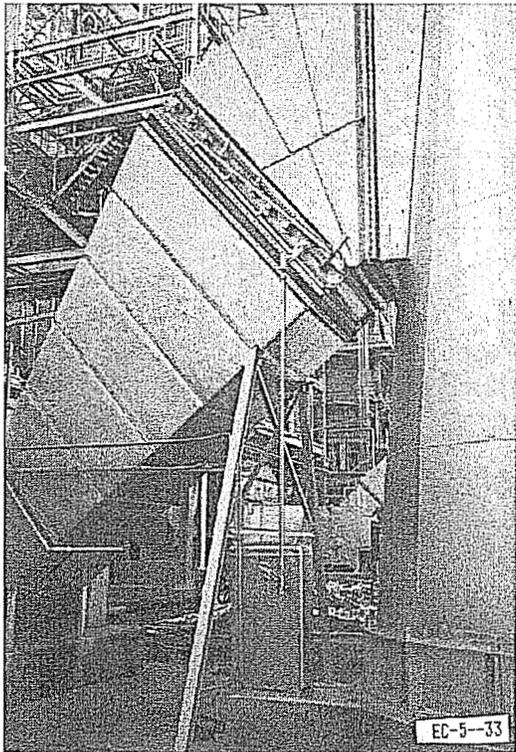
Figure B-5
Louver Style Damper on the Boiler Structure at the El Centro Steam Plant
Which Experienced the 1979 Imperial Valley Earthquake

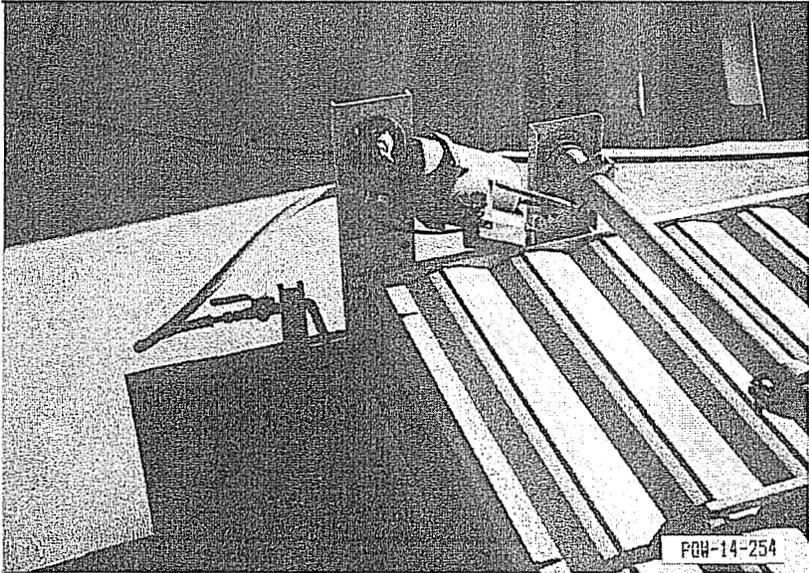
Figure B-6
Pneumatic Actuator at the Puente Hills Landfill Gas and Energy Recovery Plant

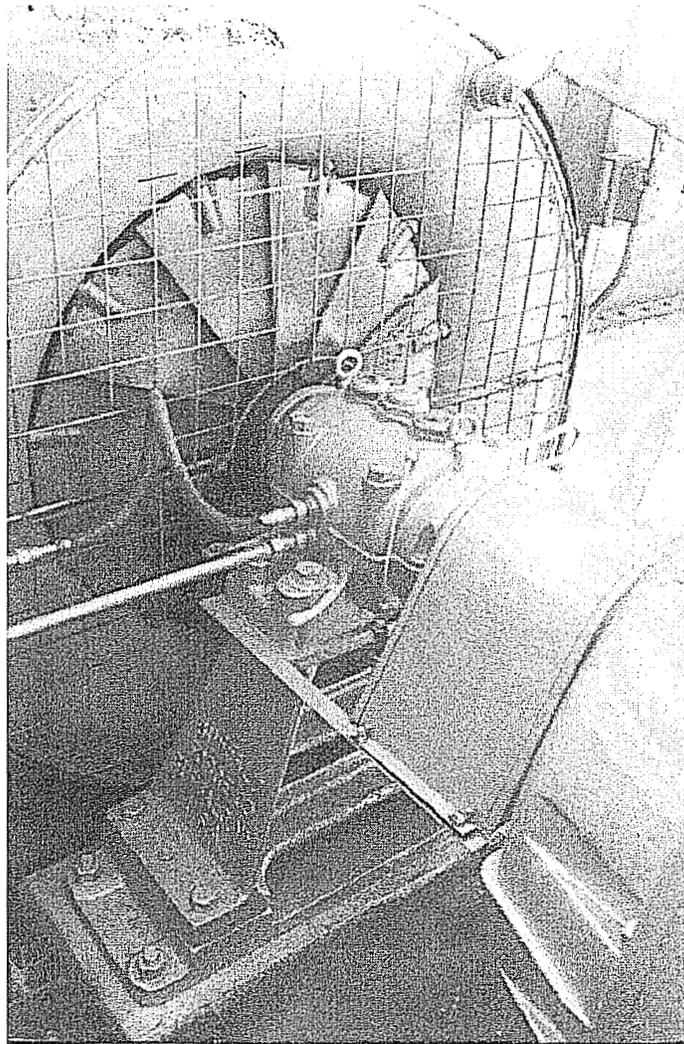
Figure B-7
Radial Type Damper at the El Centro Steam Plant Subjected to the 1979 Imperial Valley and 1987 Superstition Hills Earthquakes

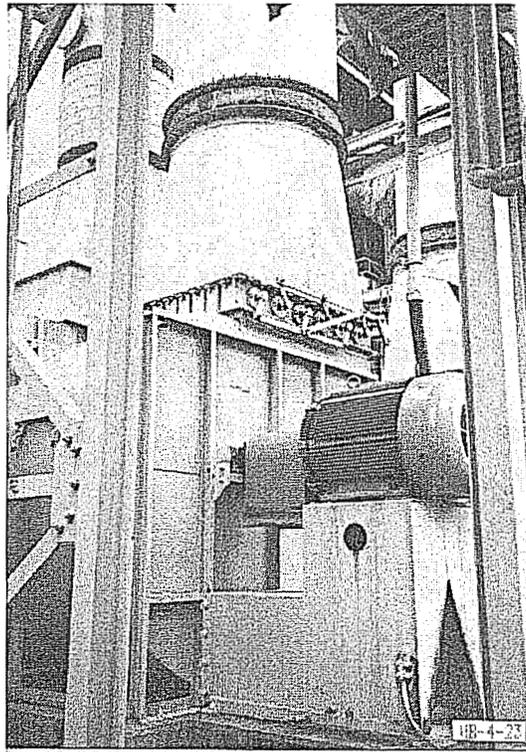
Figure B-8
Louver Type Damper at Humboldt Bay Power Plant

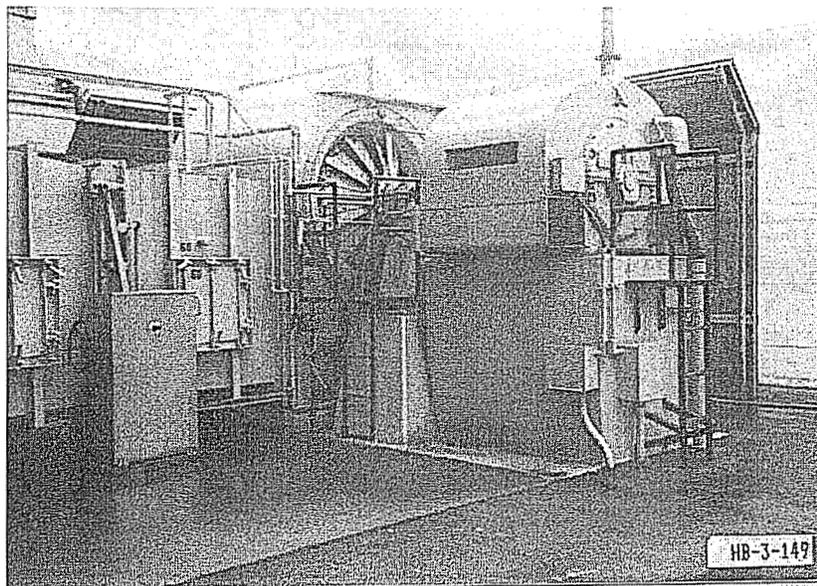
Figure B-9
Radial and Louver Type Dampers at the Humboldt Bay Power Plant, Which Experienced the 1975 Ferndale Earthquake

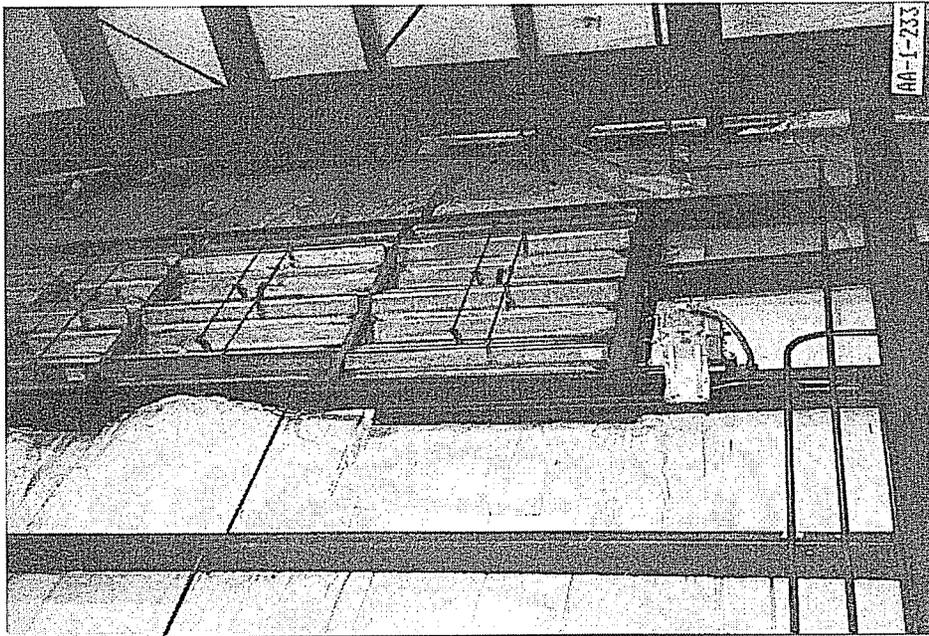
Figure B-10
Motor-operated Damper at Adak Naval Station, Which Experienced the 1986 Adak Alaska Earthquake

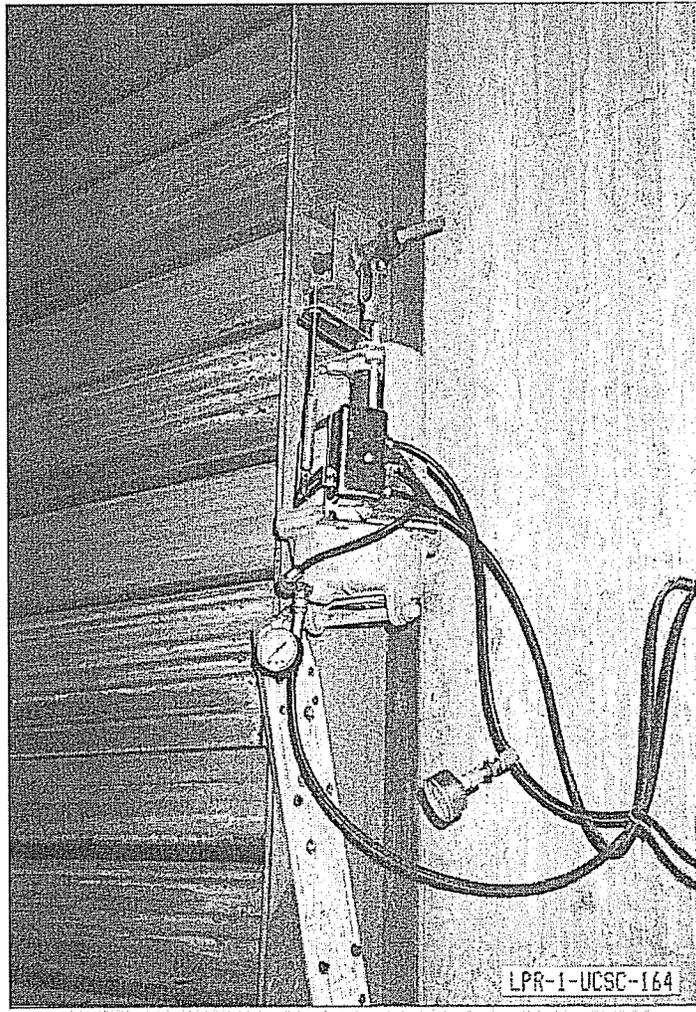
Figure B-12
Pneumatically Controlled Damper at UC Santa Cruz Applied Science Building Subjected to 1989 Loma Prieta Earthquake

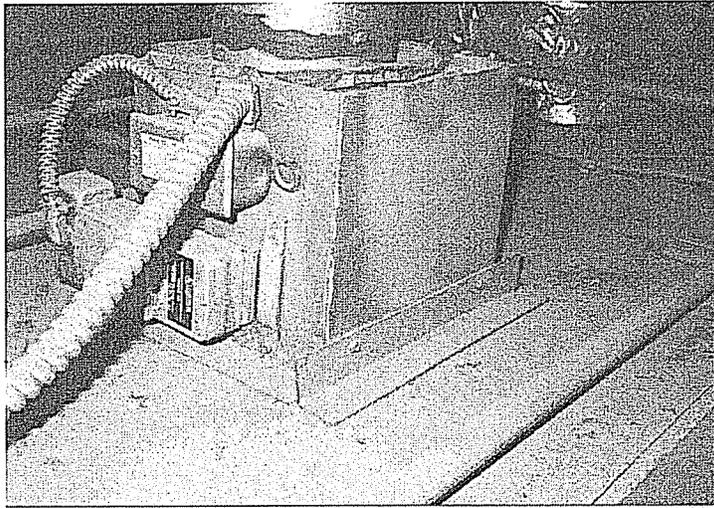
Figure B-13
Electric Motor for a Fire Damper at AES Placerita Cogeneration Plant, Which Experienced the 1994 Northridge Earthquake

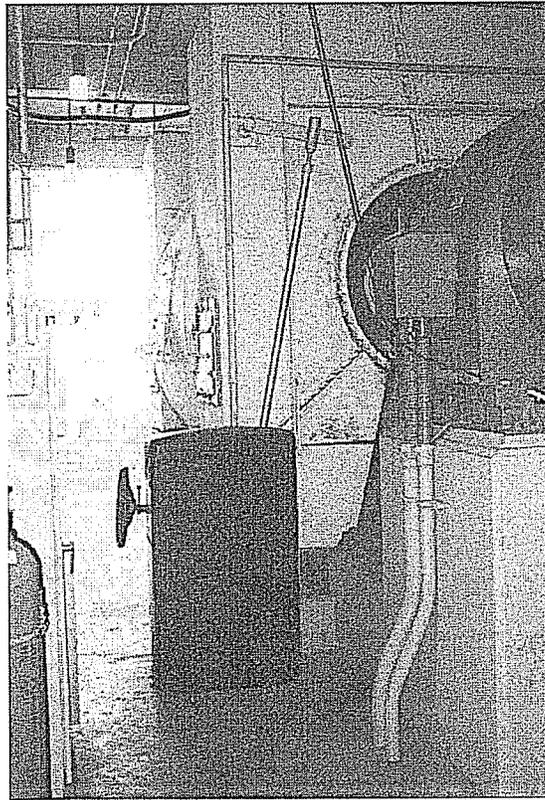
Figure B-14
Pneumatic Damper With Long Actuator at Valley Steam Plant , Which Experienced the 1971 San Fernando and the 1994 Northridge Earthquakes
