Transmittal of Information to Support
License Amendment Request 241, Alternative Source Term
Seismic Evaluation Guidelines for HVAC Duct and Damper Systems

Seismic Evaluation Guidelines for HVAC Duct and Damper Systems

Revision to 1007896

Seismic Evaluation Guidelines for HVAC Duct and Damper Systems: Revision to 1007896.
EPRI, Palo Alto, CA: 2006. 1014608.

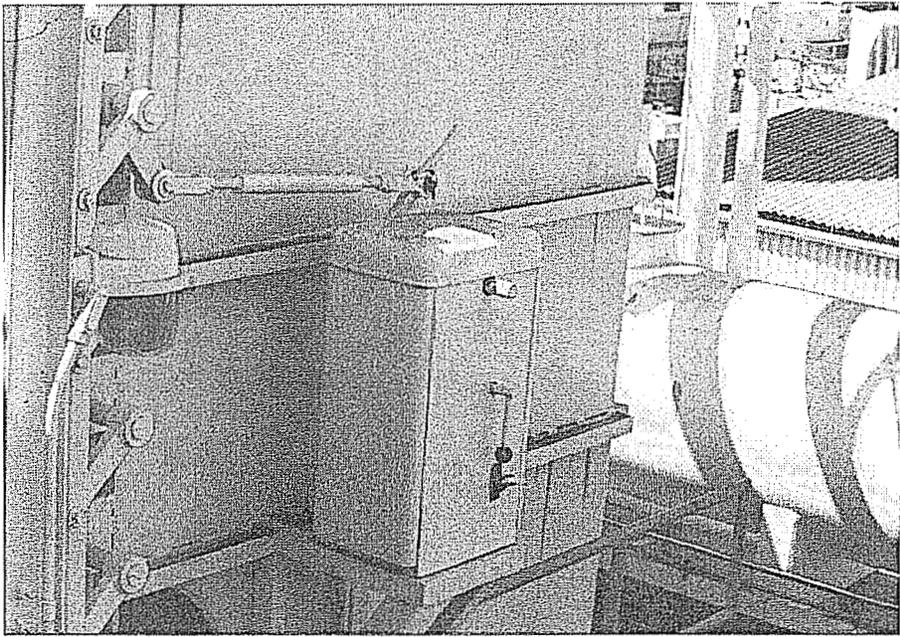
Figure B-15
Pneumatic Louver Control Damper at Pasadena Power Plant, Which Experienced Several Database Earthquakes

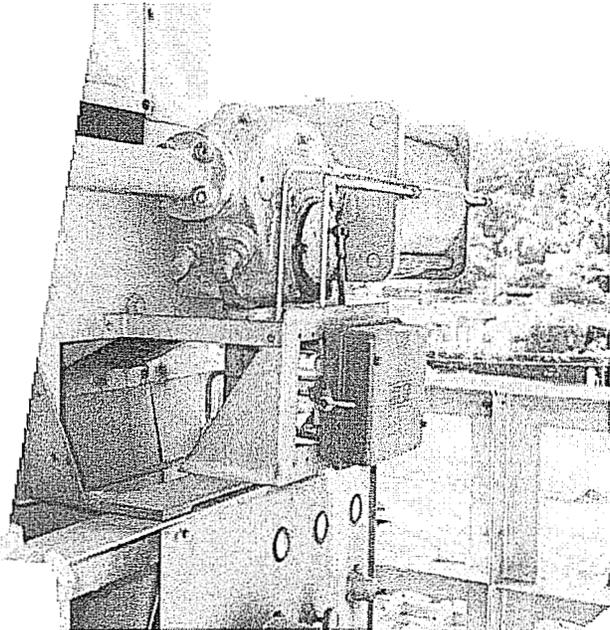
Figure B-16
Heavy Pneumatic Controller With Independent Support for a Large Damper at Pasadena Power Plant Located Very High in the Boiler Structure

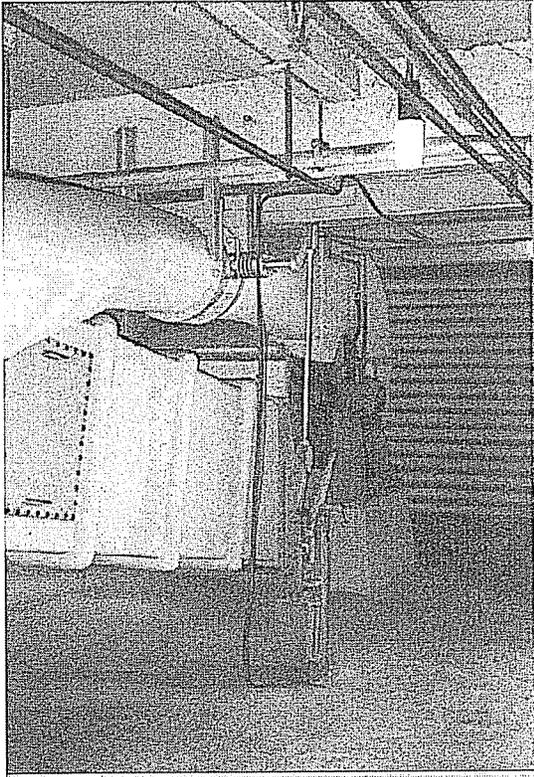
Figure B-17
Air Operated Damper With Floor-Mounted Actuator at Burbank Power Plant, Which Experienced the 1971 San Fernando and the 1994 Northridge Earthquakes

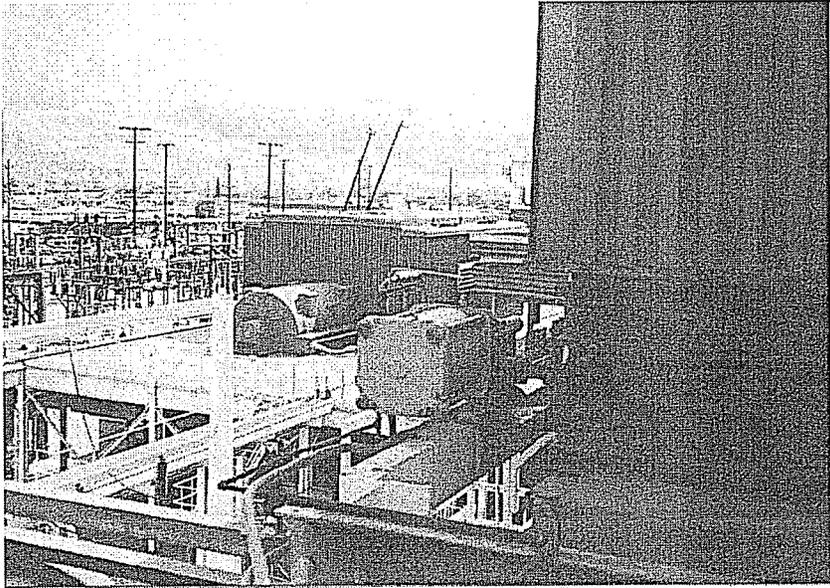
Figure B-18
Large Independently Supported Damper Controller at the Burbank Power Plant

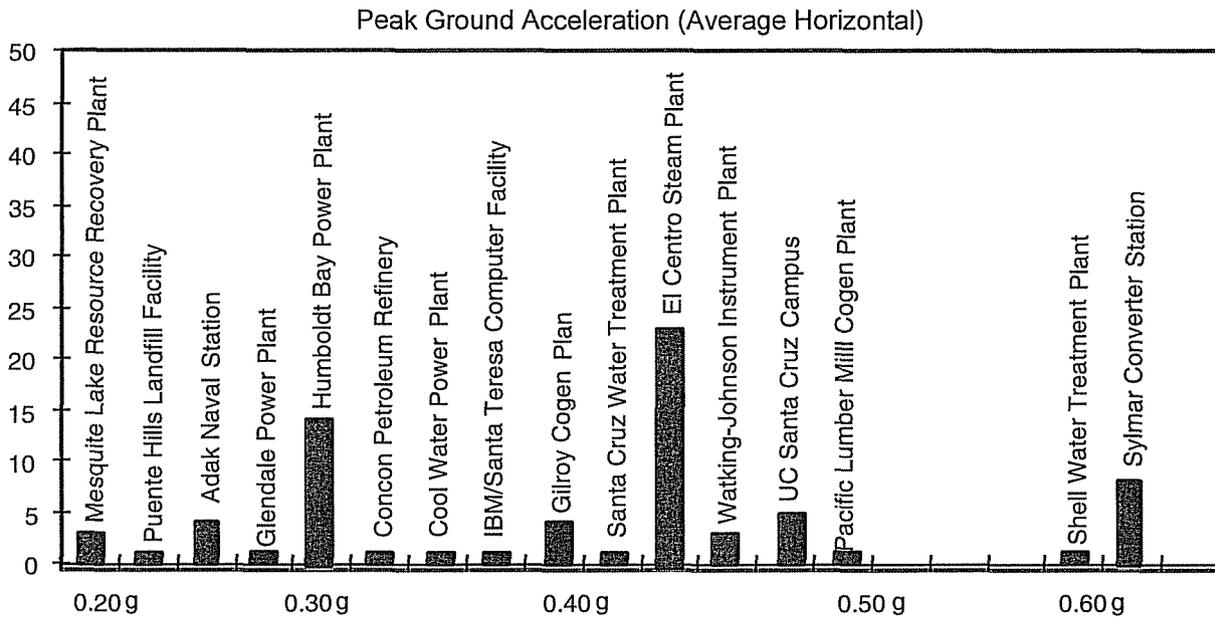
Figure B-19
Inventory of Dampers Within Experience Database

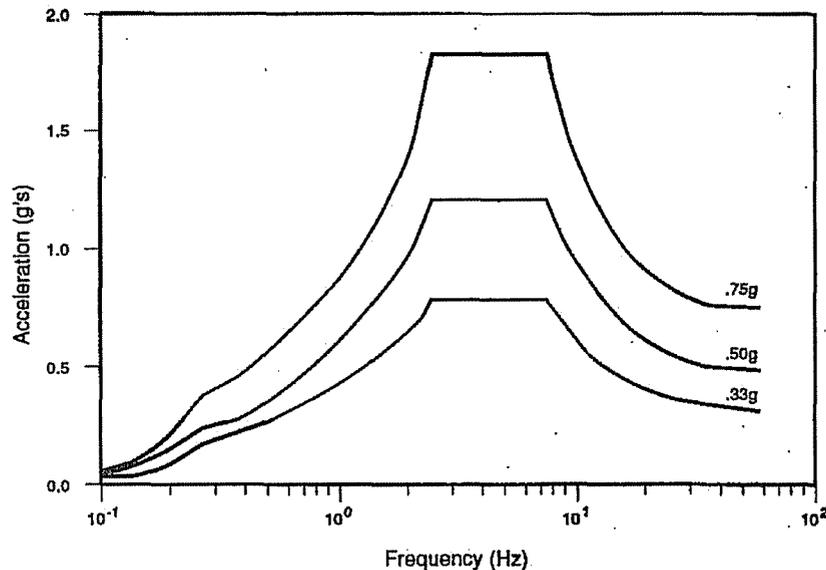
Figure E-1
Bounding Rod Fatigue Spectra

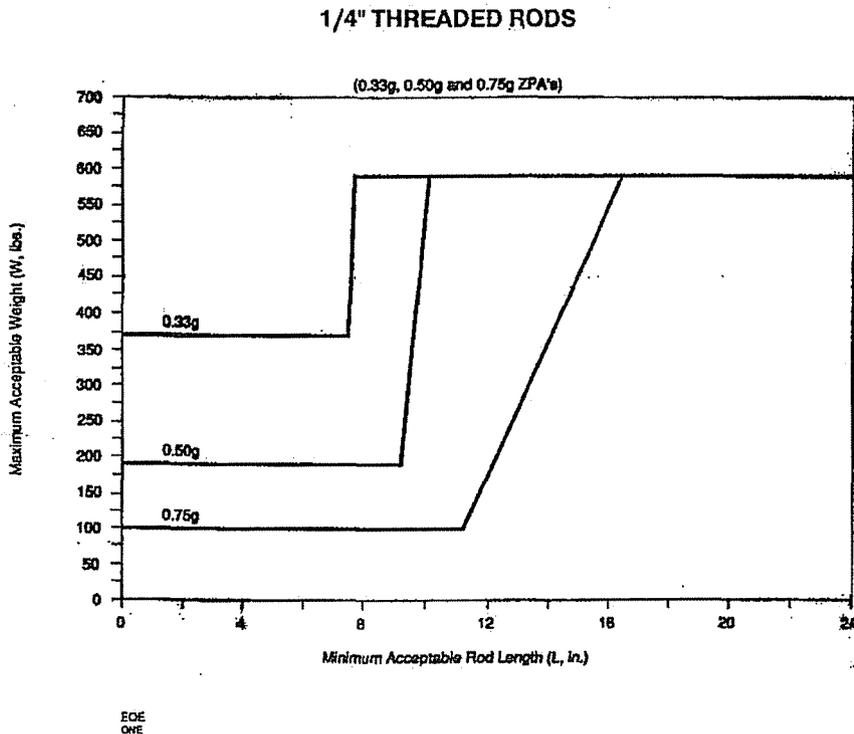
Figure E-2
Fatigue Elevation Screening Chart for 1/4 inch Diameter Manufactured All-thread Rods.
Weight Corresponds to the Total Supported Load (i.e., on both Rods). Length Corresponds to Clear Length

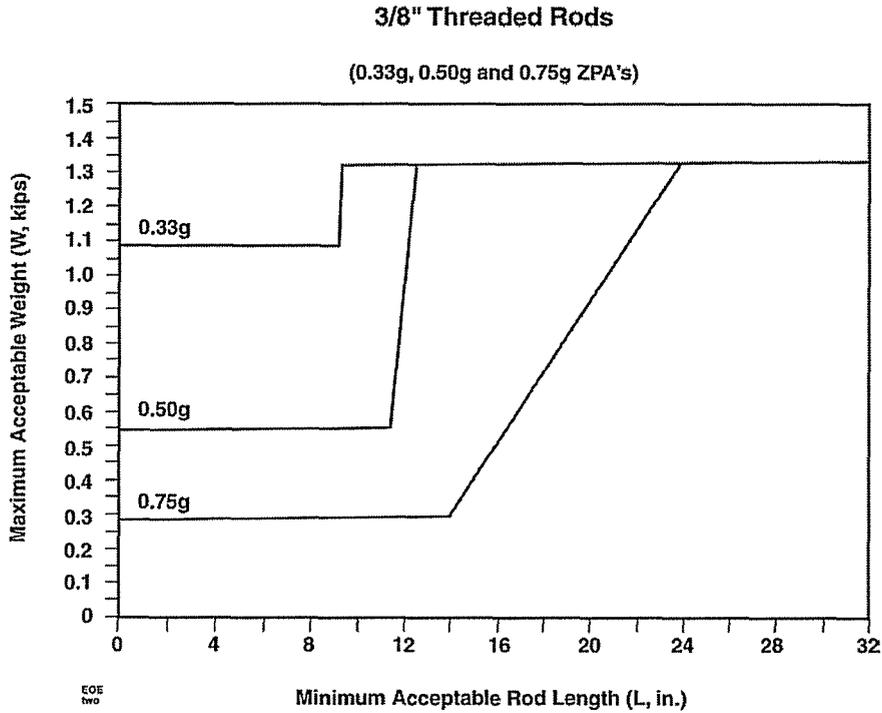
Figure E-3
Fatigue Evaluation Screening Chart for 3/8 inch Diameter Manufactured All-thread Rods.
Weight Corresponds to the Total Supported Load (i.e., on both Rods). Weight Corresponds to Clear Length

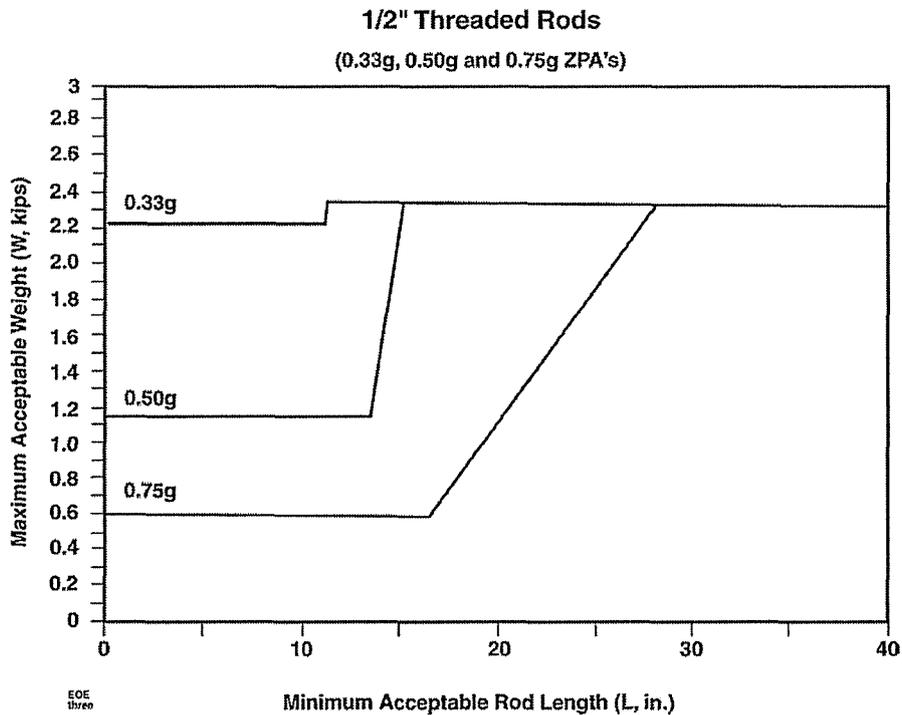
Figure E-4
Fatigue Evaluation Screening Chart for 1/2 - inch Diameter Manufactured All-thread Rods.
Weight Corresponds to the Total Supported Load (i.e., on both Rods). Length Corresponds to Clear Length

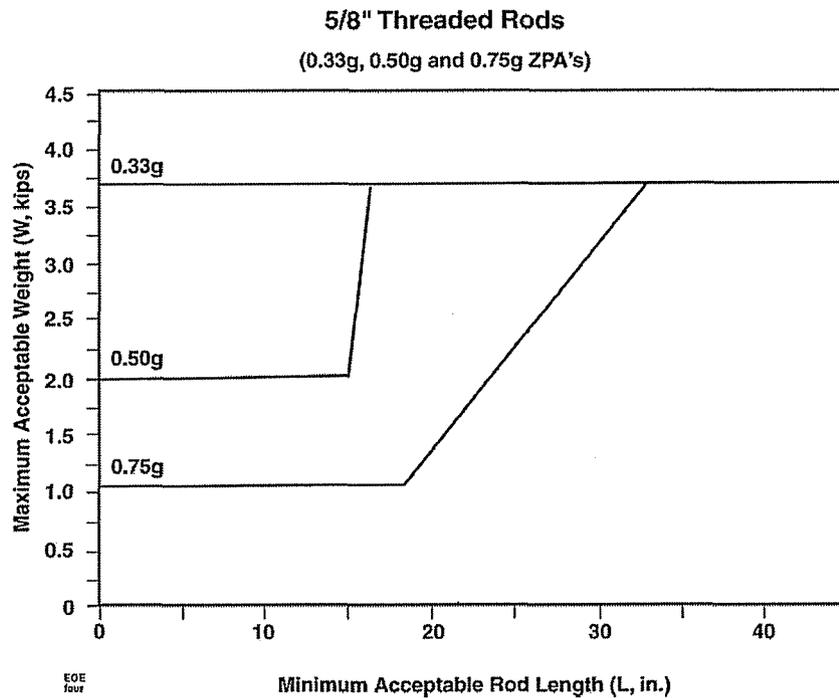
Figure E-5
Fatigue Evaluation Screening Chart for 5/8-inch Diameter Manufactured All-thread Rods.
Weight Corresponds to the Total Supported Load (i.e., on both Rods). Length Corresponds to Clear Length

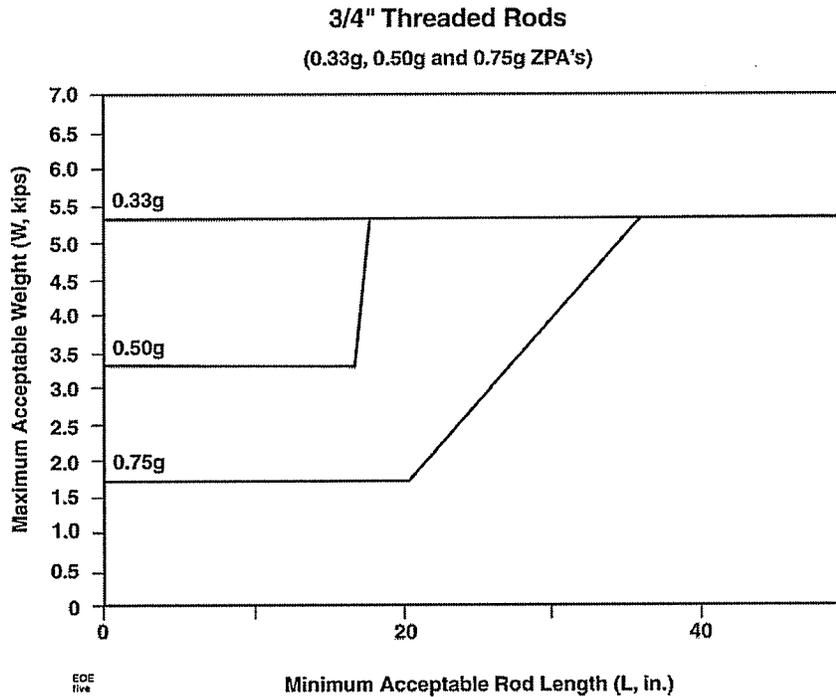
Figure E-6
Fatigue Evaluation Screening Chart for 3/4-inch Diameter Manufactured All-thread Rods.
Weight Corresponds to the Total Supported Load (i.e., on both Rods). Length Corresponds to Clear Length

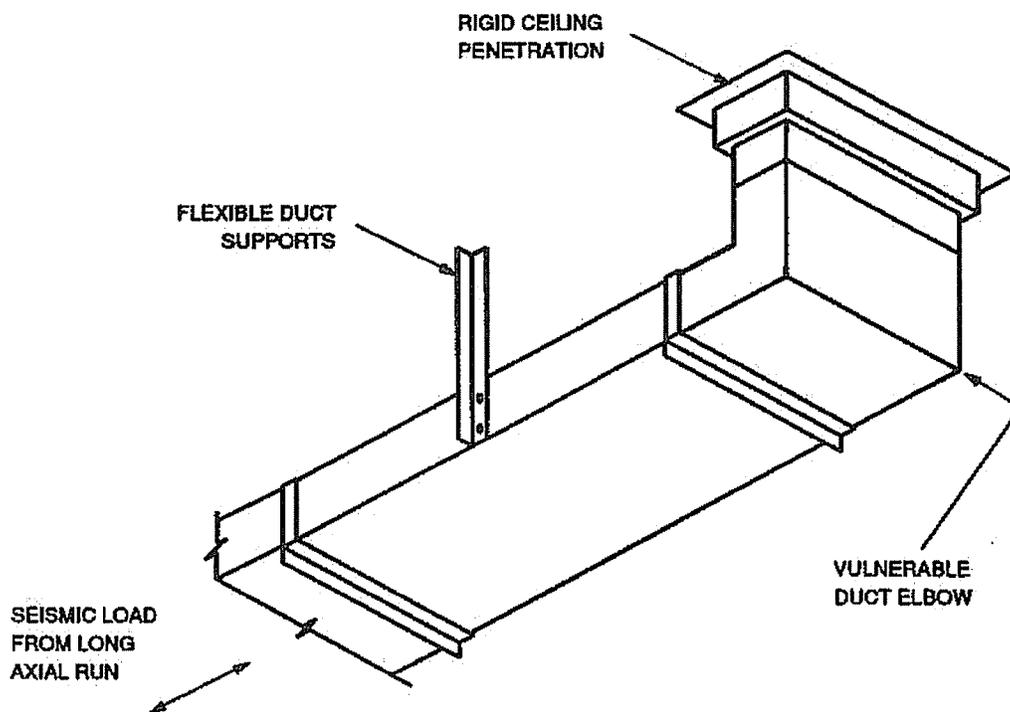
Figure F-1
Vulnerable Duct Elbow Adjacent to Rigid Lateral Restraint

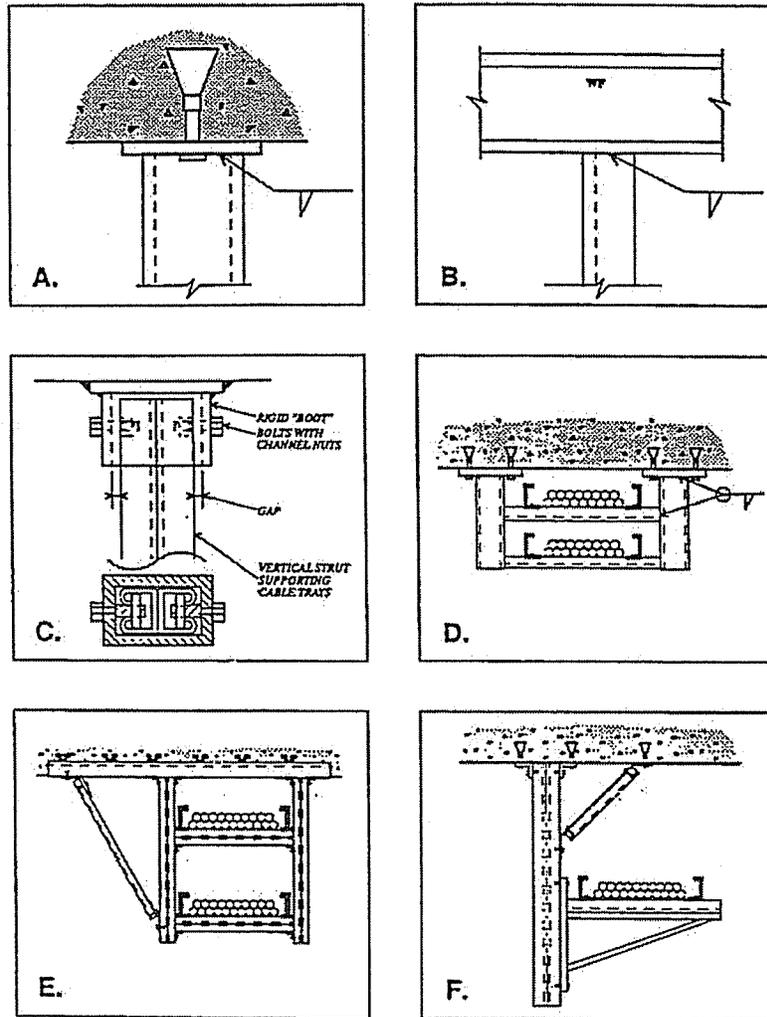
Connections A and B are partially welded connection details. Partial welds cannot develop the plastic moment capacity of the vertical member, and are considered non-ductile.
