FIGURE 2.5-307
Construction Photographs, Units 1 and 2

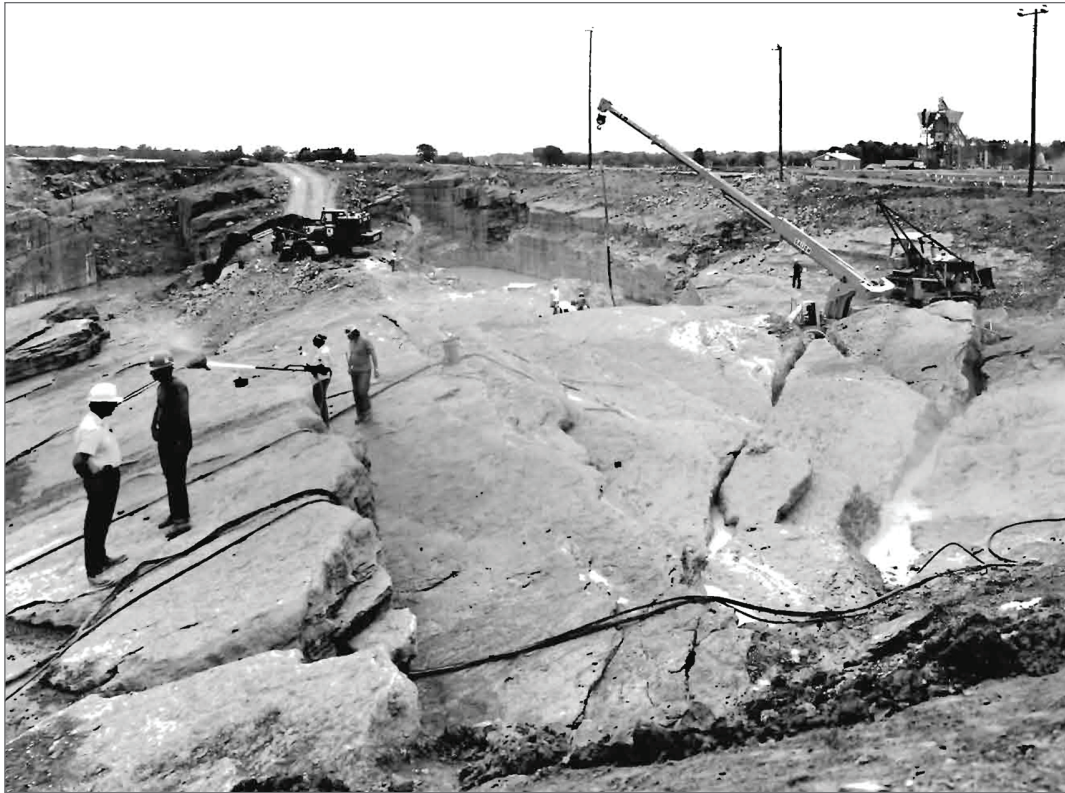
(A) 1975 Excavation for turbine building showing vertical joint oblique to bedding

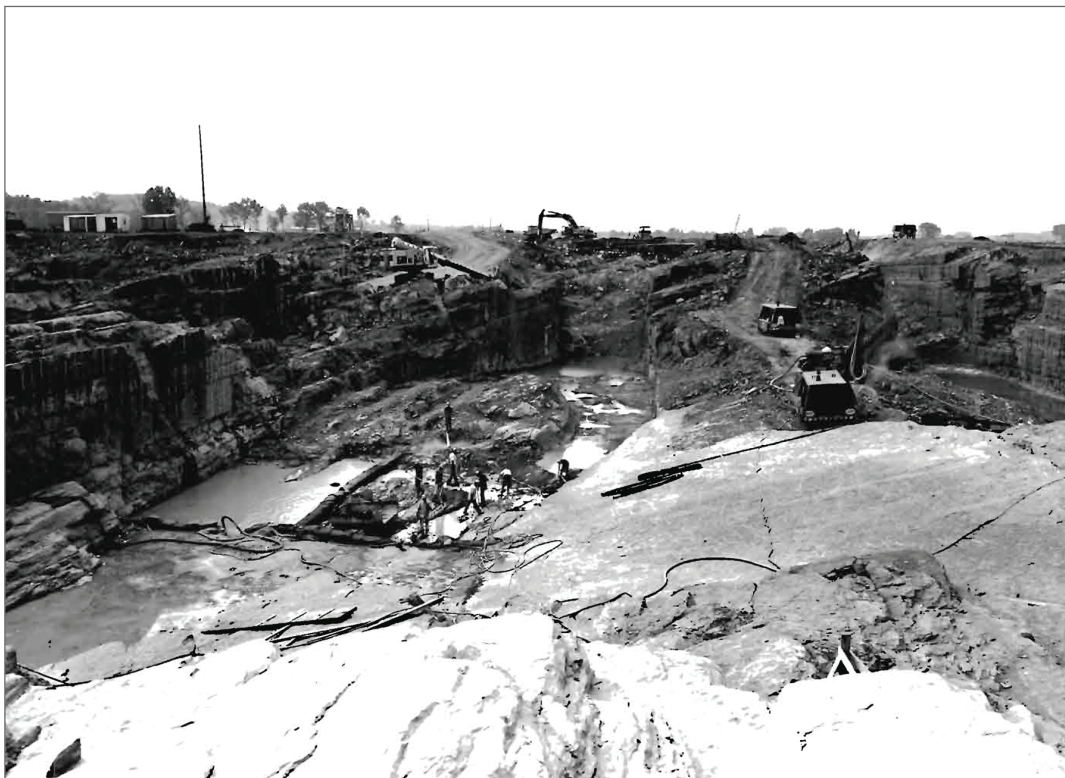
(B) 1975 Excavation for turbine building
