# Fire-Induced Failure Mode Testing for dc-Powered Control Circuits<sup>1</sup>

**Abstract:** The U.S. Nuclear Regulatory Commission, in concert with industry, continues to explore the effects of fire on electrical cable and control circuit performance. The latest efforts, which are currently underway, are exploring issues related to fire-induced cable failure modes and effects for direct current (dc) powered electrical control circuits. An extensive series of small and intermediate scale fire tests has been performed. Each test induced electrical failure in copper conductor cables of various types typical of those used by the U.S. commercial nuclear power industry. The cables in each test were connected to one of several surrogate dc control circuits designed to monitor and detect cable electrical failure modes and effects. The tested dc control circuits included two sets of reversing dc motor starters typical of those used in motor-operated valve (MOV) circuits, two small solenoid-operated valves (SOV), one intermediate size (1-inch (25.4mm) diameter) SOV, a very large direct-acting valve coil, and a switchgear/breaker unit. Also included was a specialized test circuit designed

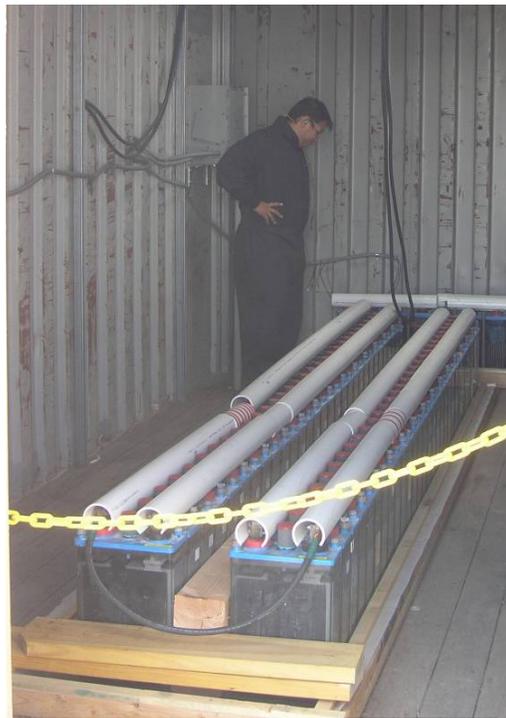
**Figure 1: Photograph of the 60-cell battery bank used in testing.**

The various control circuits were powered from a relatively large 60-cell lead-acid dc battery bank

providing fault currents that are of the same order as typical station batteries (13,000A maximum fault current). The battery cells were made available to the test program through the EPRI collaboration. Figure 1 provides a photograph of the 60-cell battery bank.

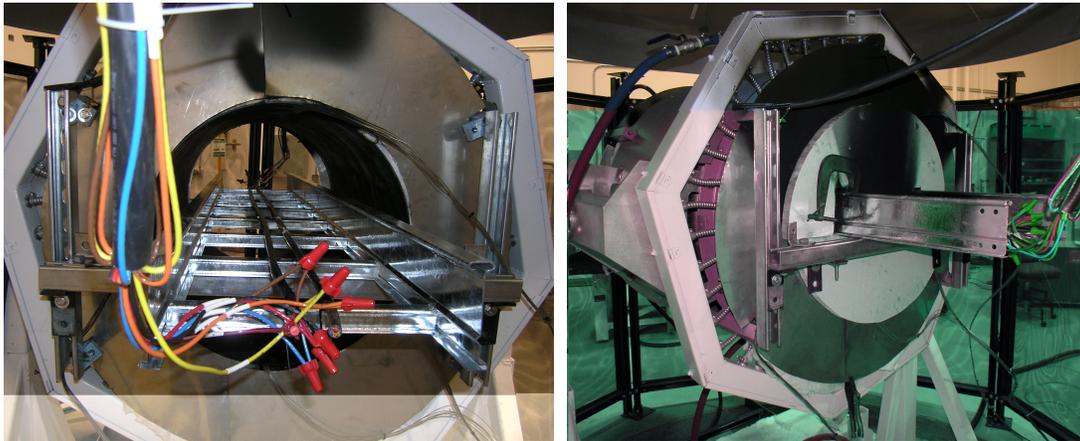
Figure 2: Penlight testing apparatus shown with a cable tray in an open configuration (left) and with the cylinder ends covered by an insulating board and ready for testing (right).

The testing involved both small- and intermediate-scale tests. The overall approach paralleled that of the earlier CAROLFIRE project and both test facilities are described in detail in the project report [3]. The small-scale testing apparatus is known as Penlight. Test samples, in this case the control cables, are placed in the center of a cylindrical steel (inconel) shroud that measures approximately 20 inches (0.51m) in diameter and 32 inches (0.81m) long. The outside of the shroud is heated by a set of computer-controlled quartz lamps to a desired set-point temperature. The shroud is painted flat-black on both the inner and outer surfaces and acts as an intermediate radiant heating surface between the lamps and the test sample. That is, the lamps heat the shroud and the shroud, in turn, heats the test sample. The radiant exposure intensity is easily calculated based on grey-body radiant heating equations.

For this program, as in the previous CAROLFIRE testing, the cables were routed through Penlight either in open ladder-style cable trays or in rigid metal conduit. Figure 2 provides a photograph of Penlight in the cable tray configuration. Note that for testing, the ends of the exposure shroud are closed off with insulating board material to minimize air flow through the exposure region during testing. Penlight tests generally involved two energized sample cables (one cable connected to each of two dc circuits) plus a third cable monitored for temperature response. One goal of the small-scale tests was to verify the proper operation of each of the dc surrogate circuits and to ensure that the failure modes and effects behavior could be elicited from the test data. The second primary goal was

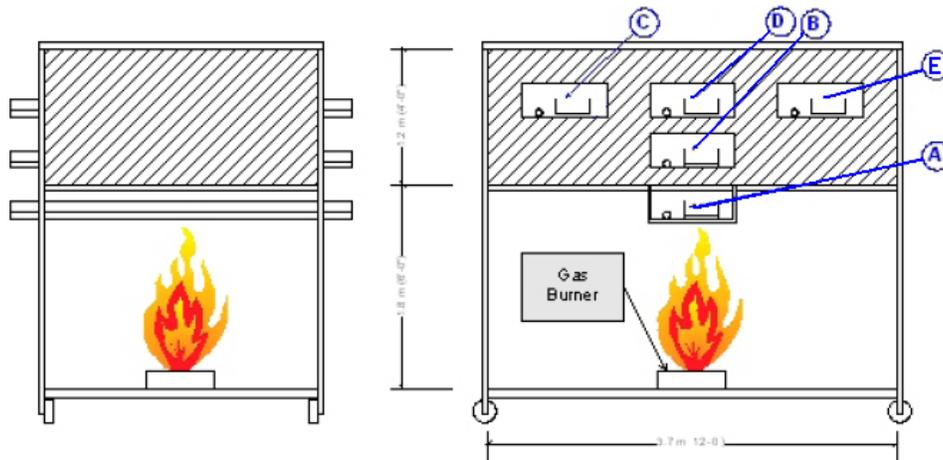
Figure 3: Intermediate-scale test framework.

The intermediate-scale tests were also essentially identical to the test configuration used in the previous CAROLFIRE test program. The test setup involves a propylene gas burner placed under a partially-enclosed metal framework with cable trays and raceways passing through the upper part of the framework. The upper portion of the framework is enclosed on the top and all four sides down 4 feet (1.2m) from the top. The lower portion of the framework is open on all four sides. The intent of the framework is to capture hot gasses from the fire and to create a damaging hot gas layer condition. This framework is enclosed within a larger test facility. Figure 3 provides a general schematic of the intermediate-scale test apparatus. Note that the test framework is scaled to match the overall dimensions of an ASTM E603 standard test enclosure.

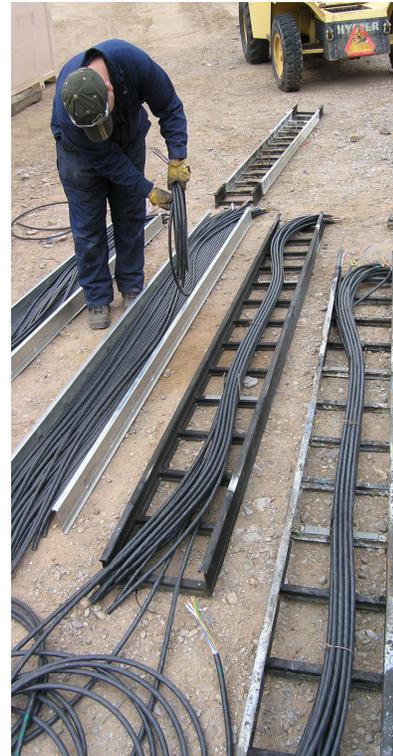
**Figure 4: Photograph of full-fill (left) and partial-fill (right) cable trays being prepared for testing.**

typically meant 3-4 layers of cable. The energized sample cables would be embedded within this cable mass. Each such cable mass was typically comprised of 16-20 individual cable lengths typically including two energized cables. Figure 4 is a photograph showing cable trays of both types (fully loaded and partial fill) being prepared for testing.

As in the Penlight test, the intermediate scale tests varied the cable type used on each circuit. The intermediate scale tests also varied the location of the cables in the facility. Generally, each test location ('A' through 'E' as shown in Figure 4) contained two-to-four energized cables, and all of the dc circuits were utilized in every intermediate scale test. Locations A and B are typically within the gas burner's flame zone and represent the most severe exposure conditions. Location D is typically outside the flame zone of the burner itself but within the burner plume. Cables at Location D will experience flame impingement as the cables at Locations A and B burn. Locations C and E are outside the plume and outside the flame zone so these locations experience only hot gas layer exposure conditions.

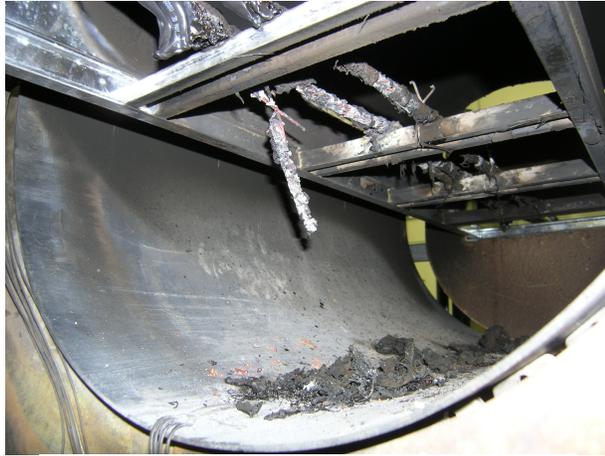
**Figure 5: Photograph of a typical case where arcing faults resulted in conductors being severed during testing (note the cable on the left in this photo).**

One of the first behavioral differences noted during testing was the fact that the dc faults were generally more energetic than were the faults observed with the AC circuits in previous testing. In the case of the AC circuits, cable electrical failure is typically accompanied by minor arcs followed relatively quickly by a fuse-blow which de-energizes the circuit. These arcs were readily observed and sufficient to ignite the cables in most cases. The dc cable failures also generated arcs, but by comparison, the arcs generated by the dc cable failures are far more energetic. The arcs also tended to be short-lived and, in the case of the larger fuses (15A and 35A) generally were not of sufficient duration to cause the protective fuses to activate (blow to an open circuit condition). In the case of the dc cables, the arcing behavior is not only sufficient to ignite the heated cables, but was also sustained for a longer period of time and often times was sufficient to actually melt the conductors. Figure 5

illustrates typical post-test conditions observed. This illustration is taken from a Penlight test, but similar behavior was also noted in the intermediate scale tests. Note that some of the conductors have been broken (melted) and that pieces of copper conductor and copper slag are evident laying on the inside-bottom of the Penlight exposure shroud. These faults were also sufficient in many cases to either weld a conductor to the metal rungs of the cable tray and/or to burn holes into the tray rungs.
