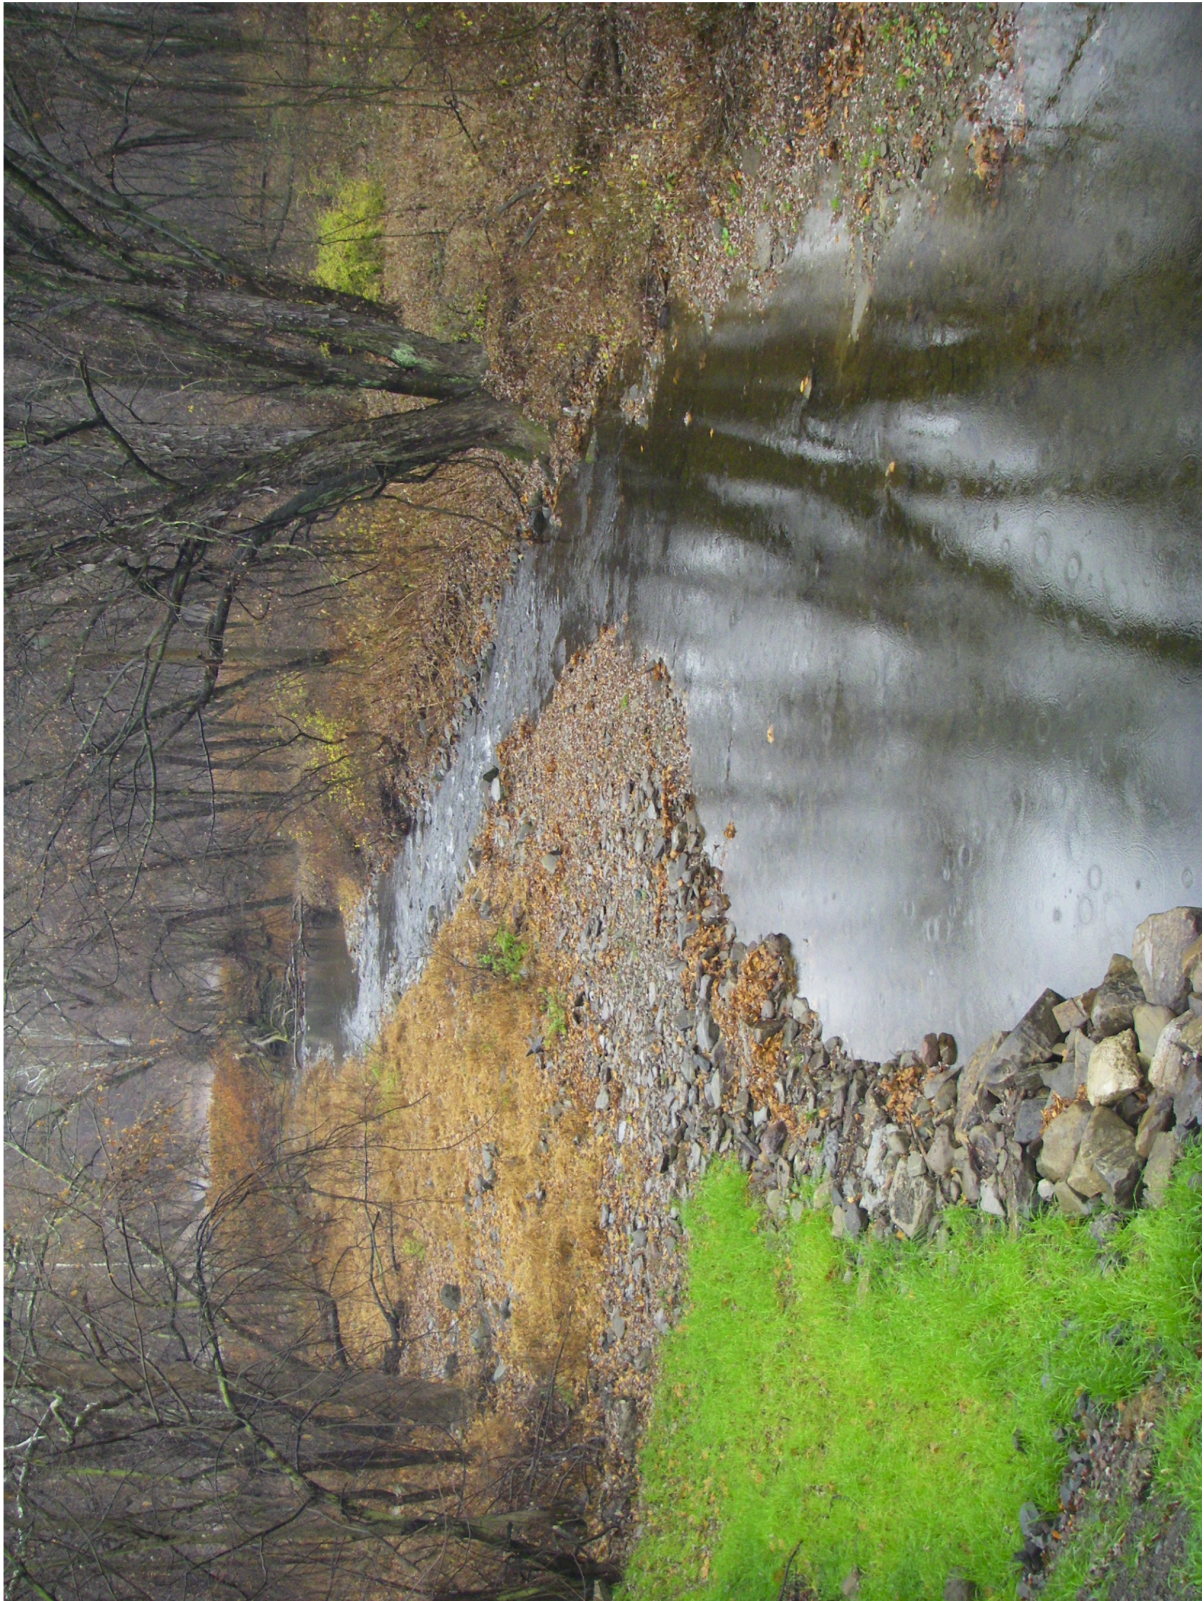
**Figure 2.5-129—{Gravelly Deposits along Hunlock Creek, a Tributary to the Susquehanna}**

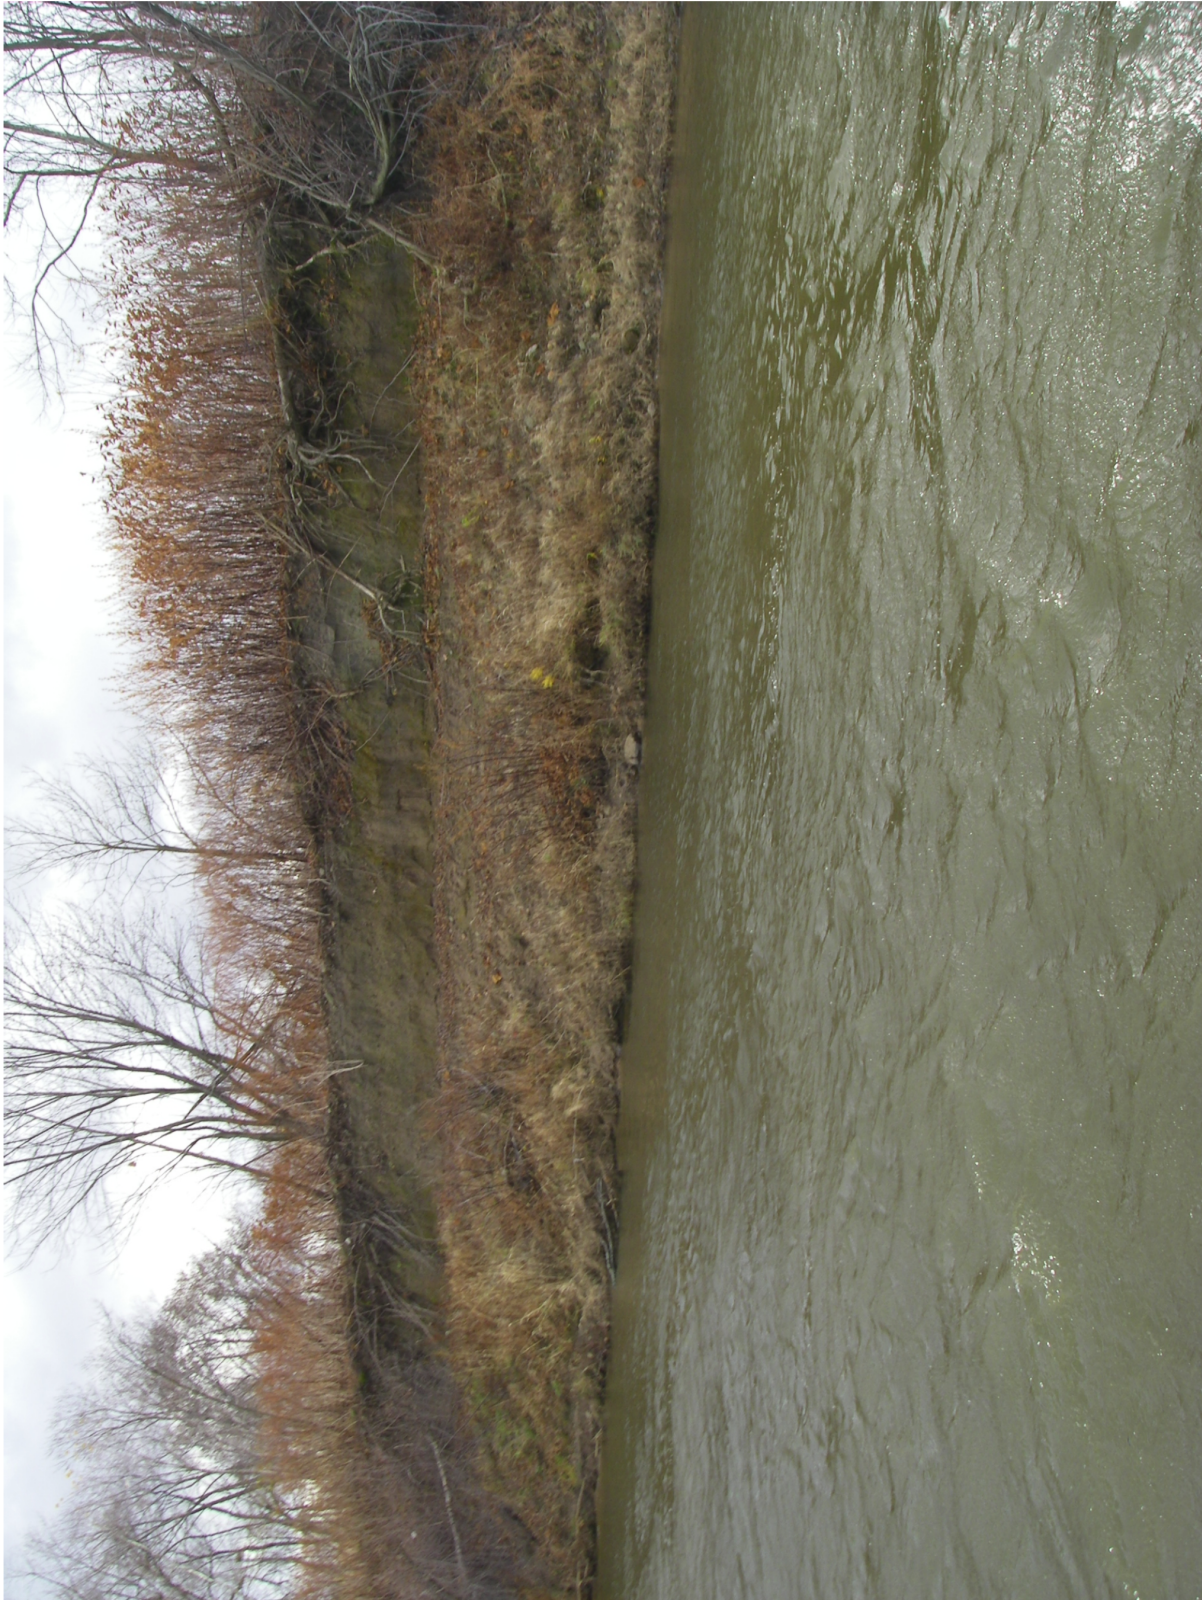
**Figure 2.5-130—{Exposure of Soft Sediments on the East Bank of the Susquehanna River}**

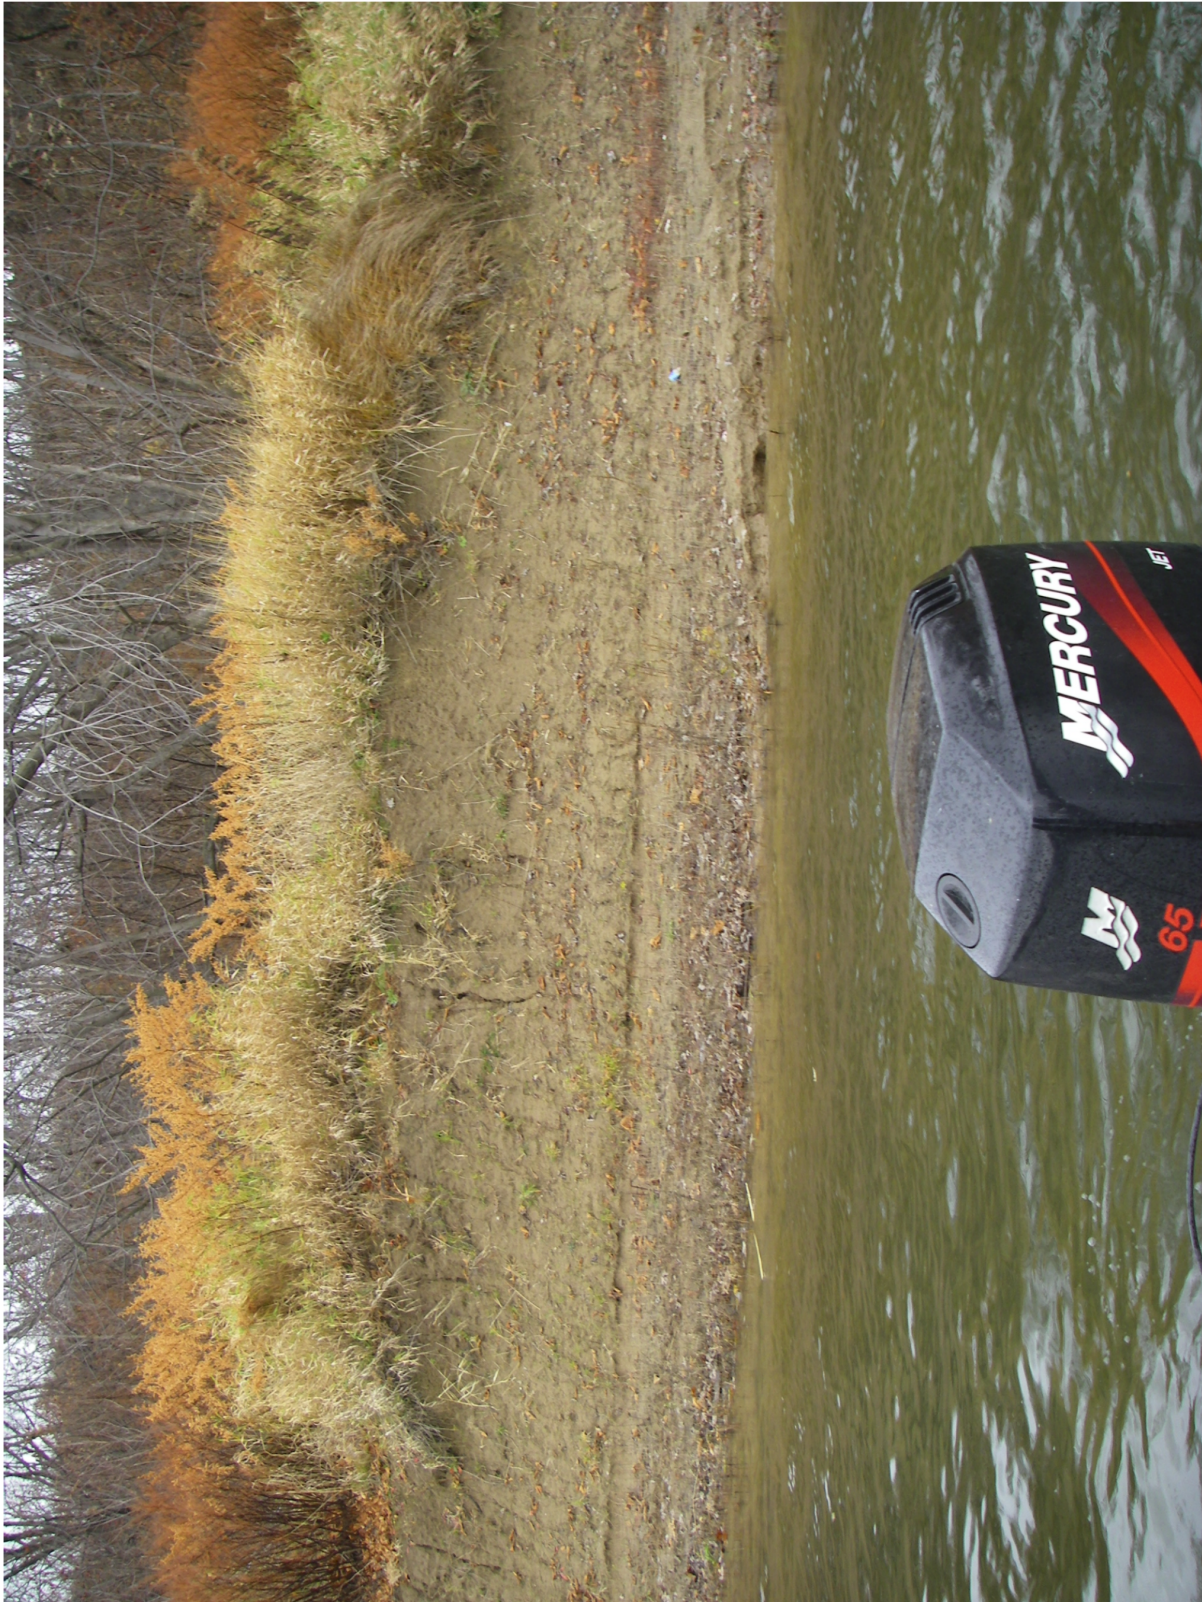
Figure 2.5-131 —{Exposure of Man-made Fill on the Susquehanna River}
