Century Industries

Test Report

NCT Evaluation Test Series (Compression & Penetration) Of Century Industries' Versa-Pac Shipping Containers

US NRC Docket Number 71-9342

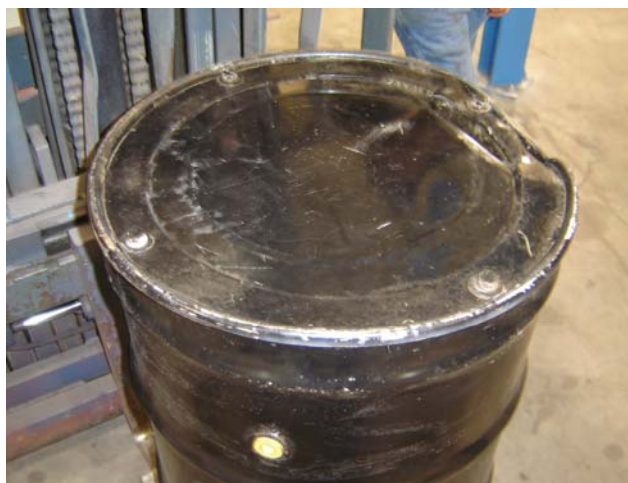
Previously Dropped Prototype

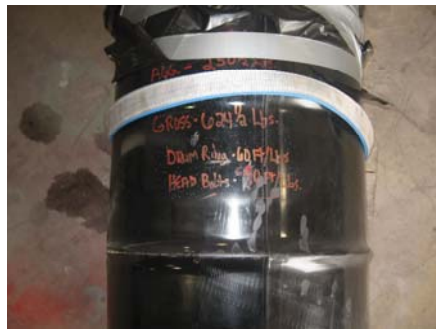
The test article was positioned horizontally on a flat 8 inch concrete floor with the penetration bar positioned vertically directly over a vertical inner stiffener thru the outer sidewall of the package. The bar was lifted to a height 40 inches (1 meter) and allowed to be released through a 2 inch PVC guide tube to provide the correct impact on the surface of the test package.

Pre-Drop Surface

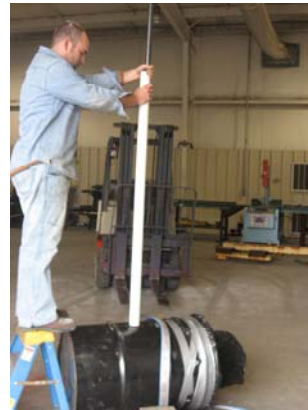
Penetration Set-up

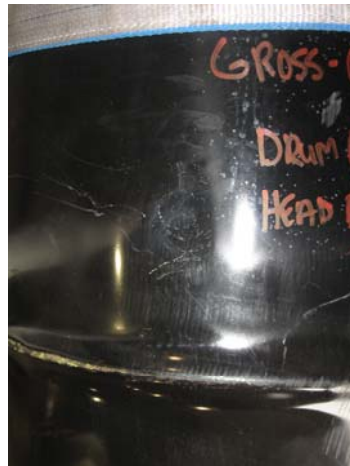
The result of this impact to the sidewall of the test articles resulted in un-measurable damage to the package impact area.

Post Drop Results

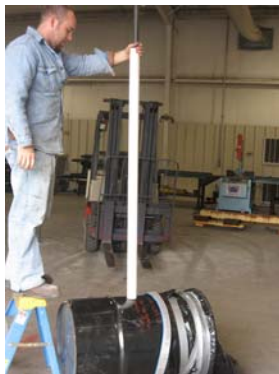
The test article was positioned horizontally on a flat 8 inch concrete floor with the penetration bar positioned vertically directly between two vertical inner stiffener thru the outer sidewall of the package. The bar was lifted to a height 40 inches (1 meter) and allowed to be released through a 2 inch PVC guide tube to provide the correct impact on the surface of the test package.

Penetration Set-up

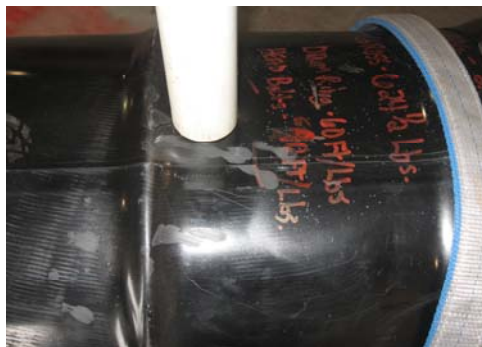
Post Test Results No Damage

The result of this impact to the sidewall of the test articles resulted in measurable damage to the package impact area with only a slight marring of the package paint.

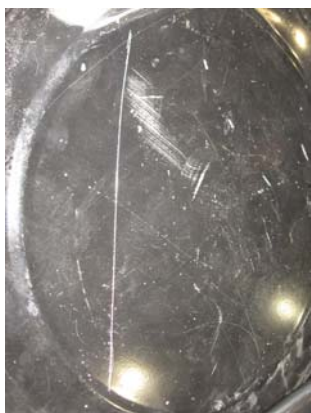
The test article was positioned vertically on a flat 8 inch concrete floor with the penetration bar positioned vertically directly between on the center of the drum lid of the package. The bar was lifted to a height 40 inches (1 meter) and allowed to be released through a 2 inch PVC guide tube to provide the correct impact on the surface of the test package

Pre-Drop Surface

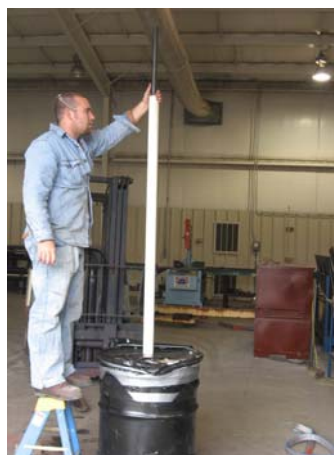
Penetration Set-up

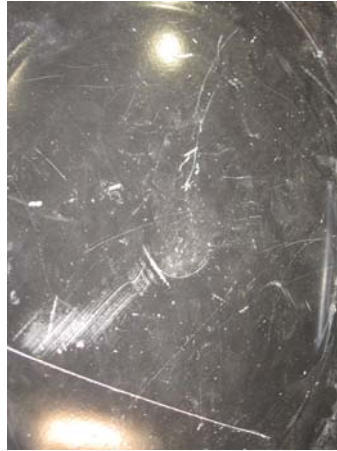
The results of this drop produced a slight marring of the drum lid surface.

Post Test Damage - Marring

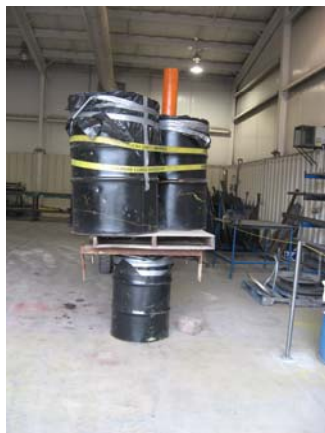
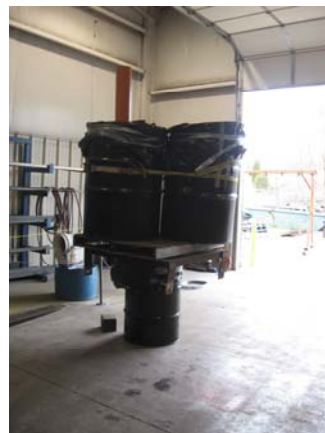
The test article was positioned vertically so that the load was directly applied to the top of the package. The test article weighed 624.5 pounds, to meet the requirement of 5 times the weight of the package; a load of 3,200 pounds was loaded on the top surface of the package, for a period of 24 hours.

No damage or buckling of the package was found upon inspection of the test article.

Stacking Test
