LICENSE RENEWAL BOUNDARY DRAWING
LR-M010C REV. 0

DAVIS-BESSE NUCLEAR POWER STATION
UNIT NO. 1
 THE TOLEDO EDISON COMPANY

PIPING & INSTRUMENT DIAGRAM
MAKE-UP WATER TREATMENT SYSTEM

JOB NO.	DRAWING NO.	REV.
12501	M-010C	42

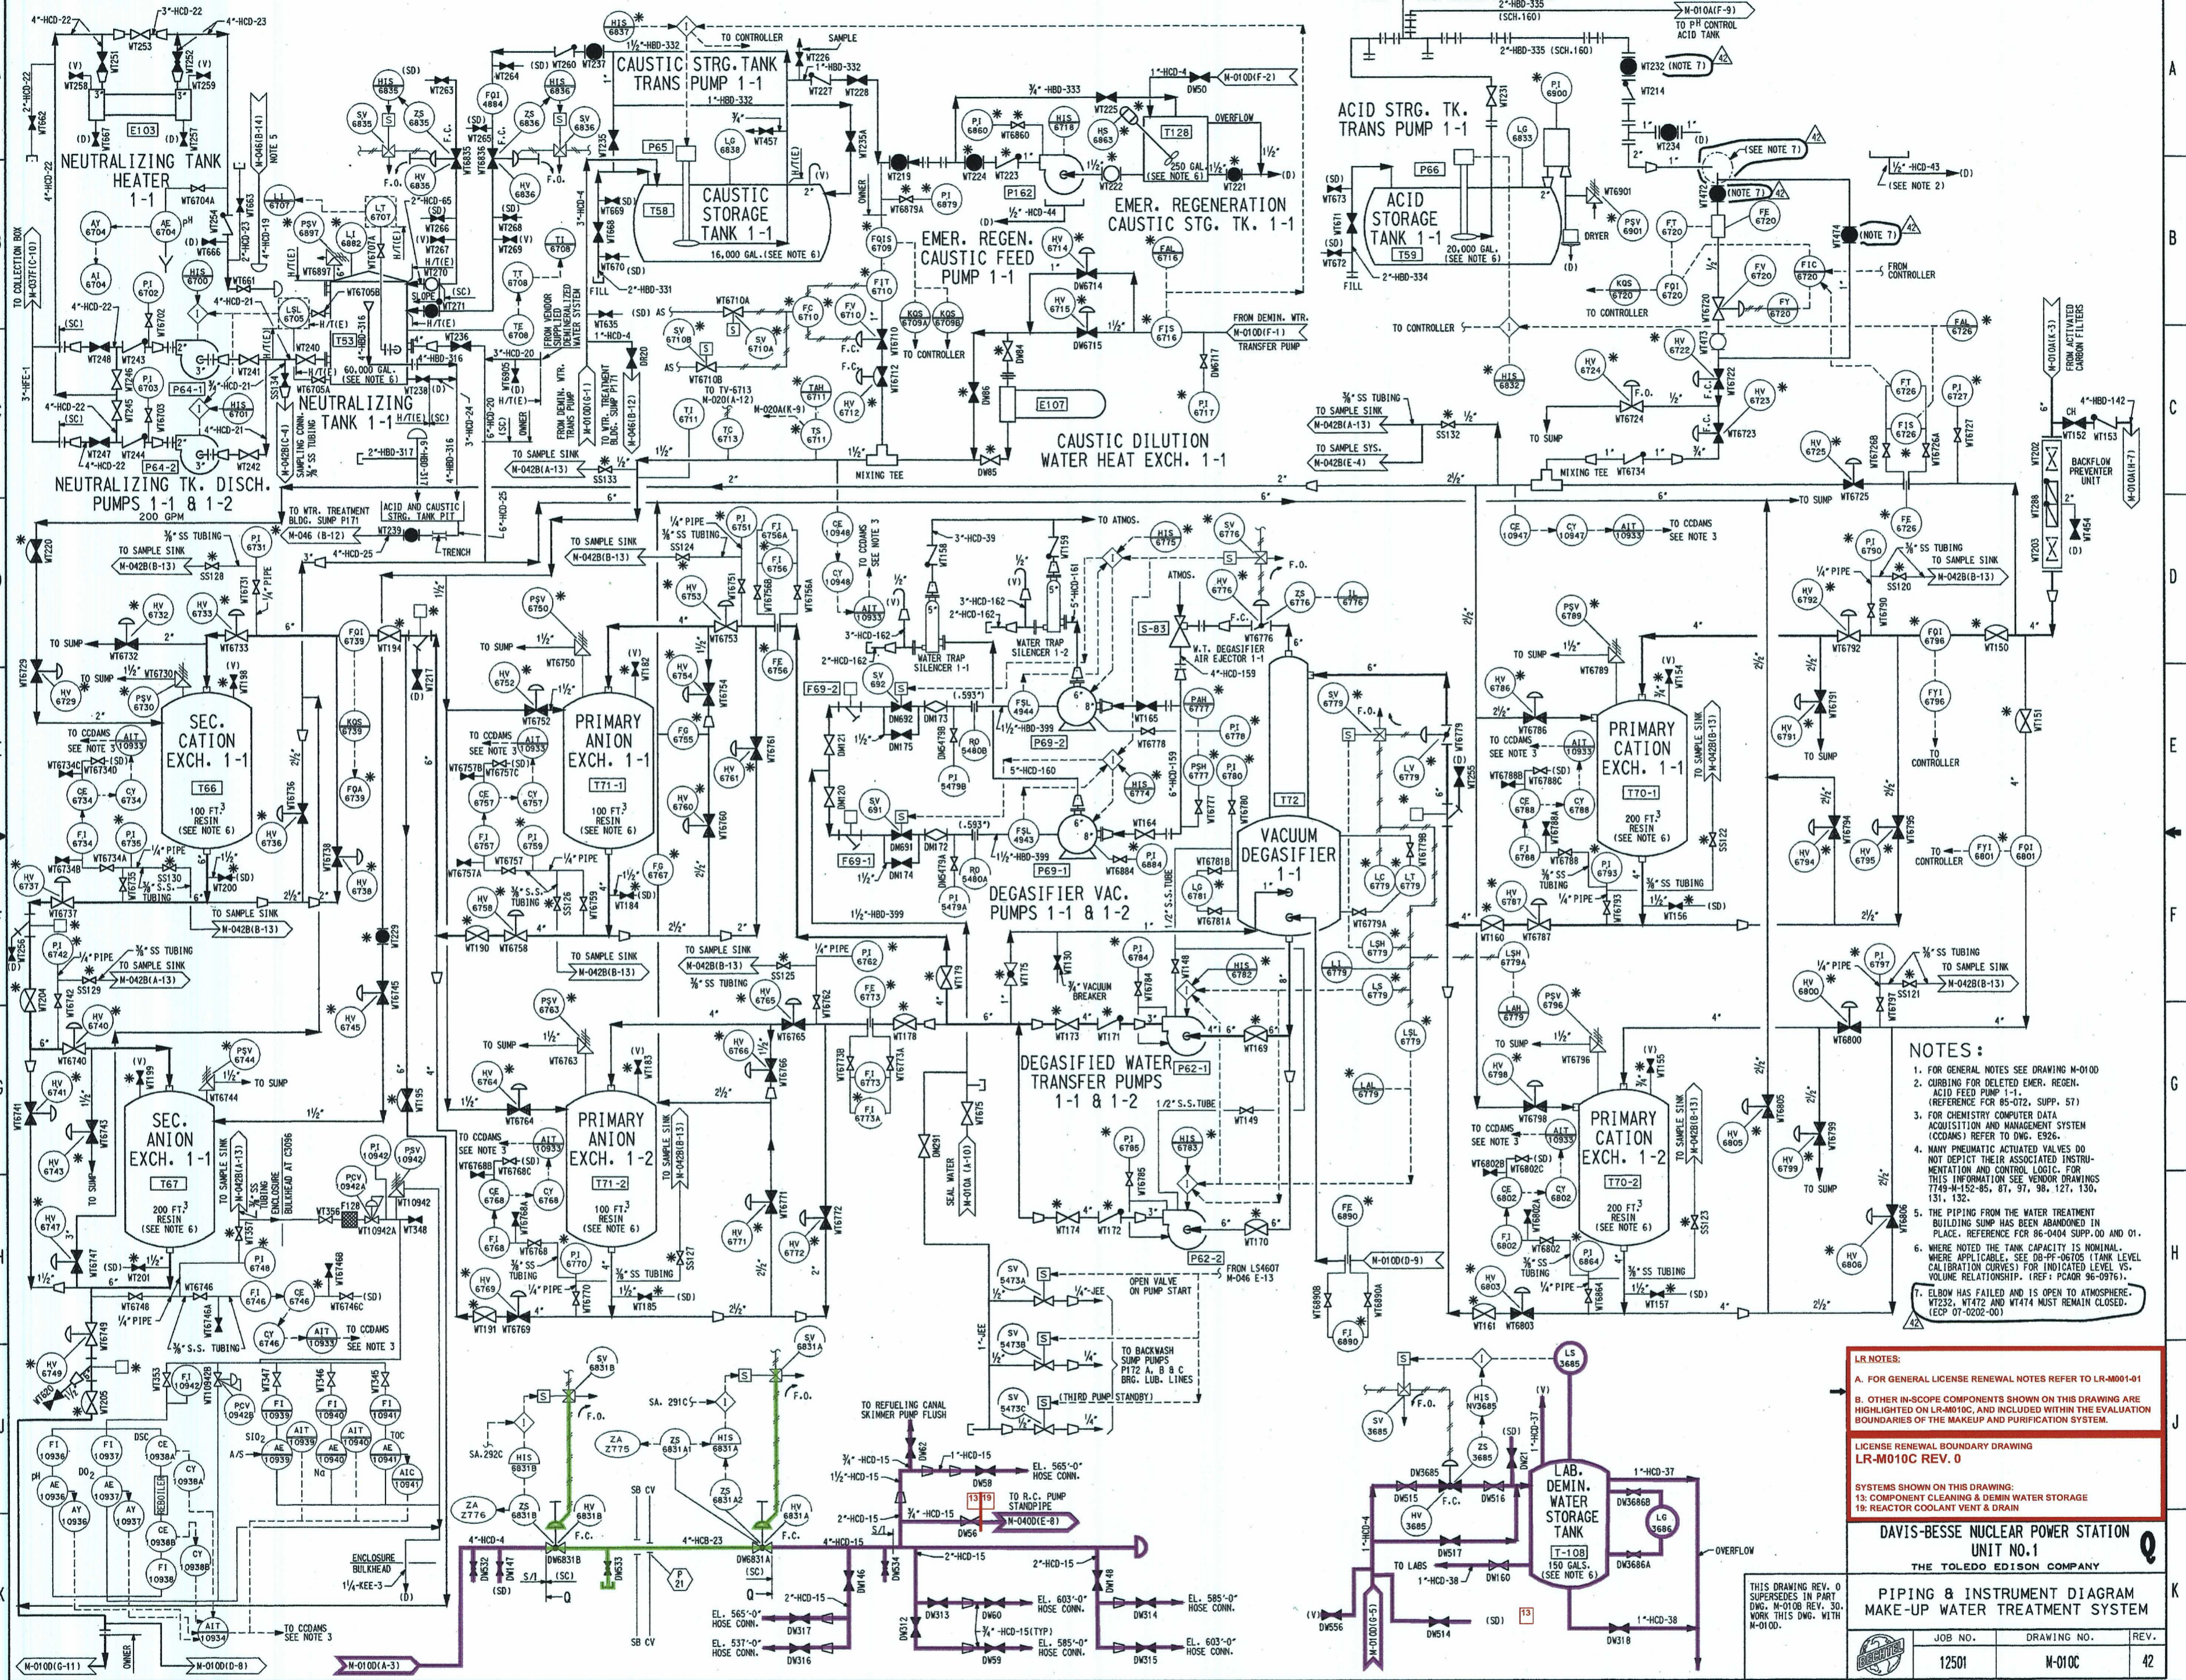
B. OTHER IN-SCOPE COMPONENTS SHOWN ON THIS DRAWING ARE HIGHLIGHTED ON LR-M010C, AND INCLUDED WITHIN THE EVALUATION BOUNDARIES OF THE MAKEUP AND PURIFICATION SYSTEM.

SYSTEMS SHOWN ON THIS DRAWING:
 13: COMPONENT CLEANING & DEMIN. WATER STORAGE
 19: REACTOR COOLANT VENT & DRAIN
