Turkey Point Units 6 & 7  
COL Application  
Part 3 — Environmental Report

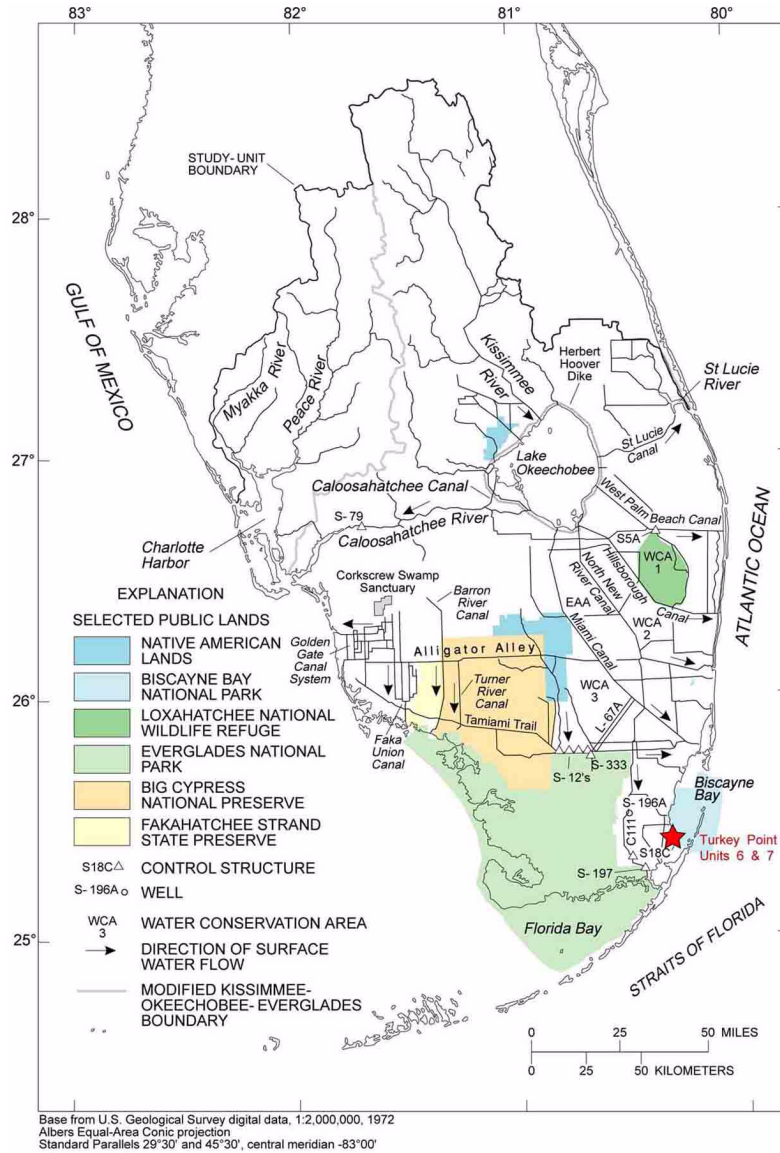
**Figure 2.3-7 Selected Public Lands and Post-Development Flow Alteration within the South Florida Watershed**

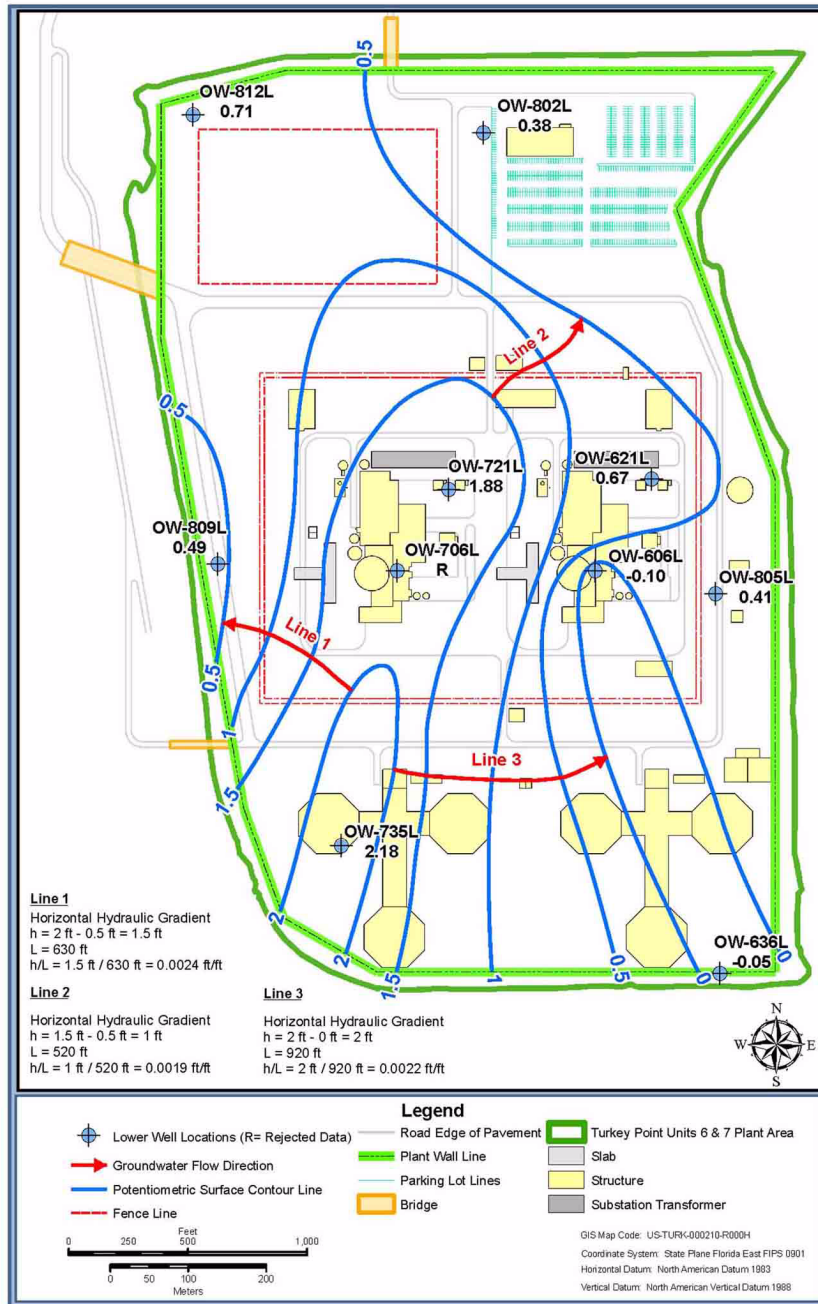
Figure 2.3-31 Biscayne Aquifer Potentiometric Surface Map, Lower Monitoring Interval, August 15, 2008 (Sheet 2 of 2) Low Tide
