# Thermal Imaging of the Waccasassa Bay Preserve: Image Acquisition and Processing

By Ellen A. Raabe and Elzbieta Bialkowska-Jelinska

Open-File Report 2010–1120

U.S. Department of the Interior U.S. Geological Survey

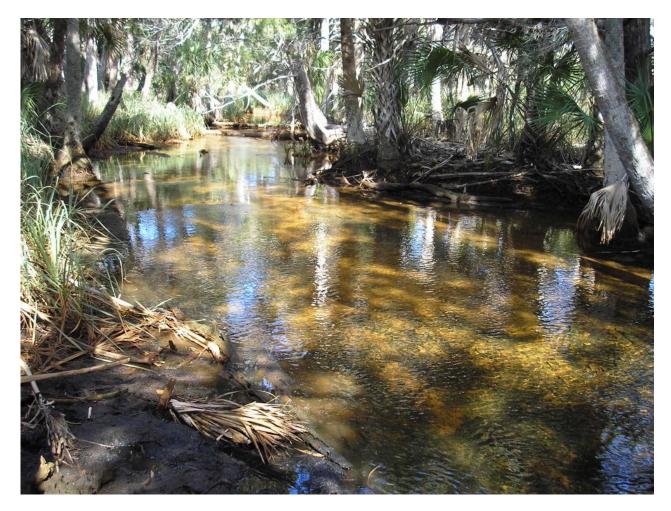
Figure 19. Photo showing Lancaster Spring looking north along the spring run, February 2009.

An example of the comparison between 2005 and 2009 TIR imagery can be seen at Lancaster Spring, a well-established coastal spring (Scott and others, 2004; figs. 19 and 20). The spring itself is located approximately 1 mi from the coast. Spring Creek, the spring-fed tidal creek, meanders southward to Waccasassa Bay east of Cedar Key. Lancaster Spring consists of a 6.5-ft deep pool with several boils surrounded by a narrow coastal hammock bordered on the west by sawgrass, to the south and east by salt marsh, and to the north by an elevated dirt road. Lancaster Spring and Spring Creek were among those sites with reduced thermal signature in the 2009 imagery (fig. 20a). Although this site was identified in both 2005 and 2009, the spring was rated Level 3 in 2009, and no thermal trace was indicated in the tidal creek. In 2005, Lancaster Spring showed a large thermal anomaly at the spring and thermal traces within the tidal creek (fig. 20b).

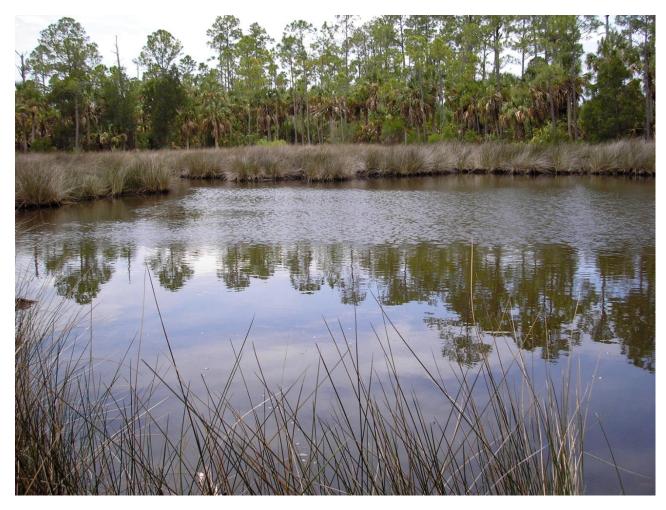
Figure 22. Photo showing Level 4 pond at Lukens Creek surrounded by high marsh and pine hammocks.

A double pond with a strong thermal signal rated Level 4 is situated between two hammocks surrounded by tidal marsh near the head of Lukens Creek (fig. 22). Figure 23 shows the upper portion of Lukens Creek with a color-infrared (CIR) image on the left (fig. 23a) and TIR night image on the right (fig. 23b). Natural features in this area of the Cedar Key Scrub Reserve include coastal hammock, oak scrub, marsh, creek, sand bars, and varying degrees of exposed, wetted, and vegetated soils. Most of the natural surface features range from 44 to 55 °F. Notable features include the sand bars to the west, the partially vegetated wet marsh, and areas with tree canopy. No natural material in this image compares thermally with Lukens Creek or the temperature anomaly in the ponds despite the presence of a sand hill, sand bars, and surfacewater flow paths traversing the area. Field observations of high marsh grasses, sawgrass meadows to the north and east, and a decaying alligator nest situated along the "warmest" pond edge, indicate freshwater flow may be present here.

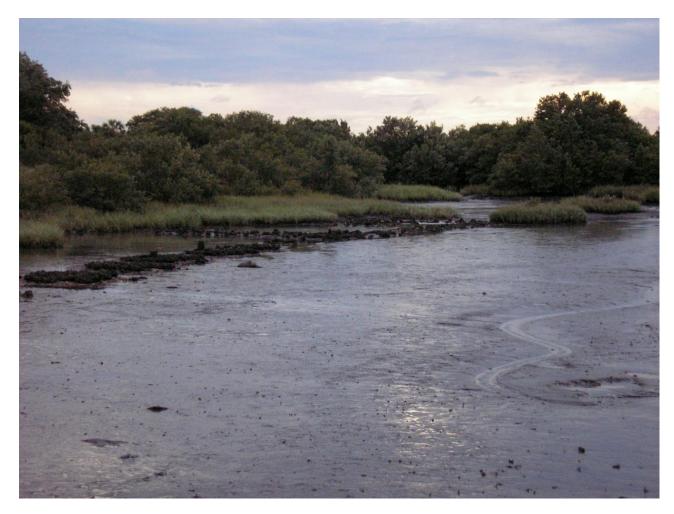
Figure 24. Photo showing mudflat near Cedar Key exposed at low tide, looking west.

A mudflat exposed at low tide near Cedar Key is shown in figure 24. The temperature of this feature in 2009 TIR image, 48 to 49° F, was considerably lower than the ambient temperature of Creek or Bay water, as would be expected from exposed muddy substrate. A small boat embayment nestled between hotels and condominiums is illustrated in figure 25. This shallow, mud-bottomed water feature, at 55 to 56° F, was in the ambient surface water temperature range for the Creek zone. Both features can be seen in figure 26, showing the east end of Cedar Key with CIR (fig. 26a) and TIR night imagery (fig. 26b). Swimming pools stand out as the warmest features, considerably warmer than either mudflat or boat bay. Notable features in Cedar Key include cool rooftops, warm swimming pools, asphalt roads in the mid-range similar to the creek, and the moderating effect of vegetation over wet ground. Mud and sand features, exposed during low tide in the 2009 night TIR image, reliably exhibited low temperatures within or below the ambient water temperature for Creek and Bay zones.

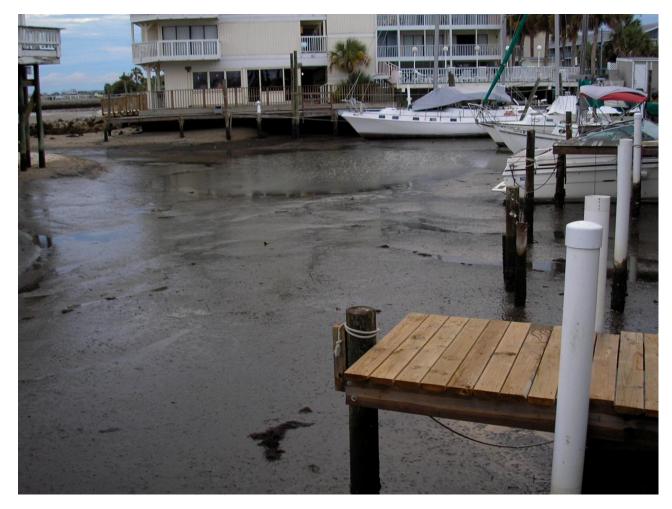
Figure 25. Photo showing shallow boat bay between hotels and condominiums in Cedar Key.

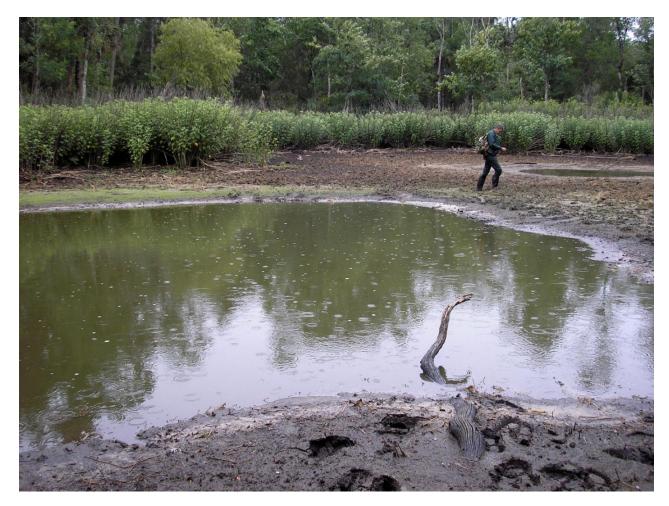
**Figure 27.** Photo showing Jacks Creek Level 4 twin ponds in dry season with corkwood at perimeter of two mud holes in May 2009. Photo looking south.

An area near Jacks Creek demonstrates the difficulty comparing what is visible to the eye and what can be detected with TIR imagery (figs. 27-33). Figure 28 illustrates Jacks Creek area with CIR (fig. 28a) and TIR night imagery (fig. 28b). Vague traces of dirt roads can be seen in the imagery and only minor temperature differences can be detected between marsh and forest. Ten Level 4 temperature anomalies were mapped among many pond and depression features, most not thermally different from Creek-zone background temperature. Arrows on figure 28b indicate photos taken at Level 4 sites (fig 27 and 29), a Level 1 site (fig. 30) and ponds with no temperature signal (figs. 31-32). Jacks Creek area is primarily coastal forest with creeks, exposed rock, depression features, and tidal marsh toward the coast. Photographs illustrate the difficulty in making visual distinctions in the field based on water clarity and the variety of pond depths, exposed limestone, and persistent mud deposits observed at depressions in the region (figs. 27, 29-33).

Although time of year and groundwater conditions can have a significant impact on field assessments, TIR imagery can be used to pinpoint an otherwise unidentifiable site. Figure 27, a Level 4 site, consisted of two pools of muddy water in a large muddy depression with animal tracks, carcasses, and droppings in May 2009. The area was clearly frequented by a variety of wildlife, including large alligators and feral hogs, but otherwise did not appear to be a seep despite the TIR temperature anomaly. A band of corkwood and marsh mallow stood on high ground around the perimeter of the feature. Figure 33 shows the pond in the wet season during September 2009. The fully flooded ponds appeared healthy, and shallow water spread to the corkwood perimeter. Two distinct clearings appeared on the water surface in the same location as the two muddy pools photographed in May (fig. 27).

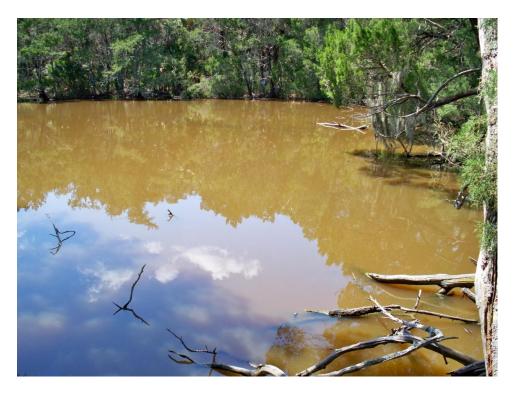
Figure 29. Photo showing Level 4 site near Jacks Creek with murky rust-colored water and bird rookery.

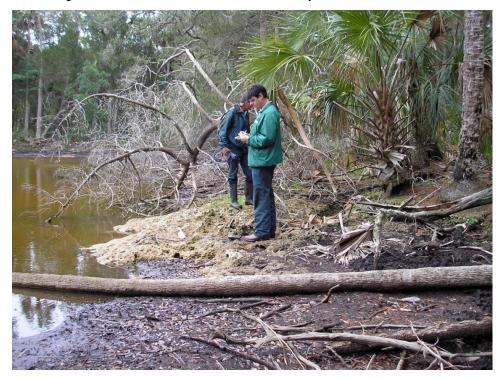
**Figure 30.** Photo showing large Level 1 limestone-rimmed pond near Jacks Creek with alligators in rock caverns. State employees making observations and water-quality measurements.

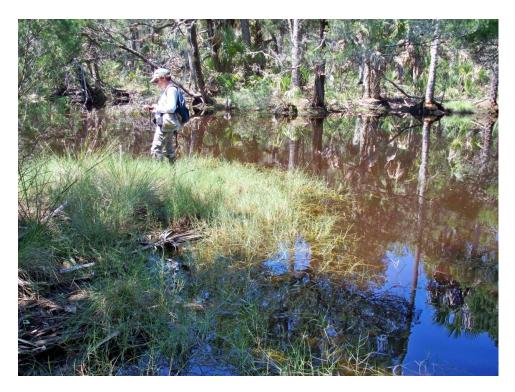
**Figure 31.** Photo showing control site near Jacks Creek with murky water, mud bar, marsh and coastal forest. USGS scientist confirming GPS position.

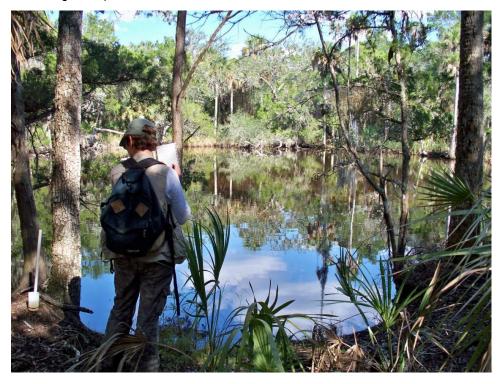
Figure 32. Photo showing USGS scientist at control site 100 yards east of Jacks Creek twin ponds (fig. 27).

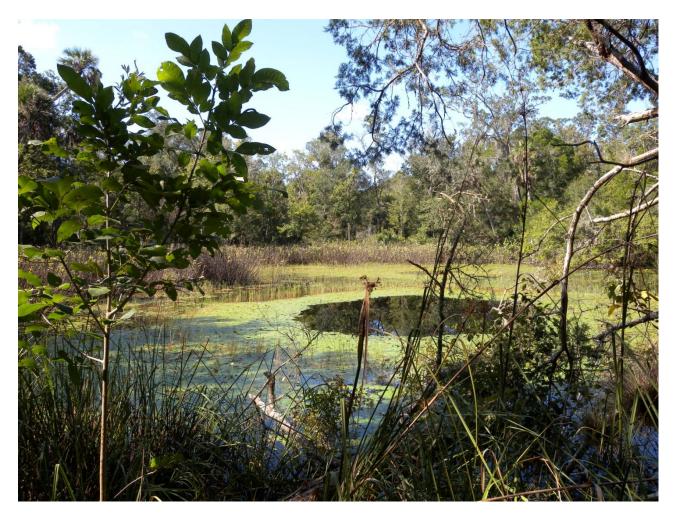
**Figure 33.** Photo showing Jacks Creek twin ponds September 2009 flooded to corkwood perimeter with two watersurface clearings at location of May mud holes. Photo looking south. Compare to fig. 27. The benefits of field observations include opportunities to observe a feature during different tidal cycles, seasons, and groundwater levels. However, field reconnaissance is limited to observations of single features, one at a time, and discharge vents may be inaccessible for direct measurement. If a vent is not at the edge of a feature, the actual measurement location may represent a mixing of groundwater flow with surface water, revealing water quality or temperature that does not reflect groundwater seepage. Airborne imagery can capture all features at a given instant and provides a geographically comprehensive view of the landscape that is not limited to feature edge or accessible depressions.

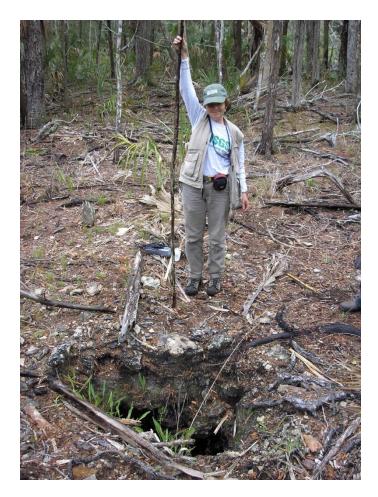
**Figure 34.** Photo showing solution hole near Jacks Creek: water surface 3' below ground surface, 4 ppt and 71° F at depth, May 2009.

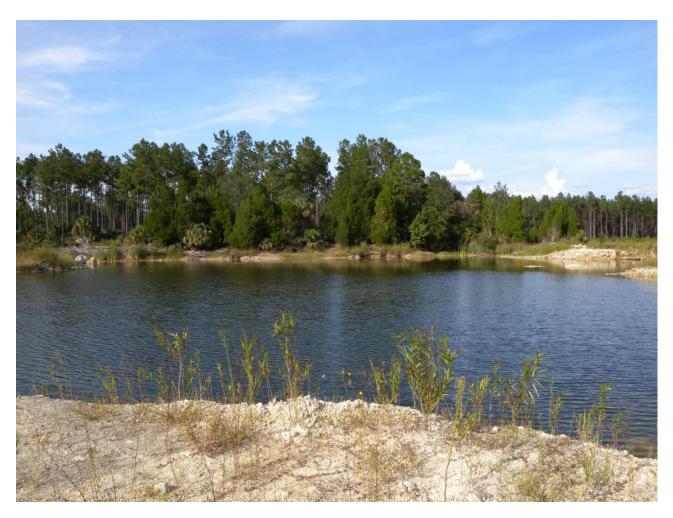
Figure 35. Photo showing excavation pits on Robinson Rd. with freshwater and large Level 4 thermal anomalies.

Figure 35 depicts a large excavation site east of Waccasassa River and Cow Creek. The surface water was deep and fresh and the surrounding landscape was a combination of

silviculture, roads, and second-growth forest. The headwaters of Bullfrog Creek can be seen in the upper left corner of figure 36a with the distinct signature of marsh leading into a wooded swamp. A faint temperature signal shows in the TIR imagery in a depression north of the excavation site (fig. 36b), but the primary thermal target in this area is the excavation site itself (fig. 35). Many borrow pits in the region showed multiple, significant, Level 4 temperature anomalies.

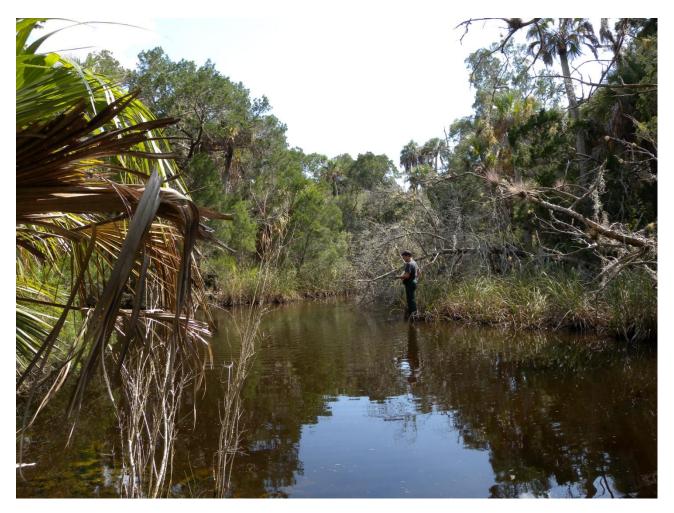
Figure 37. Photo showing irregularly shaped, limestone-lined, Level 4 pond with deep pool near Beetree Slough.

A series of small thermal features dots the landscape from Waccasassa River south to Withlacoochee River. Many of the thermal signals were in surface-water bodies near the marsh and forest boundary, approximately 1.5 mi from the coast. Examples of these features are shown in figures 37-41, an area near Beetree Slough. Limestone exposures, muddy sediments, tall coastal-forest canopy, and various emergent, submerged, and floating aquatic-vegetation communities were common. Although the ponds appear relatively isolated, they are connected by shallow surface waterways during high-water intervals, as indicated by the white/tan-color pathways (fig. 38). The landscape is a fragmented series of hammocks, karst surfaces, depressions, creeks, marsh, and areas of downed trees (fig. 41). Anecdotal evidence of a large seep at Turtle Creek spurred an earlier investigation that identified traces of a thermal signal in daytime TIR (Jeff DiMaggio, Florida State Park Service, oral commun., 2002; VeriMap, 2002). The feature was not corroborated with this mission, but it remains a possibility in future work during periods of relatively high groundwater levels.

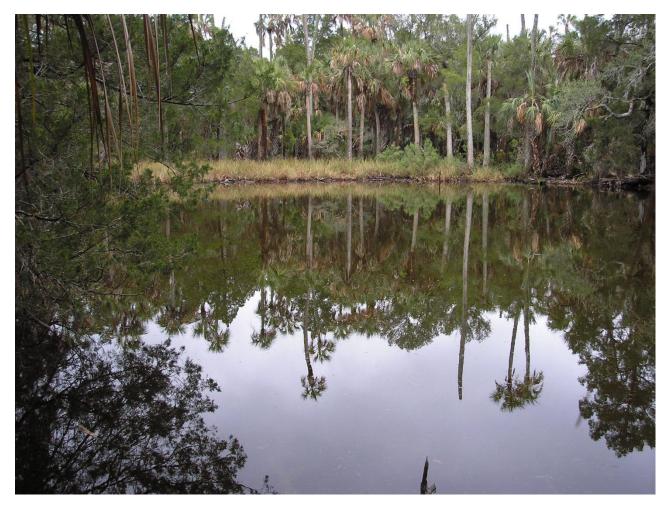
Figure 40. Photo showing Level 3 pond near Beetree Slough surrounded by coastal forest and high marsh.
