Progress Energy Florida

**Levy Nuclear Plant
Units 1 and 2
Part 2, Final Safety Analysis Report**

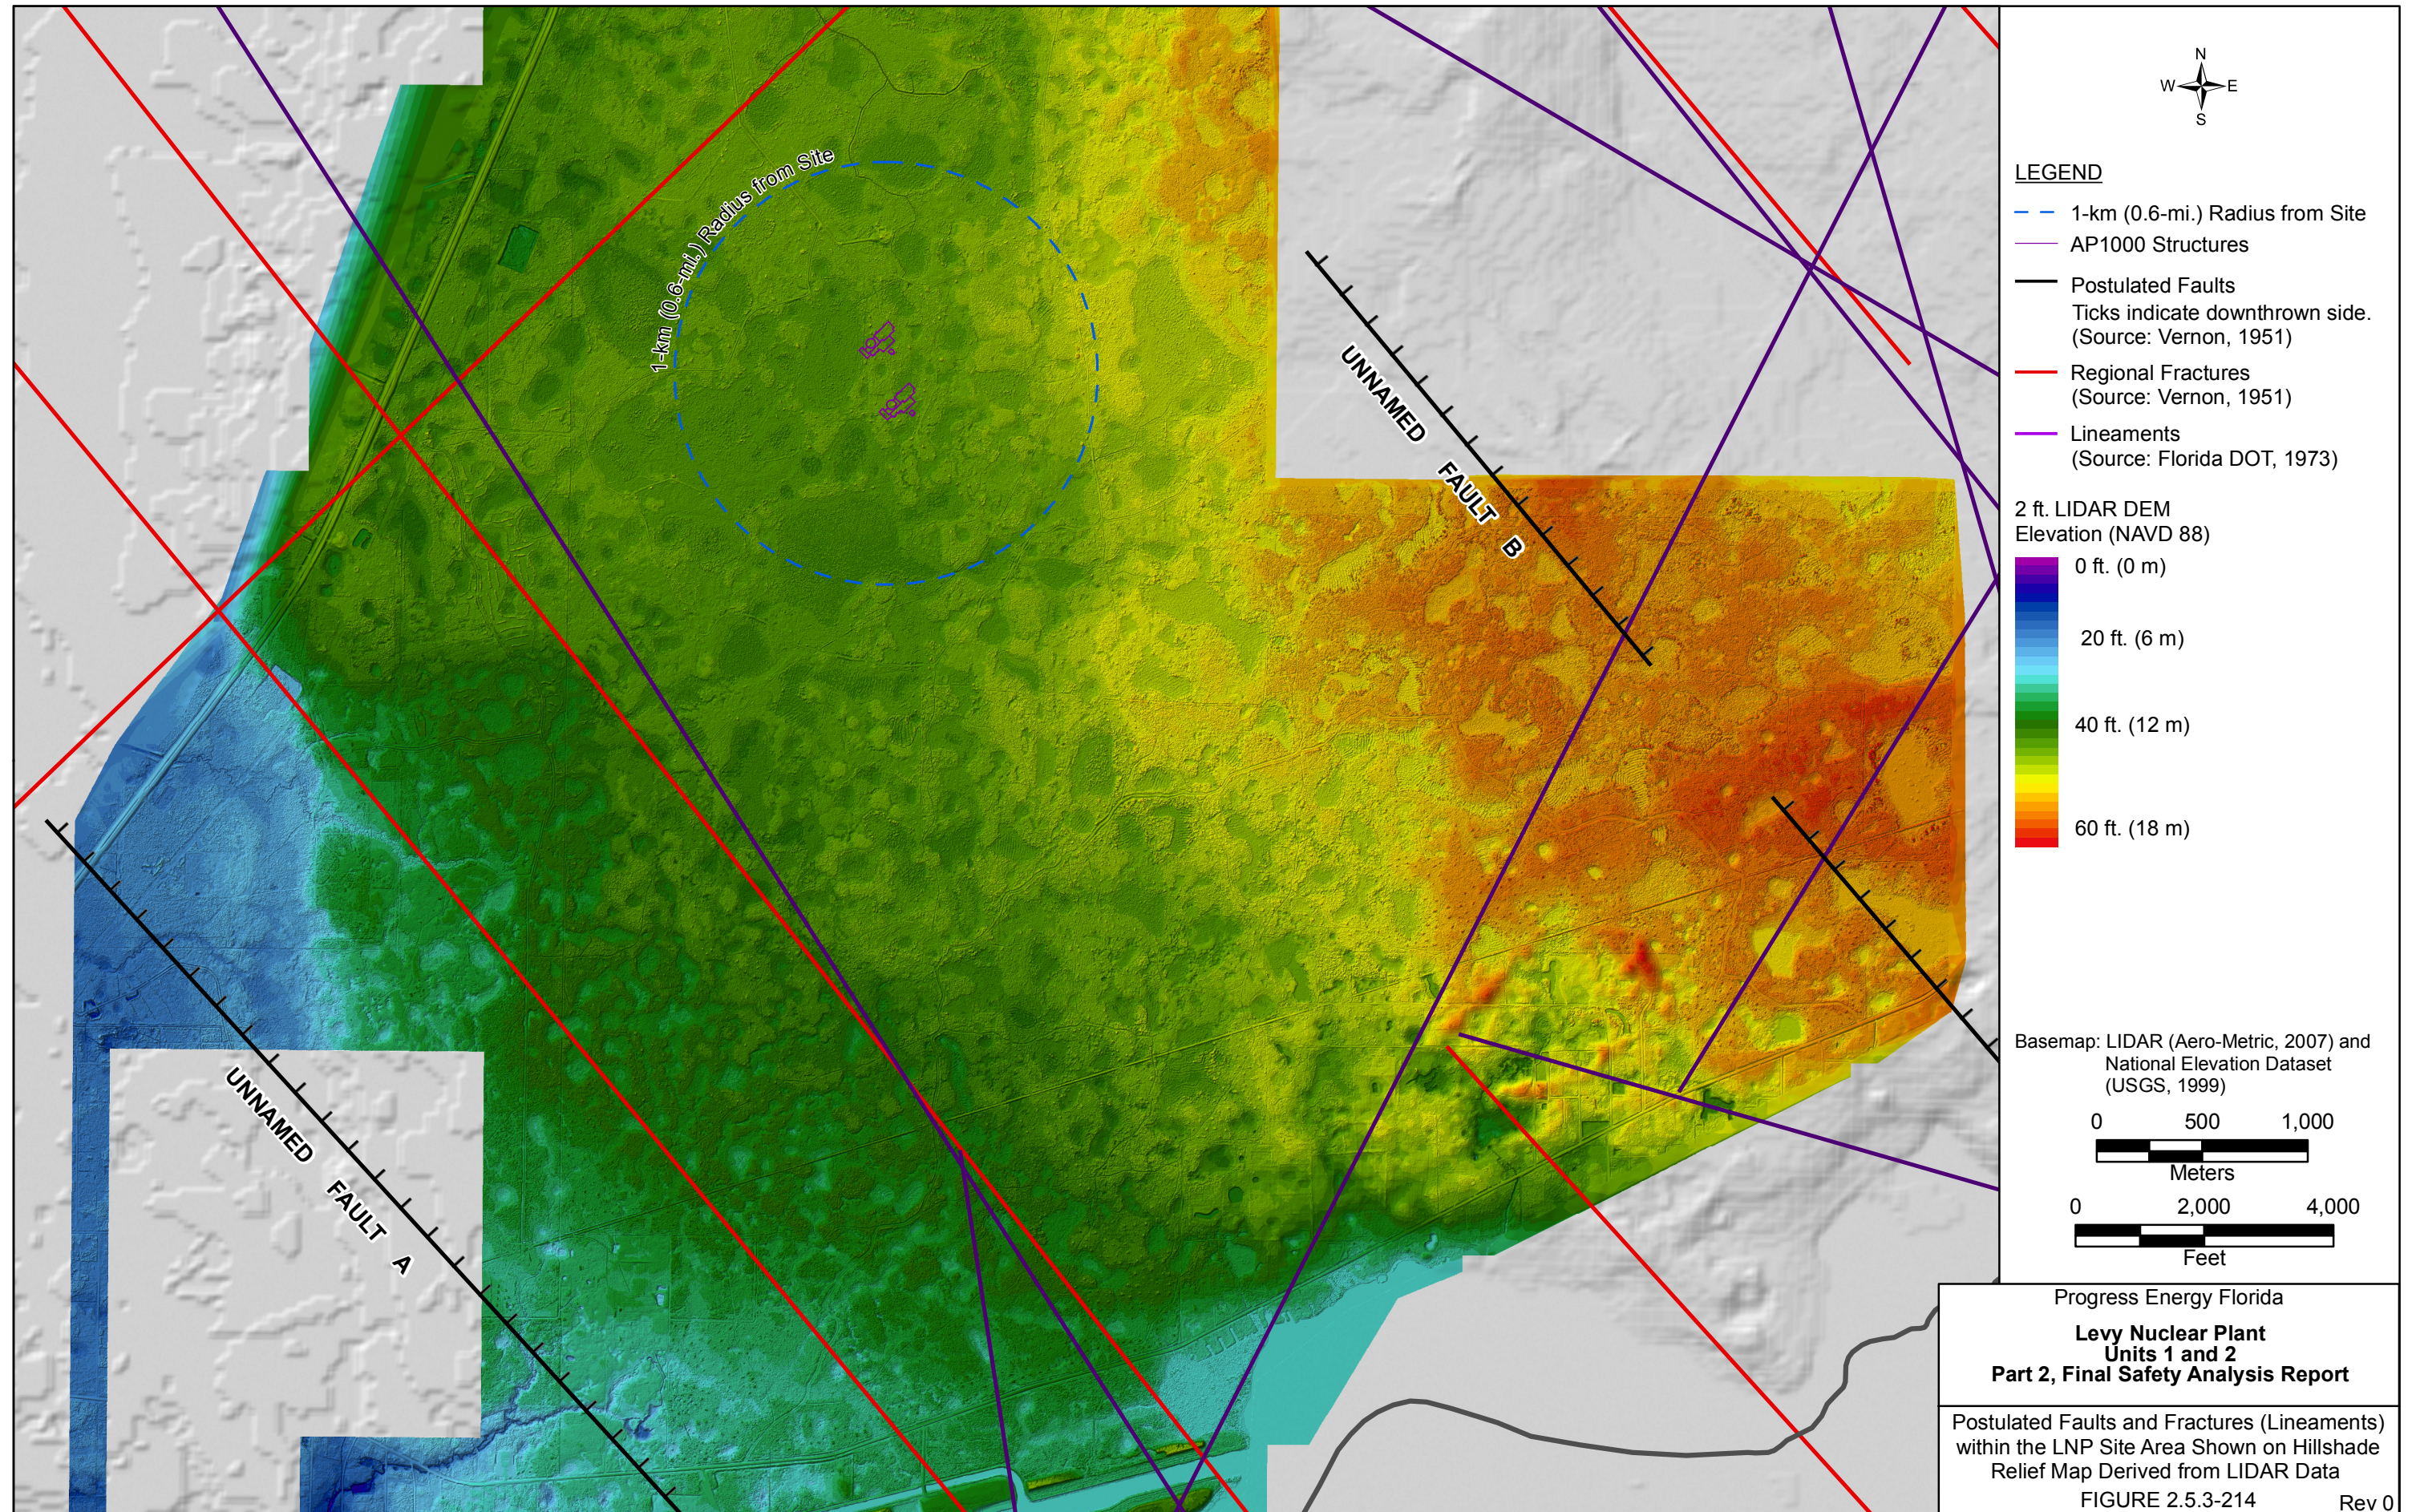
Postulated Faults and Fractures (Lineaments)
within the LNP Site Area Shown on Hillshade
Relief Map Derived from LIDAR Data
