# Insights from Review of an Early Site Permit Application for Potential New Nuclear Power Plants by U.S. NRC Geoscientists

AEG 2010, Charleston - 24 September 2010

# NRC Review of the Vogtle ESP Application

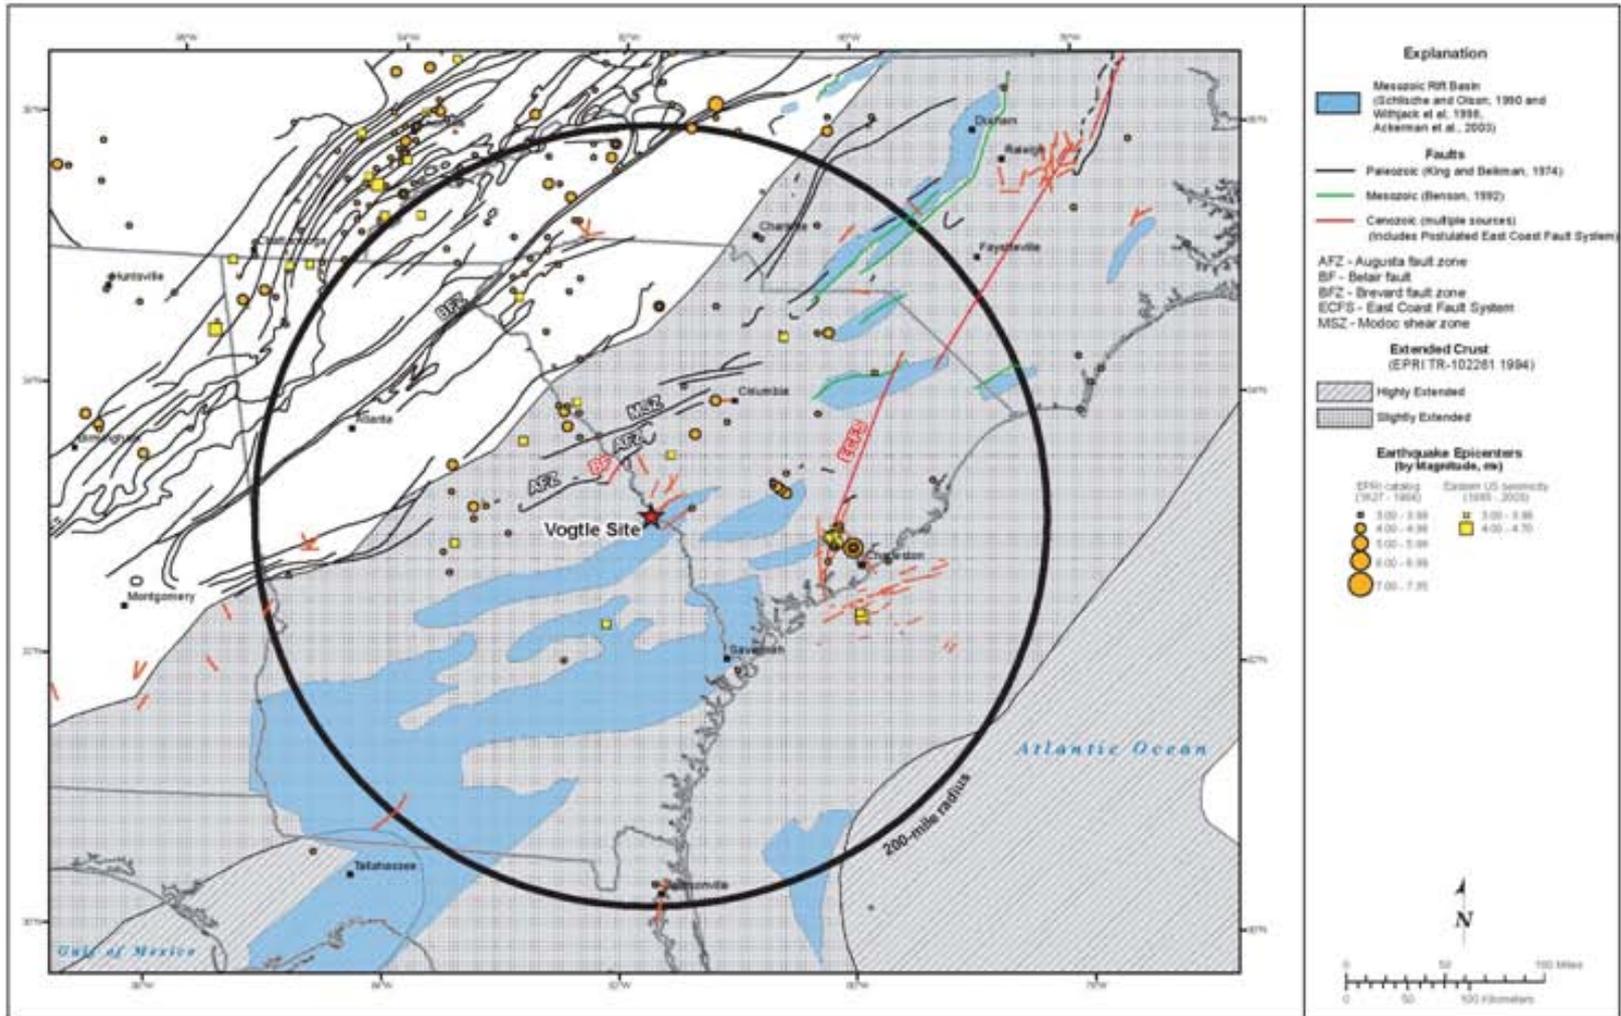
Figure 2.5.1-13 Regional Tectonic Features Map (200-Mile Radius)

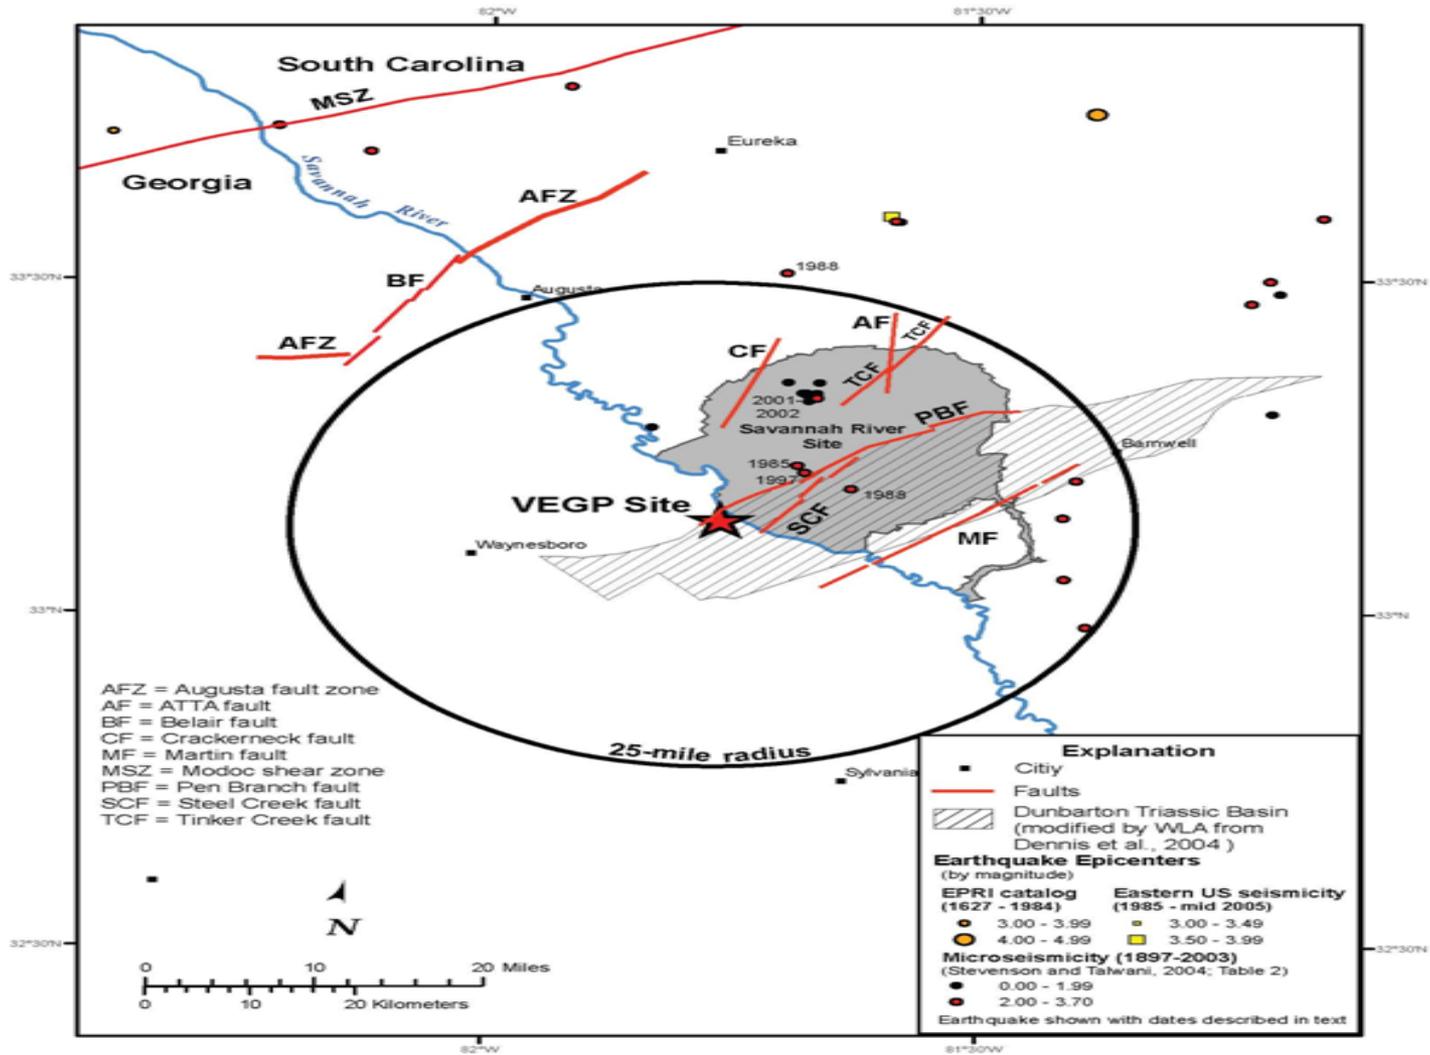
Figure 2.1-16 Site Vicinity Tectonic Features and Seismicity

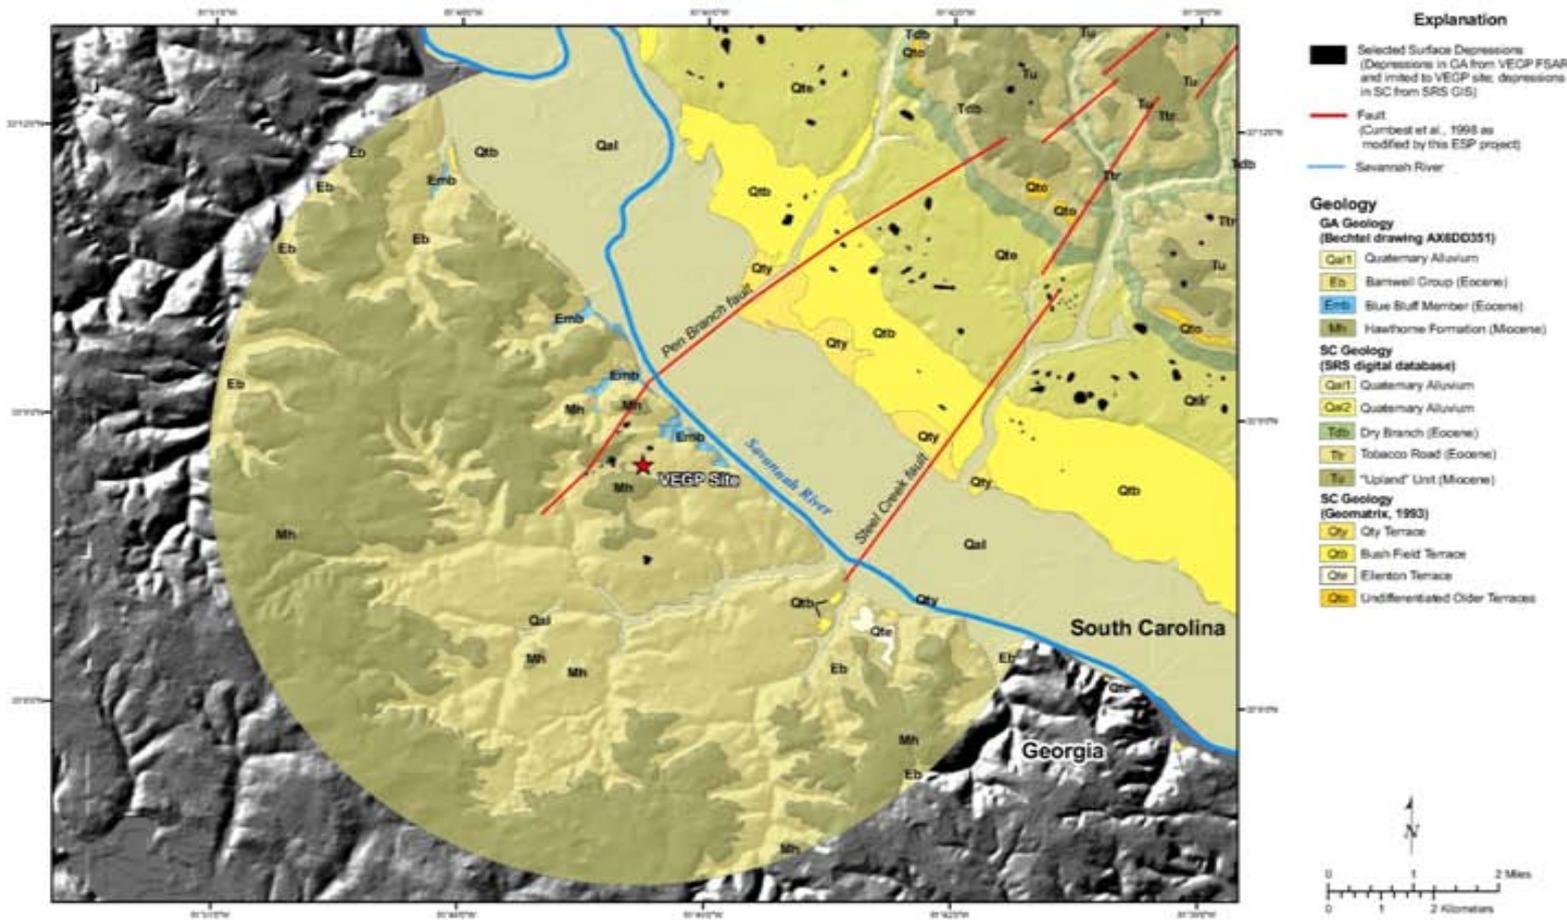
Figure 2.5.1-29 Site Area Geologic Map (5-Mile Radius)

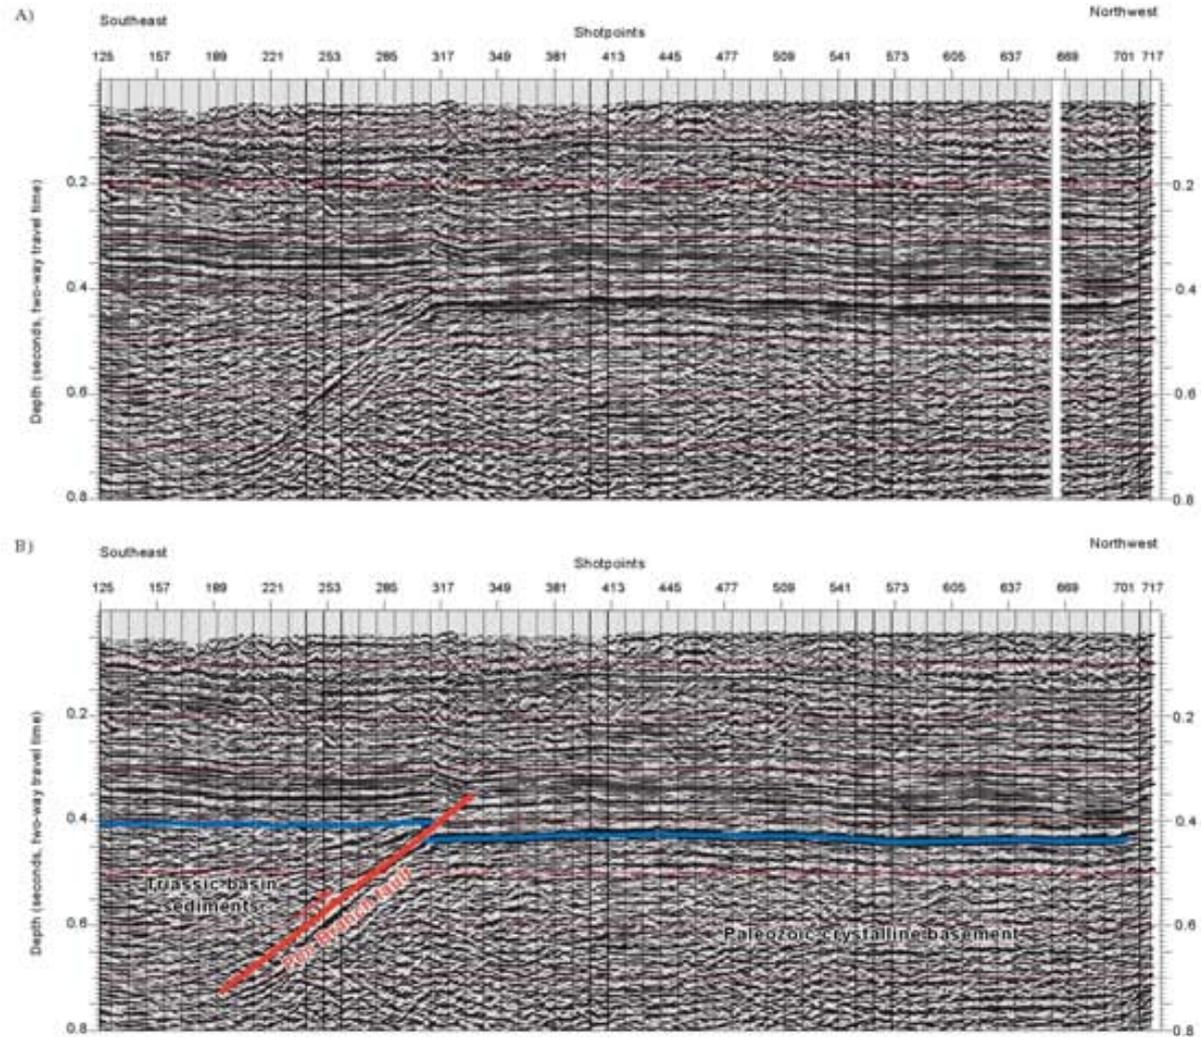
Figure 2.5.1-37 (A) Seismic Reflection Line 4 (Time Section; Display Velocity = 12,000 fps)  
(B) Interpretation (Blue Line Represents Top of Basement)

- Applicant documented that no stratigraphic evidence indicates any displacement more recent than Eocene (i.e., not  $<33.9$  Ma).
  - Seismic reflection data showed no disruption of sedimentary units younger than Eocene.
  - No tectonic deformation of units overlying the Eocene Blue Bluff Marl (BBM) was observed in trenches crossing the projected surface trace of the PBF, including above a fault-related monoclinial flexure in the BBM.
- Based on 2600 elevation points surveyed atop a Quaternary fluvial terrace which crosses the projected surface trace of the PBF, the applicant documented that the terrace does not show any tectonic deformation due to slip on the PBF.

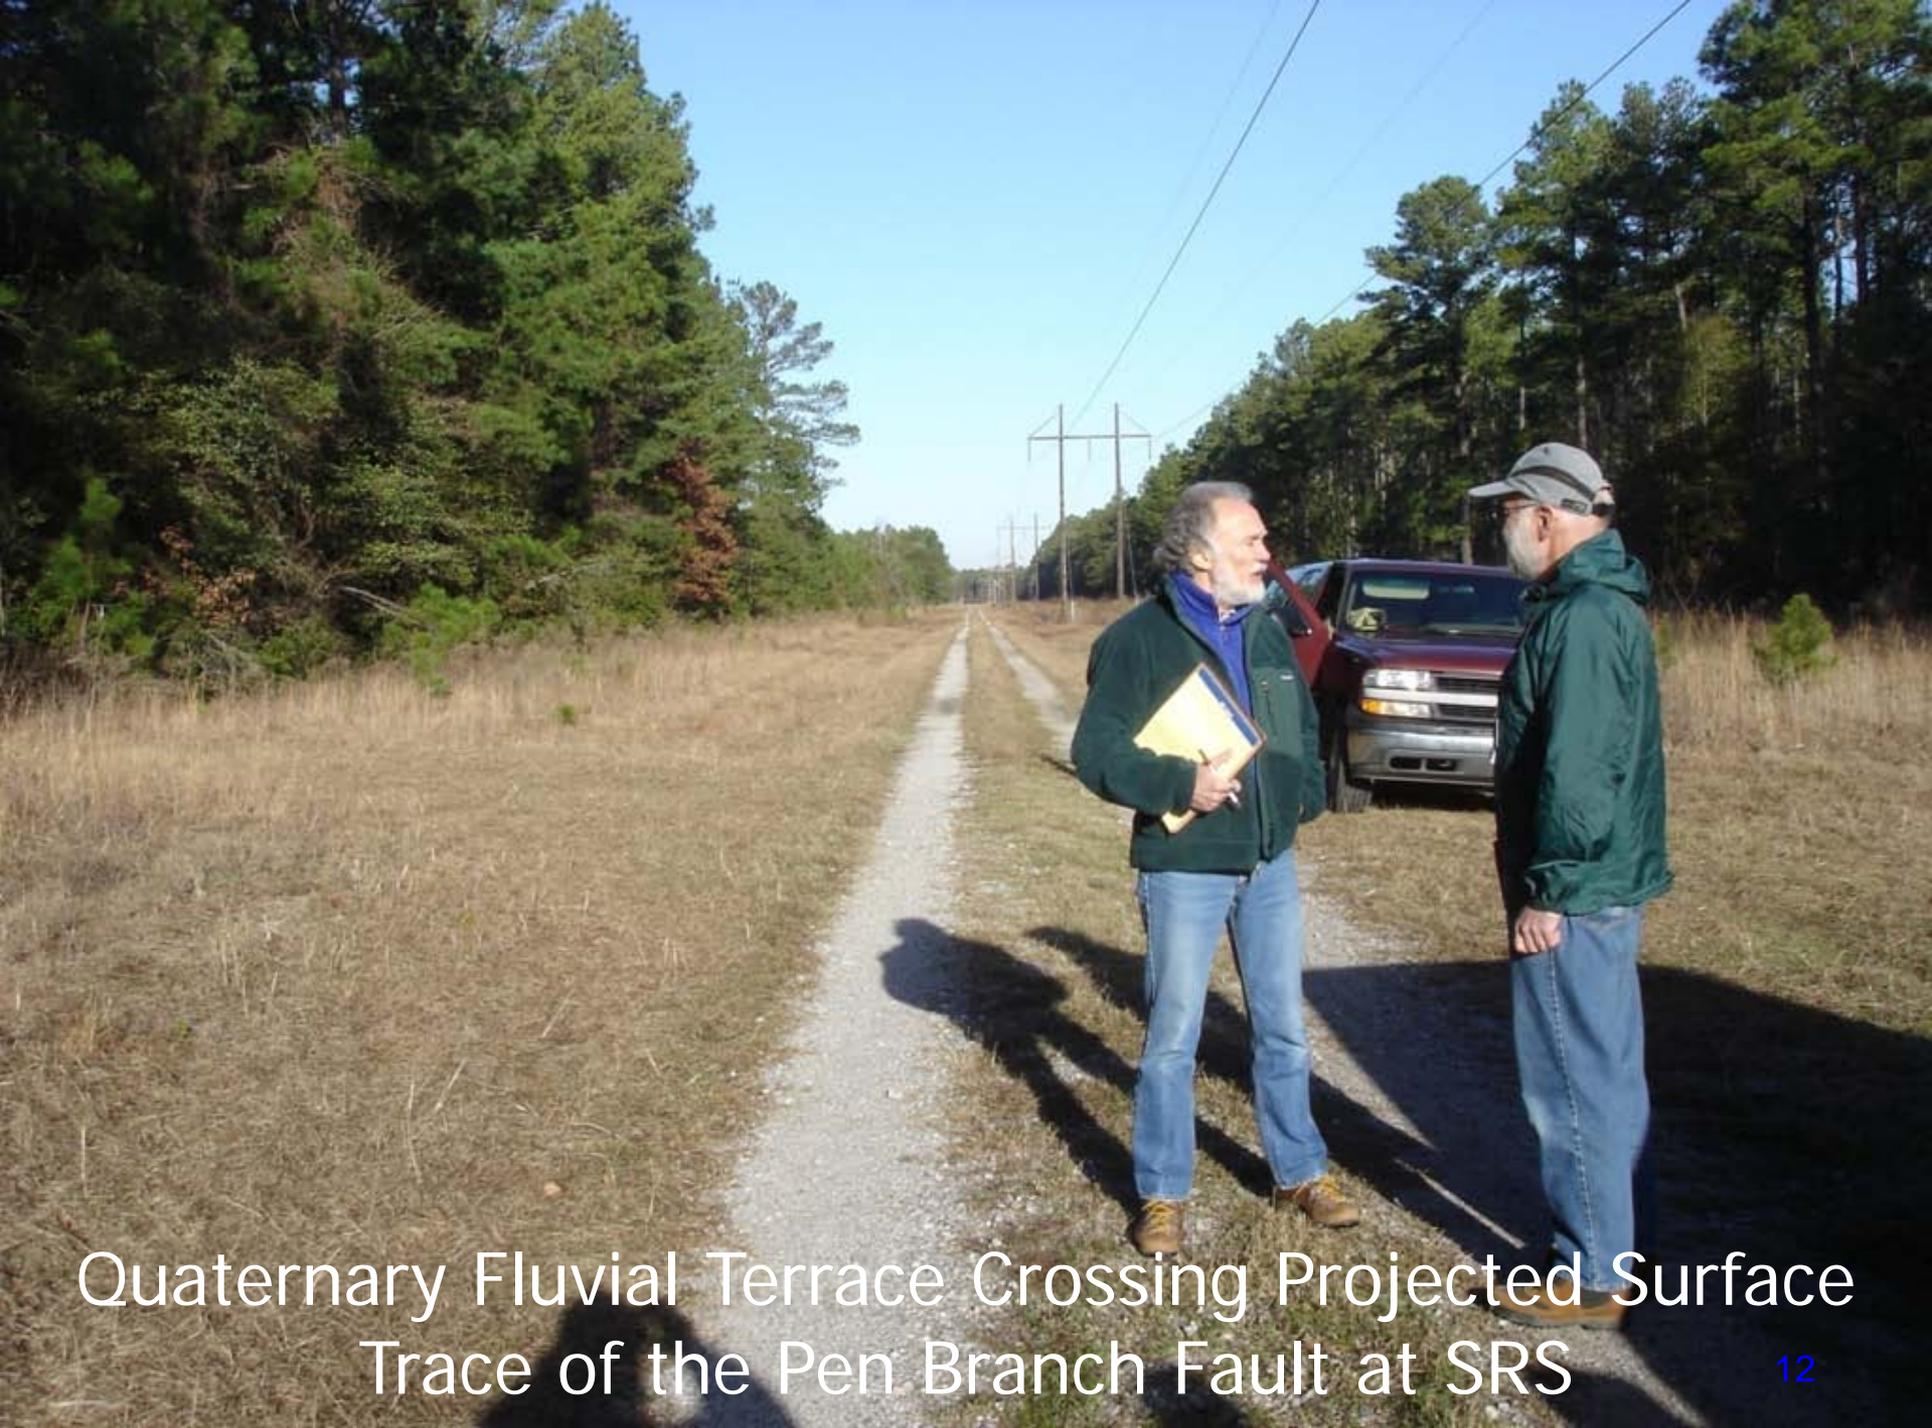
Quaternary Fluvial Terrace Crossing Projected Surface  
Trace of the Pen Branch Fault at SRS

NRC geologists performed a detailed technical review of data and conclusions presented in the SAR, conducted independent literature research, examined borehole data, and assessed the field evidence for lack of tectonic deformation of the Quaternary fluvial terrace.

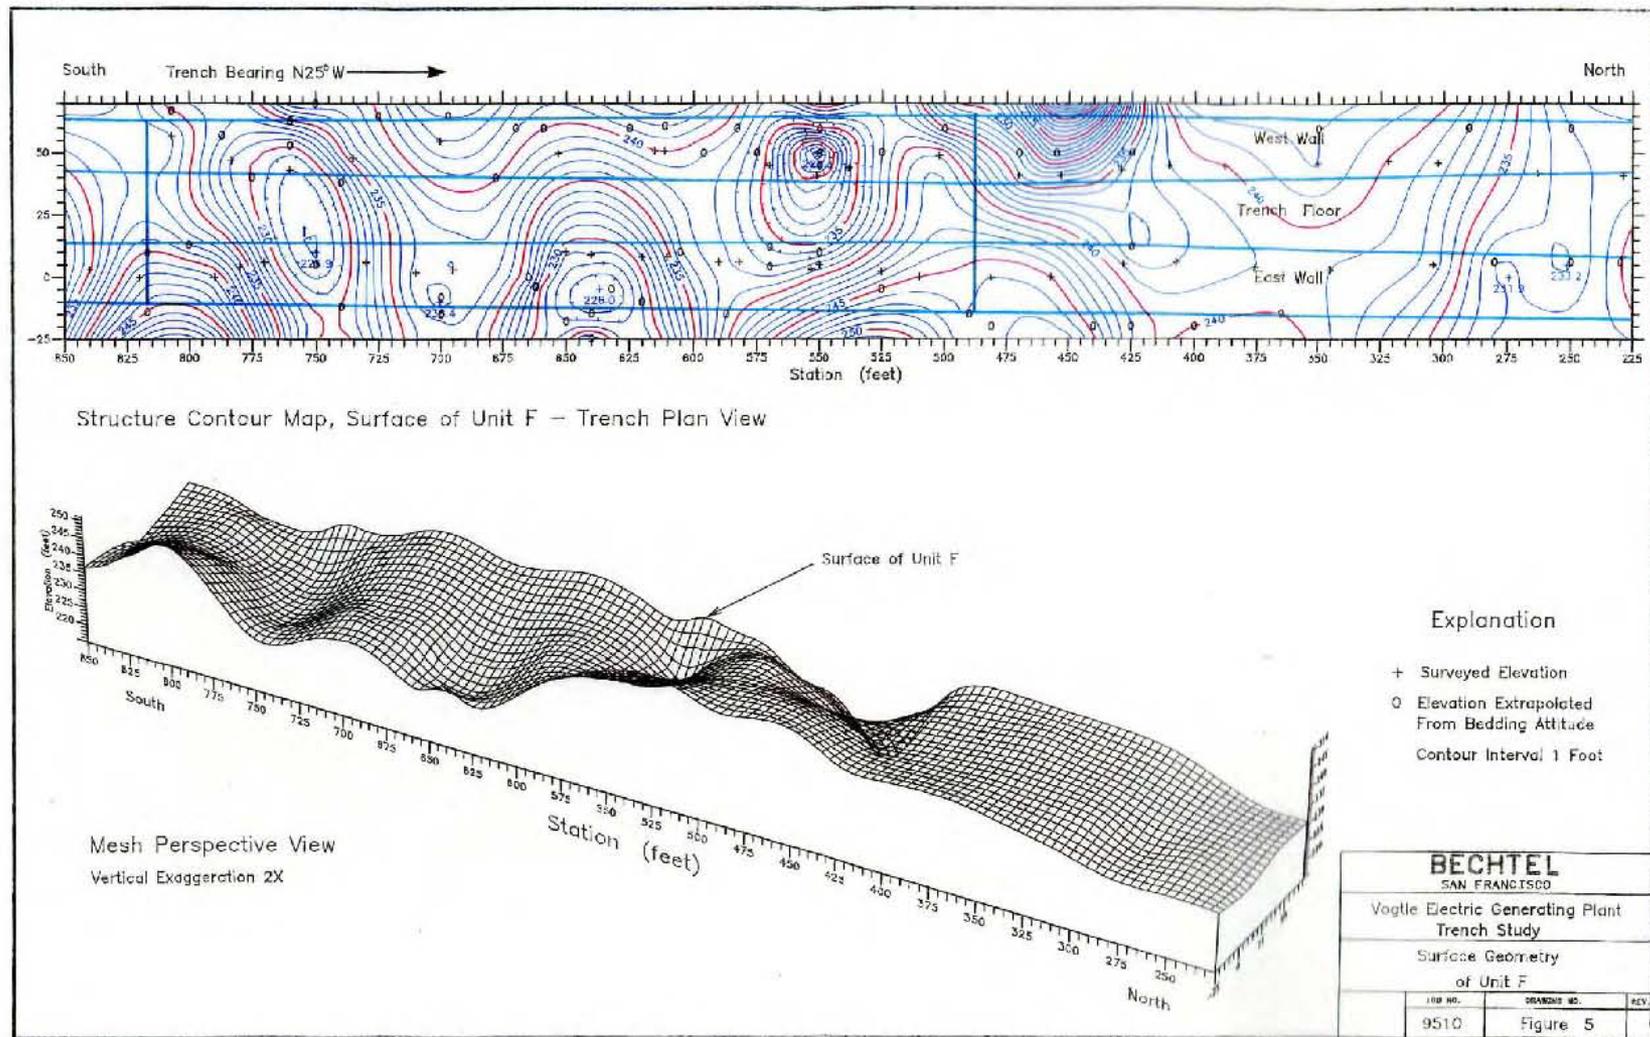
RAI Figure 2.5.3-2B. Surface Geometry of Unit F Illustrating Localized Nature of Deformation

- Geologic characteristics of the dikes and spatially-related features (Cont'd):
  - Barnwell sands locally exhibit warped bedding, fractures, and small-scale faults at the same three locations which are spatially associated with depressions related to dissolution of the underlying Utley LS.
  - The localized dissolution depressions to which all deformation features are spatially related, including the injected sand dikes, are defined by an “egg carton” geometry of the surface of Unit F, one of the Barnwell Group units overlying Units C and D.

- Applicant documented the spatial association of local deformation features, including the injected sand dikes, with dissolution collapse depressions in the Utley LS.
  - Data showed deformation features and injected sand dikes occurred at the margins of discontinuous, irregular contoured lows on the surface of Unit F, which defined locations of subsurface dissolution depressions; and the dikes predated a Miocene erosional event (i.e., >5.3 Ma).
  - No liquefaction of sand units was observed at locations other than where spatially associated with dissolution of the Utley LS.

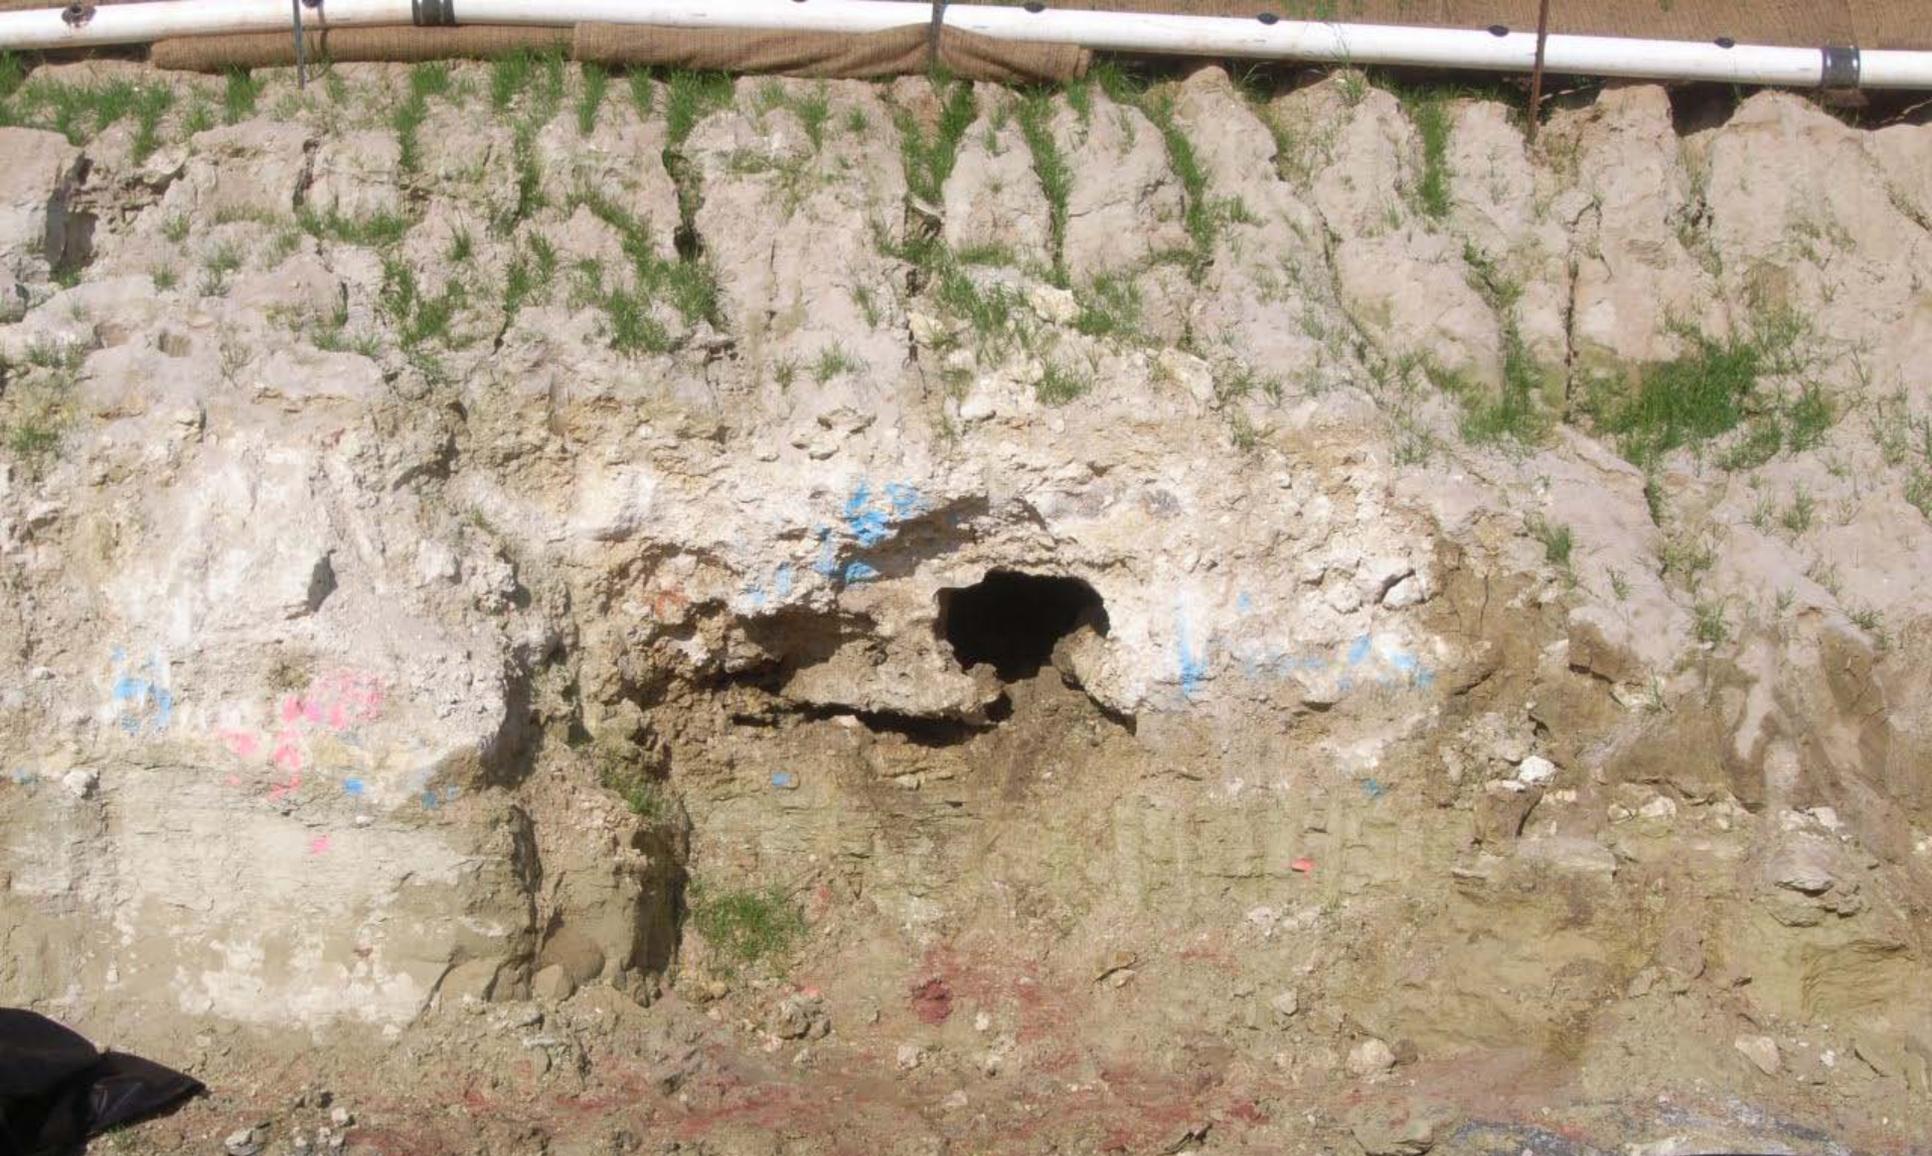
Dissolution Cavity in Utley LS Overlying the Blue Bluff Marl, Vogtle Unit 3 Excavation

Using geologic field data, applicant concluded that injected sand dikes formed due to liquefaction and injection resulting from collapse of wet sediments above dissolution features in the Utley LS, rather than from a paleoearthquake.

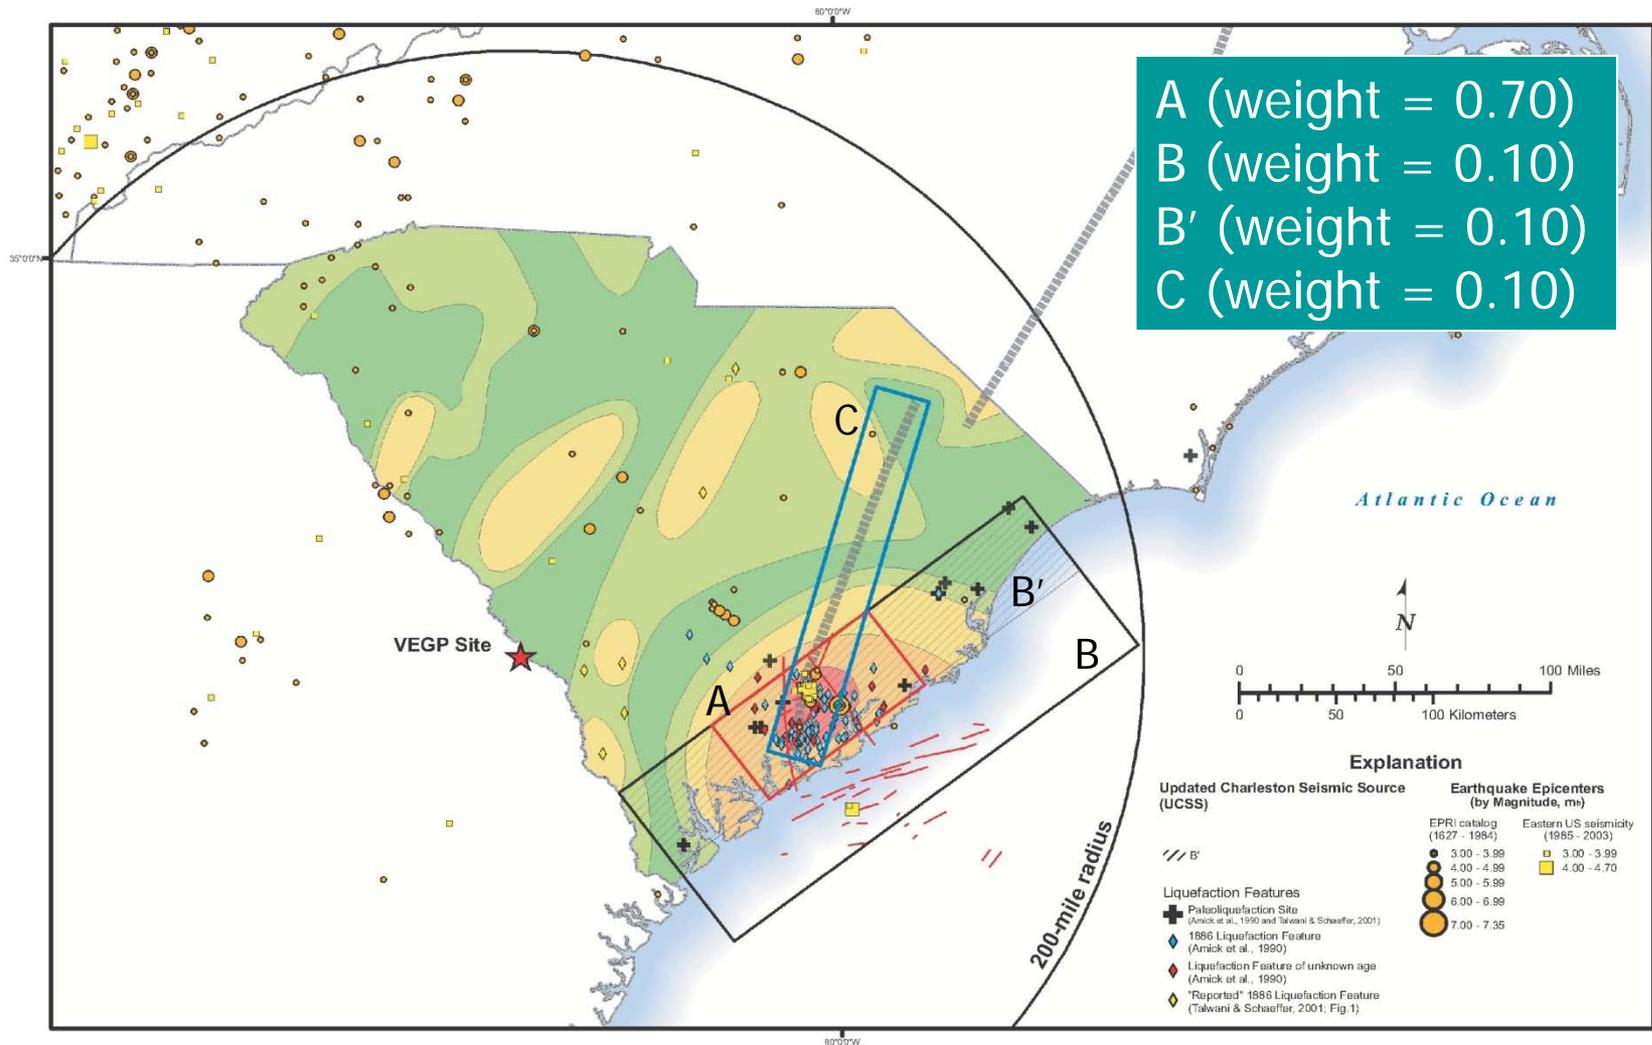
# UCSS Zone Geometries A, B, B', C and Distribution of Liquefaction Features

- Updated Charleston Seismic Source (UCSS) Model Parameters
  - Applicant's update of the 1986 EPRI source model for the UCSS model involved changes in source geometry, maximum earthquake magnitude ( $M_{\max}$ ), and recurrence interval.
    - UCSS Geometry "A" (weight = 0.7) is centered on the 1886 Charleston meizoseismal area, includes the majority of inferred fault intersections and most reported 1886 liquefaction features, and envelopes instrumentally-located earthquakes spatially associated with the Middleton Place-Summerville seismic zone.
    - UCSS weighted  $M_{\max}$  mean magnitude = **M7.1**.

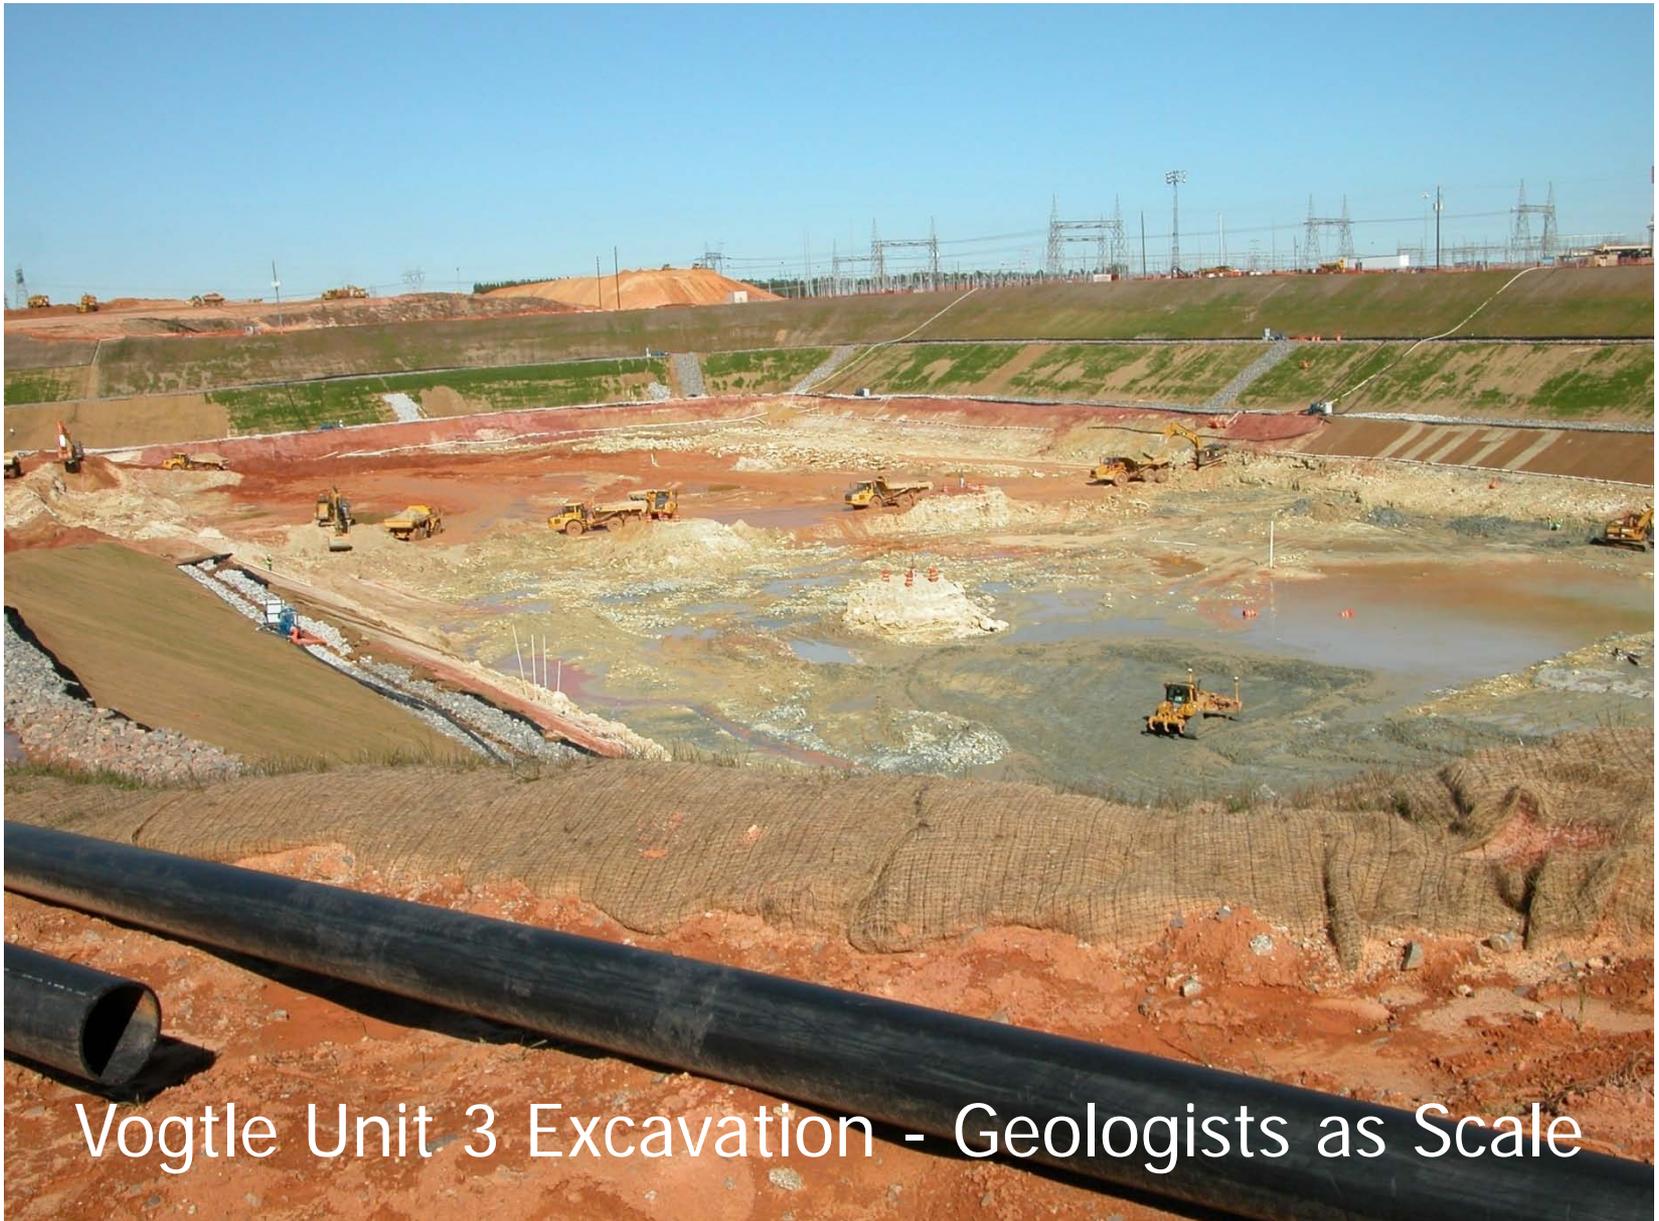
Vogtle Unit 3 Excavation - Geologists as Scale

- Directly examined the foundation unit (BBM) and sedimentary materials overlying the BBM in excavations for Units 3 and 4, as well as geologic maps and cross sections of excavation walls and floors prepared by the applicant.
  - Assured that no features indicative of capable tectonic structures (i.e., Quaternary faults or earthquake-induced liquefaction) occurred in the excavations.
  - Because the Utley LS overlying the BBM was removed during excavation of Units 3 and 4, NRC geologists did not consider dissolution to pose a geologic hazard for the site.
