Plum Brook Reactor Facility

Final Status Survey Report

Attachment 2

Service Equipment Building (Building 1131)

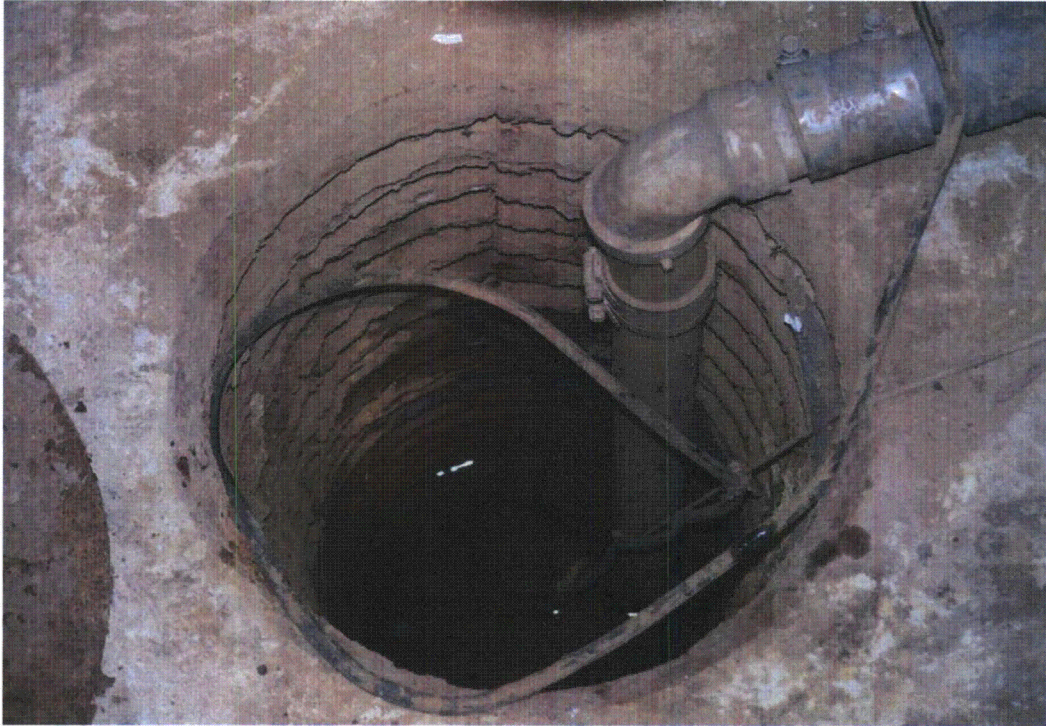
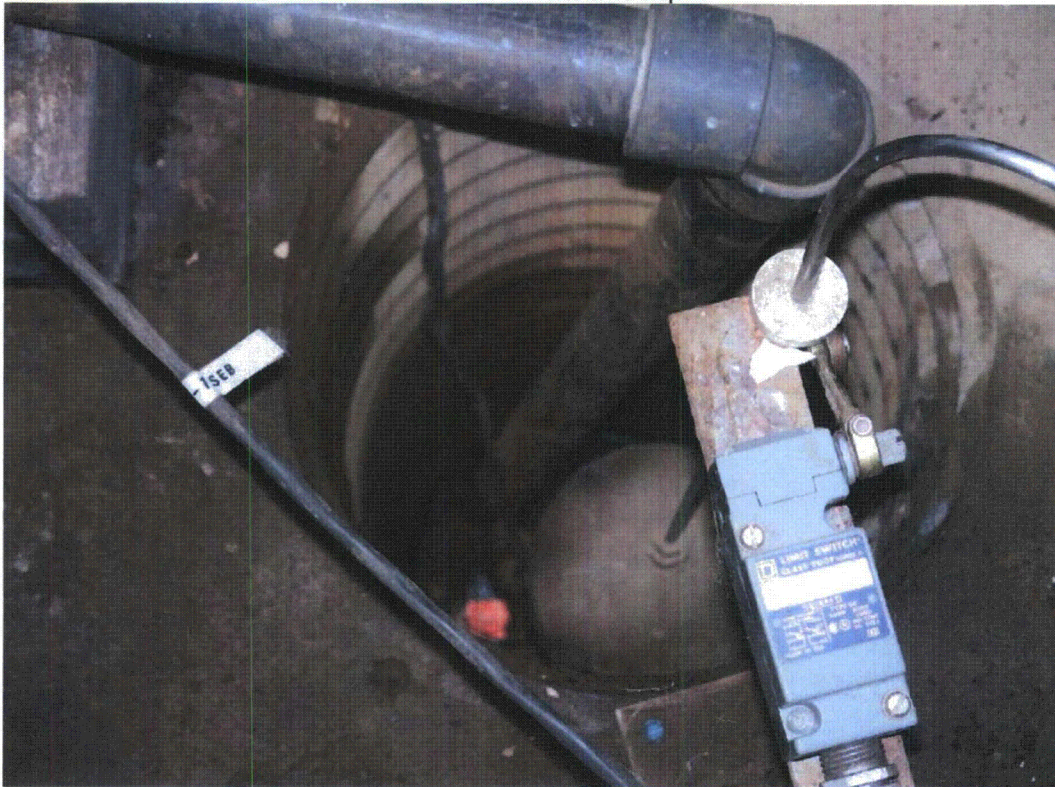
Exhibit 8, SEB Basement Sumps 1 and 2 (Survey Unit SE-3-32)
General Area View of Sump 1

General Area View of Sump 2

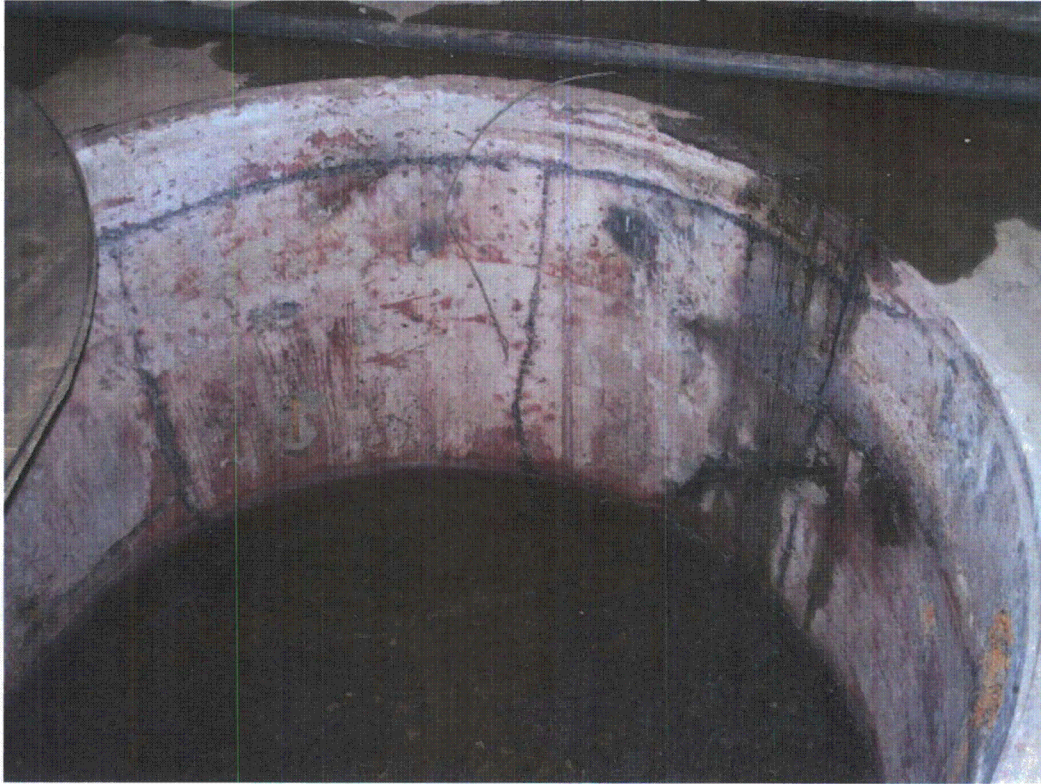
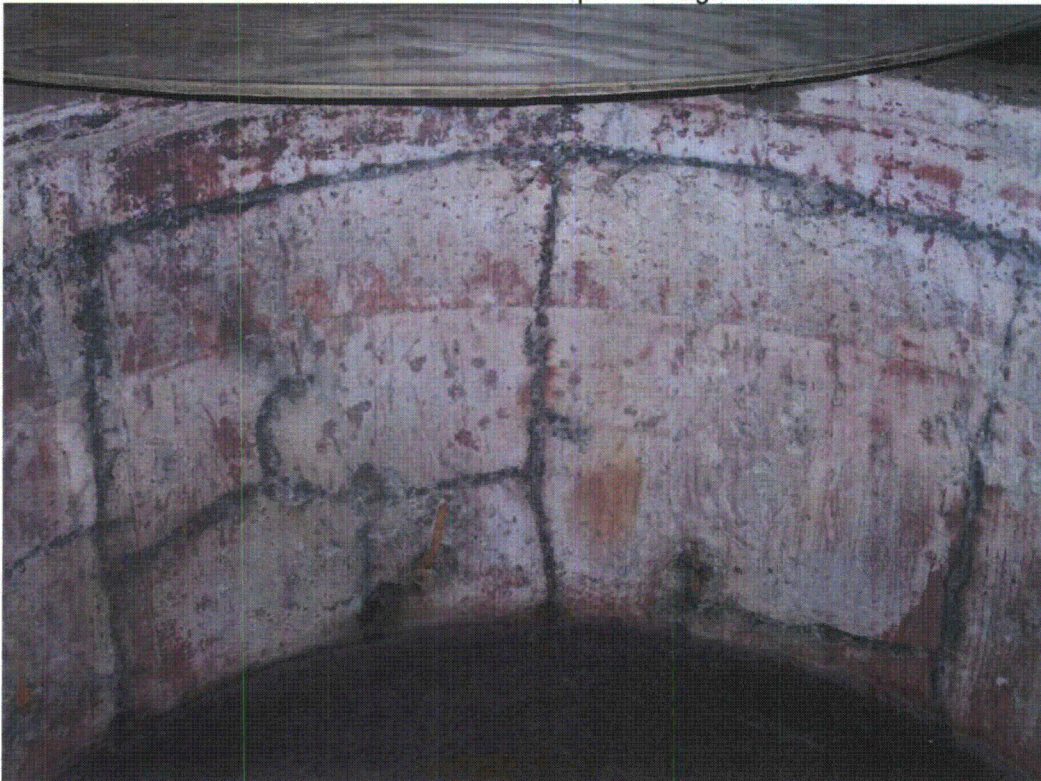
Exhibit 9, SEB Basement Sump 3 (Survey Unit SE-3-32)
General Area View of Sump 3 Looking north

General Area View of Sump 3 Looking West

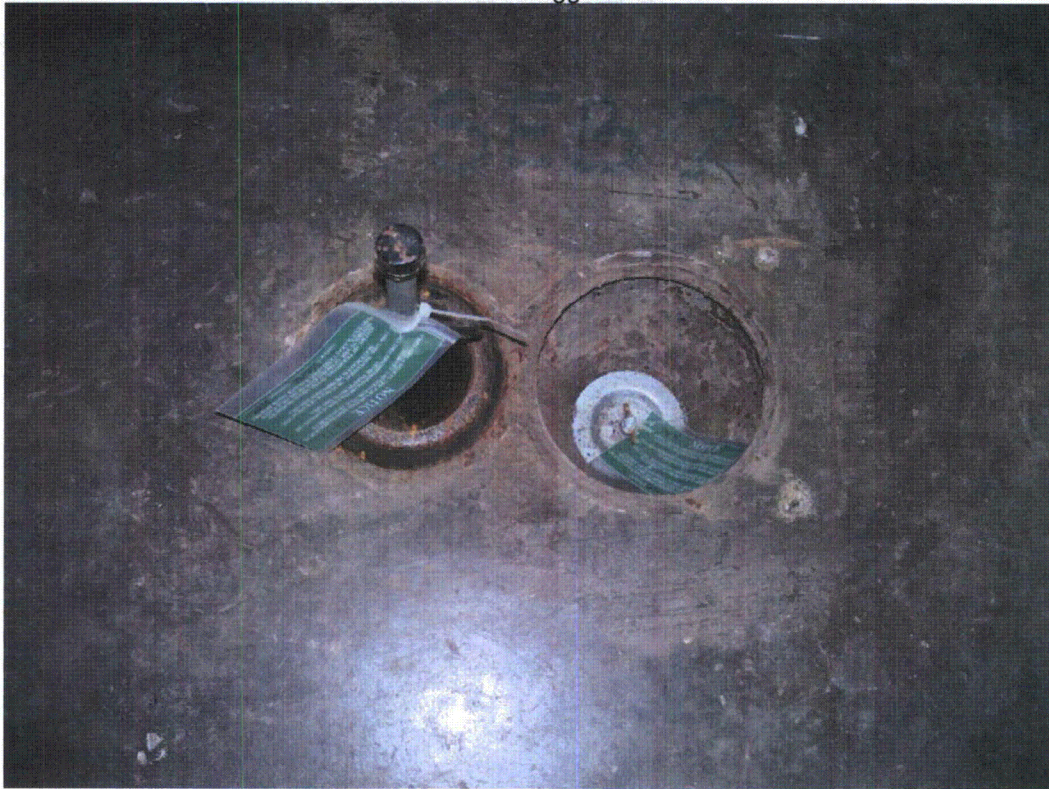
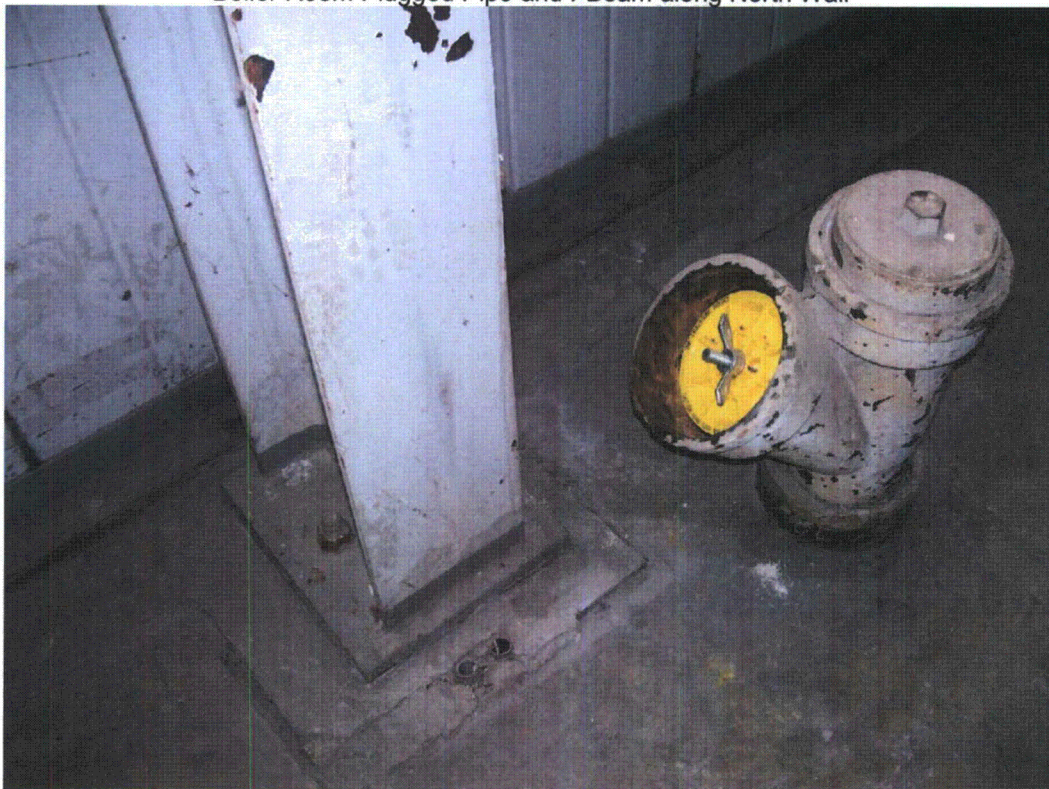
Exhibit 10, Views of SEB Boiler Room Drains and Floor Details (Survey Unit SE-1-7)
Boiler Room Plugged Drains

Boiler Room Plugged Pipe and I-Beam along North Wall

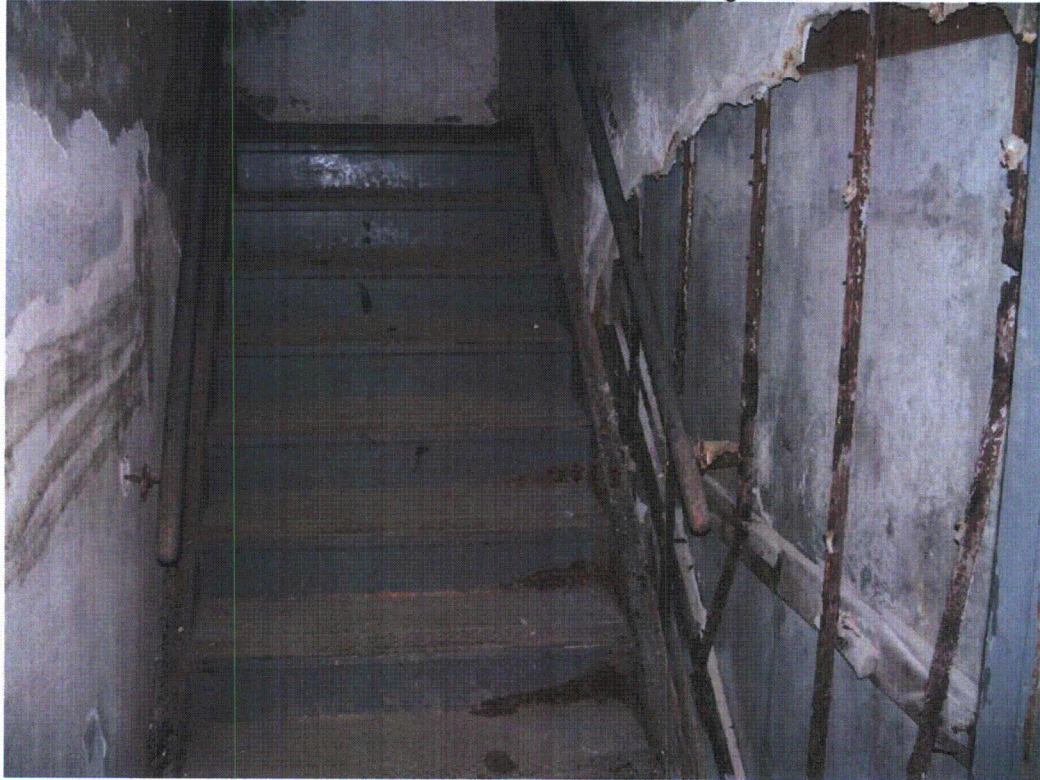
Exhibit 26, SEB Basement Stairwell (Survey Unit SE-3-32)

Electrical Room Bottom of Stairwell Looking South

Modifications to survey instructions are adjusted to account for unusual measurement conditions. Modified detection sensitivities may be applied taking into account adjustments in detector efficiency. Scan speeds may be reduced to ensure that required scan sensitivities are achieved. The bases for adjustments due to non-standard conditions are provided in PBRF Technical Basis Documents. Examples of areas or locations in SEB survey units where special measurement conditions apply are shown in Exhibits 26 and 27 of Appendix A.

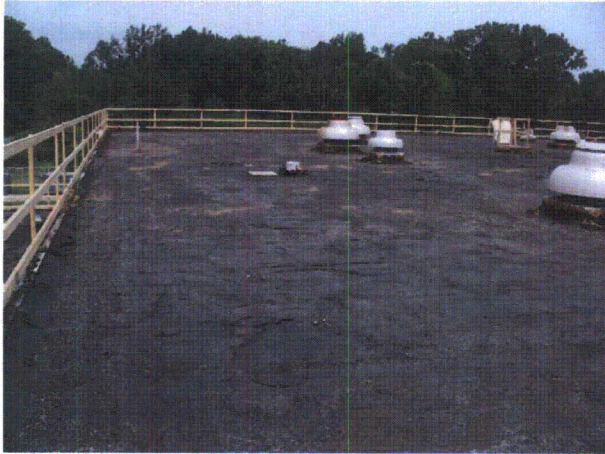
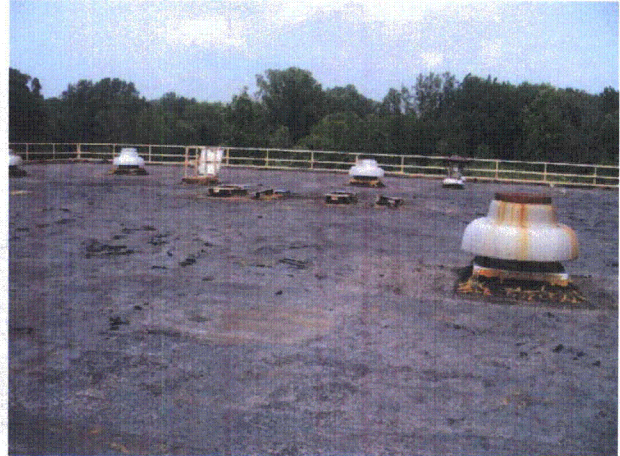
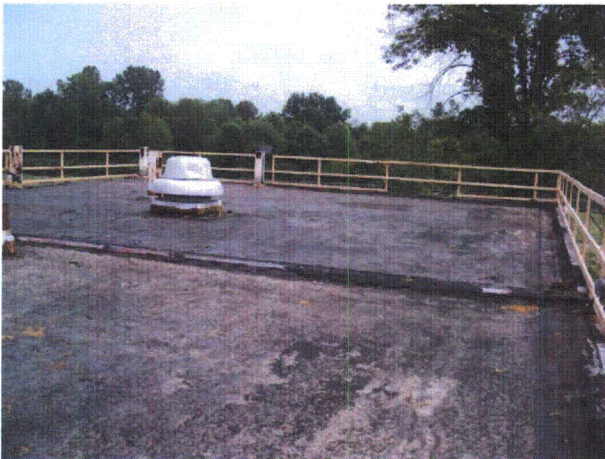
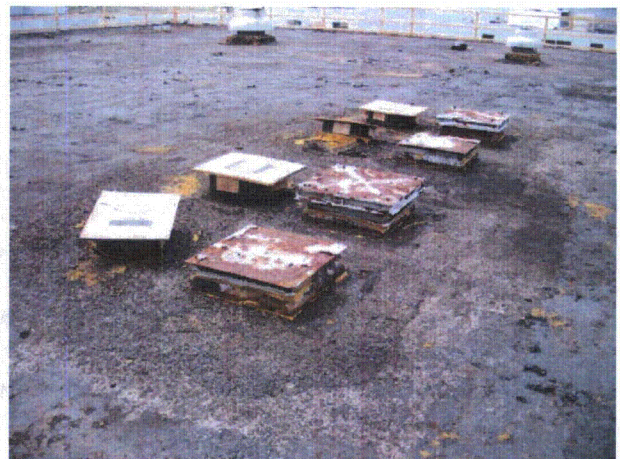
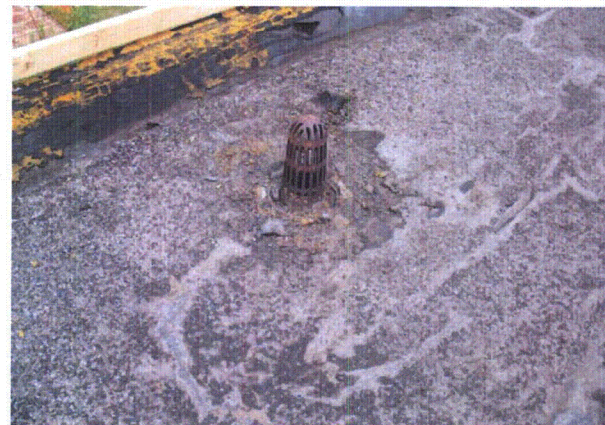
Exhibit 27, Views of SEB Roof (Survey Unit SE-4-1)

Penetrations with tar and gravel area

Roof drain

Curling tar paper

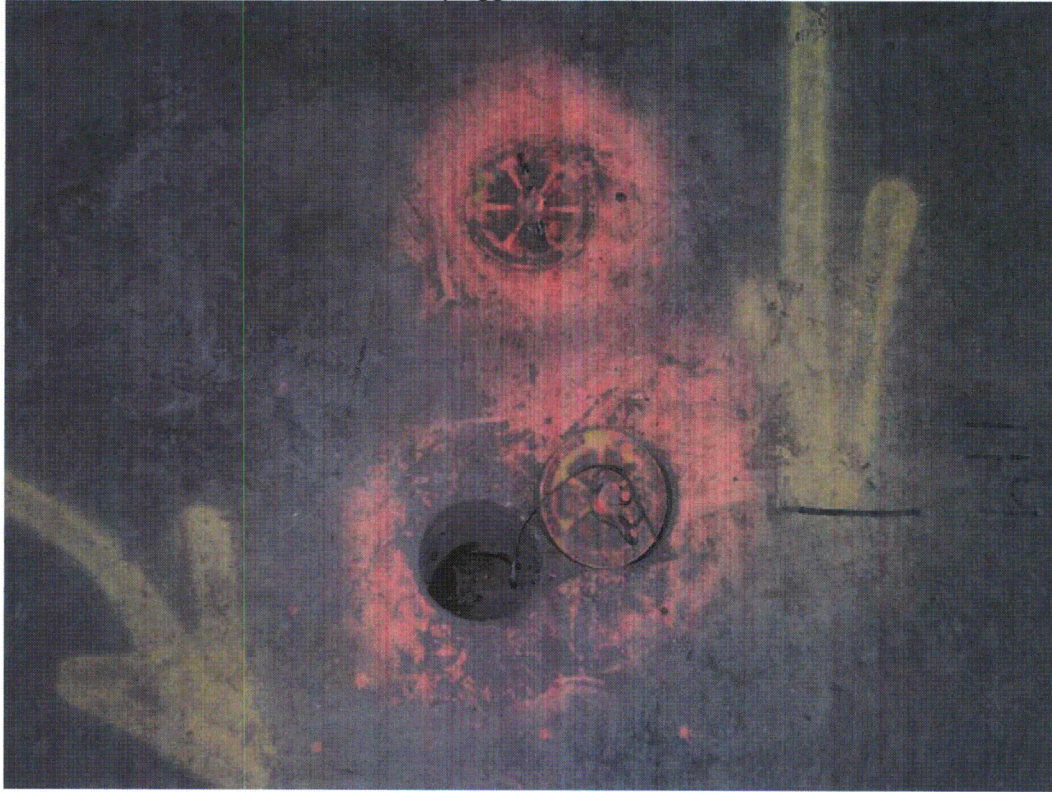
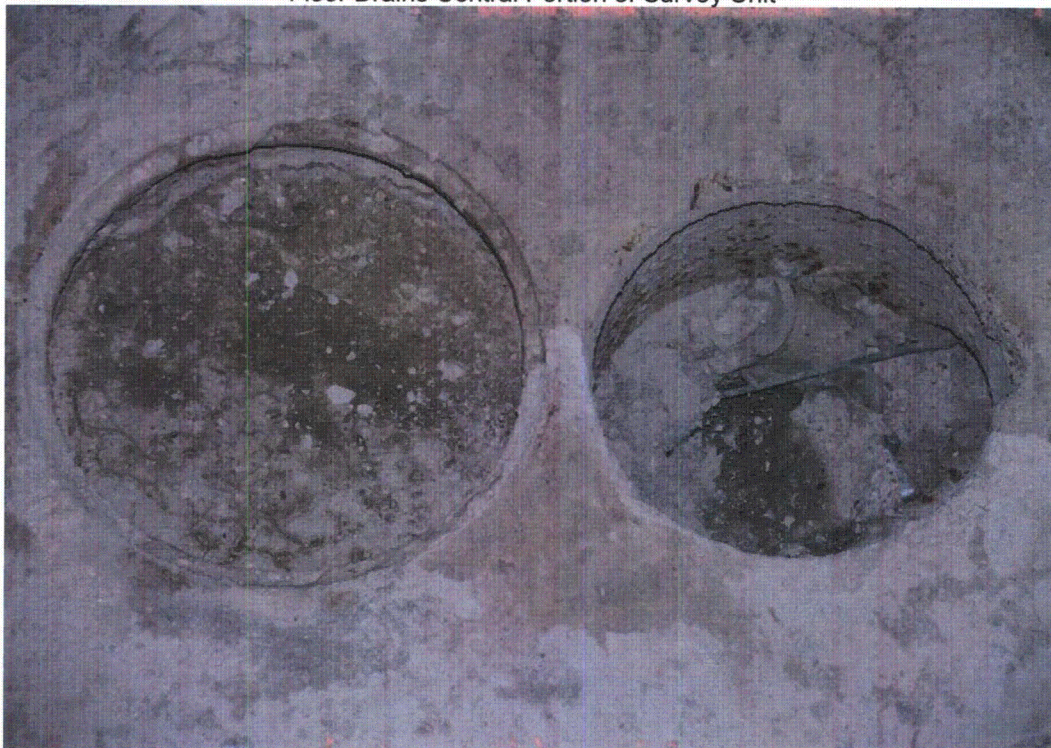
Exhibit 28, Views of Unusual Condition Measurement (UMC) Areas (Survey Unit SE-3-5)
BSI plugged Core Bores

Floor Drains Central Portion of Survey Unit

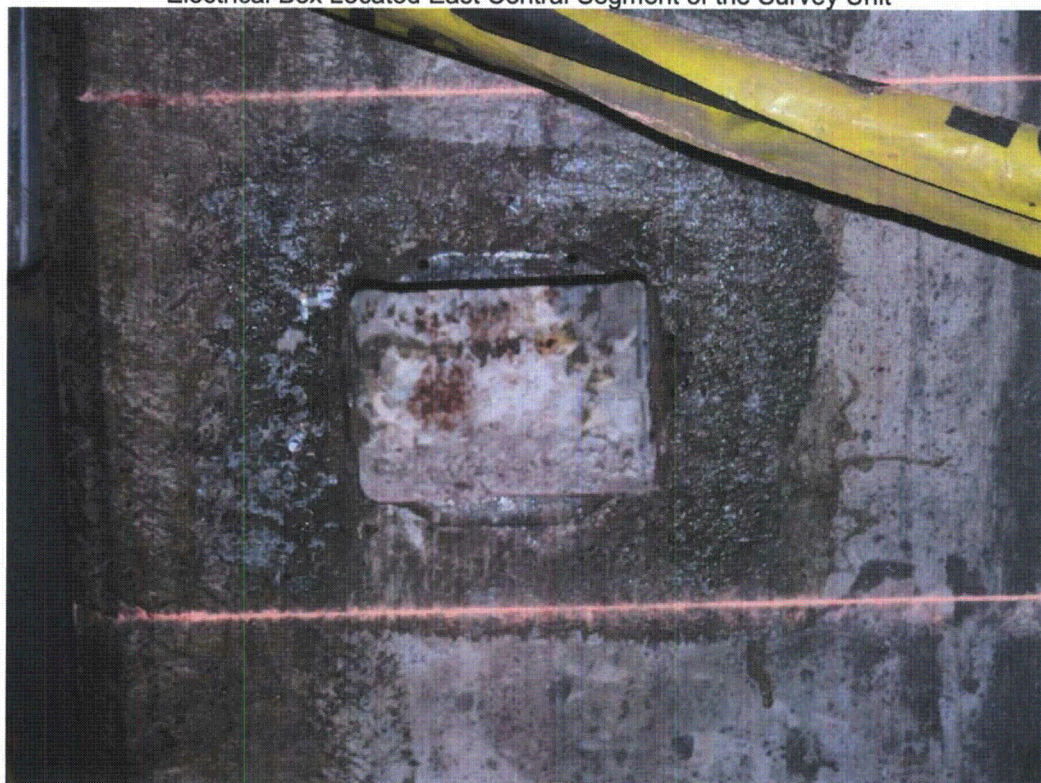
Exhibit 29, Views of Unusual Condition Measurement (UMC) Areas (Survey Unit SE-3-16)
UCM1 Located in the West Central Segment of the Survey Unit

Electrical Box Located East Central Segment of the Survey Unit
