# West Terminus - Cross-Florida Greenway Assessment

*Work Order 1 Final Report*

## ***Lower Withlacoochee River Restoration Alternatives Feasibility Study***

December 31, 2003

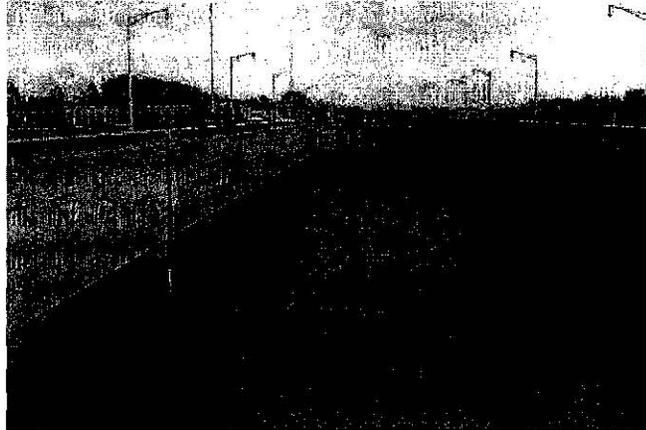
**Photo 4-9: Inglis Lock**

Inglis Lock is located at the eastern terminus of the Barge Canal. The lock was designed to raise and lower ocean-going vessels between the Gulf of Mexico and Lake Rousseau, and works with water levels in the range of -2 to 28 ft-NGVD. One lockage cycle requires about 11 million gallons of water supplied from Lake Rousseau (Inglis Pool). **Photos 4-9, 4-10 and 4-11** illustrate the Inglis Lock and its associated gates. At present, Inglis Lock is not operational. The State of Florida is in the process of developing design plans for future renovations.

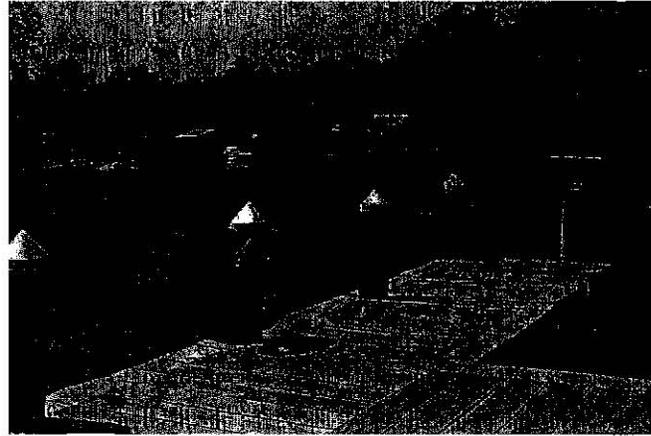
**Photo 4-16: Withlacoochee River - Lower Segment at Coast Guard Station**

The segment of the Withlacoochee River starting at the mouth and going upstream to the Bypass Channel Spillway is commonly referred to as the Lower Segment. The lower segment is approximately 6.5 miles long and has an average bottom slope of 0.006 percent. The primary source of fresh water for this segment of the river is from Lake Rousseau via the Bypass Channel Spillway. This natural conveyance system is characterized by forested channel banks and flood plain areas. Urbanization is occurring primarily on the north bank of the system over the entire reach length and to a lesser degree on the south bank areas. As of December 2002 there were 448 known residences in this reach and a large number docks on the river. This reach contains a single pair of bridges that serve US-19. **Photos 4-16 and 4-17** illustrate some typical areas within this segment.

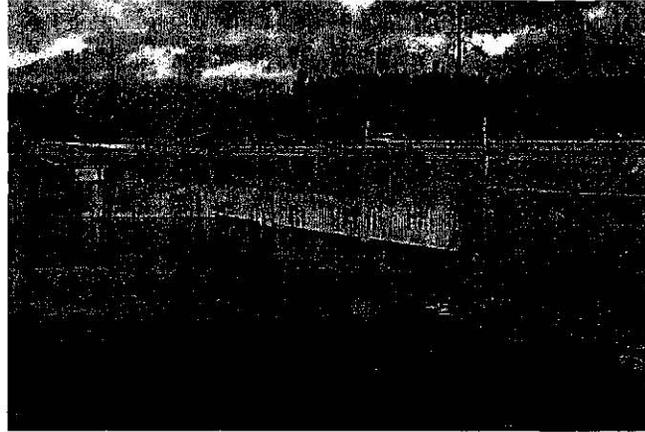
**Photo 4-21: Lock Access Road Bridge over Bypass Channel**

The Lock Access Road Bridge at the Bypass Channel was constructed as part of the Cross-Florida Barge Canal System. The bridge consists of three concrete box culverts wide enough to accommodate two traffic lanes. This bridge forms the flow control for the Bypass Channel System. **Photo 4-21** illustrates the existing bridge. **Figure 10** illustrates the location and alignment of the lock access road at the Bypass Channel.

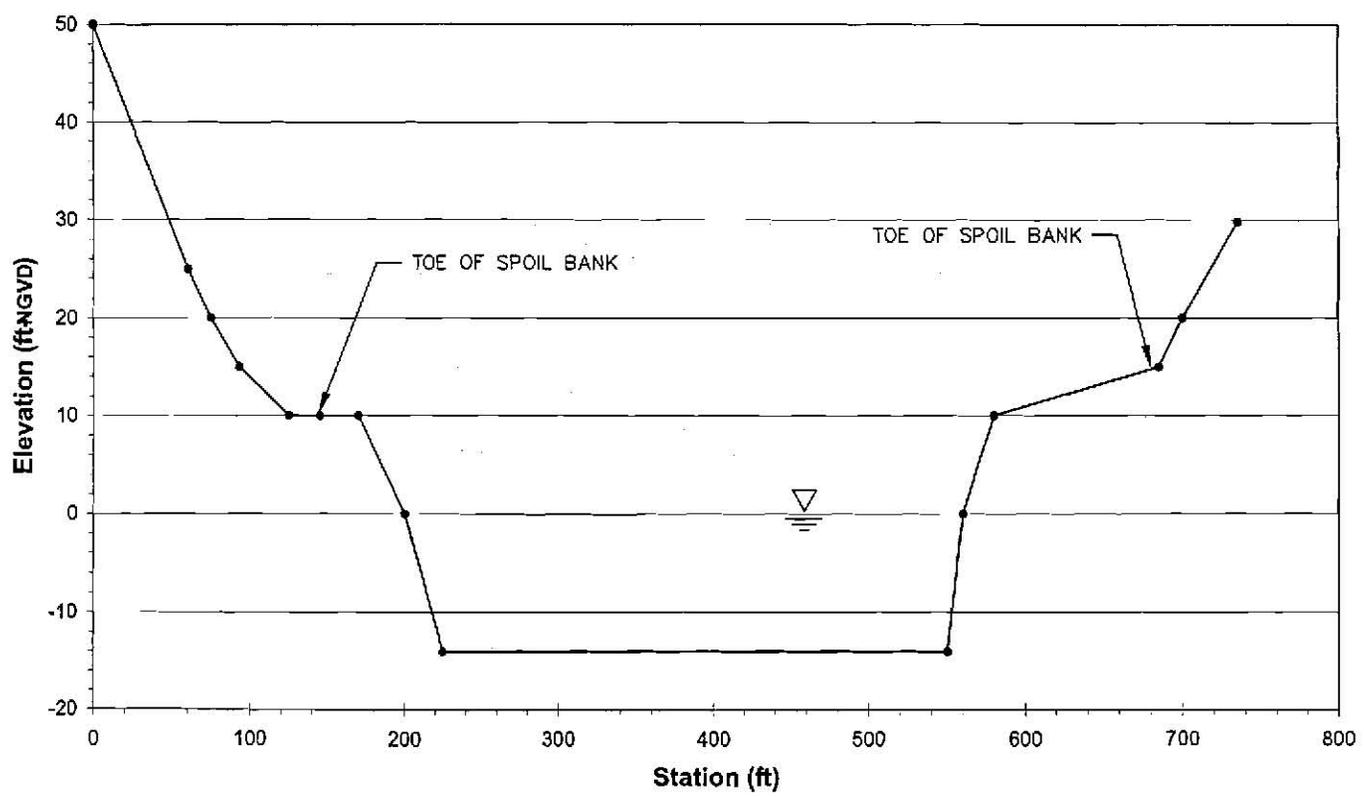
FIGURE 3  
BARGE CANAL CROSS-SECTION  
(Typical)

The Cross-Florida Barge Canal within the west terminus area is approximately 7.4 miles long. The canal begins on its west end at the Gulf of Mexico and terminates on the east end at Inglis Lock. The canal, a prismatic channel, was designed to provide a minimum draft of 12 feet and ranges in width from 350 feet to 500 feet. The Barge Canal has a 1,500 feet long waiting basin at the west end of the lock. **Figure 3** illustrates a typical section of the Barge Canal.

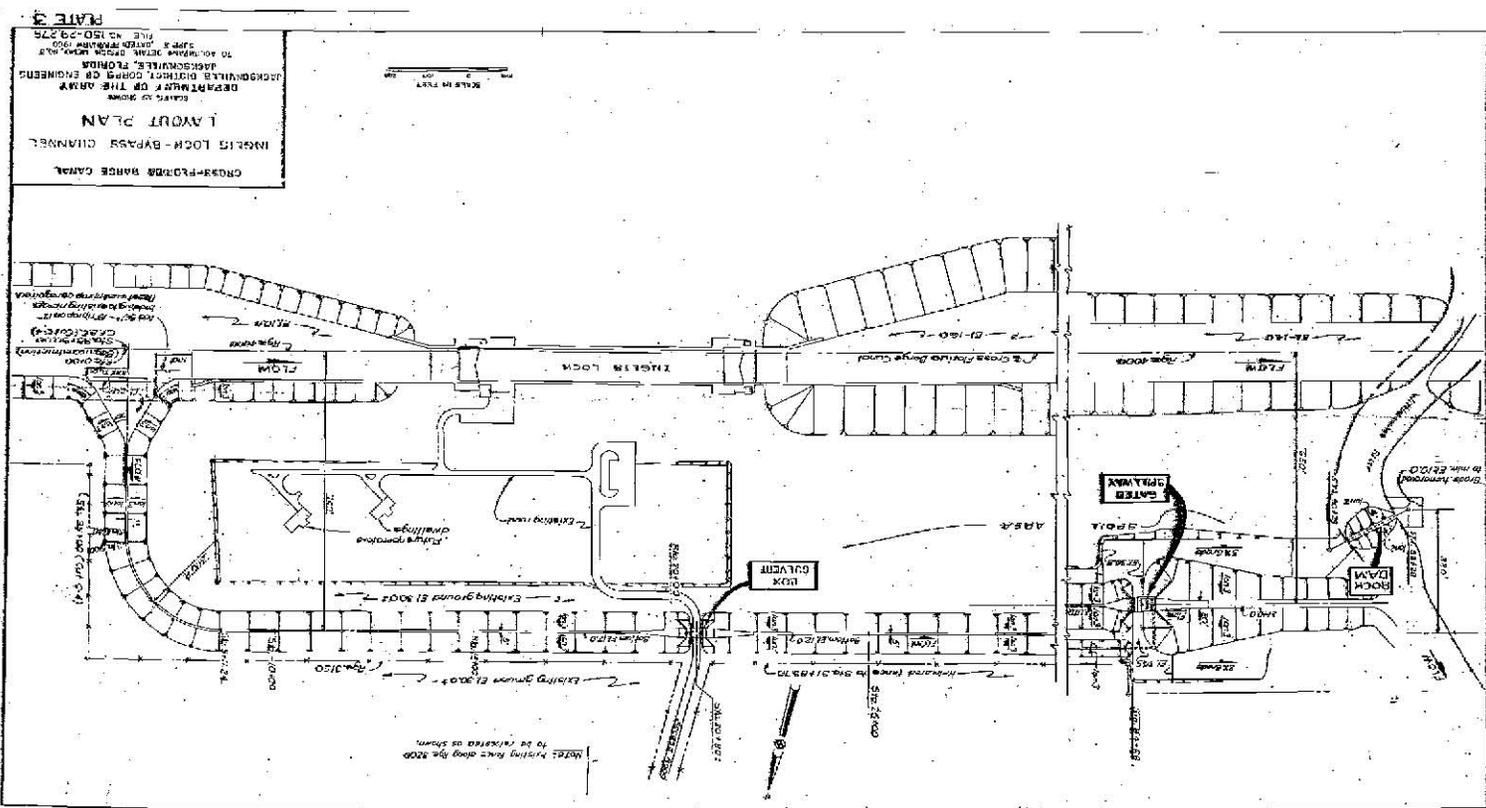
URS Corporation, 7800 West Courtney, Tampa, FL 33607-1440, Project No. 00000002, Figure 10, Bypass Channel System Layout Plan, Date 3/1/00

System Component	Design Data	Plans and Details
(proposed)	<ul style="list-style-type: none"> <li>• Lanes Each Span 2</li> <li>• Clear Span Length 753 ft</li> <li>• Vertical Clearance 40 ft</li> </ul>	
Lock Access Road Bridge at Bypass Channel	<ul style="list-style-type: none"> <li>• Lanes 2</li> <li>• Hydraulic Design Condition:                             <ul style="list-style-type: none"> <li>- Design Discharge 1,540 cfs</li> <li>- Headwater Elev. 26.9 ft-NGVD</li> <li>- Tailwater Elev. (tidal) 26.5 ft-NGVD</li> </ul> </li> <li>• Box Culvert:                             <ul style="list-style-type: none"> <li>- Number of Openings 3</li> <li>- Width x Height 12 ft x 12 ft</li> <li>- Invert Elev. 16 ft-NGVD</li> </ul> </li> </ul>	Figure 10

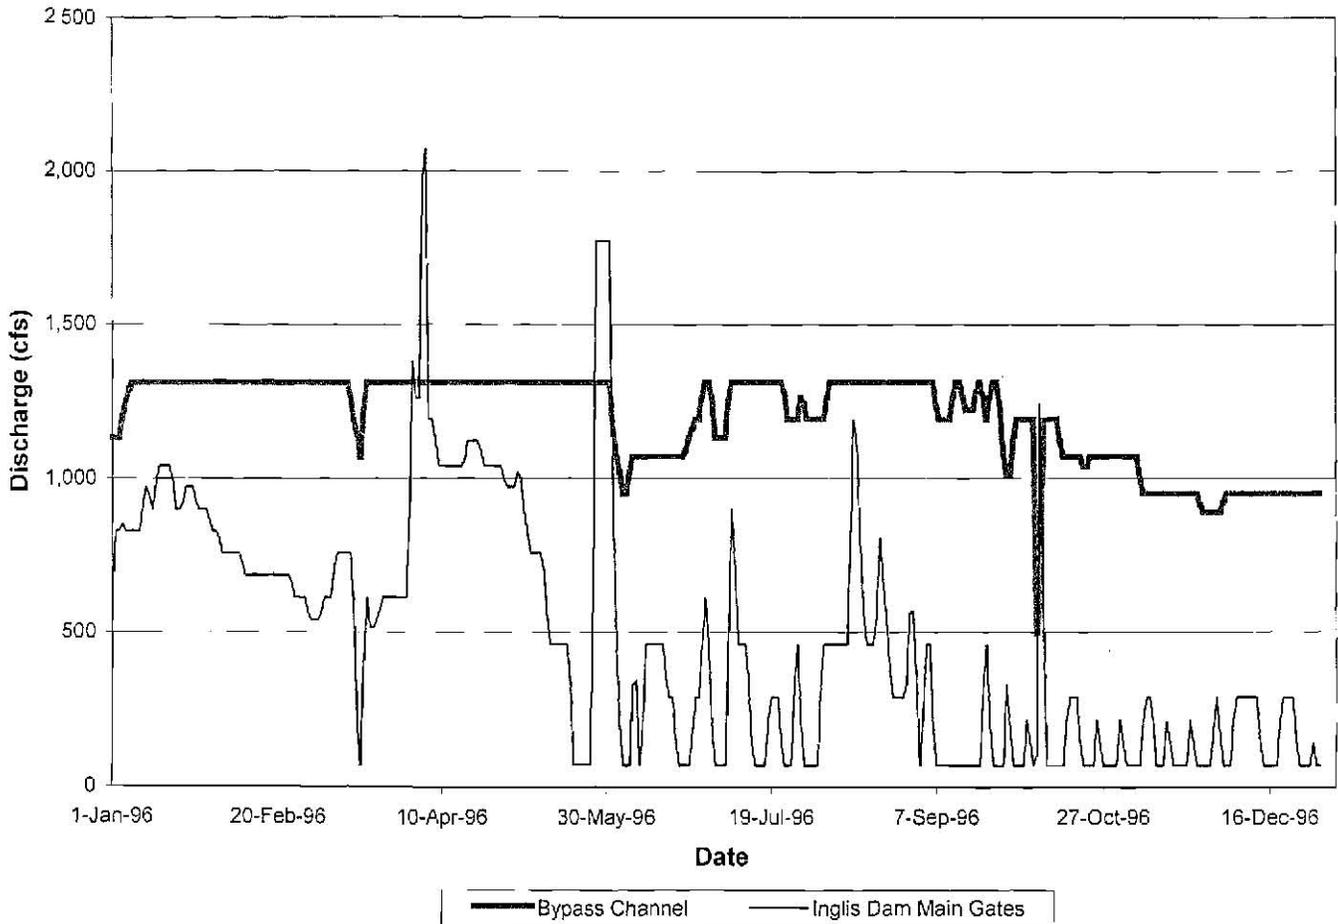
FIGURE 14  
 LAKE ROUSSEAU MEDIAN YEAR DISCHARGE  
 ALTERNATIVE 4 (Baseline Condition)

The flow records for year 1996 were extracted from the period of record for each of the gage stations listed above. **Figure 14** illustrates the "Average Year" flow hydrograph selected for use in the long-term simulations. These hydrographs represent discharges from Lake Rousseau, which will be used as the upstream boundary condition in the simulation models.

As described above, the "Average Year" flow condition was determined to be 1996. The long-term flow hydrograph for the baseline condition (Alternative 4) was determined from Lake Rousseau discharge data. Presently, discharge occurs from Lake Rousseau from two locations, the main gates and the Bypass Channel spillway system. These discharge locations have the associated USGS gage stations listed below:

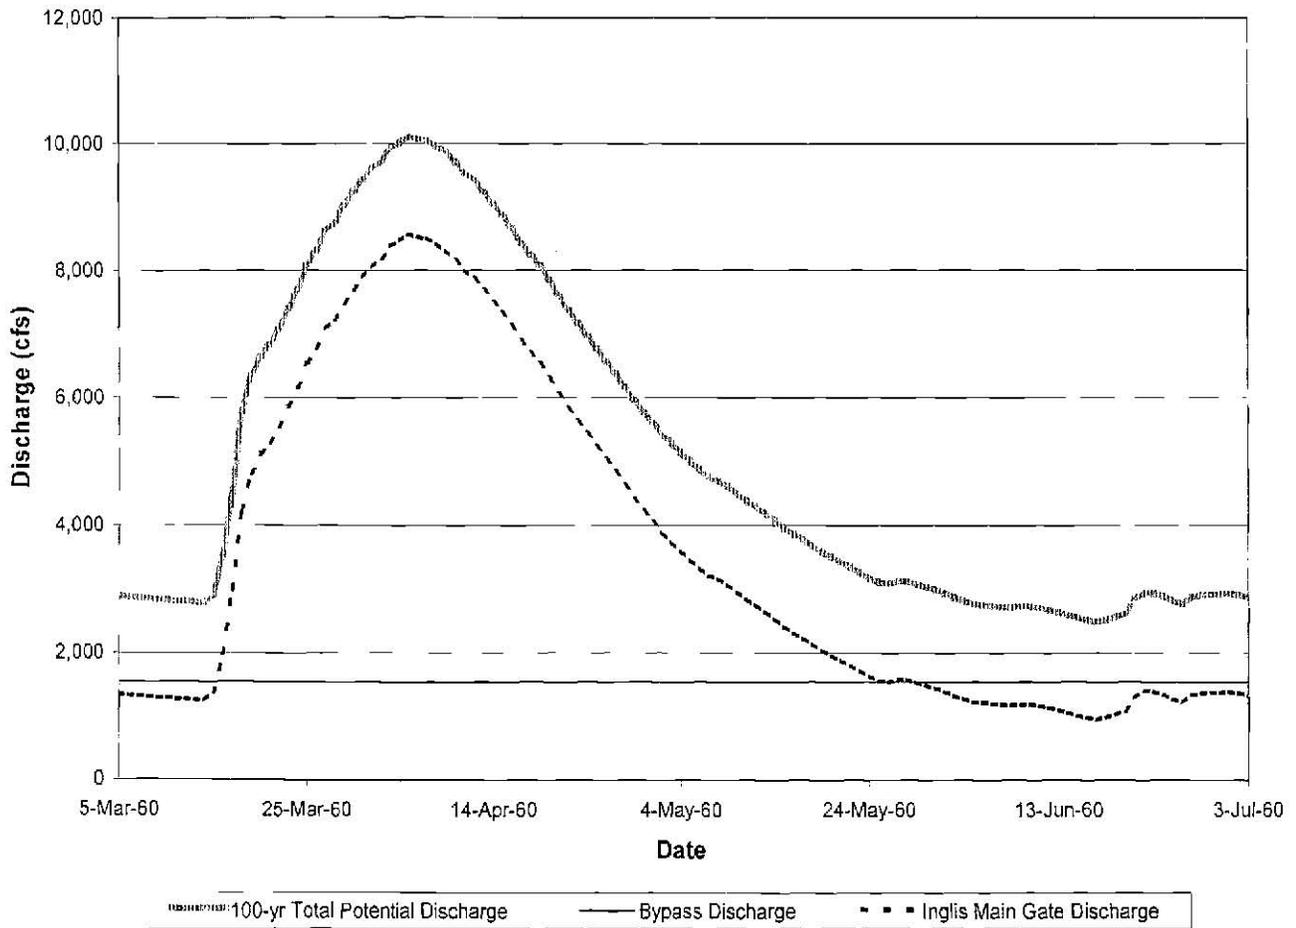
### Lake Rousseau 100-year Discharge Alternative 4 (Baseline Condition)

The estimated 100-year event, total potential discharge hydrograph for the Lake Rousseau system was used to estimate discharge from the system under baseline conditions. For baseline conditions discharge would occur from the Inglis Dam main gates and from the Bypass Channel system via the spillway. For this analysis, it was assumed that the bypass channel would be operated at its maximum discharge capacity of 1,540 cfs. Thus, the remaining flow ( $8,660 - 1,540 = 7,120$  cfs) would be discharged from the main gates, which have a design capacity of approximately 18,000 cfs. The Inglis Dam main gate discharge hydrograph was constructed by subtracting the constant 1,540 cfs flow (Bypass System) from the total potential discharge hydrograph for the Lake Rousseau system. **Figure 15** illustrates the resultant Inglis Dam main gate hydrograph and the Bypass Channel discharge hydrograph.

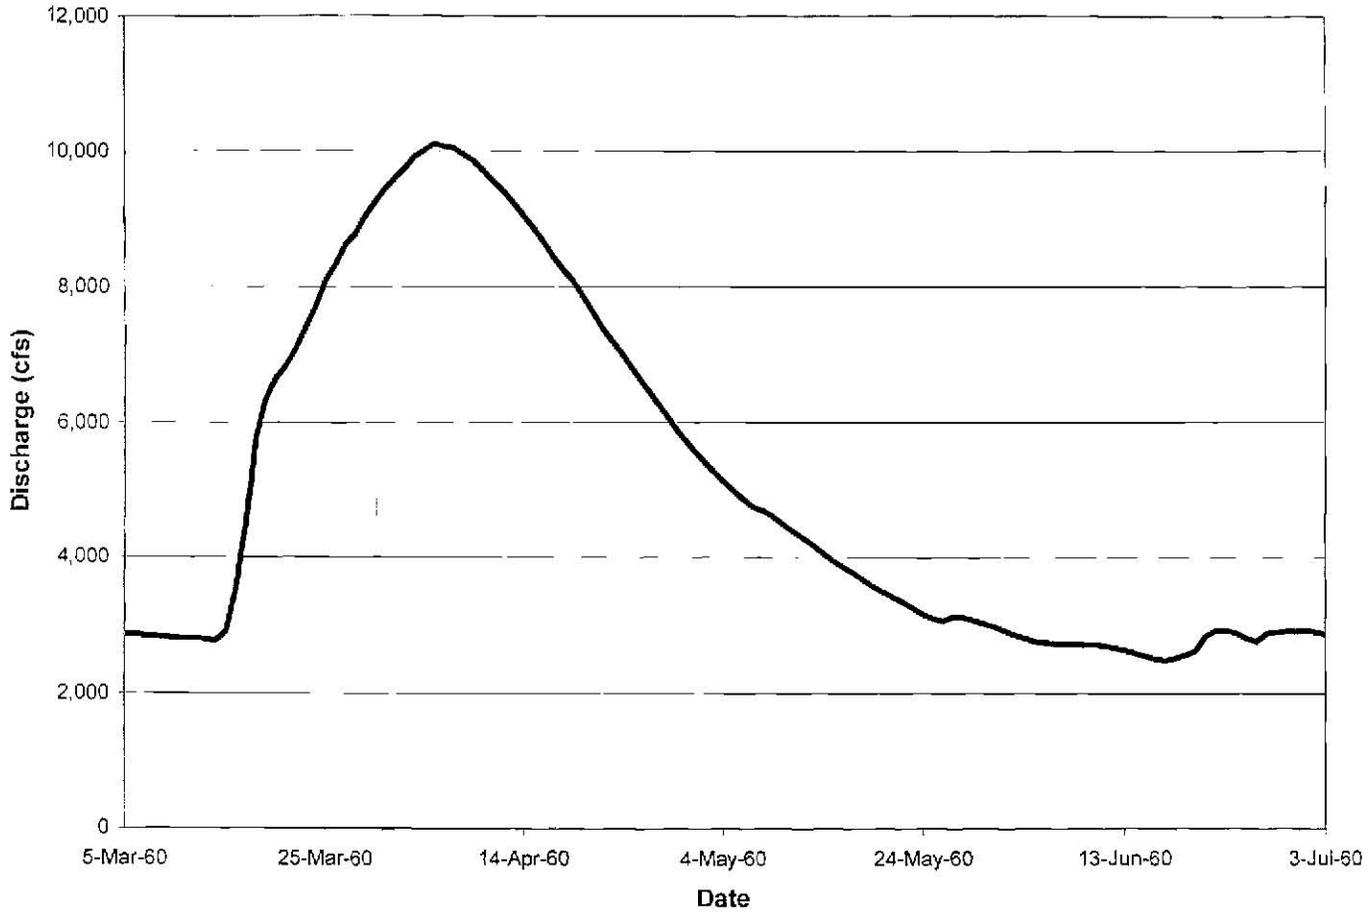
### Lake Rousseau 100-year Discharge Alternatives 1,2 and 3

As indicated in Section 6.3.2, the alternatives proposed as part of this study require a change in the manner in which water is discharged from Lake Rousseau relative to the baseline condition. Proposed modifications to the system that will be assessed include making the Inglis Dam main gates the primary discharge point for the system and re-sizing the Bypass Channel system. This reservoir outflow will be manipulated in the hydraulic study to determine its destination (i.e. all directly to the Withlacoochee, or a portion to a Bypass Channel etc.). For the alternatives modeling, the total potential outflow from the reservoir is required. The total potential discharge hydrograph for the Lake Rousseau system is the hydrograph that will be used to assess Alternatives 1 and 2. **Figure 16** illustrates the discharge hydrograph that will be used for these alternatives. Alternative 3 requires increasing the discharge capacity of the Bypass Channel system. The maximum allowable flow rate of the proposed Bypass Channel system will be determined as part of this study. The allowable discharge hydrograph for the bypass system will be abstracted from the total potential discharge hydrograph for the Lake Rousseau system (**Figure 16**) to develop the Inglis Dam main gate discharge hydrograph.

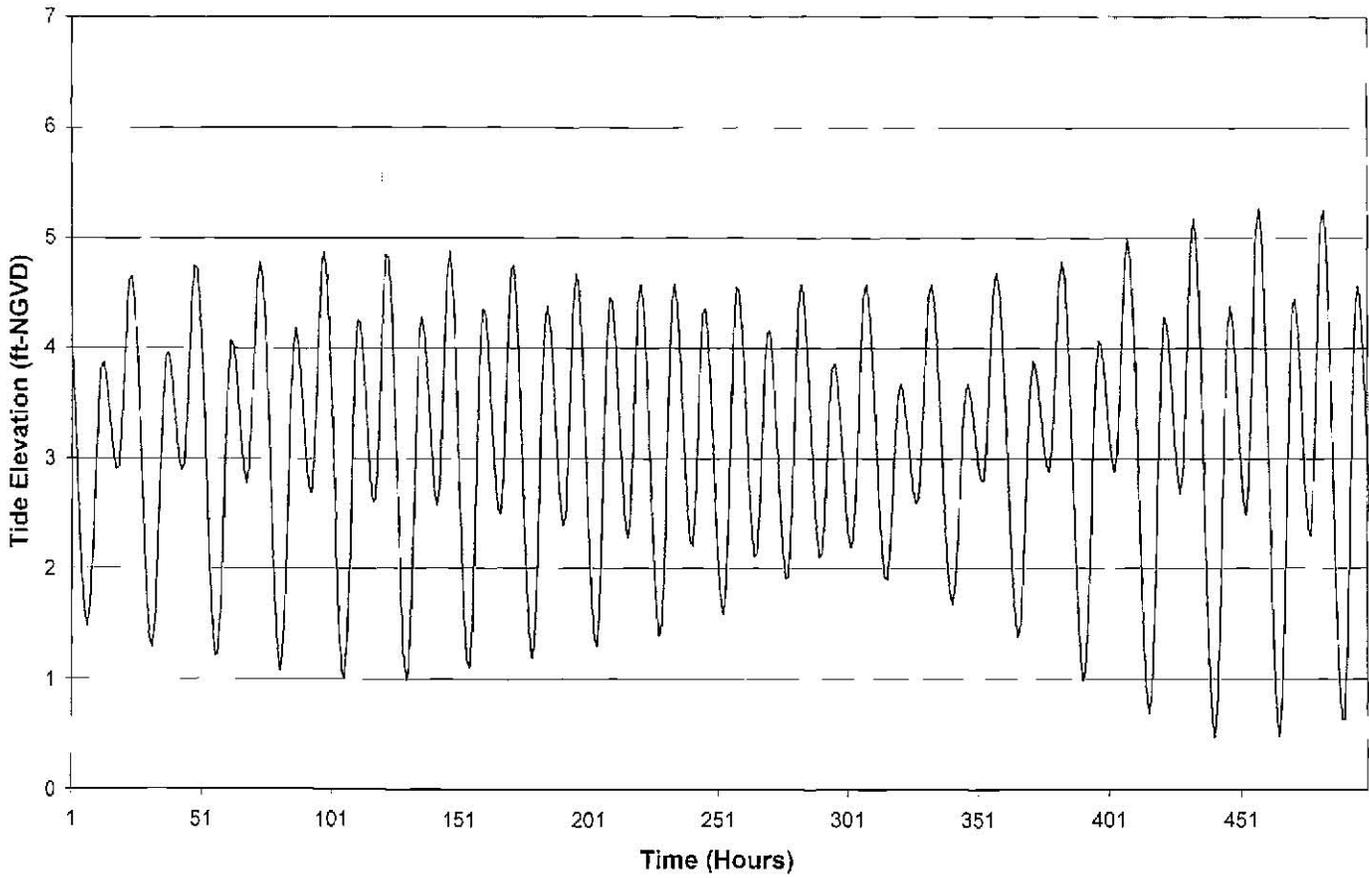
**Withlacoochee River Tidal Variation - Median Year  
Baseline Condition (First 500 hours of 1-Year Dataset)**

An analysis was conducted to determine tidal conditions in the Withlacoochee River. This tidal information was used to develop tide stage hydrographs for long-term flow and flood flow model

simulations. The tide stage hydrographs were used as downstream boundary conditions in the simulation models.
