MILLSTONE POWER STATION UNIT 3
RESPONSE TO REQUEST FOR ADDITIONAL INFORMATION REGARDING
GENERIC LETTER 2004-02

MPS3 RAI 6

RAI 6 Response for Additional Information

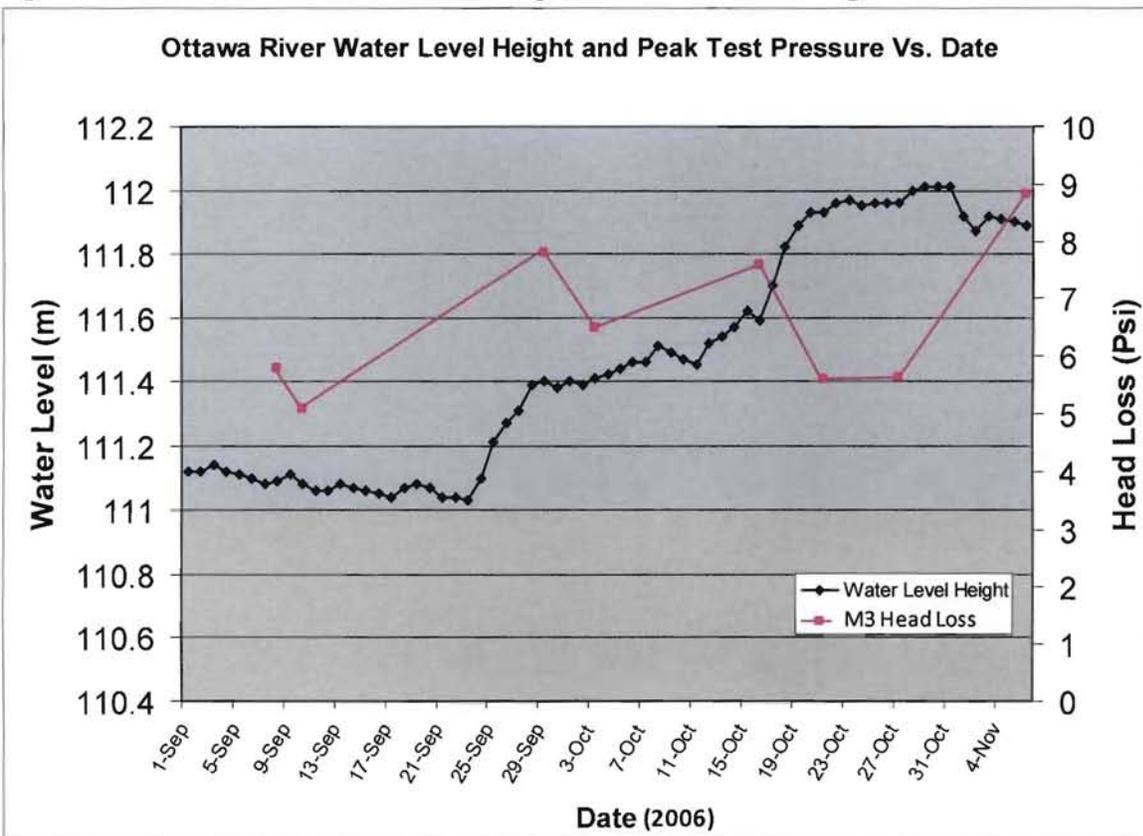
The water level height of the Ottawa River could also affect the concentration of river particles and slime forming organisms. Higher water level resulted in higher peak head loss as shown in Figure 1.

Figure 1: Ottawa River Water Level High and Peak MPS3 Rig 33 Test Head Loss

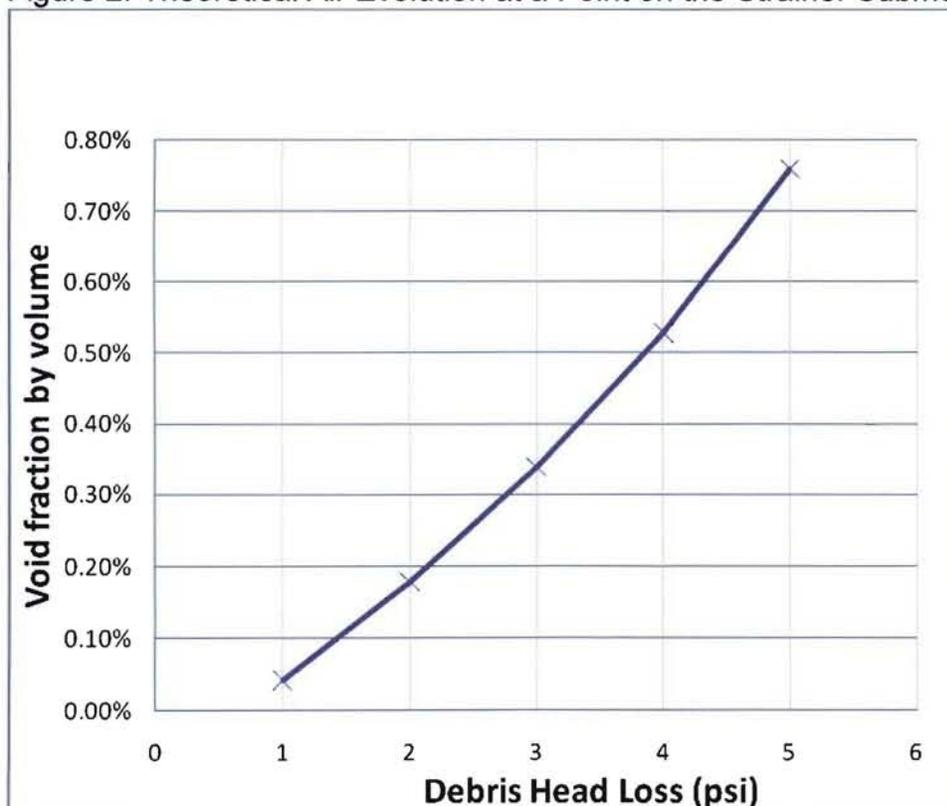
Based on a dissolved air calculation, it was found that air evolution increases significantly as the head loss across the debris bed increases. Figure 2 shows a theoretical plot of how air evolution is affected by debris head. This plot assumes that air will immediately evolve out of solution if it exceeds the saturation concentration.

Figure 2: Theoretical Air Evolution at a Point on the Strainer Submerged by 26 Inches

However, it is likely that there is some time delay and the actual air release would be less than indicated. Nevertheless, for a relatively small head loss, air evolution is very low and it starts to become more significant as head loss exceeds approximately 2 psi. The tests performed for other Dominion plants had head losses less than 2 psi, which was not enough to cause significant air evolution.

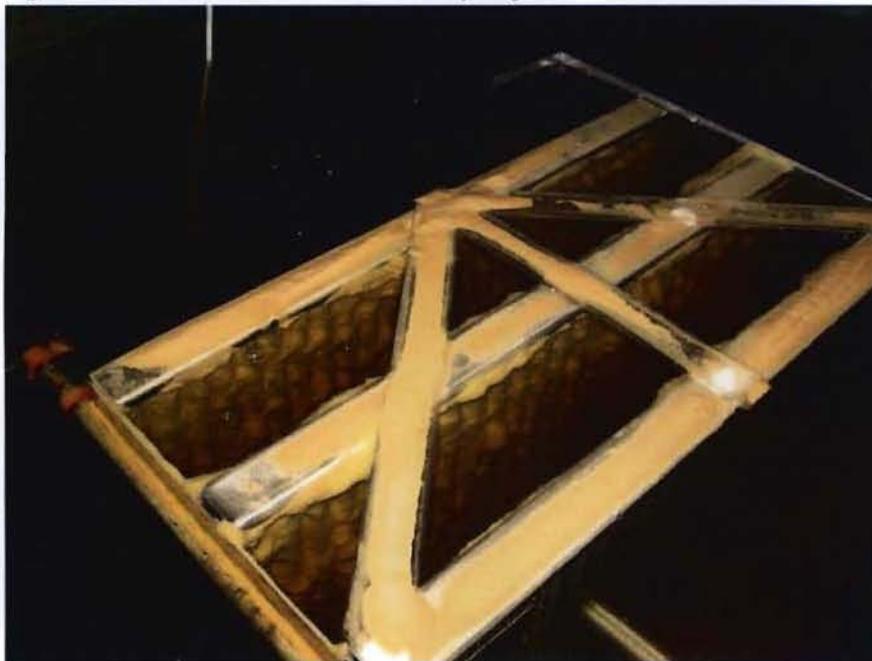
The two photos below show air bubbles observed in the MPS3 reduced-scale test (Figure 3) and large-scale test (Figure 4).

Figure 3: Air Bubbles Observed Erupting from Fin Channels at Pump Stop in Test M3-16

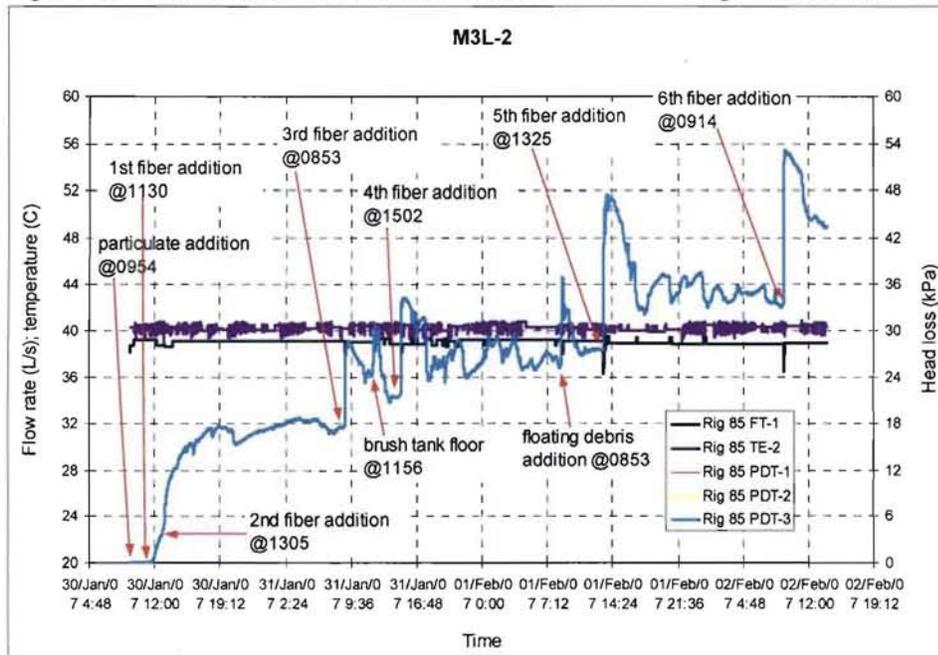
As soon as the fibers reached the debris bed, the bubbles started to migrate into the debris bed, blocking flow area and causing the head loss to increase. The increasing head loss caused the generation of more bubbles within the bed, which, in turn, caused a further increase in head loss. Once the debris addition was completed and no new bubbles were developing at the debris bed, the continuing migration of air bubbles through the debris bed into the fins began to decrease, unblocking flow area and causing further head loss decreases. Eventually, the rate of air generation decreased to become equal to the rate of air migration, and the head loss stabilized at a lower value than the peak value.

Figure 5: Head Losses vs. Debris Addition in MPS3 Large-Scale Thin Bed Test

The observed head loss spike after the fourth, fifth and sixth fiber addition was due to the air bubbles trapped inside the fibrous debris. Microscopic examination of fibers prepared in a similar fashion (i.e., using a pressure washer to agitate and break up the clumps of fiber) showed that air bubbles were attached to the fibers (see Figure 6). It was the air bubbles that initiated the pressure spikes, not the fibers.

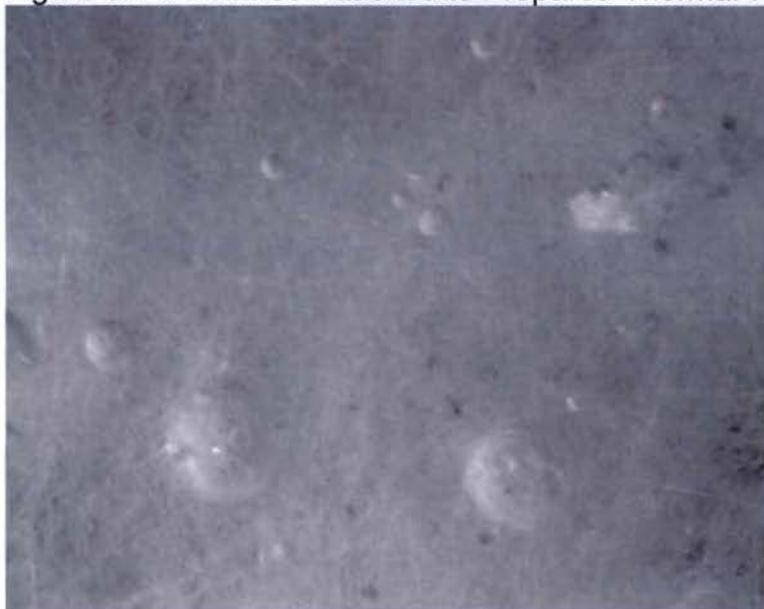
Figure 6: Air Bubbles Attached to Prepared Thermal Wrap Fiber

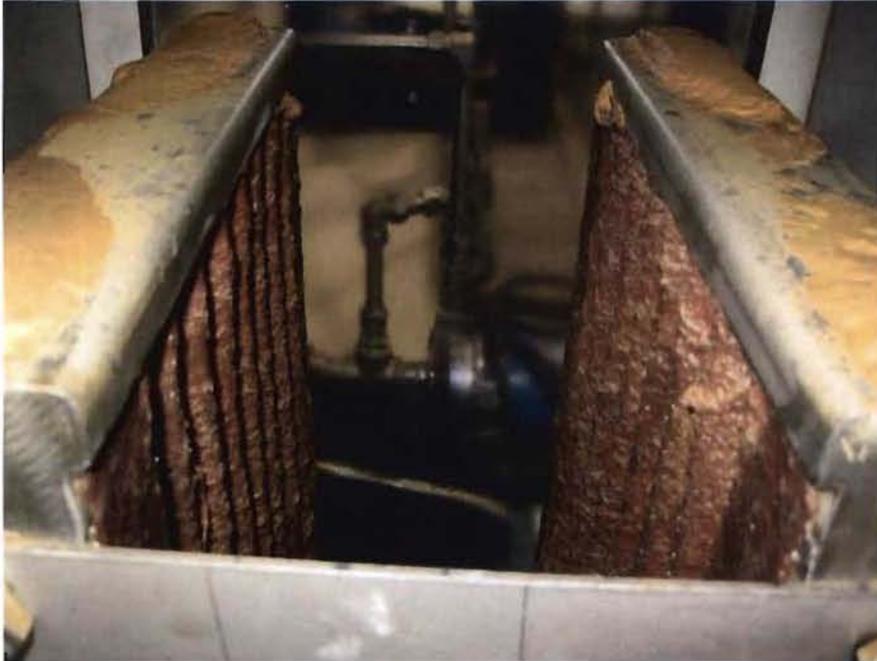
Figure 7: Debris Bed at the End of MPS3 Chemical Effects Test

The potential for the lower head loss in the Rig-89 testing to have been caused by agglomeration of fibrous debris was very low. Fibrous debris was sprayed as "single fine" by using a high pressure jet flow in a 200 liter plastic barrel. The sprayed fiber was then added into the in-line debris addition tank. The debris addition tank was equipped with a stirrer. After a batch of fibrous debris was added into the tank, the stirrer was activated to suspend the fiber and to avoid debris settling or agglomeration. The debris addition tank was then valved-in to let the fiber flow to the strainer box slowly by adjustment of the in-line control valves. Figure 7, Figure 8 and Figure 9 show that after the test, the debris bed was firm and uniform. No fibrous debris clumps were observed. The reasons for lower non-chemical head loss in Rig 89 are unclear, however sufficient margin exists as described above, to account for the higher Rig 33 non-chemical head loss results, along with the head loss due to chemical precipitants found in Rig 89.

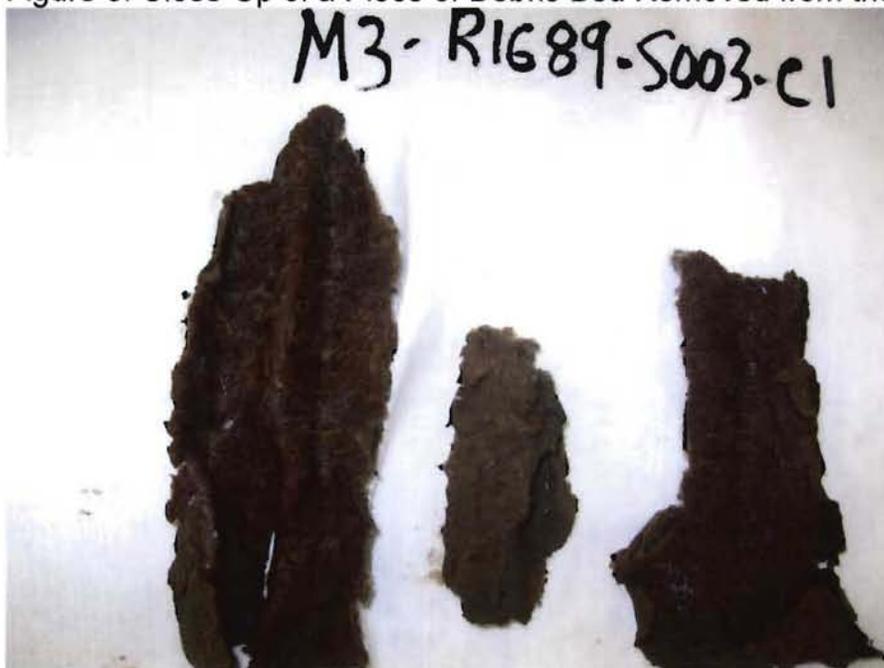
Figure 8: Close-Up of a Piece of Debris Bed Removed from the Strainer Surface

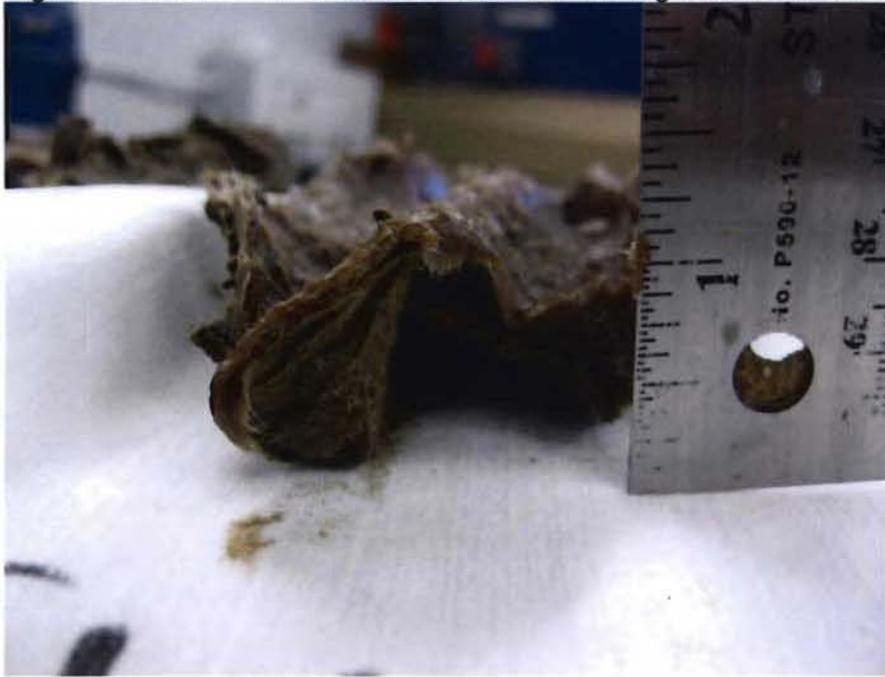
Figure 9: Debris Bed Thickness after MPS3 Rig 89 Chemical Effects Test
