Oconee Information for 09/21/2009 (Modify/Update)

Risk Significant / Emergent Activities:

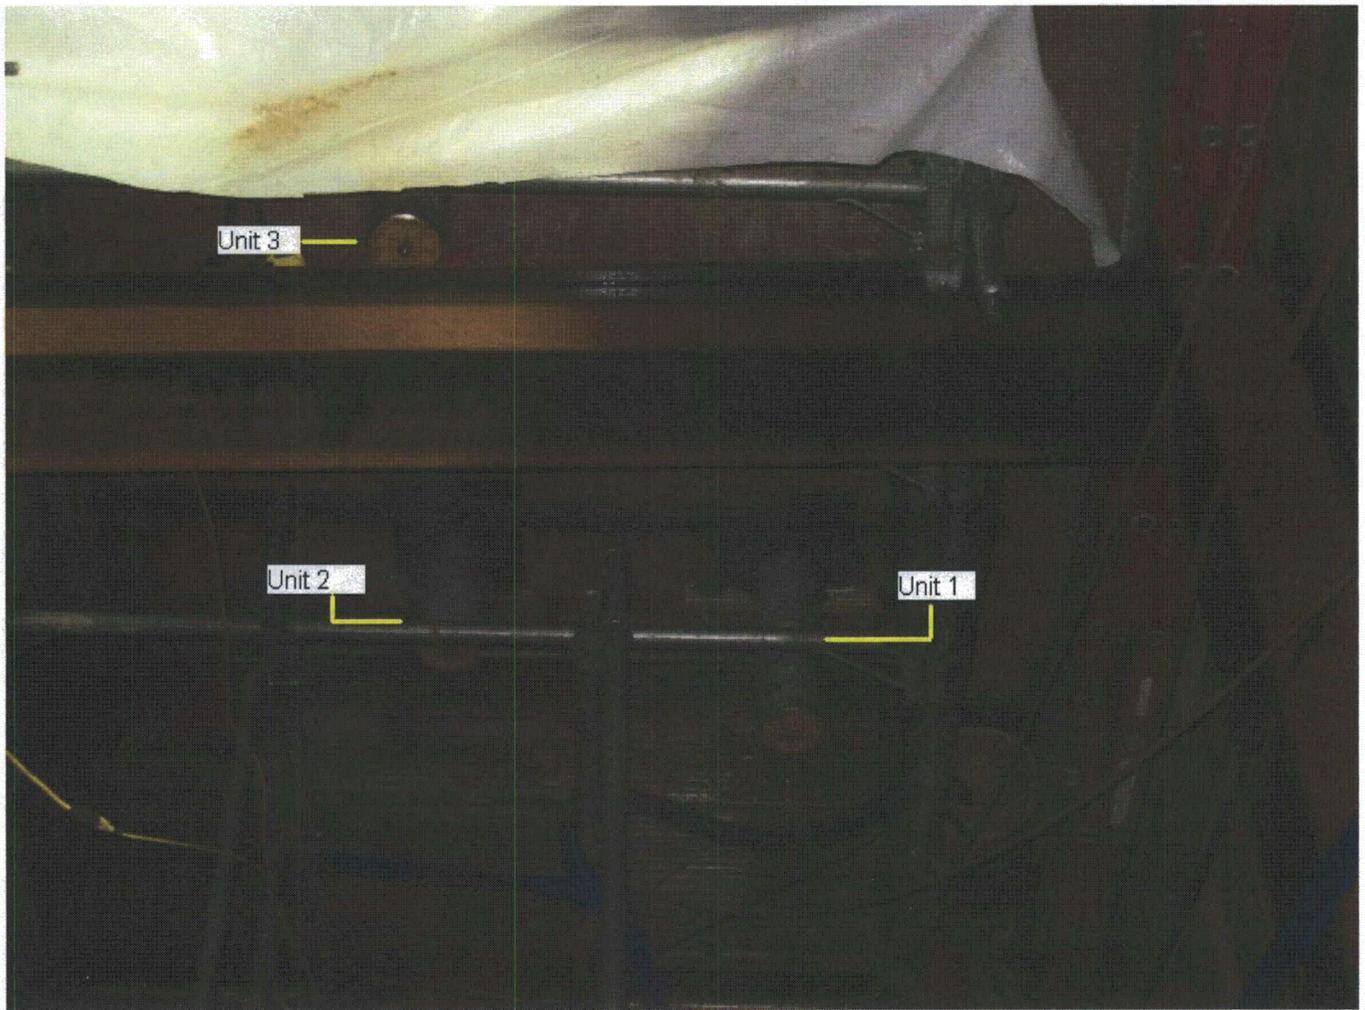
ASW Piping thru SSF wall.jpg

Work on the ASW piping replacement was impacted by the severe weather this weekend (heavy rain). Little additional excavation was performed; however, the three pipes through the outer wall in the SSF were installed. All of the piping is in-place inside of the building and final fit-up and welding will take place over the next two days. Eric Michel has provided the RI's with several codes that apply to the planned tie-in work this week regarding the coating of pipes and protection of the buried sections. This will be discussed with the project leads and inspected in the field.

(Attached photo shows the new piping coming through the SSF outer wall - penetrations have been sealed to prevent water intrusion)
