BLN COL 2.5-1 BLN COL 2.5-5

FIGURE 2.5-308 Construction Photograph, Unit 1

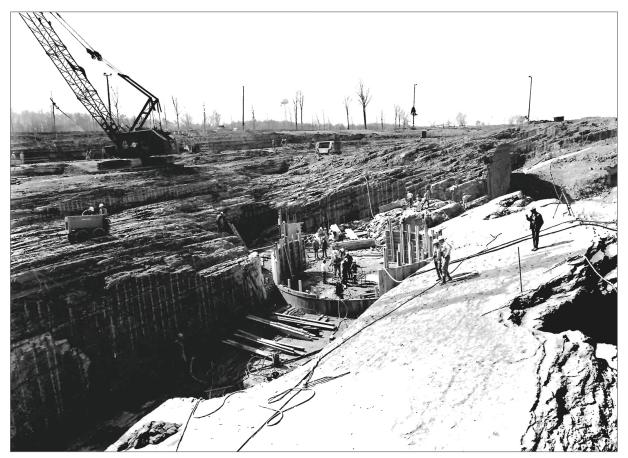
1975 Excavation for Unit 1 reactor, showing dipping beds of hard, fresh limestone
