PSEG Power, LLC  
PSEG Site ESPA  
Part 2, Site Safety Analysis Report

FIGURE 2.4.6-10 Rev 0

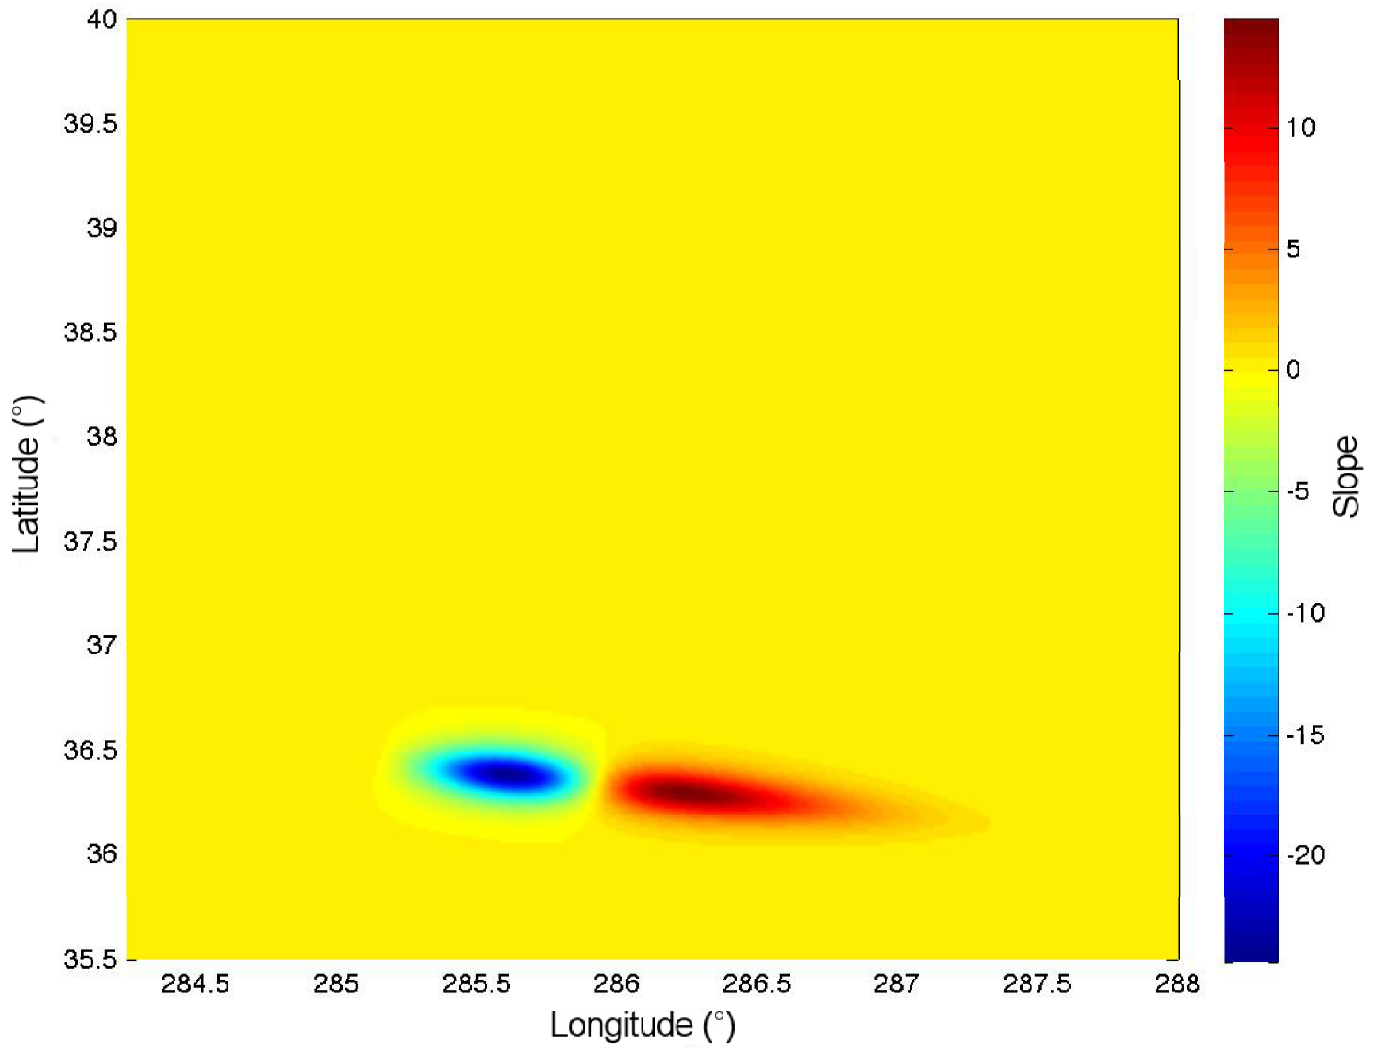
Initial Water Surface Elevations  
at Source Currituck Slide Case
