PSEG Power, LLC
PSEG Site ESPA
Part 2, Site Safety Analysis Report

FIGURE 2.4.6-18

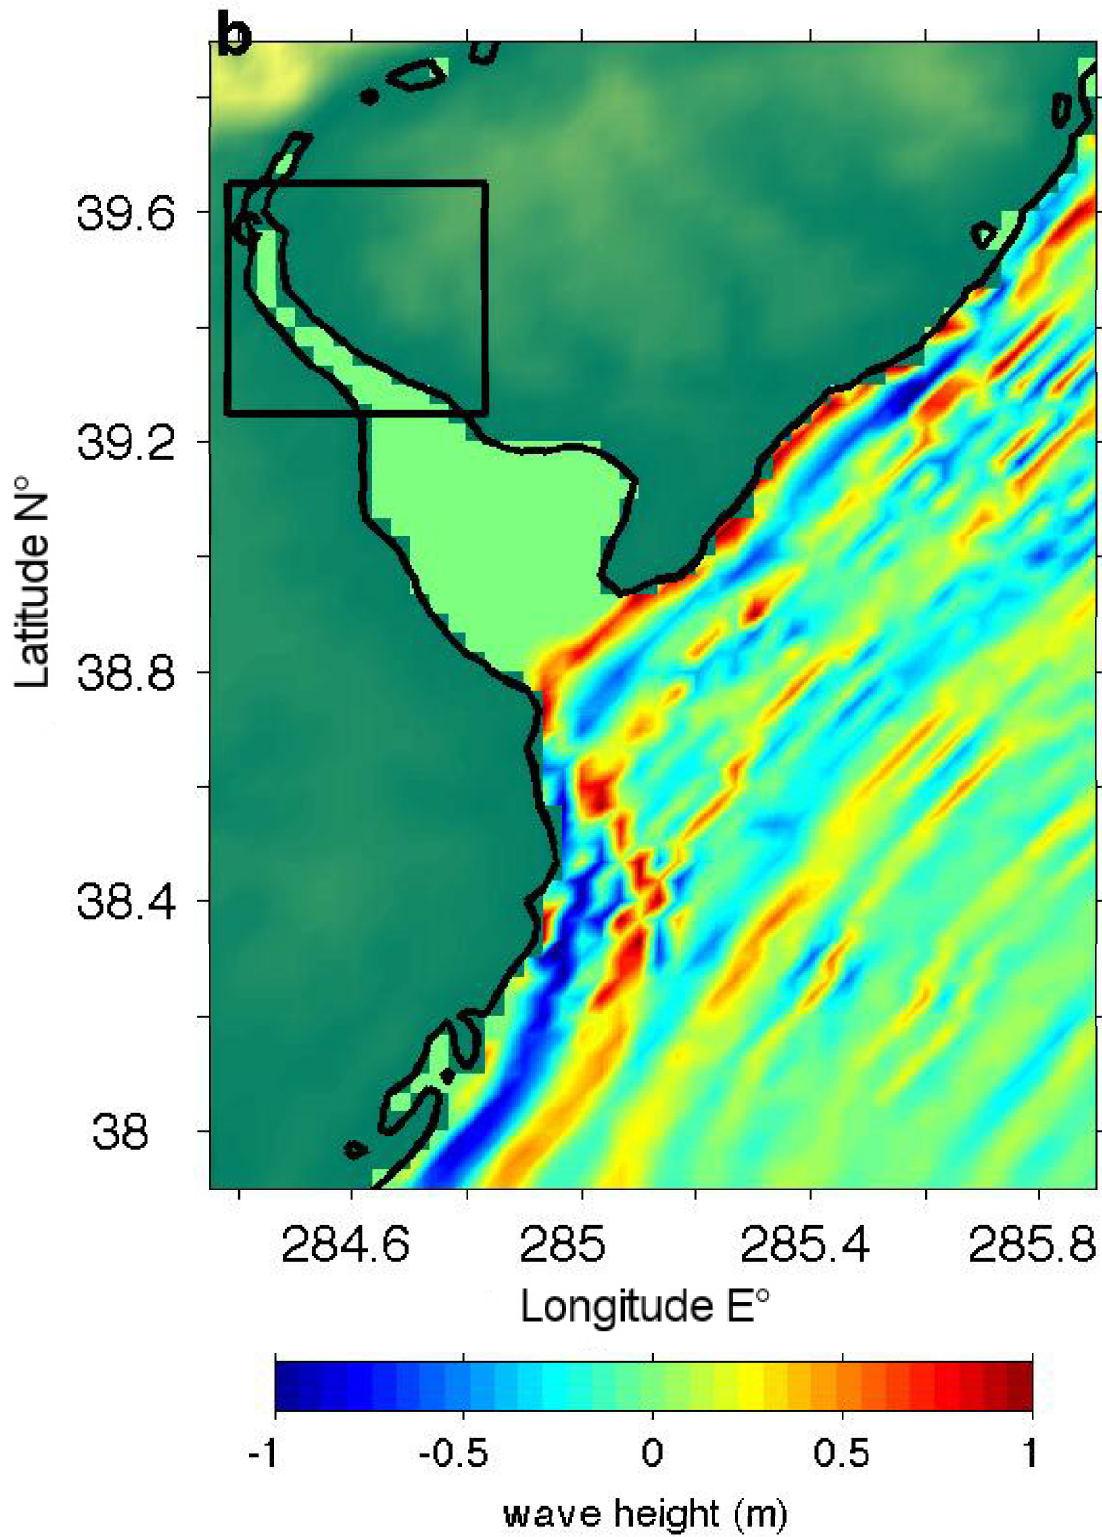
2-D Image for La Palma Slide
at 09 hours
