**Chemtura
Middlebury Connecticut
Site**

**Building Decommissioning
and Final
Radiological Status Report**

Radiation Safety Associates, Inc.

June 22, 2011

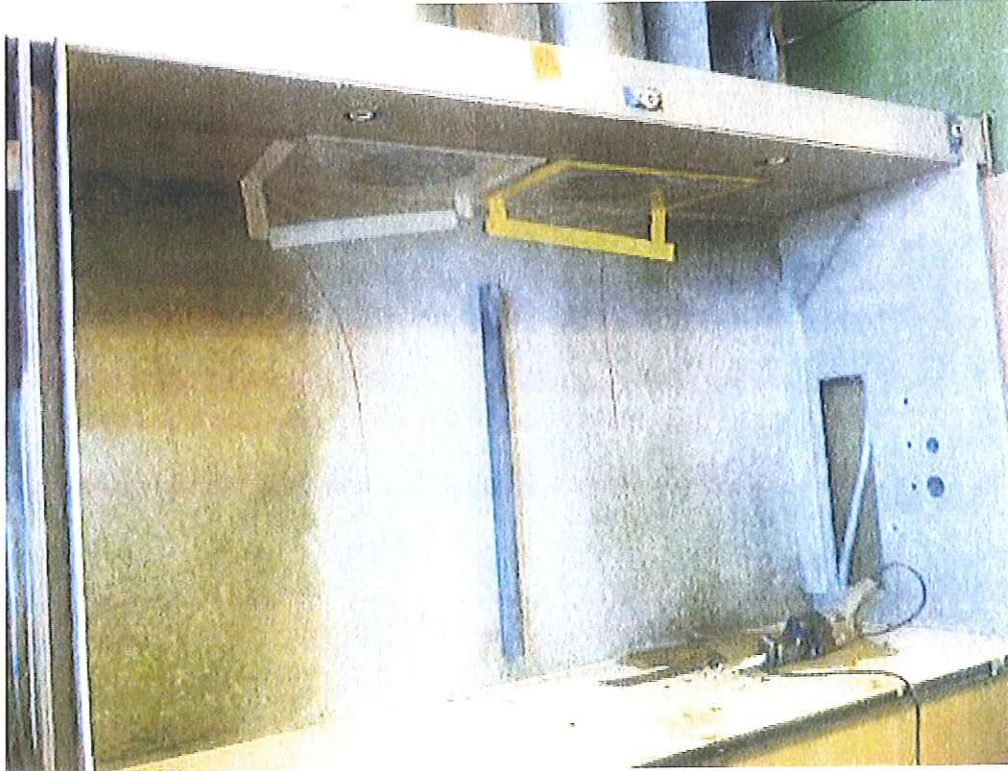
4. Spray the interior of the fume hood with a solution of Simple Green[®] and water and wipe dry. See Figure 5.

Figure 5. Interior of an 8-foot fume hood (Room 1205) with most of the metal components removed. The Transite® (asbestos) side panel as well as all the gas fittings has been removed. The clean area in the back shows that decontamination has been attempted. Non-abrasive decontamination of the Transite material was largely unsuccessful.

5. Perform a direct survey on the hood interior. If contaminated to greater than the Regulatory Guide 1.86 levels, designate for disassembly and disposal as radioactive waste. If not, perform wipe tests. If within limits, mark as clean and leave in place.
6. Survey ducting leading out of the hood. If removable or total contamination exceeded Regulatory Guide 1.86 levels, decontaminate and resurvey. If contaminated to greater than Regulatory Guide 1.86 levels after two decon attempts, designate for disassembly and disposal as radioactive waste. If within limits, leave in place.

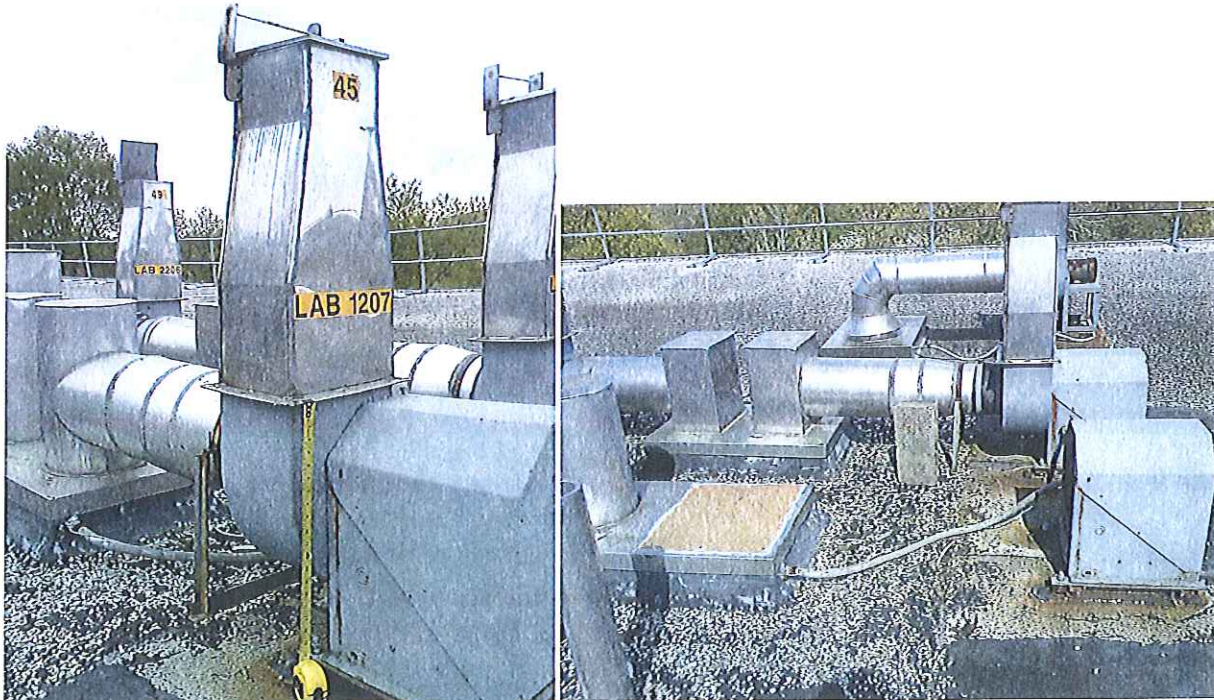
All the ducting from fume hood #45 in Room 1207 had to be removed. This included the hood damper, the blower on the roof and the discharge stack on the blower outlet. Wipe surveys taken on the roof indicated that no contamination was present. See Figure 6 for a view of the roof-mounted components, and Attachment DD for the results of roof contamination surveys. The ducting between hood #51 in Room 1206 and the damper was removed. The damper and ducting from the equipment chase to the roof met the acceptance criteria.

Figure 6. Roof-top ventilation ducting, blower and chimney for hood #45 in Room 1207 (left). Photo on right shows that the blower and ducting have been removed. The motor was not contaminated and was not removed.

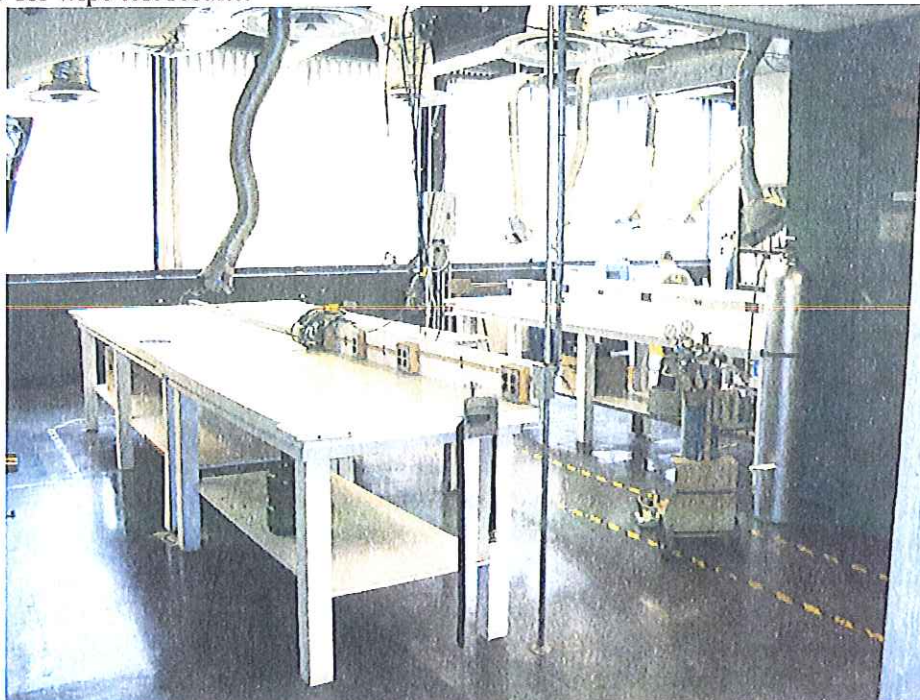
Flexible ducts were present in several of the laboratories though most were in room 1219. All were wipe tested and none were contaminated. See Figure 7 for a view of Room 1219 and Attachment EE, page 3, Lab ID #5-15 for wipe test results.

Figure 7. Room 1219 showing the flexible ducts referred to in this report. None of these ducts were contaminated.

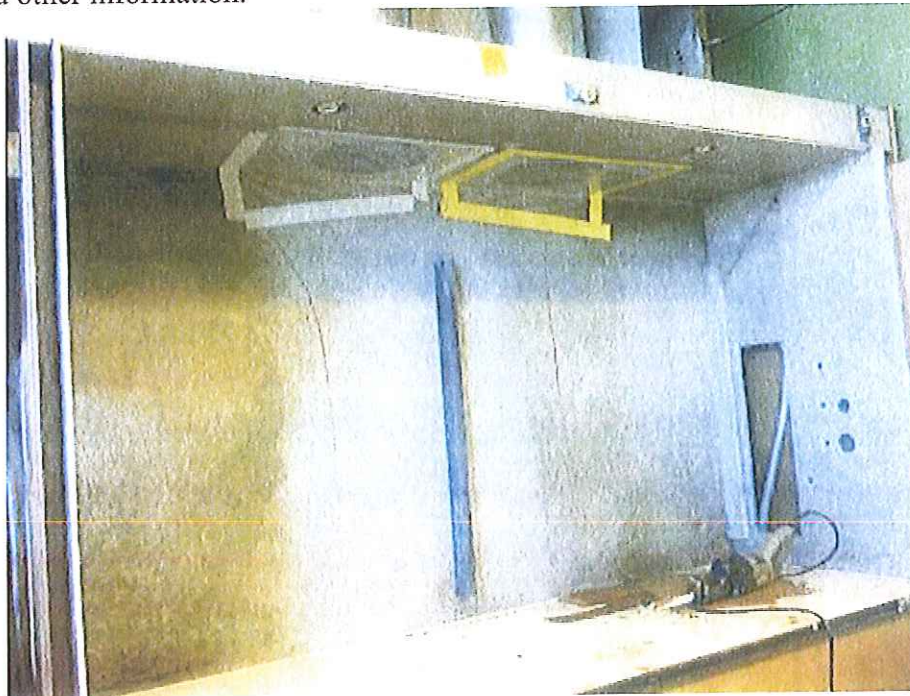
The interiors of eleven (11) of the 29 fume hoods present in the laboratories contained levels of fixed contamination greater than the ALARA goal. In order to save time a licensed asbestos abatement contractor¹² was used to disassemble the rest of the Transite portion of the contaminated hoods. The hood interiors were decontaminated to remove loose contamination prior to the asbestos contractor's arrival so that there was no need for any protective clothing in addition to what they wore for the asbestos work. Decontamination did not significantly decrease the amount of contamination fixed on the Transite. See Figure 8. Attachment OO provides hood locations and other information.

Figure 8. A typical fume hood with steel casing and glass sash removed showing the Transite lining. The bright area on the rear wall is where decontamination was performed. The dark curved lines running from top to bottom indicate the boundaries of the contamination.

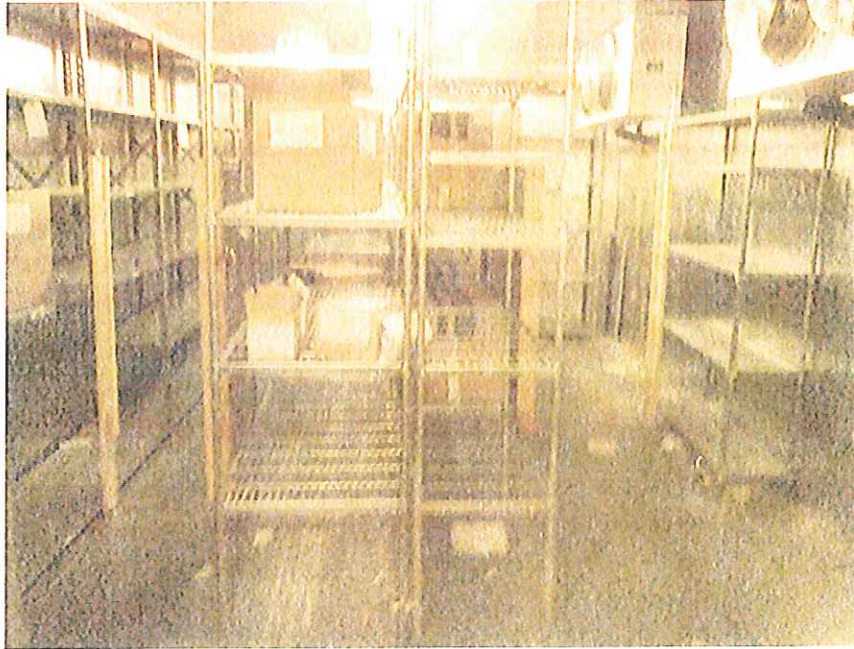
All of the accessible floor area was scan surveyed using the gas proportional floor monitor. Shelves and racks were also scanned with a gas proportional instrument. Wipe samples were also taken and analyzed. No detectable contamination was found. See Figure 10 for a view of the freezer interior and Attachment LL for Final Status Survey results.

Figure 10. Interior of the Walk-In Freezer.

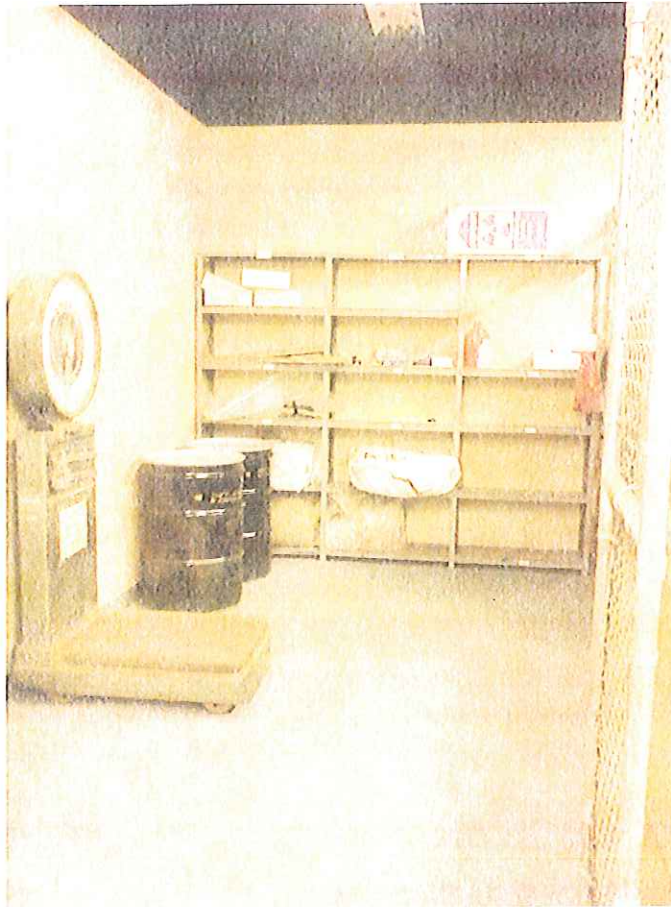
Wipe tests performed as part of the scoping survey showed no detectable removable contamination on the painted floor, walls or shelves. A direct scan scoping survey of this small area (approximately 10 feet by 13 feet) showed fixed contamination on the floor in the range of 3,000 dpm/100 cm² in the general area. Aggressive decontamination only reduced this to approximately 2,000dpm/100cm². A flatbed hand truck in this area was contaminated to levels in the range of 9,000 to 19,000dpm/100cm². This was disposed as radioactive waste. See Figure 11 for a view of this area and Attachment MM for Final Status Survey results.

Figure 11. The Radioactive Waste Storage Area after waste removal and decontamination.
