LICENSE RENEWAL BOUNDARY DRAWING
 LR-M012E REV. 2

BECHTEL ASSOCIATES
 PROFESSIONAL CORPORATION (OHIO)
 6411 THERSBURG, MARYLAND
 DAVIS-BESSE NUCLEAR POWER STATION
 UNIT NO. 1
 THE TOLEDO EDISON COMPANY
 PIPING & INSTRUMENT DIAGRAM
 SCREEN WASH AND COOLING
 TOWER MAKE-UP SYSTEM

JOB NO.	DRAWING NO.	REV.
12501	M-012E	18

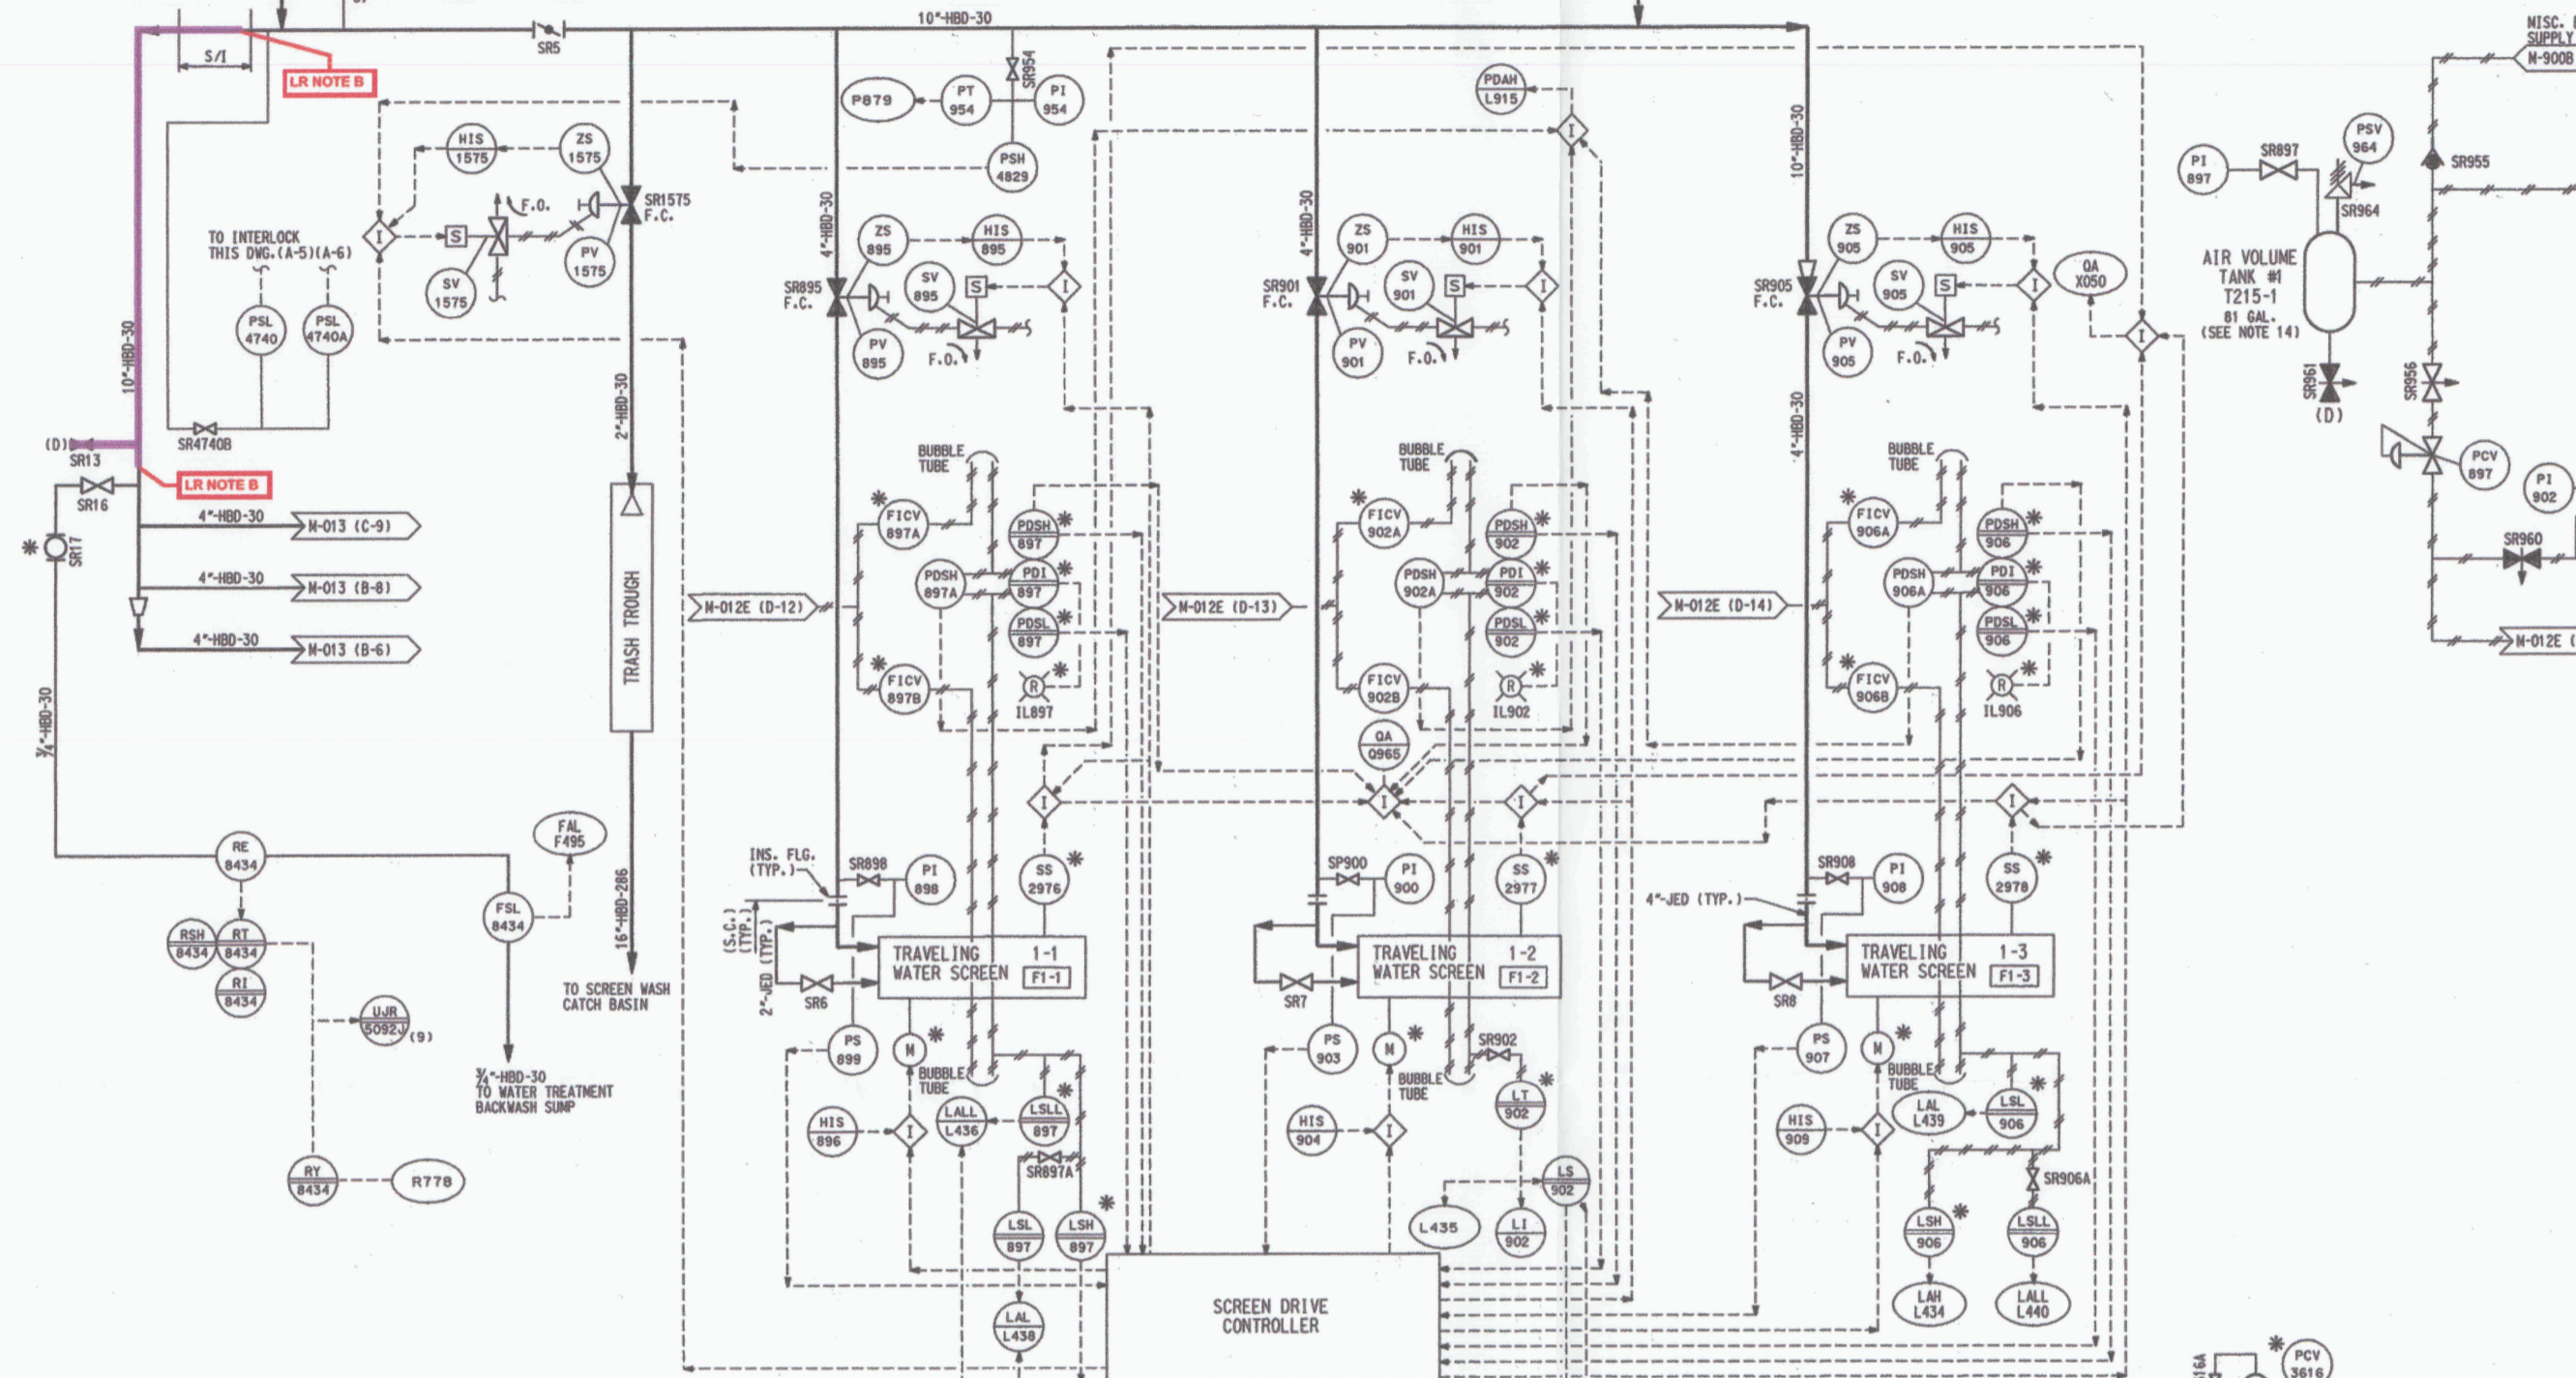
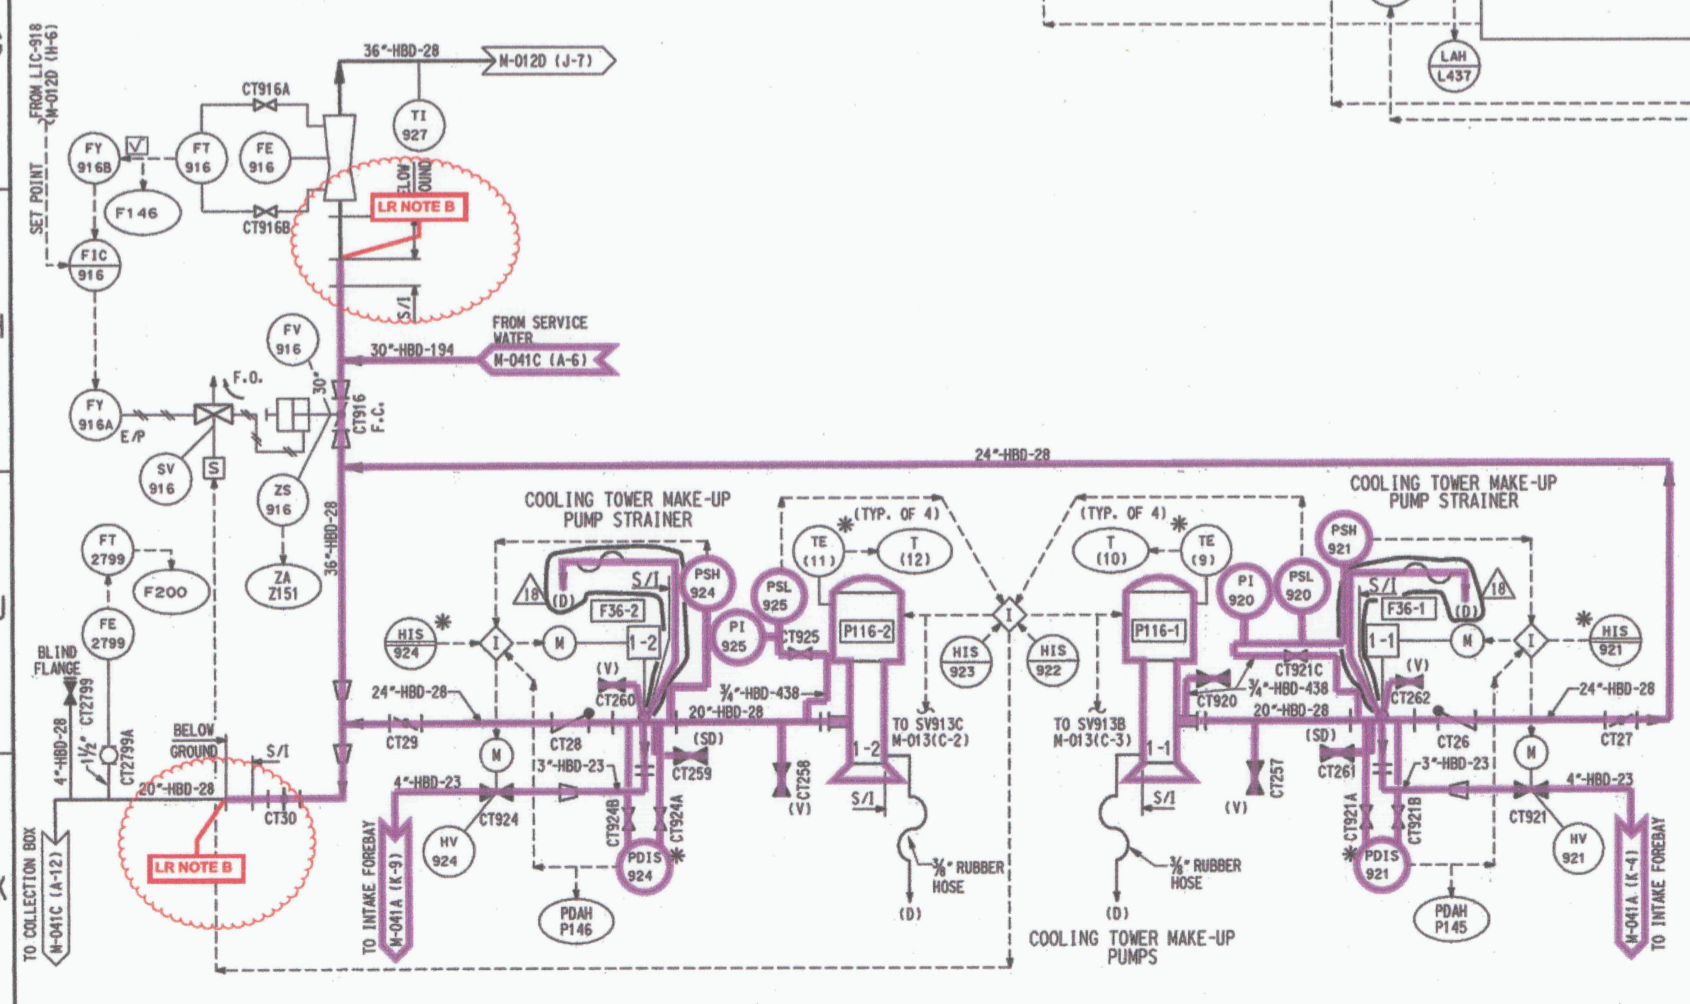
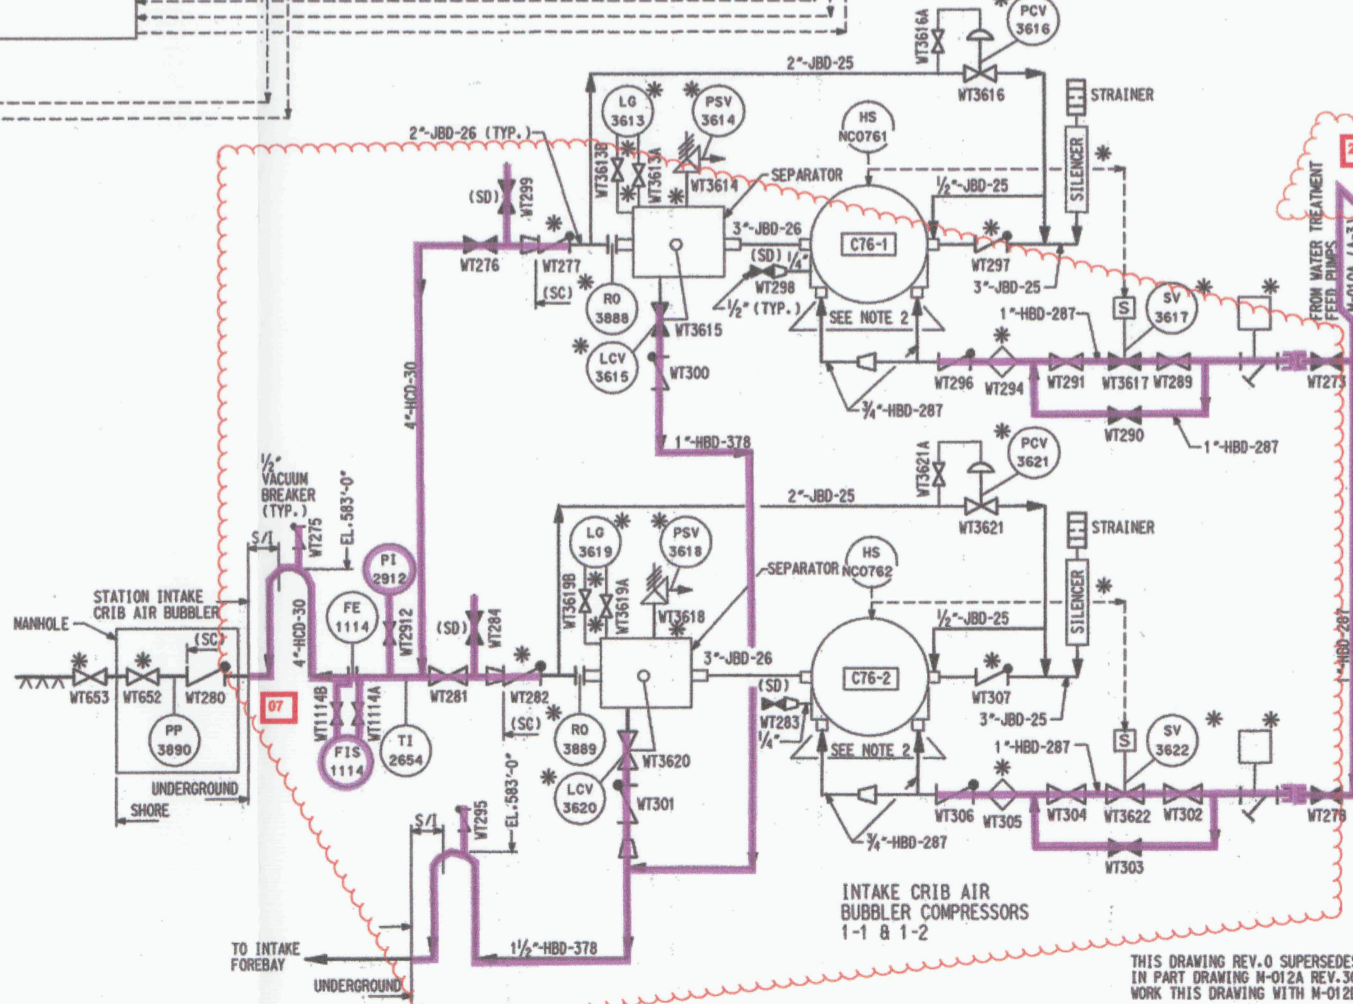
LR NOTES:
 A. FOR GENERAL LICENSE RENEWAL NOTES REFER TO LR-M001-01.
 B. COMPONENTS BEYOND THE HIGHLIGHTING ARE OUTSIDE THE INTAKE STRUCTURE, AND THEREFORE NOT IN SCOPE.

SYSTEMS SHOWN ON THIS DRAWING:
 07. SERVICE WATER
 02A. NONSAFETY-AFFECTING SAFETY
