# **Hot Isostatic Pressing of Metal Powders for Pressure Retaining PWR Components**

**EPRI/NRC Review , 27<sup>th</sup> June 2012**

**Barry Burdett  
Engineering Specialist  
Rolls-Royce**

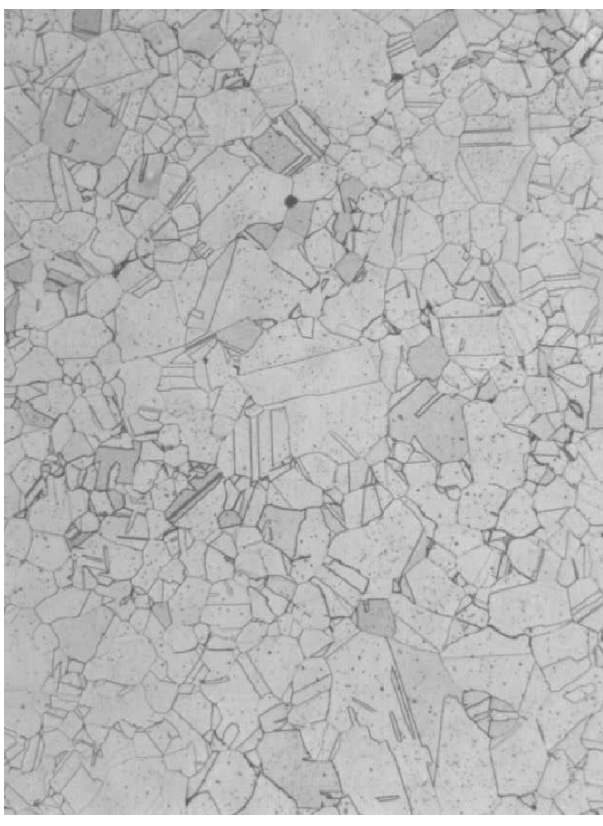
## Type 316L structures (x100)

**HIPped powder (ASTM No. 5)**

- General corrosion and environmentally assisted cracking tests have clearly demonstrated that HIP powder Type 316L material has equivalent or slightly better corrosion resistance than wrought material
- Improvements in corrosion behaviour are considered to be due to the low level of inclusions and uniform microstructure in HIP powder product.
